CRACKED SHAFT DETECTION ON LARGE VERTICAL NUCLEAR REACTOR COOLANT PUMP

L. Stanley Jenkins
Westinghouse Electric Corporation
Cheswick, Pennsylvania 15024

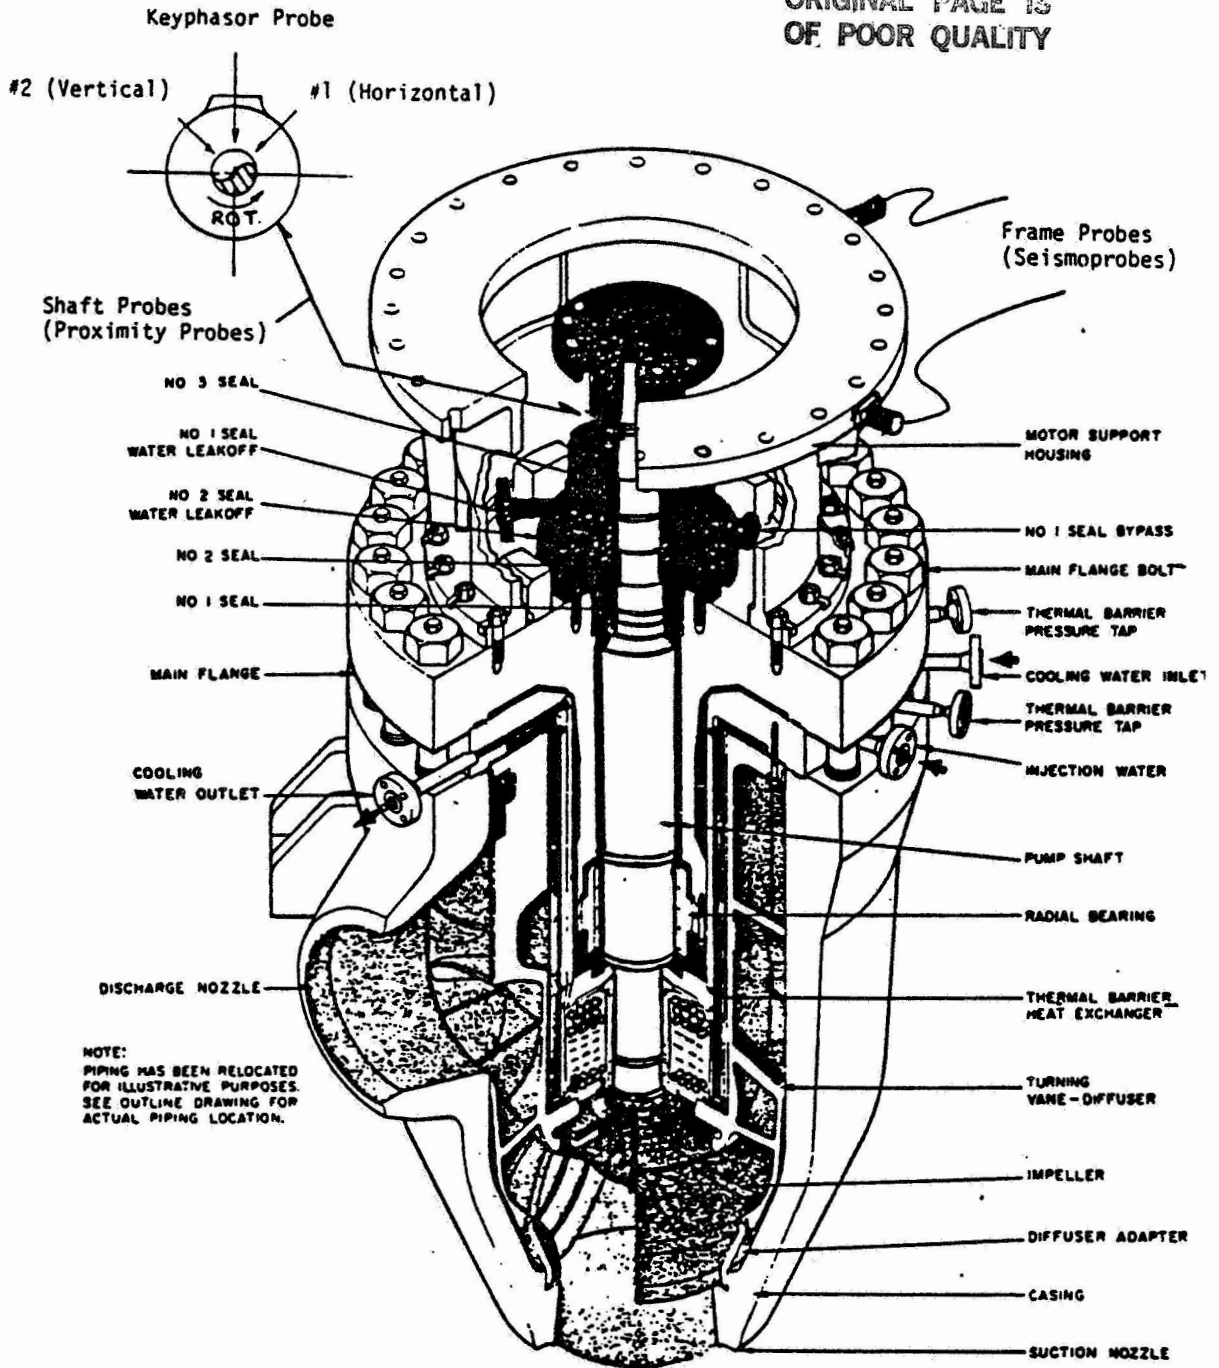
Figure 1. - Cutaway view of typical reactor coolant pump.

Vibration probe locations are shown in Figure 1. This is the standard probe location for all RCP's of this design. The shaft probes "see" the 347 stainless steel shaft surface. Nominal pump shaft diameter is 200 to 230 mm.

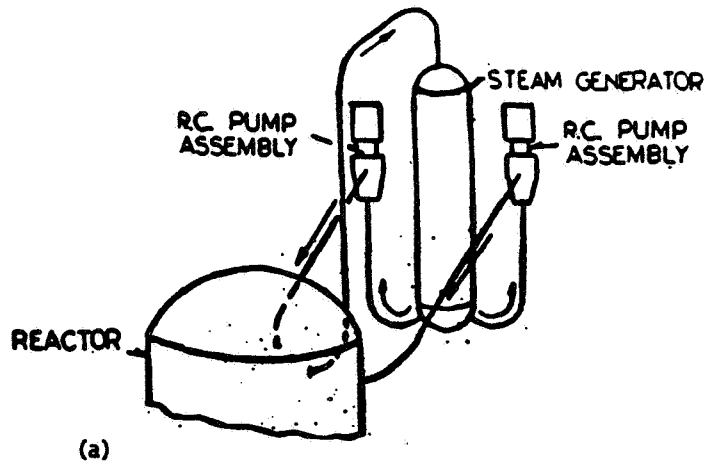
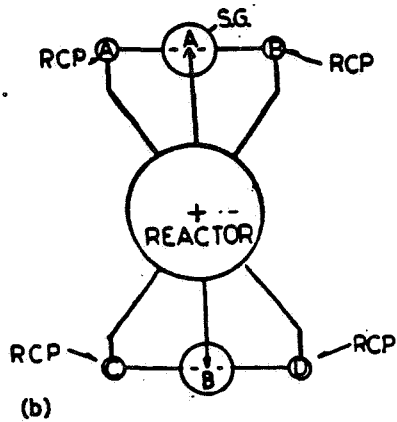
Figure 2. - Piping schematic.

The TMI #1 Reactor Coolant System (main primary piping only) is shown diagrammatically in Figure 2. The range of flows possible with this system design (as a percentage of total four pump operation "best estimate" flow) is depicted in Table 1 for typical combinations of pump operation. The negative values indicates reverse flow in the loop. Increasing flow rates generate radial loads (on the impeller, fixed relative to the casing) which increase approximately as the square of the flow rate. This load is estimated to be in excess of 2300 kgf for single pump operation at TMI #1.

(a) Isometric view of typical primary piping at TMI #1 (one S.G. loop shown).
 (b) Plan view of primary piping at TMI #1.

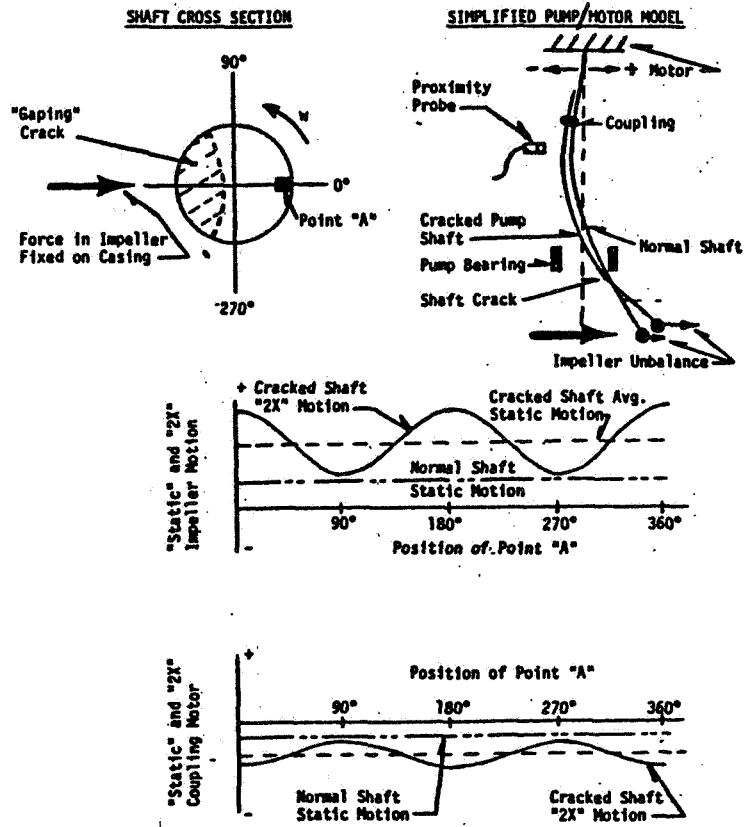
Figure 9. - Dynamic (2X) and static impeller and coupling motion.

The rationale for showing that the observed motion is predictable is more difficult. First of all, it is logical to place the crack below the pump bearing. (The presence of a fixed radial load in the casing, and the observation that balance weight response was normal suggest a crack below the pump bearing.) Then, by utilizing a simplified model of the pump shaft and taking the motor shaft between bearings as a "built-in beam," it is possible to relate a dynamic motion observed at the pump coupling to a stationary -- fixed in the casing -- hydraulic load at the impeller. The end result of this analytical exercise (using the principal of superposition of loadings and deflections to establish the proper phasing of the motions at the impeller and coupling) is shown in Figures 9 and 10. This effect was successful in not only predicting the observed 2X motion qualitatively but also, when the 1X motion is added in (generated by the "hinging" action of the impeller mass below the crack) the observed composite waveform was predicted. Compare Figure 10 with Figure 4 where 1X and 2X amplitudes are nearly equal.
