VERTICAL REACTOR COOLANT PUMP INSTABILITIES

Robert M. Jones
Tennessee Valley Authority
Soddy-Daisy, Tennessee 37379

This paper describes the investigation conducted at the Tennessee Valley Authority's Sequoyah Nuclear Power Plant to determine and correct increasing vibrations in the vertical reactor coolant pumps. Diagnostic procedures to determine the vibration causes and evaluate the corrective measures taken are described.

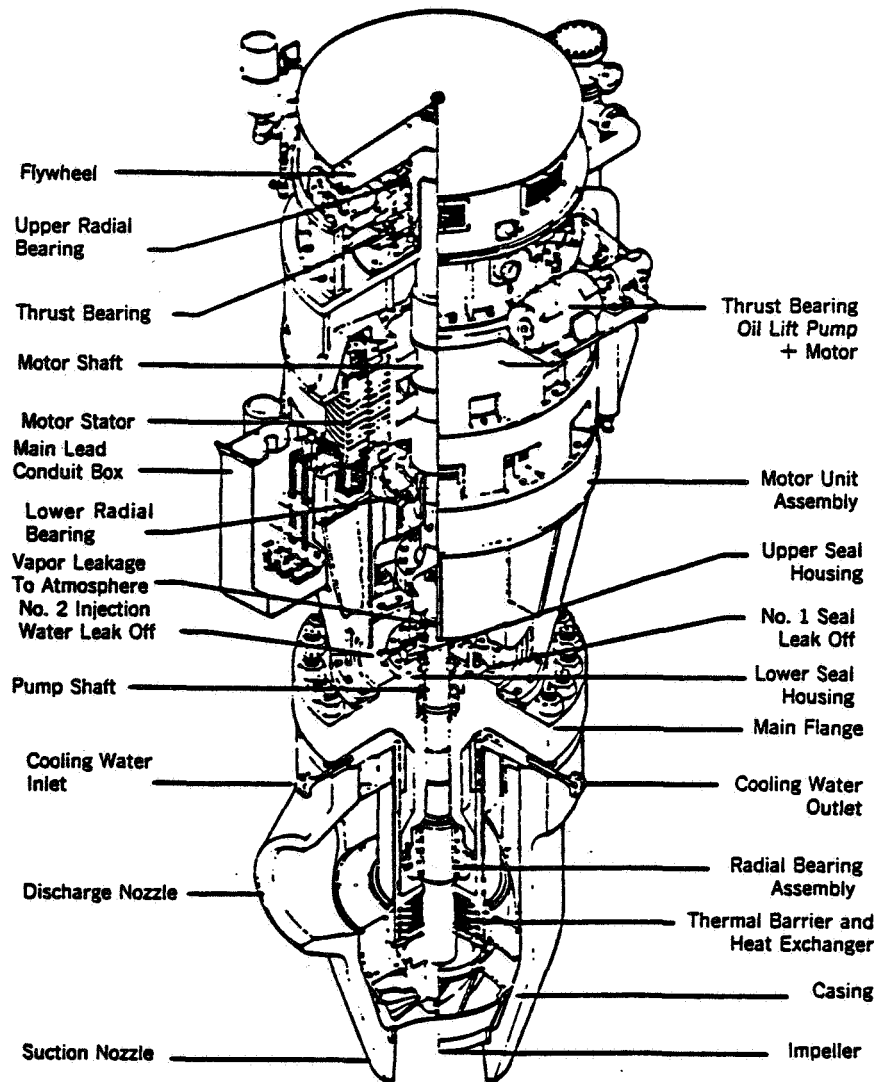
Figure 2

Our investigation began in the fall of 1983 when trend data began to show a gradual increase in vibrations from the desired level of 3-4 mils P-P displacement. At that time, vibration levels were indicating between 6 and 10 mils for no apparent reason. (Fig 1) Fig 2 illustrates a typical RCP with bearing locations and Fig 3 shows the Bently-Nevada proximity probe location on the pump shaft.

Sequoyah RCP's Physical Arrangement of Bearings and Displacement Probes
