AERODYNAMIC INSTABILITY: A CASE HISTORY

Robert C. Eisenmann
Machinery Diagnostics, Inc.
Minden, Nevada 89423

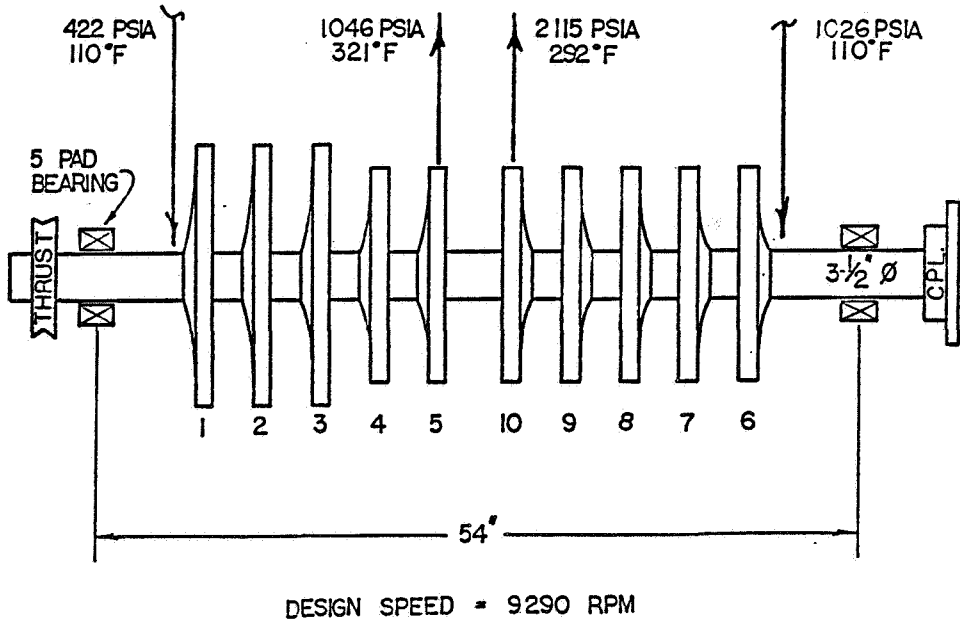
Figure 1. - Ten-stage rotor configuration.

The configuration of the high-stage rotor is presented in figure 1. The 10 wheels (5 per compression stage) were located back to back to minimize thrust load.
