INVESTIGATION OF THE CHALLENGER
ACCIDENT

COMMITTEE ON
SCIENCE AND TECHNOLOGY
HOUSE OF REPRESENTATIVES

NINETY-NINTH CONGRESS
SECOND SESSION

**OCTOBER 29, 1986.—Committed to the Committee of the Whole House on
the State of the Union and ordered to be printed**

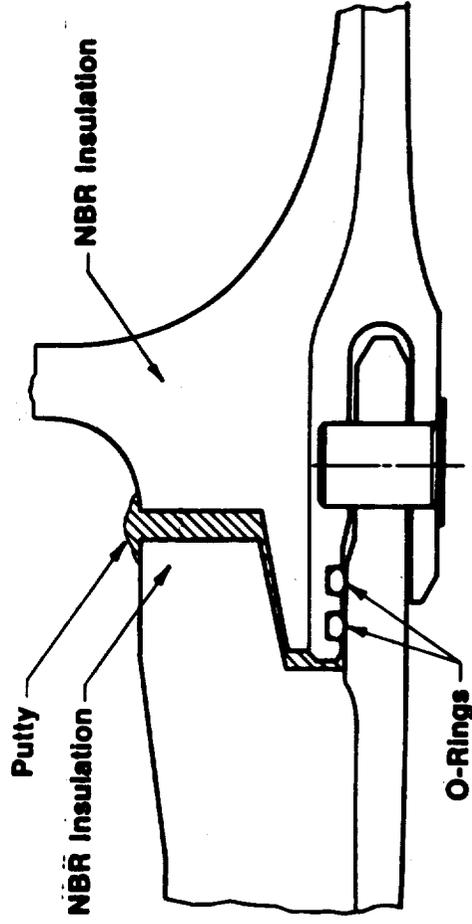
Figure 1

SRM-HPM Field Joint

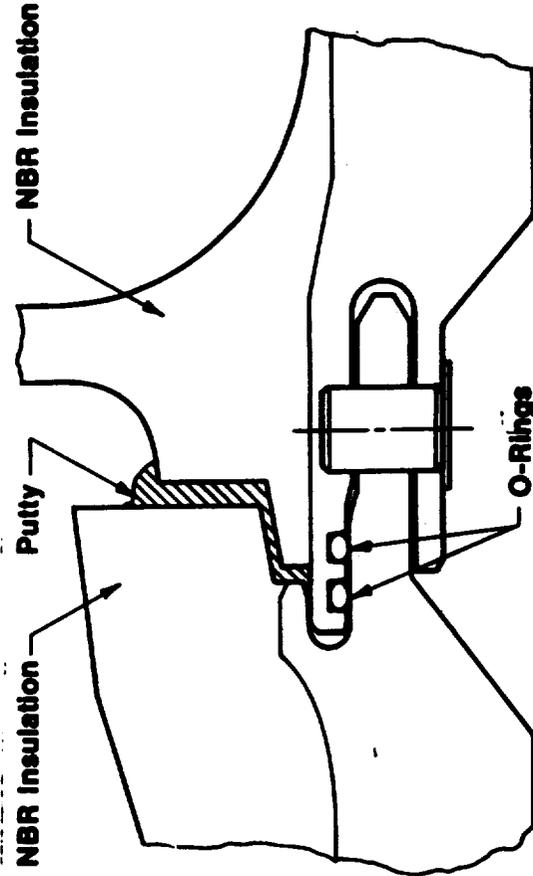
Figure 2

FWC-SRM Field Joint

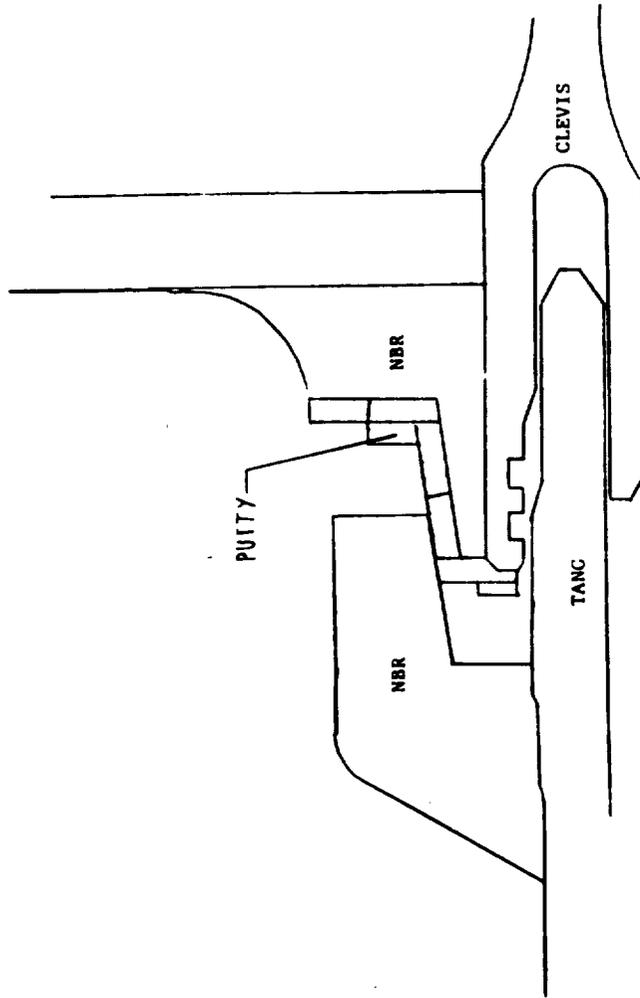
Figure 1

- a. Subscale and full scale tests to determine effects of asbestos filled, cotton and talc filled, and non-filled zinc chromate putty on O-ring sealing integrity.
- b. Full scale tests:
 - (1) Putty layup tests using current layup design.
 - (2) Putty layup tests using the attached figure 1 layup concept.
 - (3) Putty layup tests using the attached figure 2 layup concept.

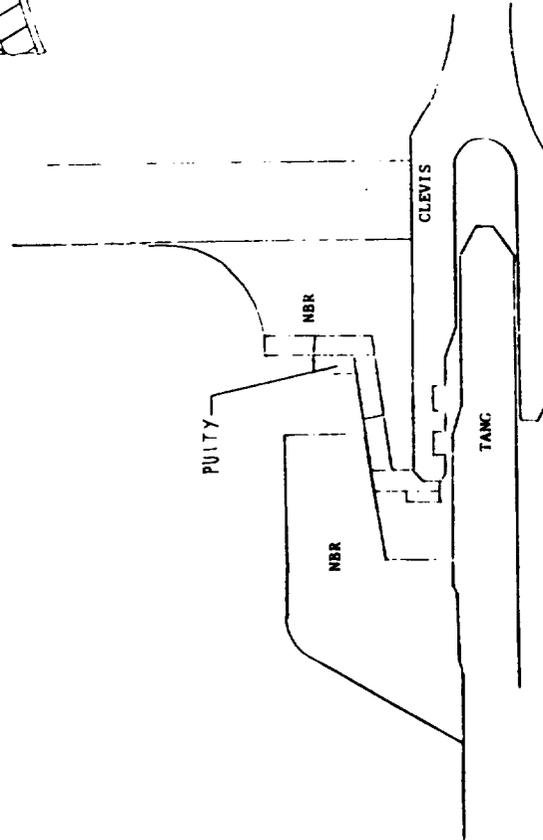
Figure 3

(4) Repeat tests (1) and (2) except with vent slots located at 120-degree interval around the circumference as shown by attached figures 3 and 4. The slots are designed to prevent air entrapment and resulting volcanoes. Evaluation of layup effectiveness should be performed with flow meters to determine cavity volumes.
