PROCEEDINGS
OF THE
SMRM DEGRADATION STUDY WORKSHOP

Organized by:
The Satellite Servicing Project
Goddard Space Flight Center

May 9-10, 1985

**SUMMARY OF THE SMRM DEGRADATION
STUDY WORKSHOP**

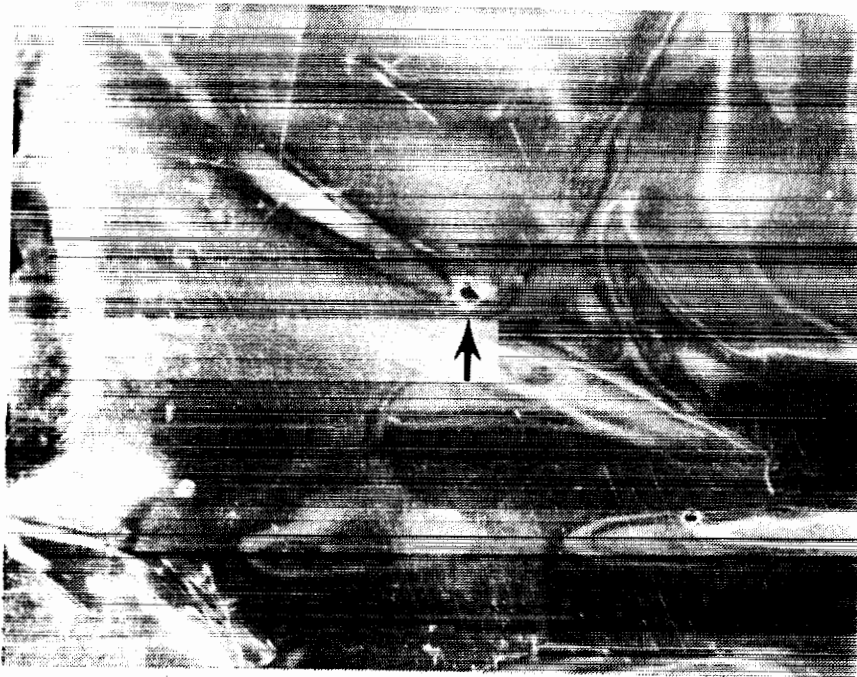
Visual examination of the thermal blanket around a Star Tracker indicated that some unknown particle had penetrated the blanket completely. In fact, it was possible to feel a slight depression in the aluminum shield for the Star Tracker and to observe with reflected light a slightly disturbed area of the black paint on the aluminum cover where the projectile had hit.

Removal of the thermal blanket permitted a closer examination of the penetration. Pictures of the front Kapton surface (Figure 10) showed a circular hole. Measurements indicated that it was an elongated hole, being 0.054 inch diameter and 0.110 inches long. The back Kapton surface also had a hole, being larger, elongated, and with a slightly torn surface (Figure 11).

Figure 10. Penetration through front side of Kapton thermal blanket which protected the Star Tracker.
