Aircraft Accident Report

NASA 712, Convair 990, N712NA
March Air Force Base, California
July 17, 1985

Facts and Analysis

NASA Aircraft Accident Investigation Board
National Aeronautics and Space Administration
Washington, D.C. 20546

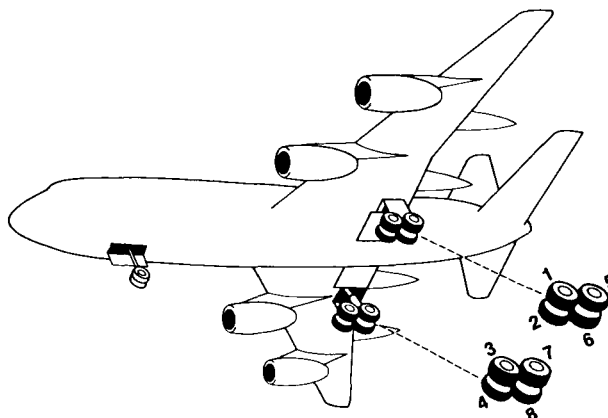
Figure 1. - Positions of tire and wheel assemblies on CV-990 main landing gear.

1.6.1 Tire service history. - The wheel, brake, and tire positions on the CV-990 main landing gear were designated by number, left to right, beginning with the forward tires (fig. 1). Nos. 1 and 2 were the forward positions of the left main gear; nos. 3 and 4 were the forward positions of the right main gear; nos. 5 and 6 were the rear or aft positions of the left main gear; and nos. 7 and 8 were the aft positions of the right main gear. The nose tires, wheels, and brakes were identified as left and right.

The tire (24 ply) in the no. 3 position was 12 years old and on its sixth retread cycle; the tire (22 ply) in the no. 4 position was missing a digit from its serial number, making the year of manufacture (1973 or 1983) indeterminate. However, since this tire was on its fourth retread in 1984, it was most likely manufactured in 1973. The tire (24 ply) in the no. 7 position was 12 years old and on its fourth retread; and the tire (22 ply) in the no. 8

position was 9 years old and on its second retread. Neither NASA nor ARC have established policy relative to age and number of retread cycles (appendix B). Tires are declared serviceable by visual inspection.

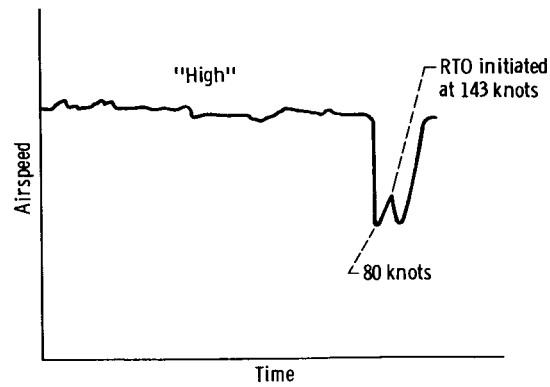
Figure 4. - Representation of indicated-airspeed trace from NASA 712 flight data recorder.

The trace (fig. 4) indicates a steep slope moving downward from "high" to 80 knots and reversing to a peak of 143 knots. It then begins to move downward toward the 80-knot point, passes 80 knots, and begins to move upward again

toward "high." This latter portion of the trace is not as steep as the beginning portion, indicating that deceleration was slower than acceleration. Measurements suggest that the deceleration rate during the RTO was approximately half the acceleration rate during takeoff roll. Figure 5 shows the time-history of the airspeed data as well as the vertical acceleration and aircraft heading variation during the incident.

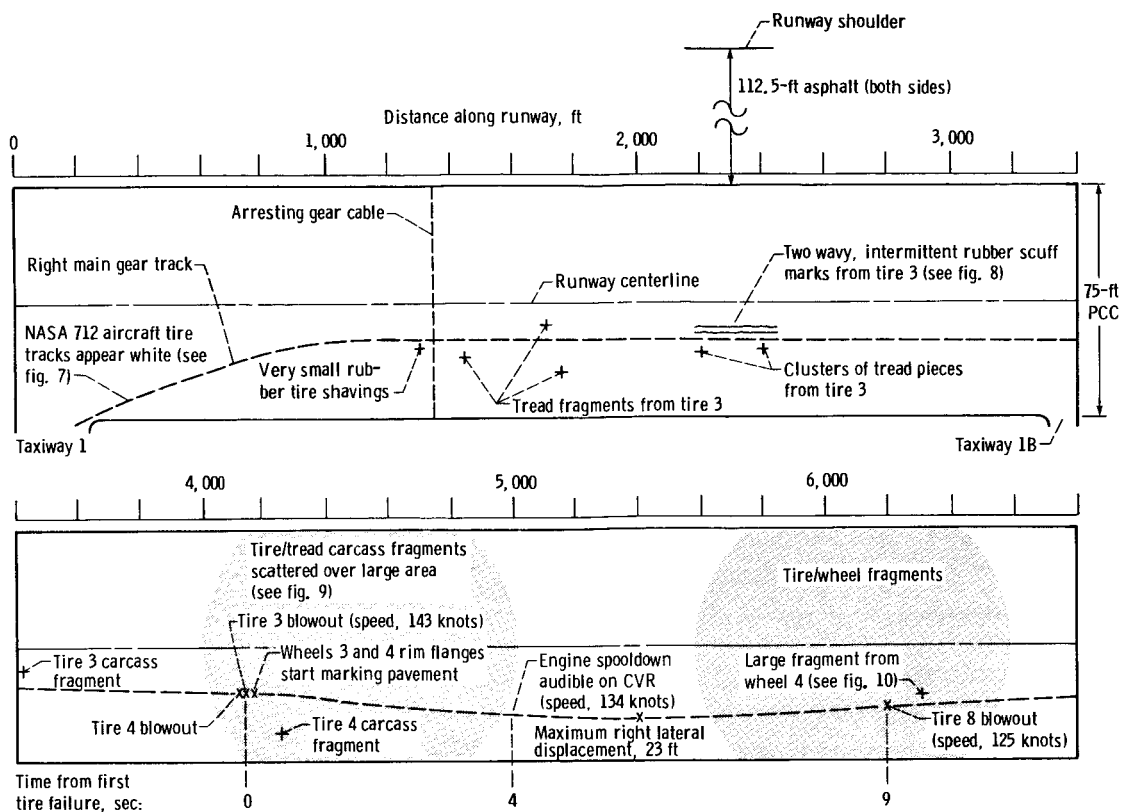
(a) Runway 32 threshold to 6800-ft mark.

The sequence of aircraft accident events was reconstructed by identifying the debris and its location on the runway (fig. 6) along with marks made on the runway surface primarily by the tire and wheel assemblies of the right main landing gear. Some debris had been identified, tagged, and removed from the runway surface by Air Force personnel before the NASA Aircraft Accident Investigation Board began their runway inspection. These tire and wheel fragments were made available for inspection by Board members.

The first marks found were white tire scrub marks, caused by the heavy aircraft scrubbing black deposits off the PCC runway surface, tracking from taxiway 1 onto runway 32. The width of each mark and the spacing between the marks of each landing gear were the same as the dimensions of the CV-990 aircraft (fig. 7). These white tire marks faded away as the airplane entered the moderately to heavily rubber contaminated area near the runway centerline at about 700 feet.² The marks did not show evidence of dragging brakes or underinflated tires. The first tire rubber shards were found at about 1,400 feet on the right side of the centerline near the arresting gear cable (fig. 6(a)). At 2,200 feet and about 11 feet right of the centerline, fresh squiggly rubber marks were found on the rubber-coated PCC surface in line with the estimated position of tires 3 and 7. These wavy intermittent rubber marks, visible for about 400 feet (fig. 8), were later associated with tire 3 by tread debris found nearby. All of the tire fragments collected on the runway between 1,300 and 4,000 feet were later identified with tire 3. Rubber marks were found on the runway surface at 4,125 and 4,138 feet, indicating where tire 4 and then tire 3 blew out. Visible score marks (fig. 9), starting at about 4,175 feet, showed where the wheel flange rims of wheels 3 and 4 contacted the PCC surface. Fragments from the remainder of tire 3 and from tire 4 were scattered over a large portion of the runway surface between 4,000 and 5,200 feet.

The wheel rim marks on the PCC surface showed the gradual right drift of the aircraft as it traveled down the runway. At about 5,665 feet the aircraft was 10 feet right of the runway centerline. Subsequent wheel marks showed a gradual turn back toward the runway centerline (fig. 6(a)). Wheel fragments from wheels 3 and 4 were found on the runway starting at about 5,600 feet. A fragment from the wheel 4 is shown in figure 10. Rubber marks on the runway surface at 6,190 feet indicated tire 8 blowout. Scuff marks on the runway surface at 7,300 feet (fig. 11) indicated tire 7 blowout. A large number of tire rubber and wheel fragments were found scattered over the runway from 7,100 to 8,400 feet.

Figure 6. - Reconstruction of NASA 712 accident. Total runway width, 300 ft with 75-ft PCC surface in center and 112.5-ft asphalt on both sides.

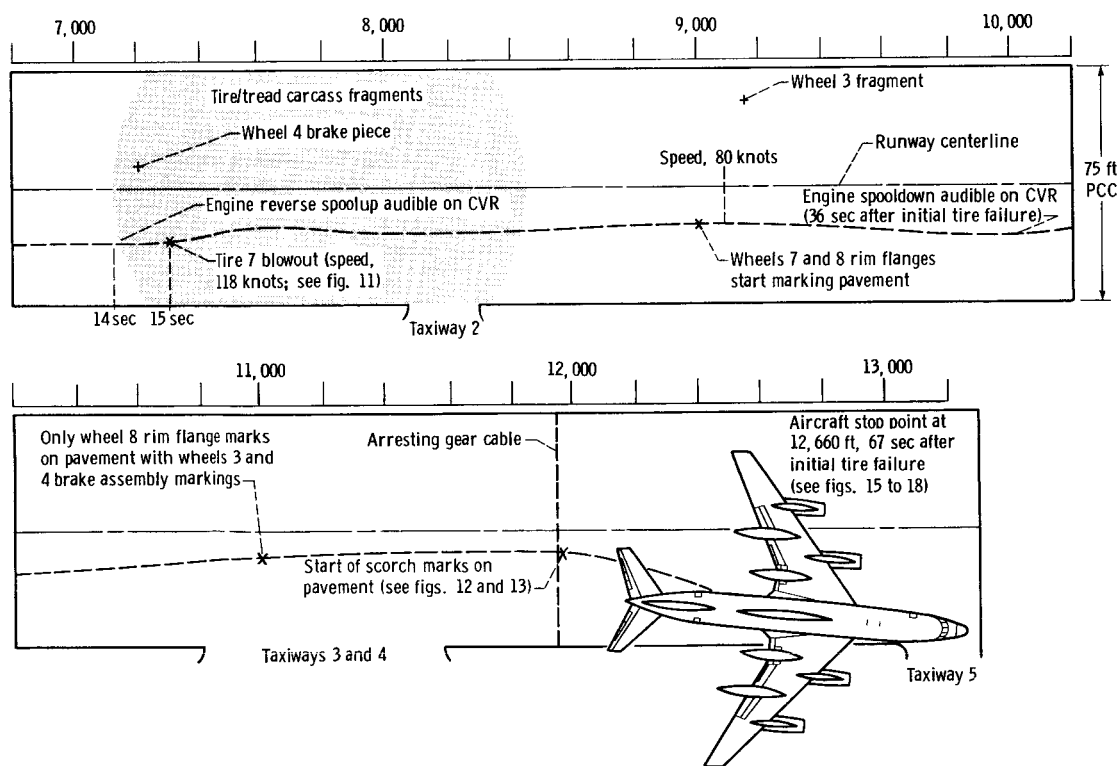
(b) 6800-ft mark to end of runway 32.

Wheel scuff marks on the runway surface at 8,000 feet indicated that wheels 3 and 4 were worn down to the hub (wide marks) but that wheels 7 and 8 still retained flanges (two narrow marks for each wheel). At 9,000 feet the aircraft was on the runway centerline, and at 10,000 feet it was 6 feet right of centerline. The first evidence of fire on the runway - scorched, discolored concrete surface - was at 11,950 feet. The marks were in line with the tracks of the right main gear wheels. The scorched surface marks persisted down the runway to the aircraft stop point at 12,660 feet (figs. 12 and 13). Some additional wheel/brake assembly debris (fig. 14) was found on the runway at various locations. The aircraft wreckage on the runway was photographed from a helicopter (fig. 15) and at various ground locations (figs. 16 to 18).

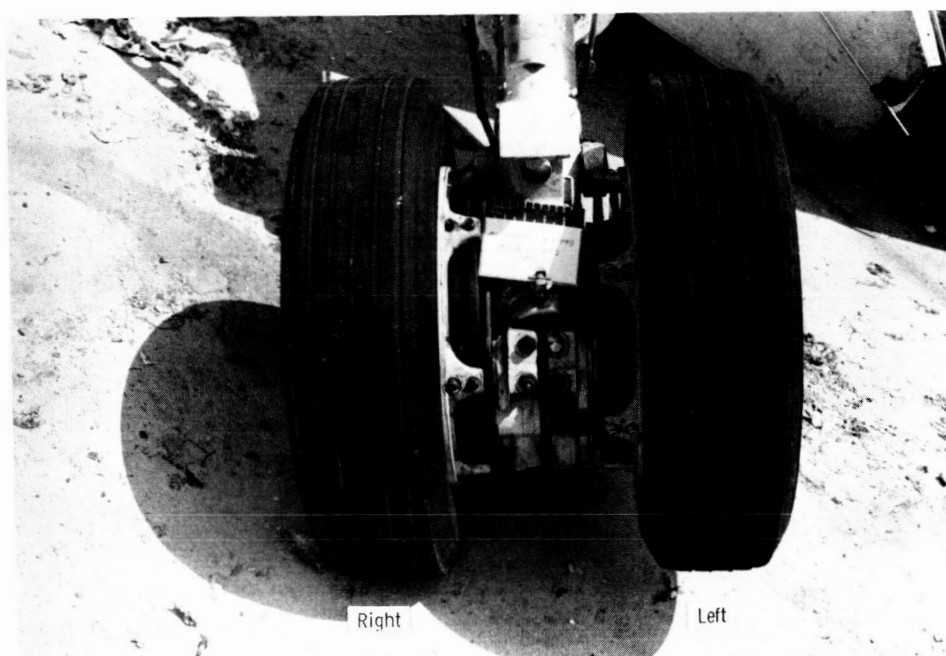
Figure 16. - Closeup view of nose gear tires.

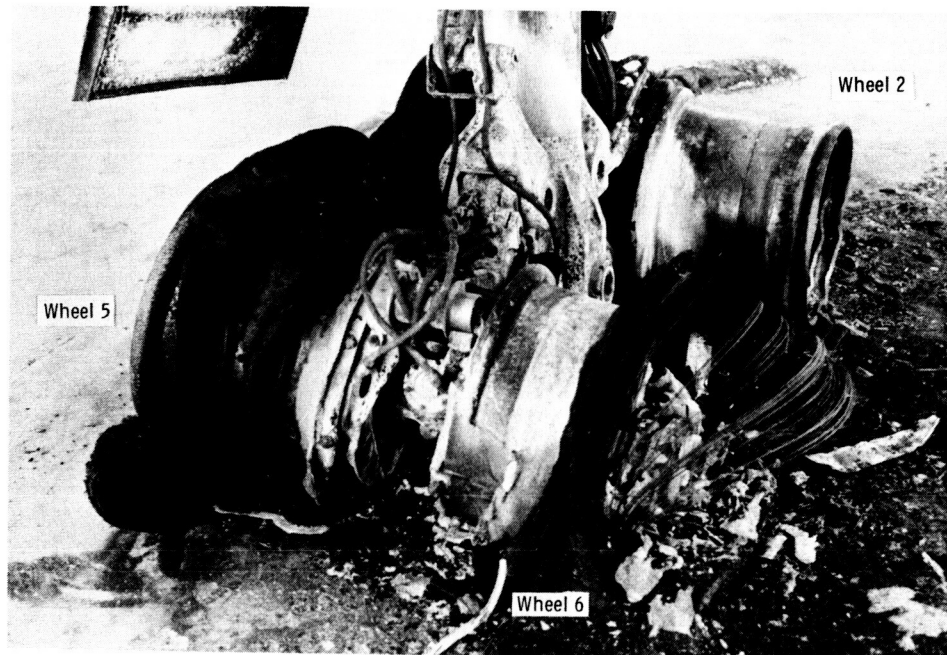
Figure 17. - Closeup view of left main gear wheels.

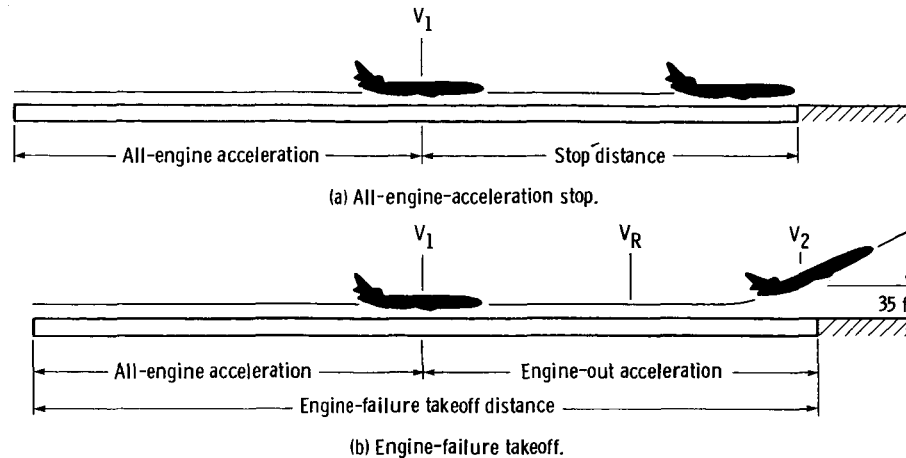
Figure 21. - Balanced-field-length takeoff.

1.16.3 Pilot training for rejected takeoffs. - The determination of the minimum runway length required for takeoff, or conversely, the determination of the maximum weight that an airplane could take off any given runway is based on what is called a balanced-field concept (fig. 21). This concept is predicated on the calculated ability of the aircraft either to stop within the runway length or to successfully continue to take off after an engine failure during the takeoff roll. The speed at which the decision must be made either to continue or to reject takeoff is referred to as V_1 . This speed is the most critical factor affecting the pilot's decision to reject or continue a takeoff. If an engine failure occurs before reaching V_1 on takeoff, the capability exists to stop the aircraft on a smooth, dry, hard-surface runway by using wheel brakes alone without reverse thrust. Decision speed V_1 is predicated on having normal brakes, wheels, and tires. If an engine failure occurs at or above V_1 , the takeoff may be continued and the pilot, using proper procedures and techniques, is assured of achieving a 35-foot height over the runway end.
