TWR-17270 VOL. VI

QM-6 FINAL PERFORMANCE EVALUATION REPORT  
IGNITER

JULY 1990

TWR-17270  
QM-6 FINAL PERFORMANCE EVALUATION REPORT  
IGNITER

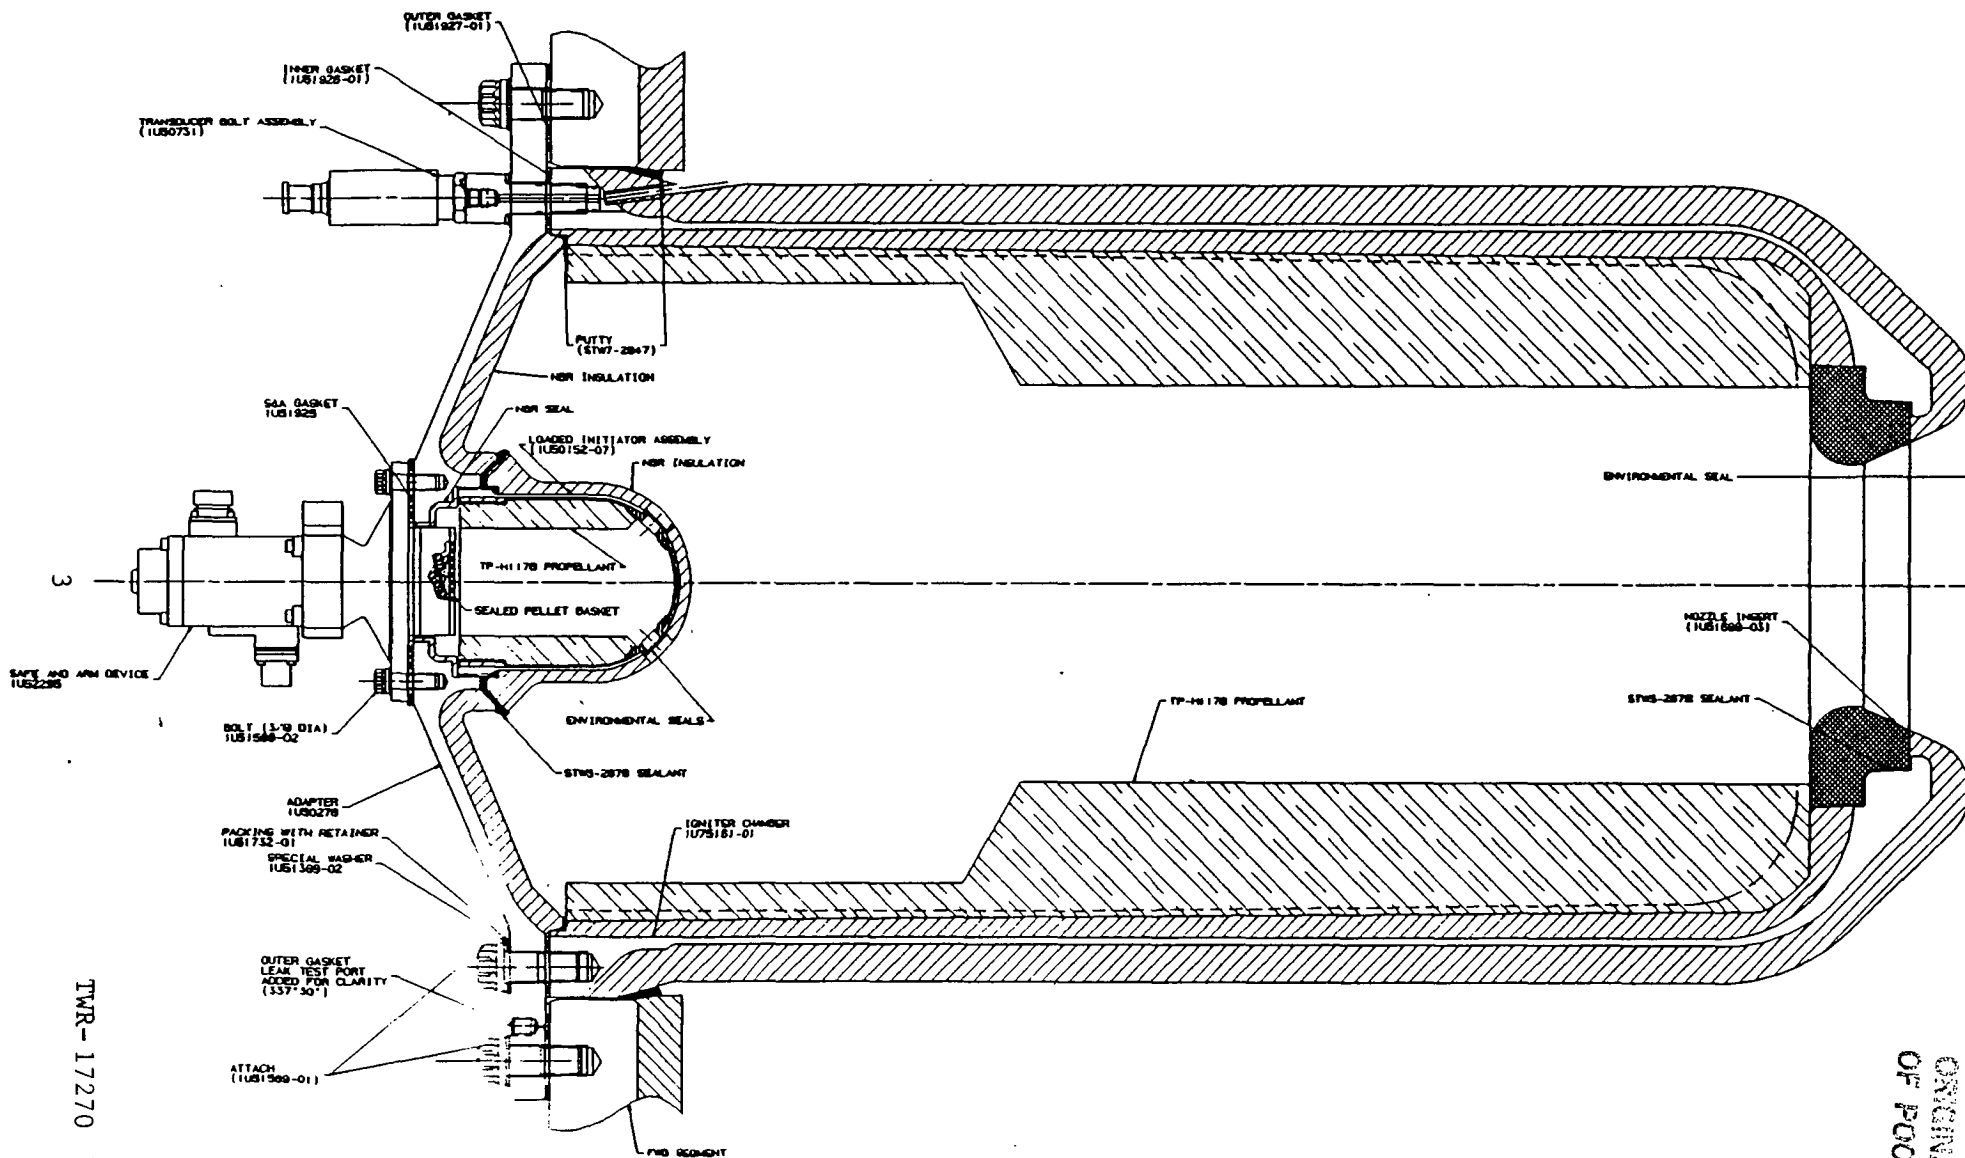
FIGURE 1. IGNITER CROSS SECTION

The overall performance of the igniter components was excellent. Figure 1 illustrates the Igniter and S & A seals and components. The igniter performance was within specified limits as shown in Figure 2. No damage or heat affected areas were noted except for minor seal damage which probably occurred during disassembly.

The sealing elements of the igniter functioned as expected with no evidence of erosion or blowby.

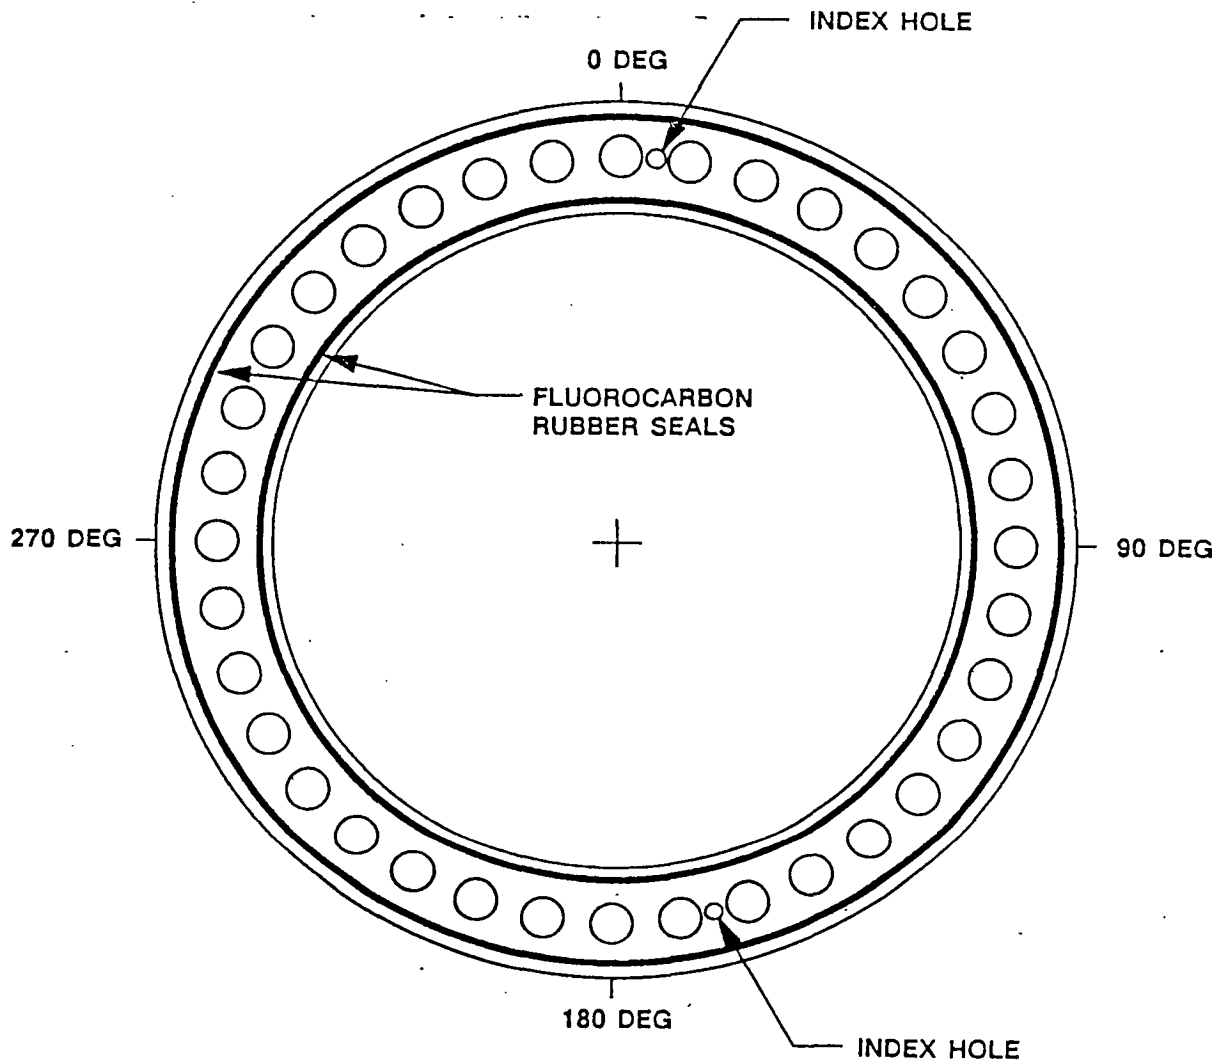
Observation Drawing Worksheet - Igniter Inner Gasket (Aft Face)  
Figure D-6

The igniter adapter-to-chamber joint was disassembled on 3 June 1988. Inspection of the inner gasket revealed no damage, heat effect, or soot to or past the primary seal (see Figures 5 and 6). Light soot was found on the outside edge of the gasket, covering the entire circumference. The sealing surfaces were free of soot and in excellent condition (see pages A-6 through A-11).
