The Hubble Space Telescope Optical Systems Failure Report

November 1990

NASA

EXECUTIVE SUMMARY

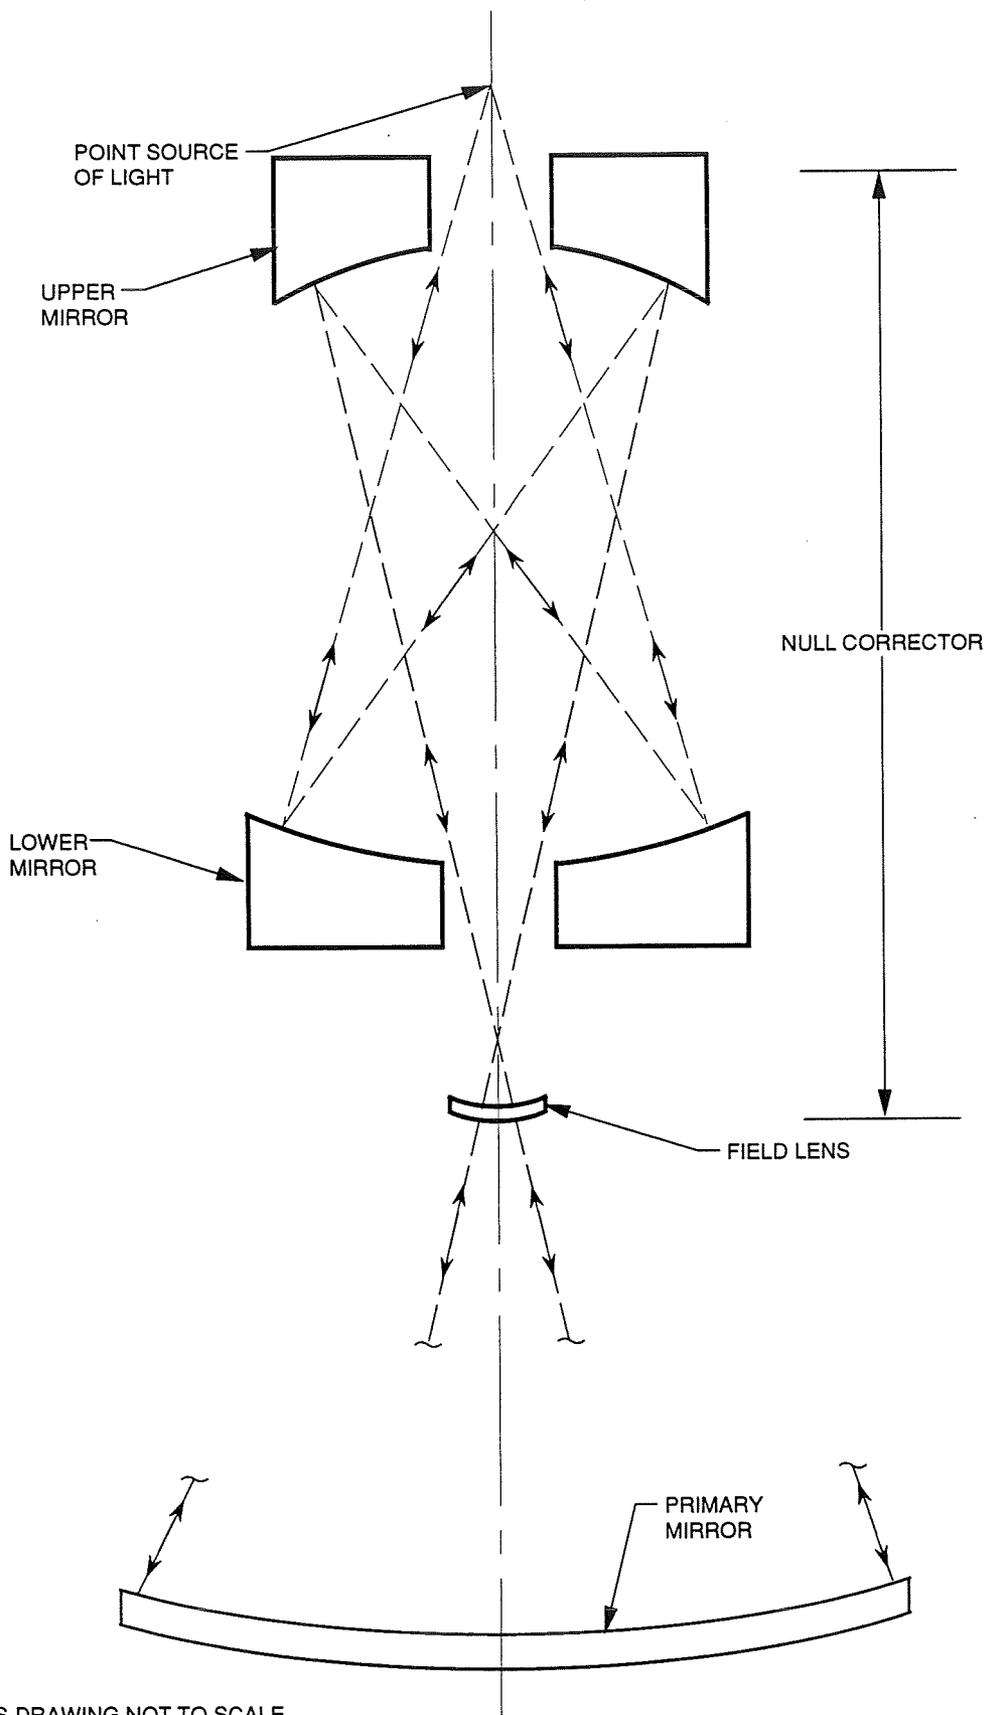
Figure 4-2. Reflective null corrector.

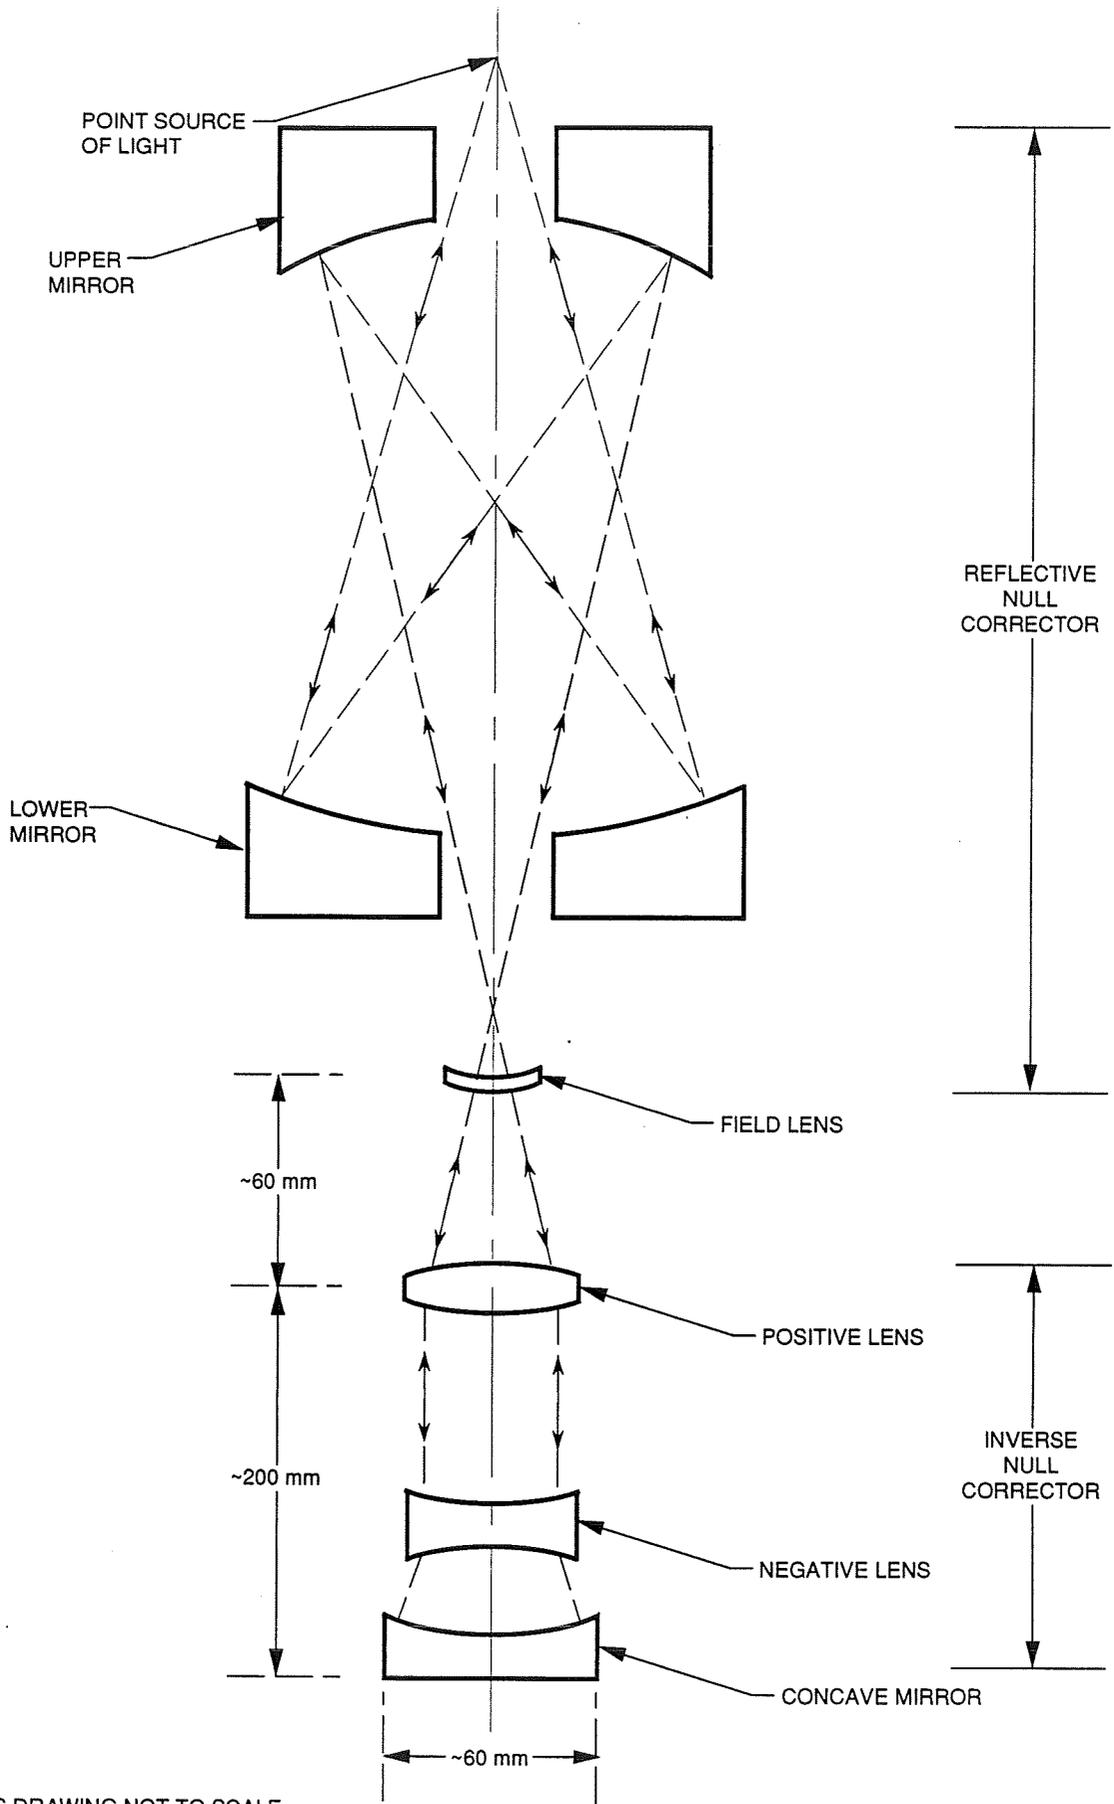
As a check on the position of the Coaxial Reference Interferometer (CORI) used with the RNC, an inverse null corrector (INC) was designed. When swung under the RNC, the INC would simulate a perfect mirror, just as a perfect primary mirror would appear with straight fringes when viewed through the RNC (Figure 4-3).

Figure 4-3. Inverse null corrector inserted below the reflective null corrector.

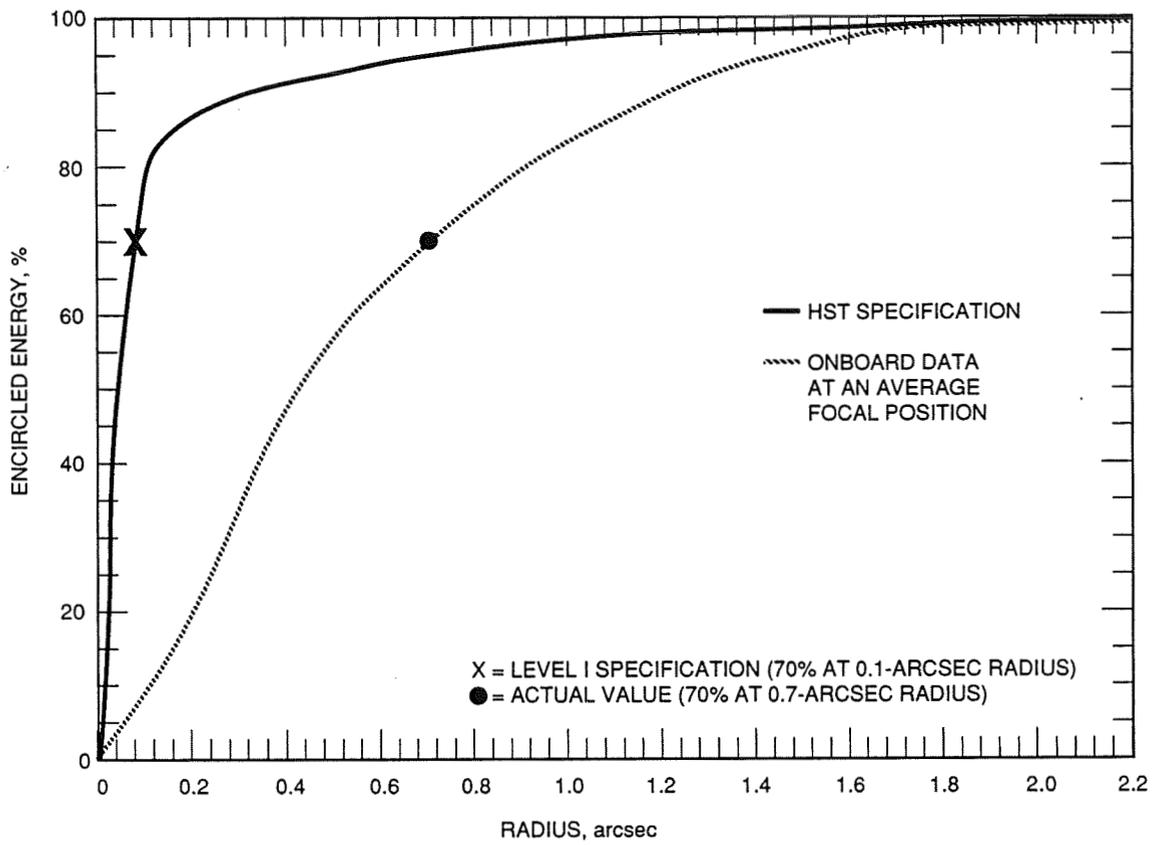
The Level I specification for the HST is to achieve 70 percent encircled energy in a circle of 0.1-arcsecond radius and to meet a Rayleigh criterion (i.e., image resolution of two objects) of at least 0.1 arcsecond. Early in the checkout phase of the mission, it was discovered that the telescope did not meet the above requirement. Instead, the telescope focused 70 percent encircled energy into a 0.7-arcsecond radius. Figure 5-1 is a plot of the encircled energy percentage versus radius in arcseconds for both the specified HST performance and the actual performance.

Figure 5-1. Encircled energy versus arcsecond radius of image produced by the HST.

- (8) When all these considerations are taken into account, at the best focus position, that is, the focus position that minimizes the rms wavefront error or puts the maximum energy into the central core of the image, 70 percent of the light from a single star is contained in a circle of about 0.7 arcsecond in radius (Figure 5-1).

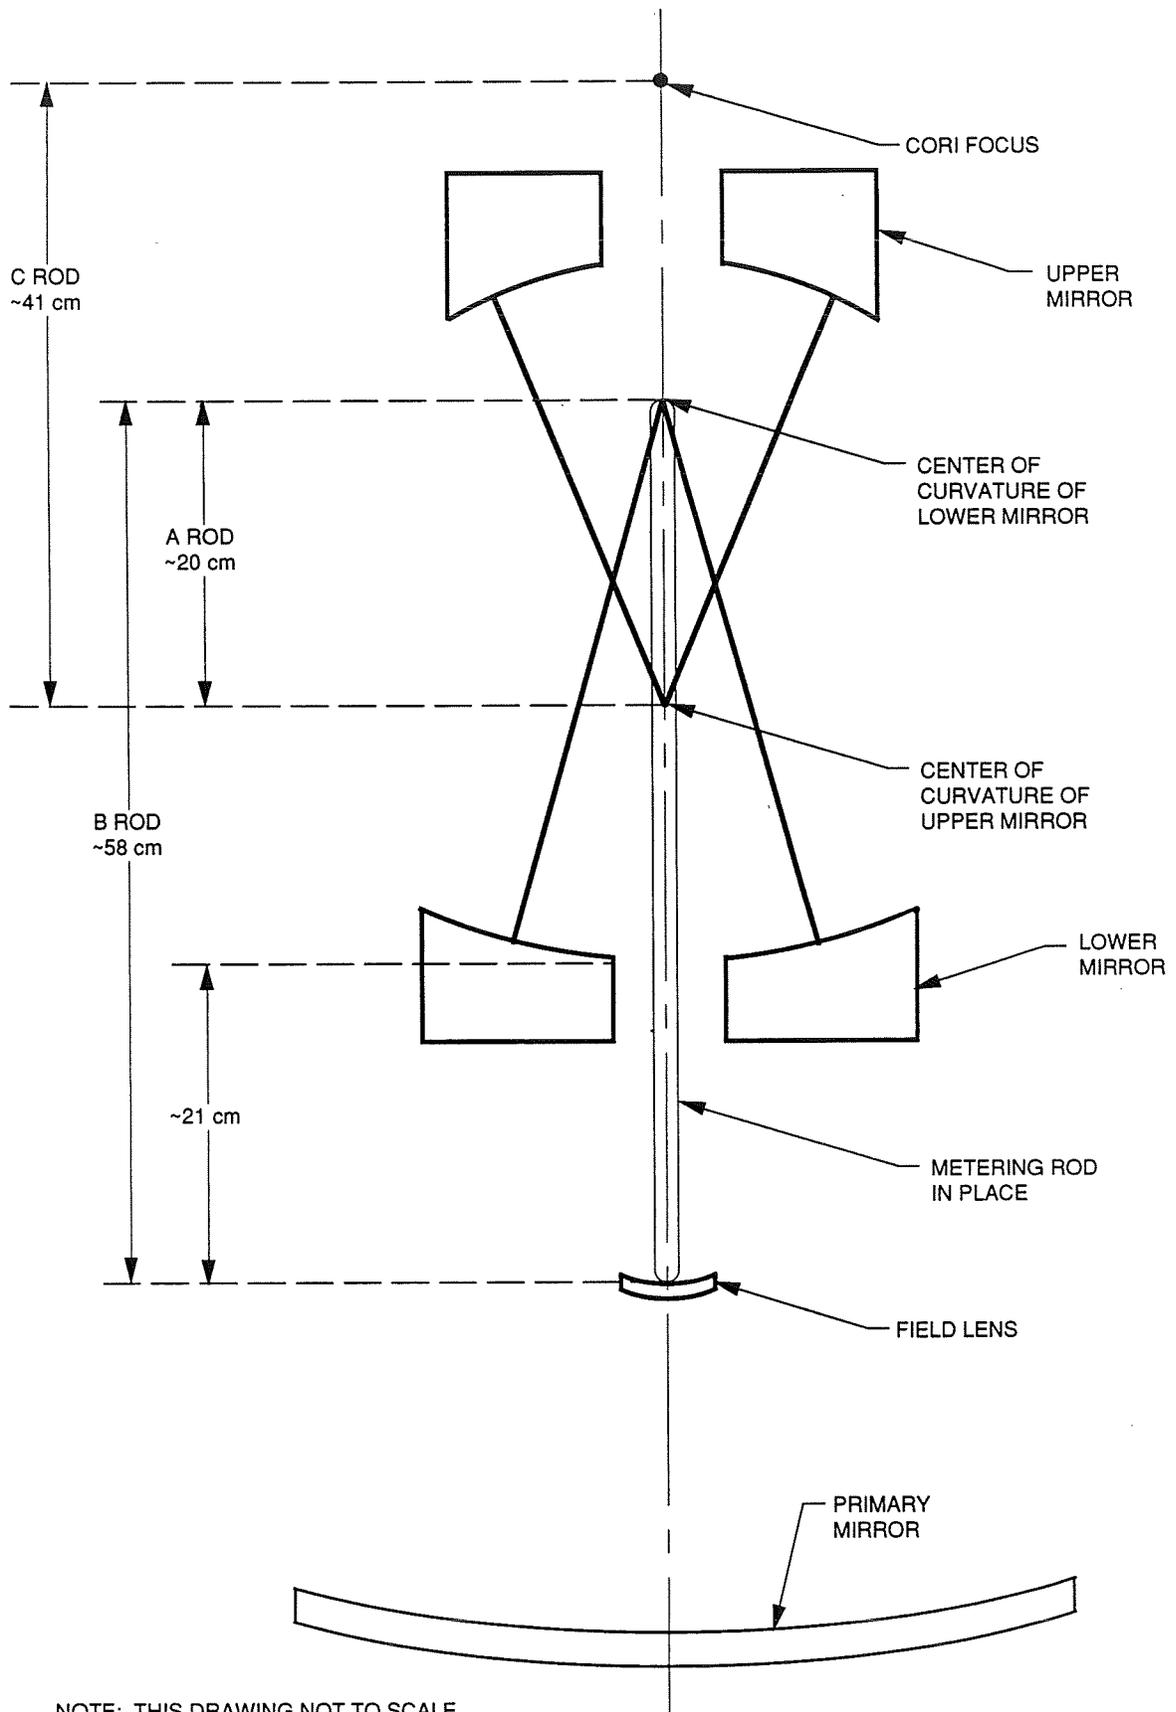
At the beginning of the program to build the 2.4-m Hubble primary mirror, P-E modified the RNC that had been used in building a 1.5-m mirror prototype. This modification required adding a new field lens and respacing the optical elements to create the correct shape for the larger mirror. Figure 7-1 is a schematic of this RNC, including the positions of the metering rods used to set the optics.

There were three metering rods (labeled A, B, and C) made of Invar, a metal with a small temperature expansion coefficient. The ends of the metering rods were rounded and polished because the very precise positioning of the optics in the RNC used an interferometer, rather than a mechanical measurement. This procedure involved auto-reflecting a focused beam of light off the end of a rod and observing an interference pattern from the beam that came back on itself. Centering the light beam on the rod end was essential for the measurement. To prevent the metering rod from being misaligned laterally with respect to the interferometer axis, P-E decided to attach "field caps" to one end of the rod (Figures 7-2 and 7-3). The field caps were fitted over the rod ends and had a small aperture in the center to ensure centering of the rod on the beam.

Figure 7-1. Position of metering rods used to space optical elements in the reflective null corrector.
