Tiltrotor Research Aircraft Composite Blade Repairs— Lessons Learned

Paul S. Espinosa and David R. Groepler

December 1991

Paul S. Espinosa and David R. Groepler, Ames Research Center, Moffett Field, California

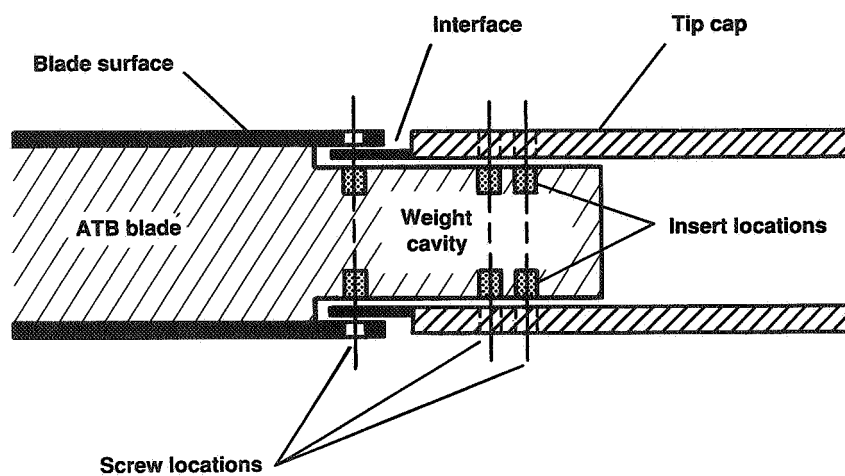
2.5.1 Description of the problem– One case of misalignment of mated composite parts occurred, with the alternate tips. They had been initially fitted to the blades in 1987 prior to flight, and then were returned to the manufacturer for completion and finishing; they had not been installed on the blades for over two years. Figure 13 shows how the tip cap fits over the weight cavity onto the blade. When the tips were to be installed on the blades they would no longer fit because of interference at the interface, which resulted in the screw holes not lining up with the screw insert locations on the spar. It appeared that either the ends of the blades had changed shape during flight testing, or the mating contour of the tips had been changed during the finishing process. Modifications (by the addition or removal of material) of the alternate tips were required to fit them on the blades, and no further fitting problems were encountered.

FIGURE 13. Interface of blade and tip cover
