LONG DURATION EXPOSURE FACILITY
M0003-5
Thermal Control Coatings
on
DoD Flight Experiment

Charles J. Hurley
University of Dayton Research Institute
Dayton, OH

INTRODUCTION

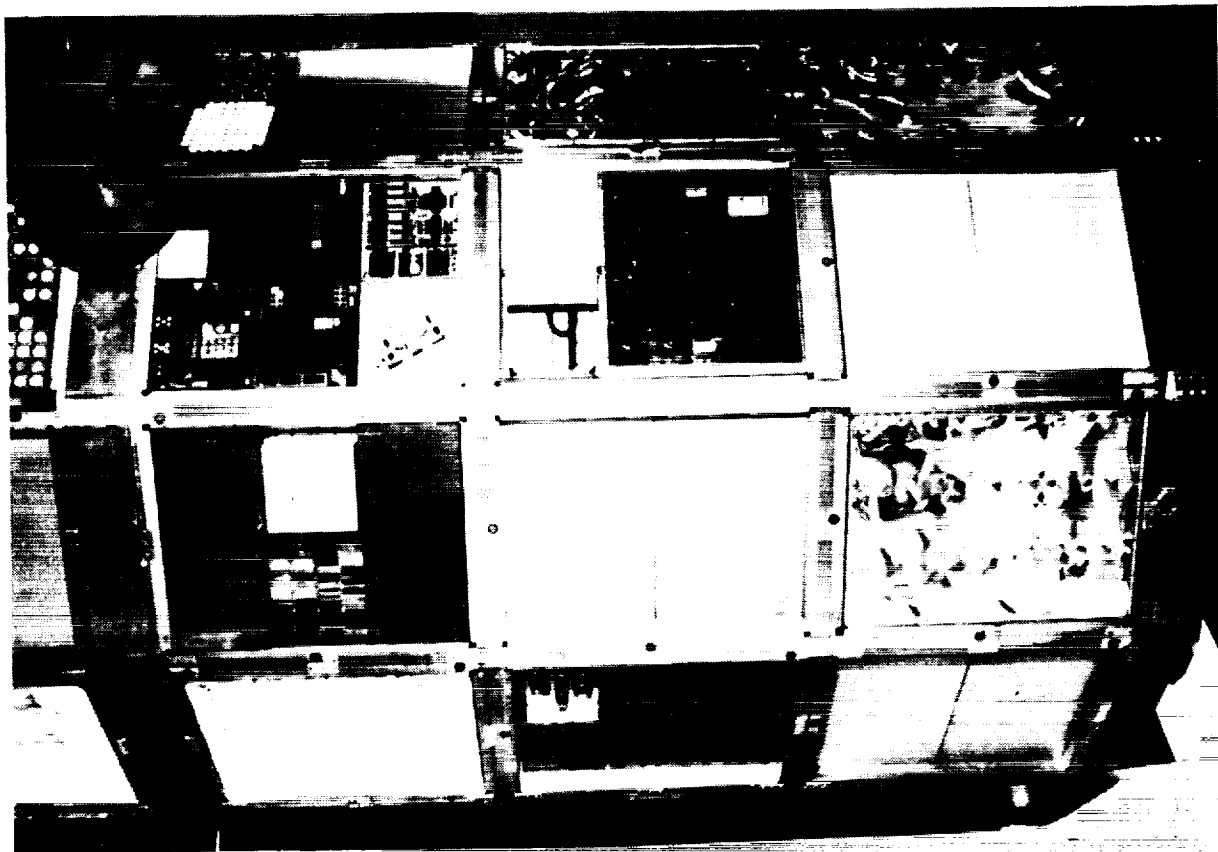
Figure 2. LDEF in SAEF II

After completion of activities in the Orbiter Processing Facility, LDEF was transported to the Spacecraft Assembly and Experiment Facility II (SAEFII). This facility provided a controlled, clean working environment for the principal investigators and other observers to examine the various experiments. The photograph in figure 2 shows only a portion of the leading edge side of LDEF. The M0003 experiment is located to the far left of the photograph near the scuff plate.

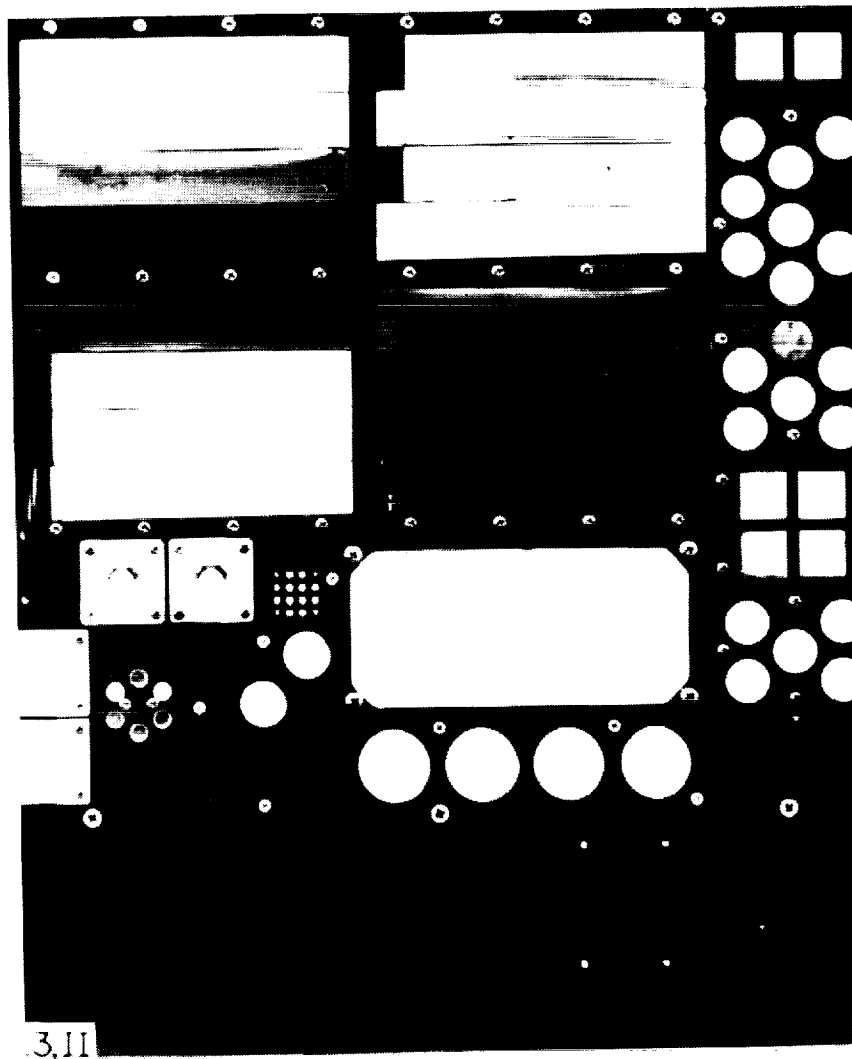
Figure 3. M0003-5 Pre flight Leading Edge Tray Experiment

The M0003-5 experiment was located in a 3 inch deep leading edge tray designated as D9. It contained a variety of thermal control pigmented coatings, metallized polymer films, clear films and mirrors. The photograph in figure 3 shows the preflight layout of the materials. The thermal control coatings discs and mirrors are located on the right hand side of the tray.

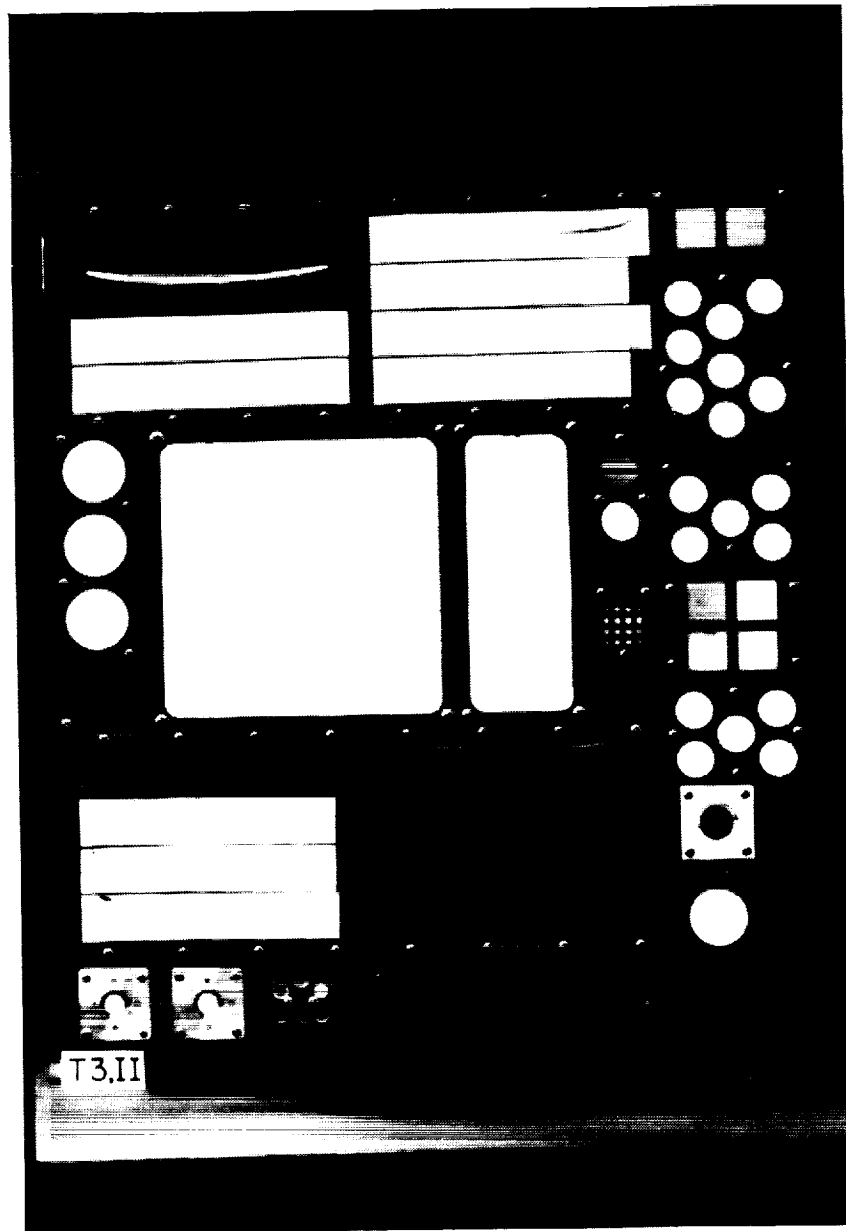
Figure 7. M0003-5 Preflight Trailing Edge Experiment

The photograph in figure 7 shows the preflight thermal control coating discs and mirrors on the right side of the tray.

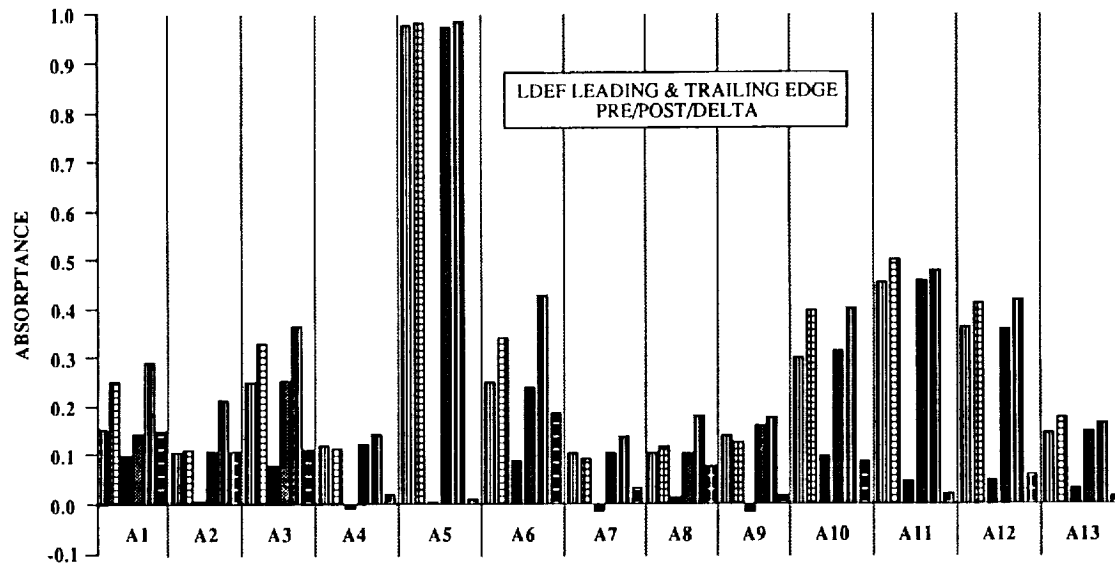
Figure 10. Absorbance Comparison Chart for Specimens A1 Through A13

The selected data listed in table 6 below is from the preceding thermo-optical data tables and is displayed in chart form in figures 10 and 11.

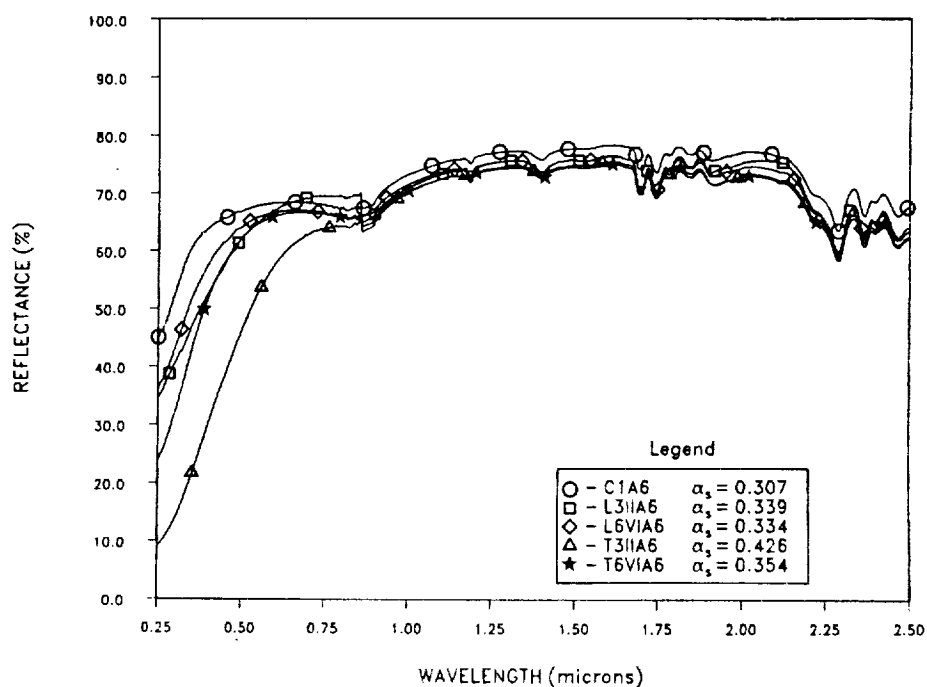
Figure 13. Comparison UV-Vis-NIR Reflectance Curves of Quartz Fabric 7 micron

A comparison photograph of the specimens is illustrated in figure 12; figure 13 compares the UV-Vis-NIR reflectance changes and figure 14 compares FTIR reflectance changes.

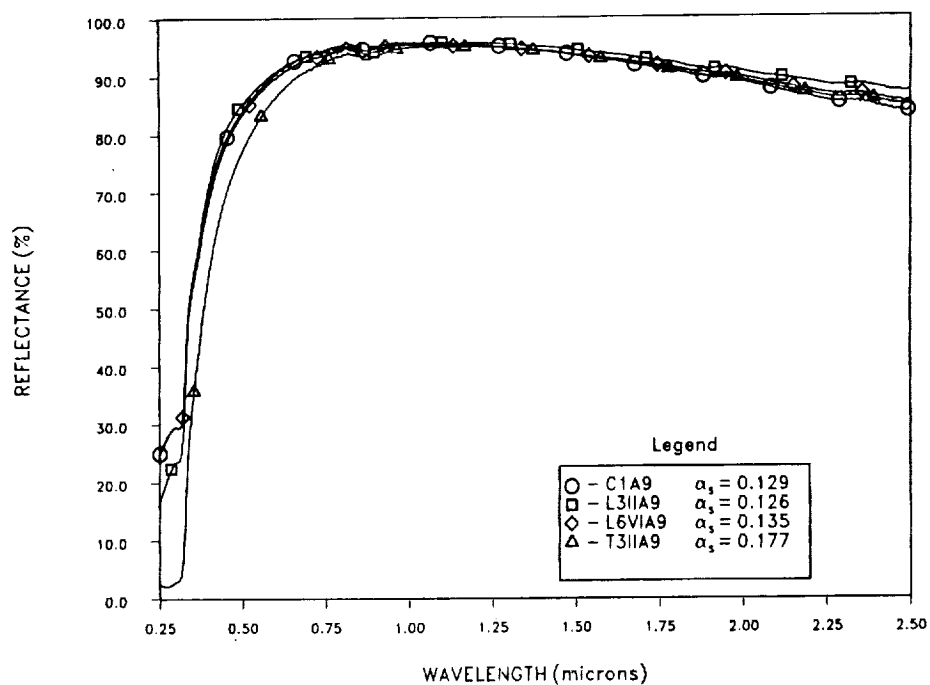
Figure 16. Comparison UV-Vis NIR Reflectance Curves of $\text{In}_2\text{O}_3/\text{FEP}/\text{Ag}/\text{INCONEL 5 mil}$

A comparison photograph of the specimens is illustrated in figure 15; figure 16 compares the UV-Vis-NIR reflectance changes and figure 17 compares FTIR reflectance changes.

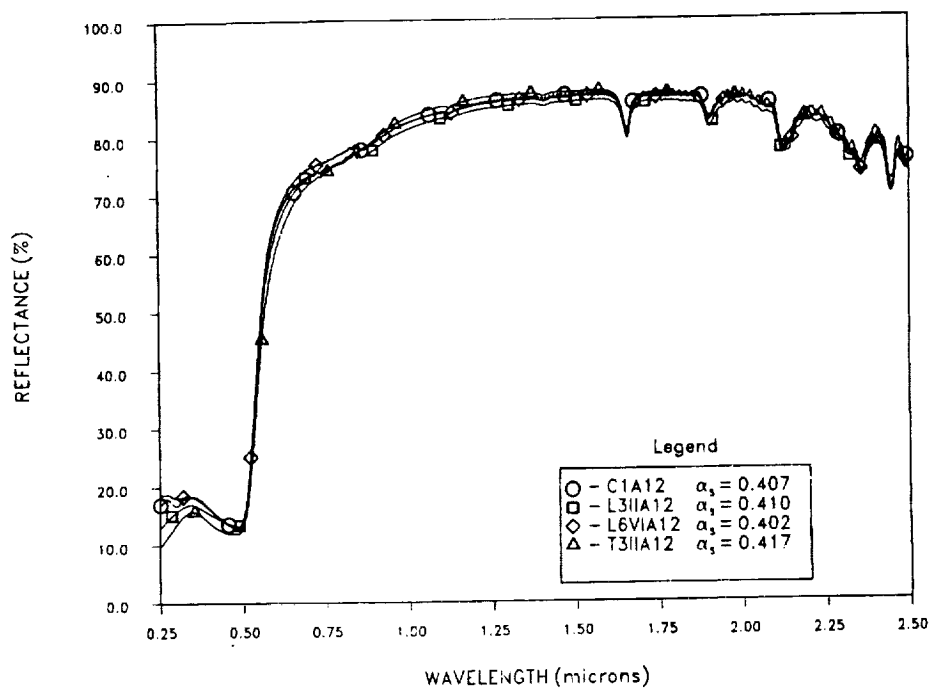
Figure 22. Comparison Curves of $\text{In}_2\text{O}_3/\text{Kapton}/\text{Al}$ 5 mil

A comparison photograph of the specimens is illustrated in figure 21; figure 22 compares the UV-Vis-NIR reflectance changes.

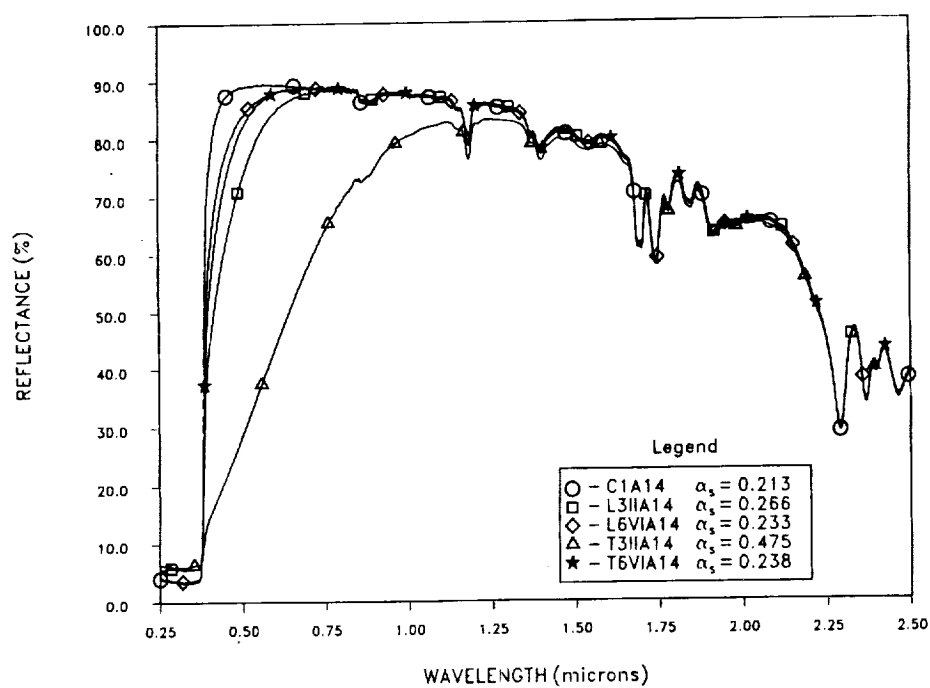
Figure 24. Comparison UV-Vis-NIR Reflectance Curves of S-13 GLO White Silicone Coatings

A comparison photograph of the specimens is illustrated in figure 23; figure 24 compares the UV-Vis-NIR reflectance changes.

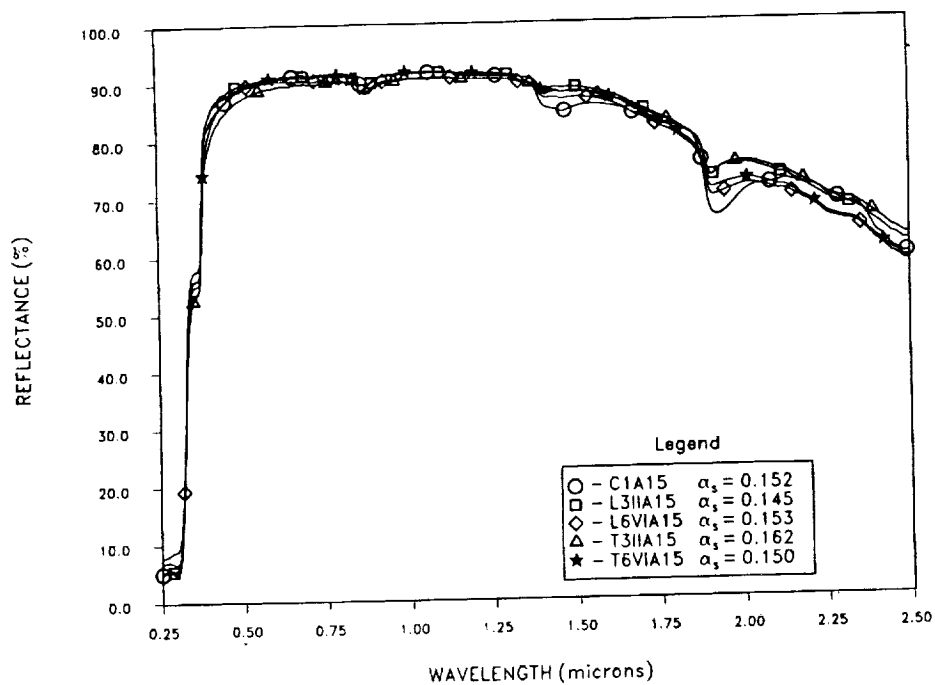
Figure 26. Comparison UV-Vis-NIR Reflectance Curves of Zn_2TiO_4 White Inorganic Coating

A comparison photograph of the specimens is illustrated in figure 25; figure 26 compares the UV-Vis-NIR reflectance changes and figure 27 compares FTIR reflectance changes.

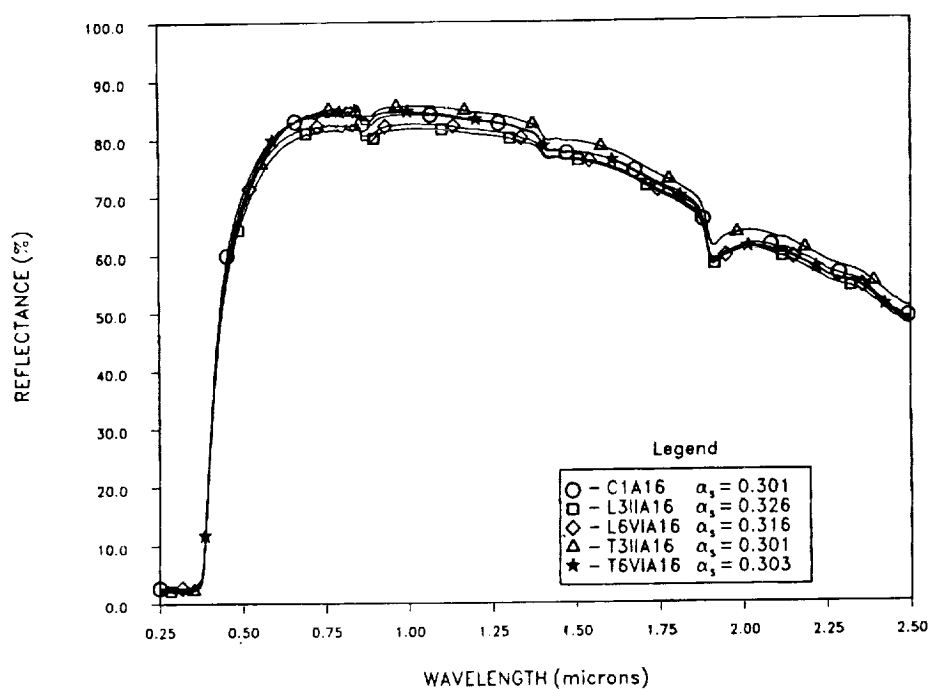
Figure 29. Comparison of UV-Vis-NIR Reflectance Curves of NS 43G White Inorganic Coating

A comparison photograph of the specimens is illustrated in figure 28; figure 29 compares the UV-Vis-NIR reflectance changes.

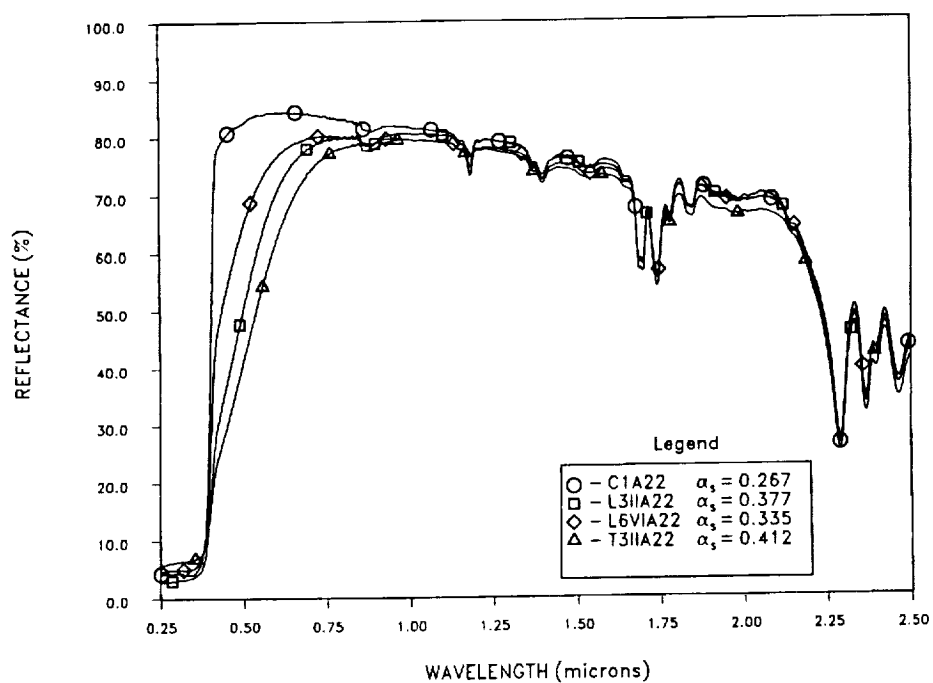
Figure 31 Comparison UV-Vis-NIR Reflectance Curves of DC92-007 White Silicone Coating

A comparison photograph of the specimens is illustrated in figure 30; figure 31 compares the UV-Vis-NIR reflectance changes.

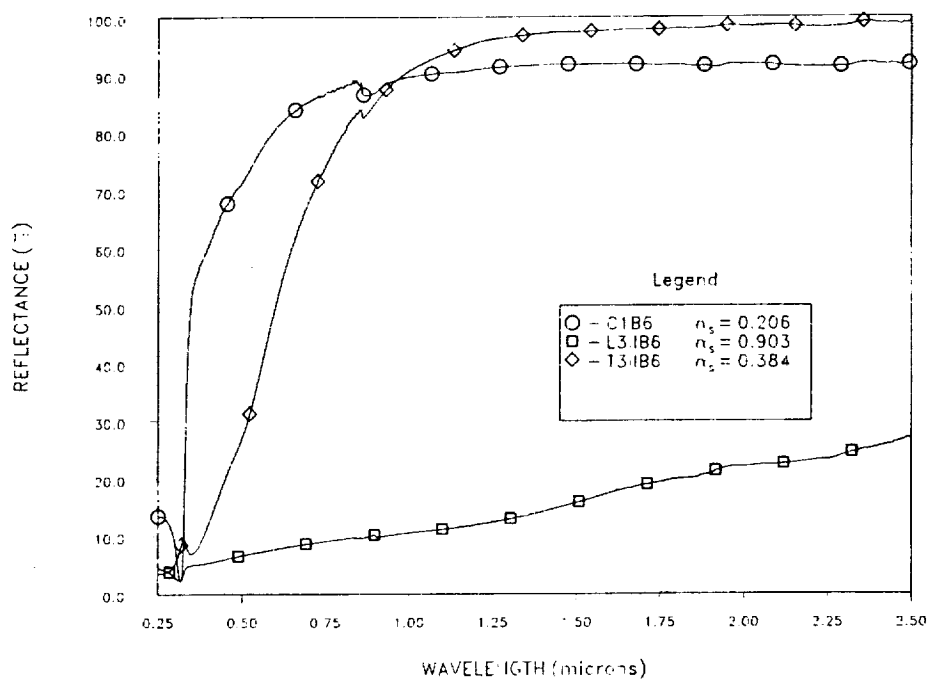
Figure 33. Comparison UV-Vis-NIR Reflectance Curves of Ag MIRROR

A comparison photograph of the specimens is illustrated in figure 32; figure 33 compares the UV-Vis-NIR reflectance changes.

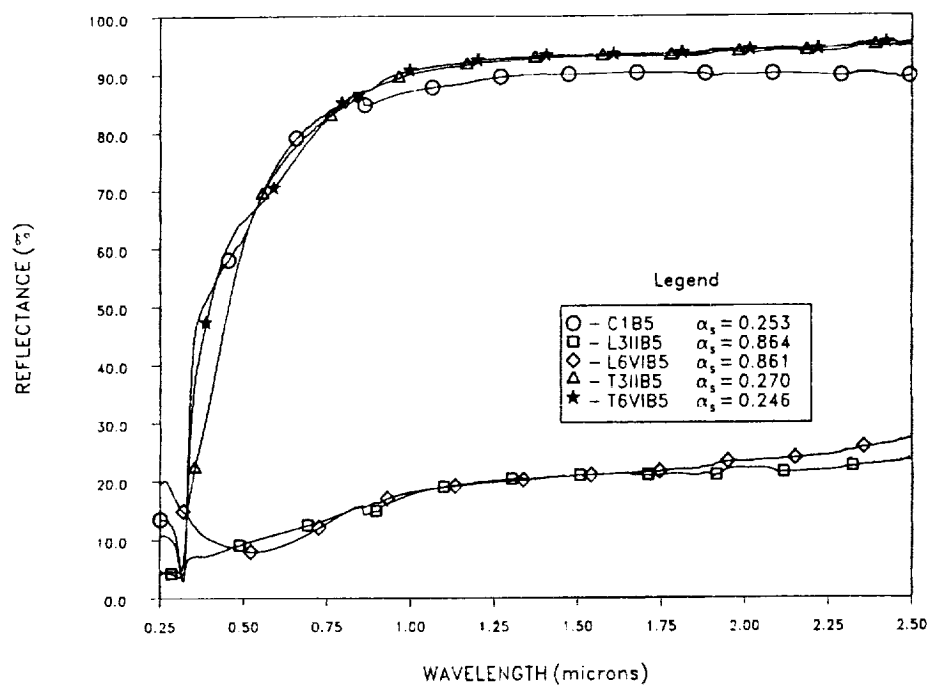
Figure 35. Comparison UV-Vis-NIR Reflectance Curves of Ag Mirror

A comparison photograph of the specimens is illustrated in figure 34; figure 35 compares the UV-Vis-NIR reflectance changes.
