NASA Technical Memorandum 104759

Analysis of Impactor Residues in Tray Clamps from the Long Duration Exposure Facility

Part 1: Clamps from Bay "A" of the Satellite

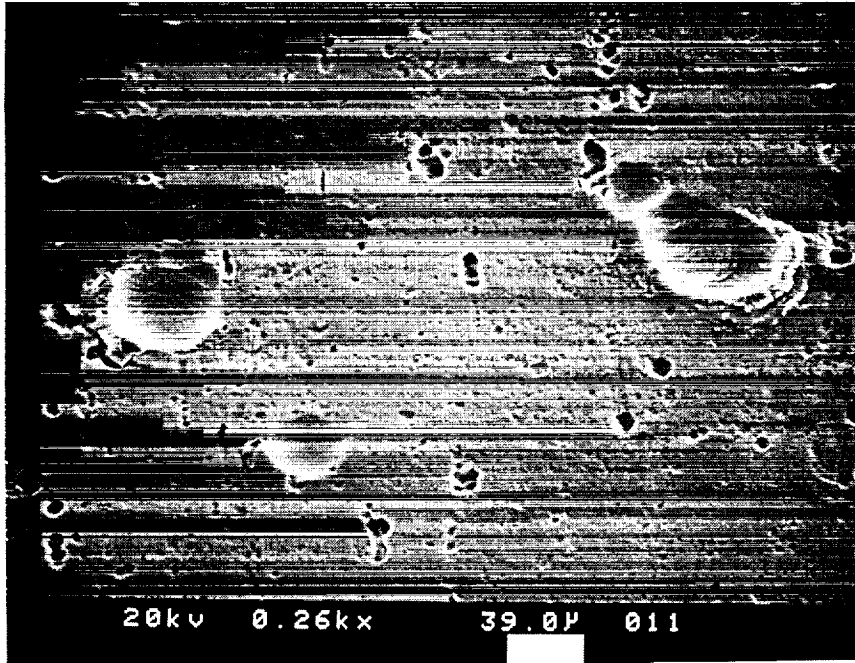
FIGURE 4. Secondary electron image of several impact-like flaws detected on the clamp surface. Features like these are quite abundant and are thought to be flaws acquired during the manufacturing and handling of the clamps.

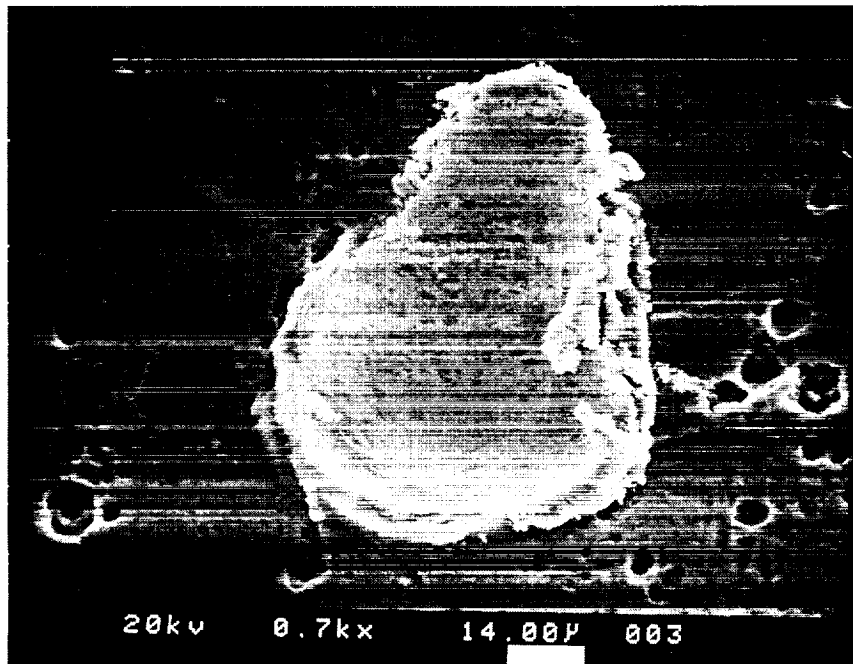
FIGURE 5. This very low velocity feature is similar to that in figure 3. During high magnification optical examination, this specimen appeared to be a typical hypervelocity impact crater. SEM examination determined its probable origin to be a handling flaw.

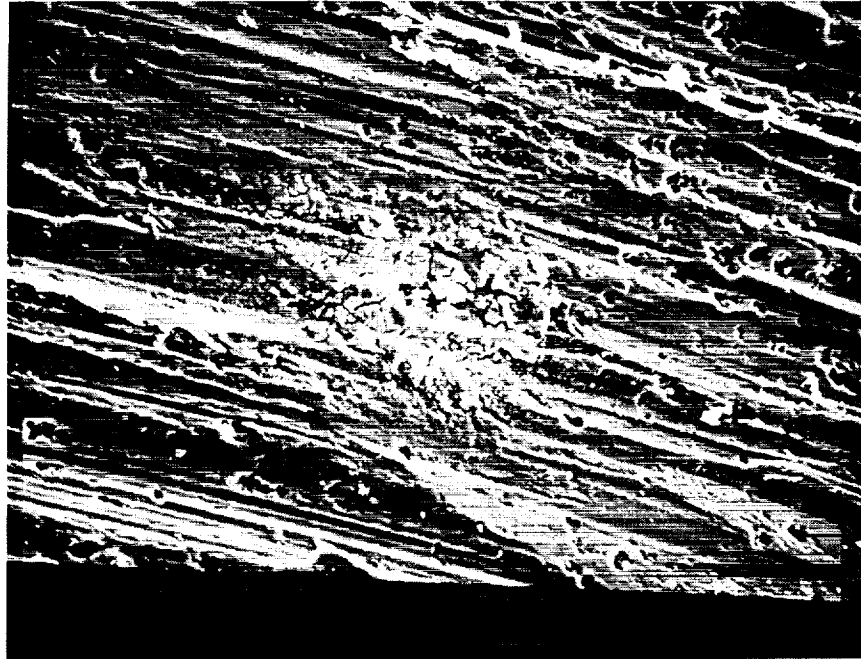
FIGURE 6. Surface flaws from chromic-anodization were also present on many of the clamps. The chemistry of such a flaw shows high levels of Si, Mg, Cl, and S, which are easily recognized by SEM/EDX analysis.

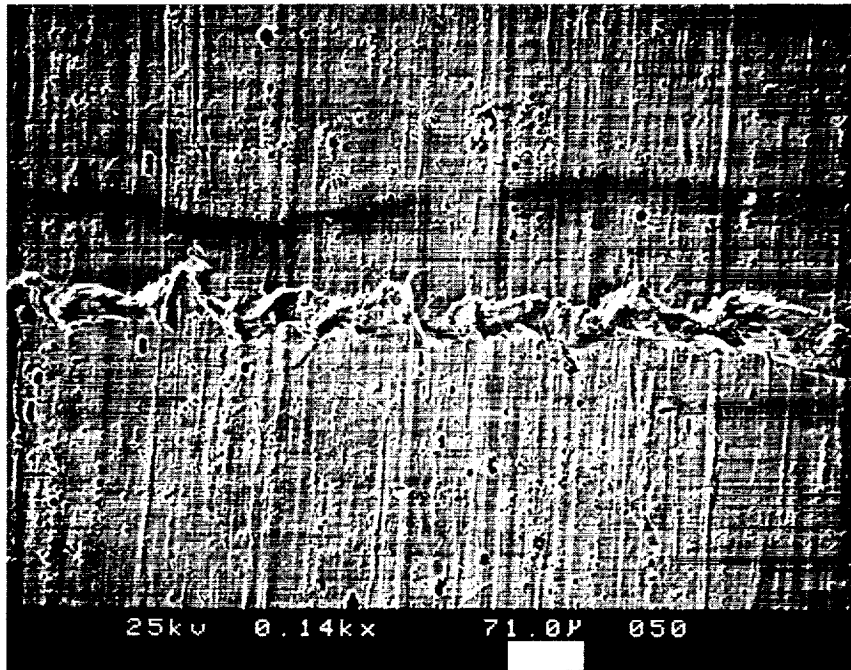
FIGURE 7. An example of a linear, repetitive-type pattern that occurred during the fabrication or preflight handling of clamps and other LDEF hardware.^[1]

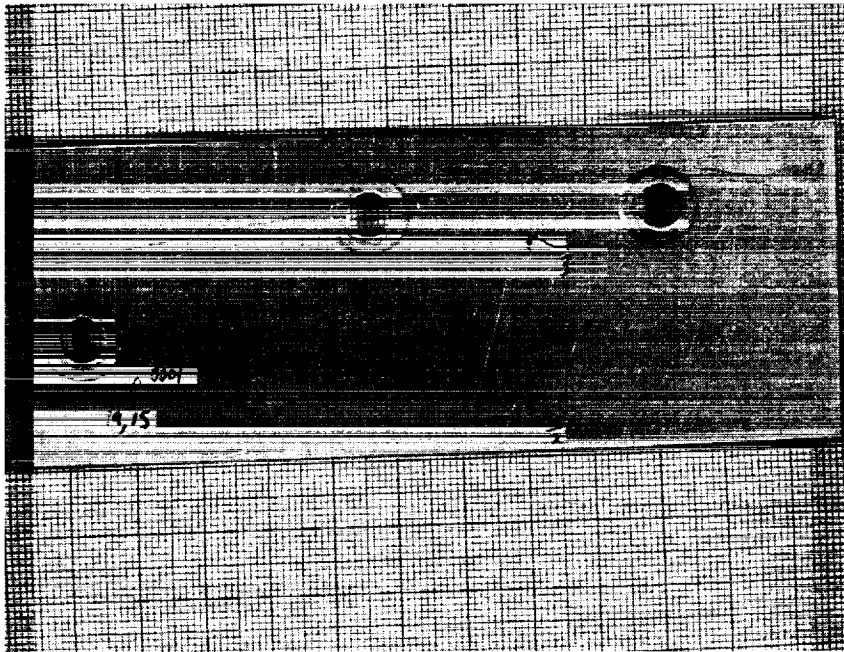
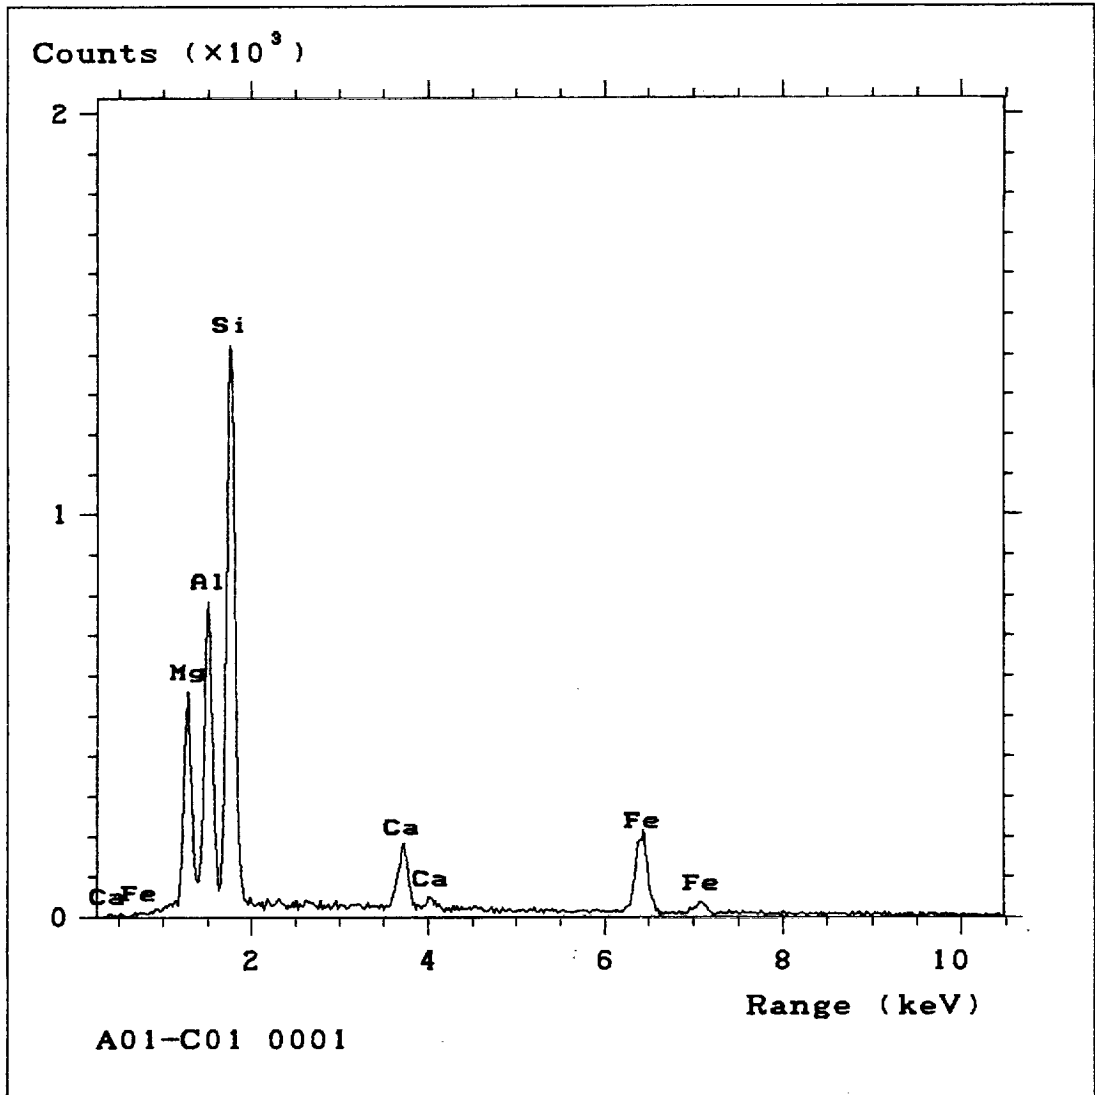
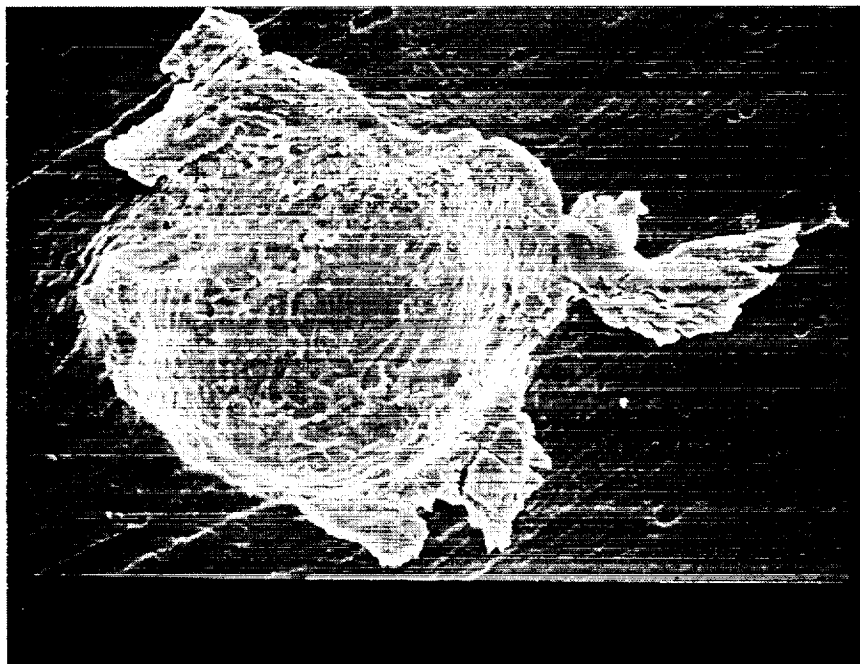
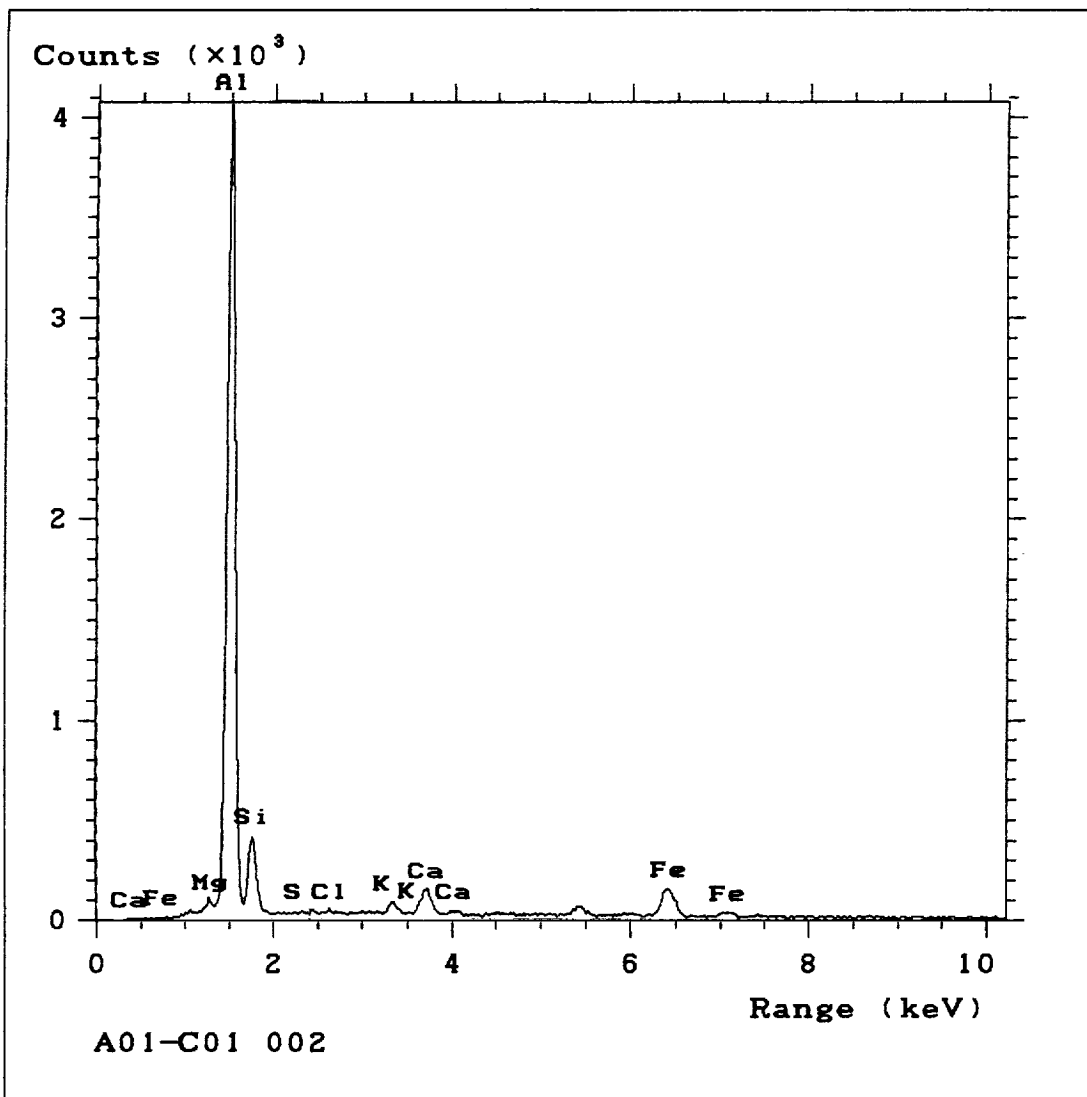
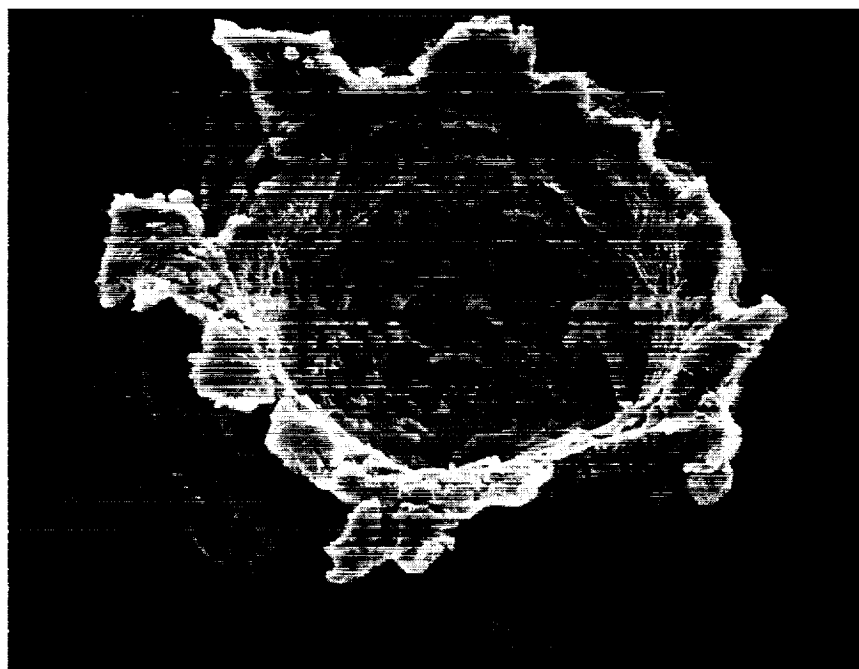
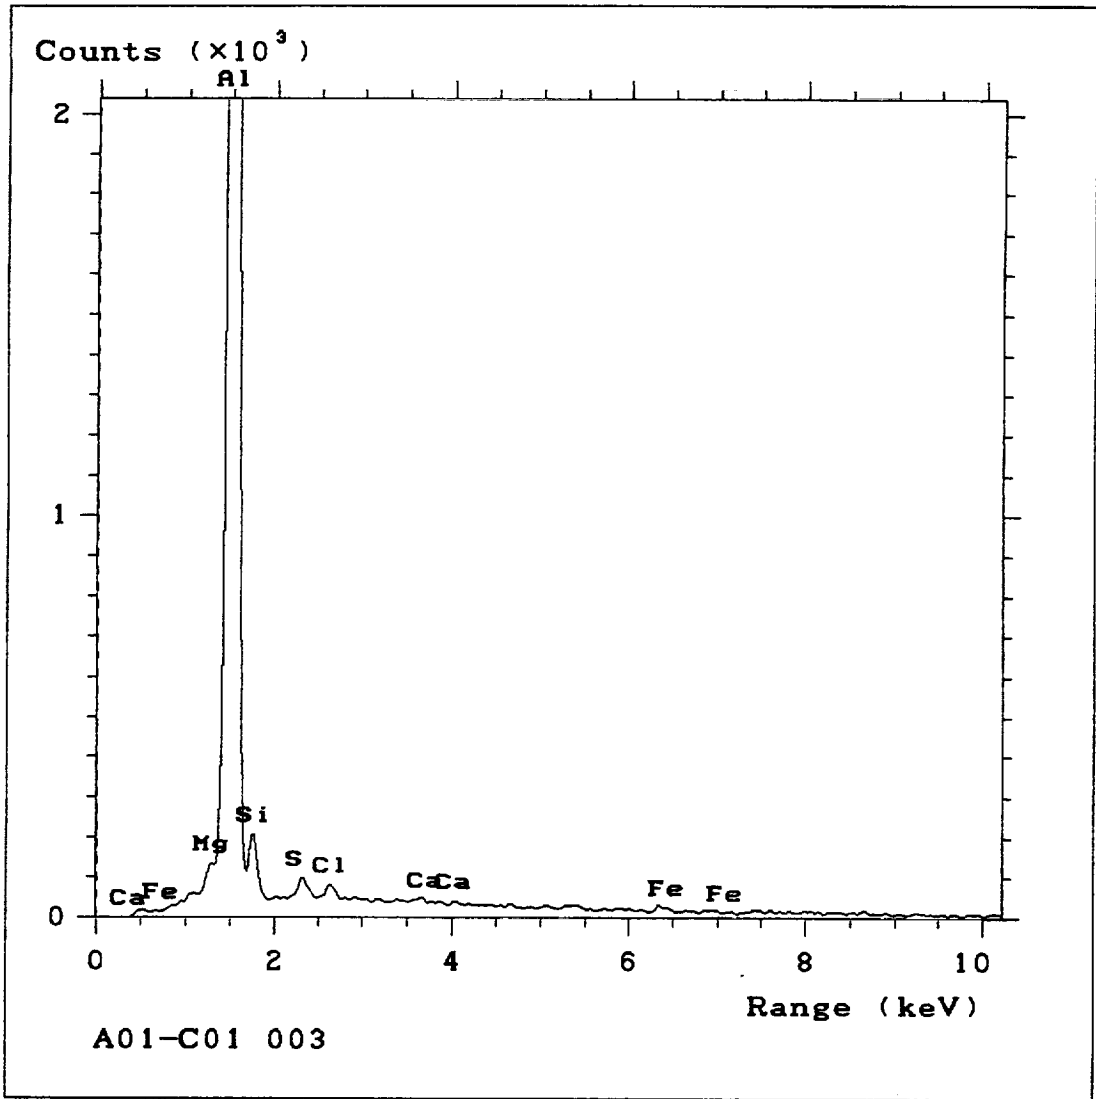
CLAMP NUMBER A01 C01

<u>IMPACT NUMBER</u>	<u>DIAMETER</u>	<u>GENERAL COMPONENTS</u>
001	200	Mg, Si, Ca, Fe
002	100	Trace
003	100	Unkown

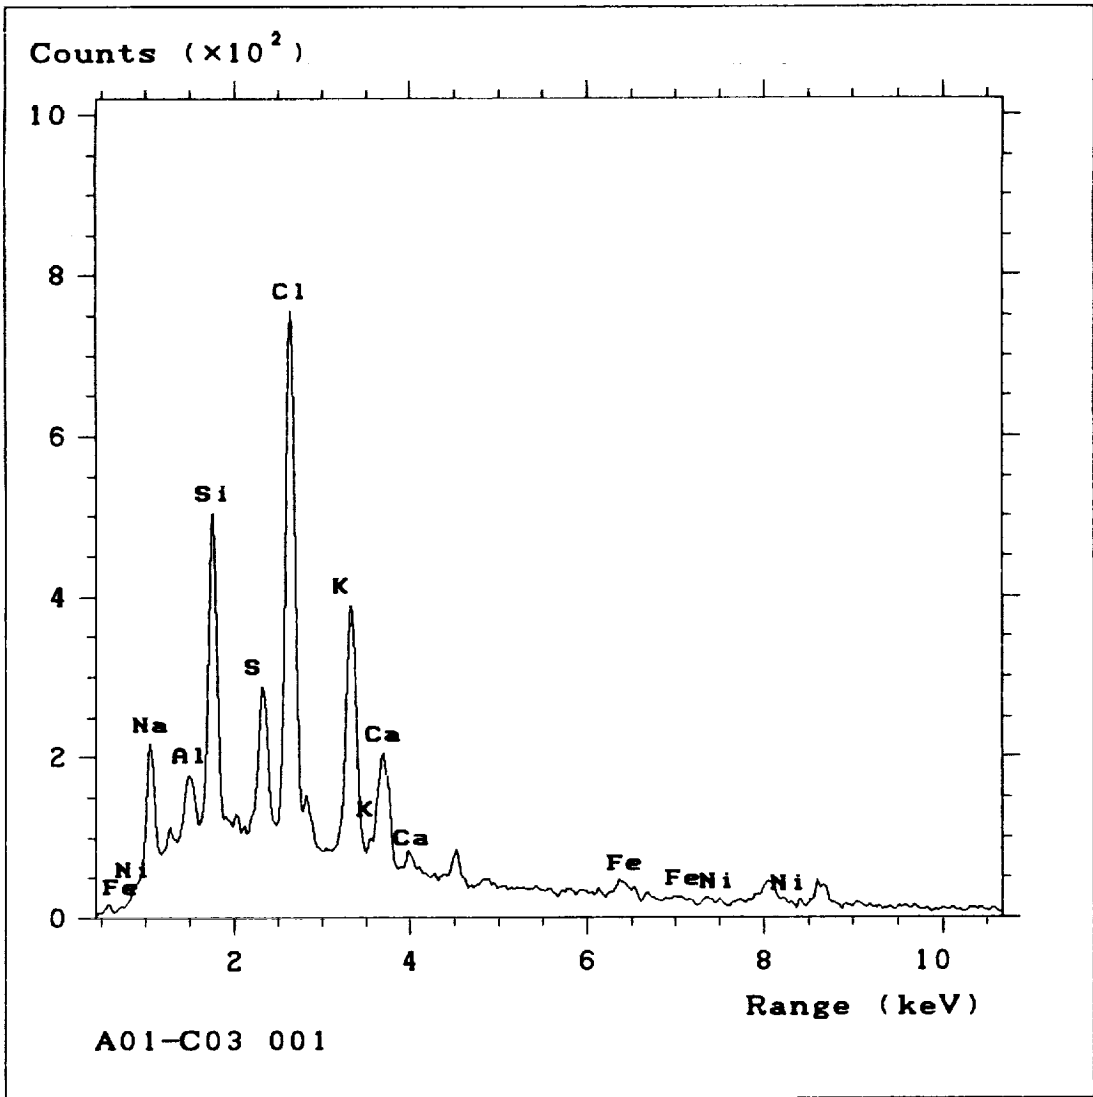
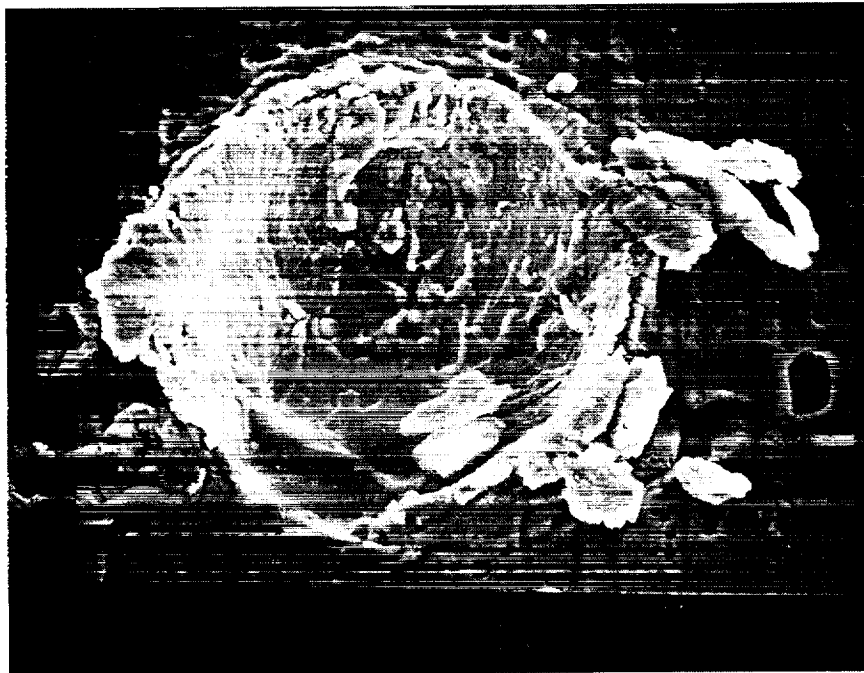
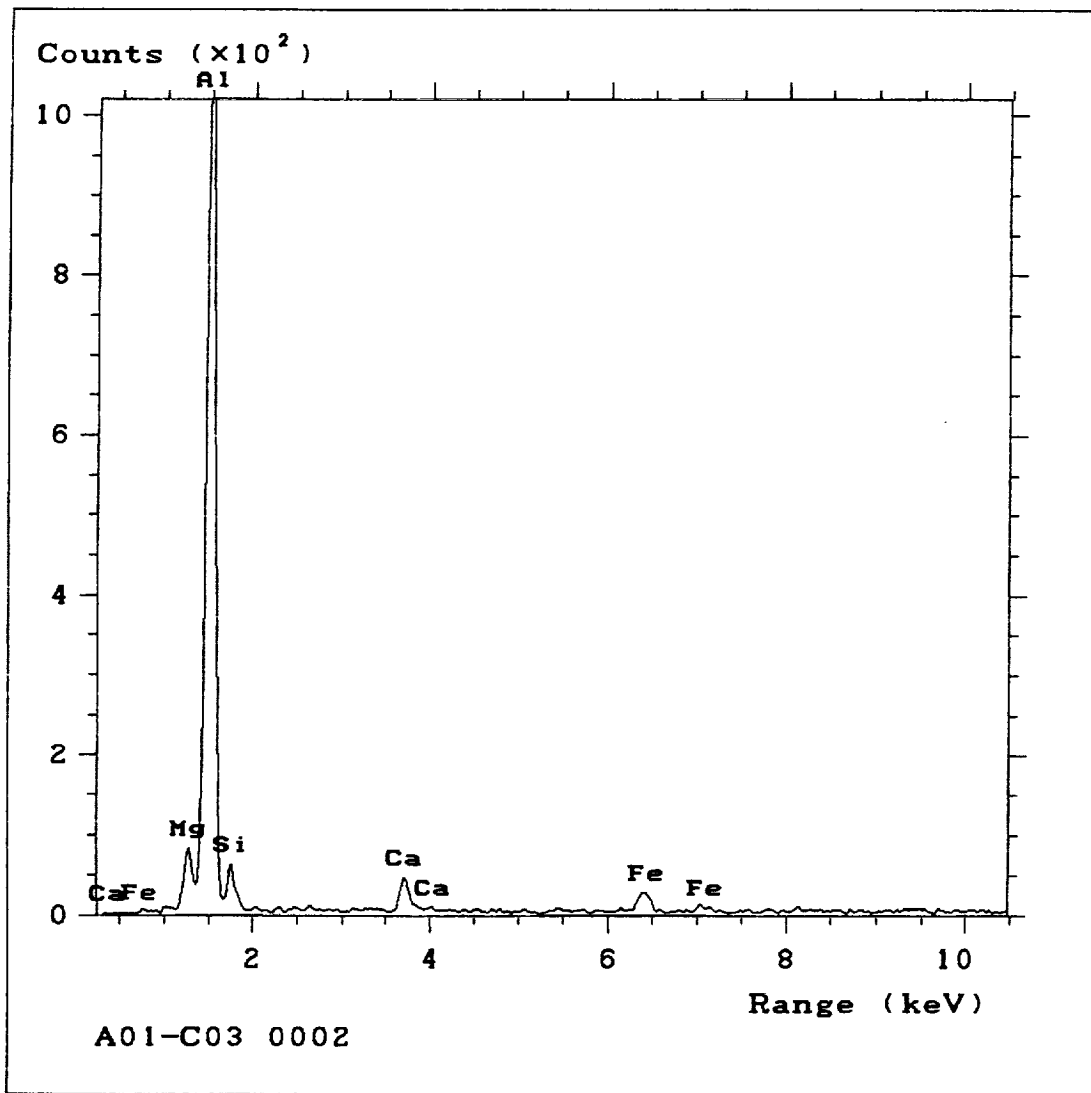
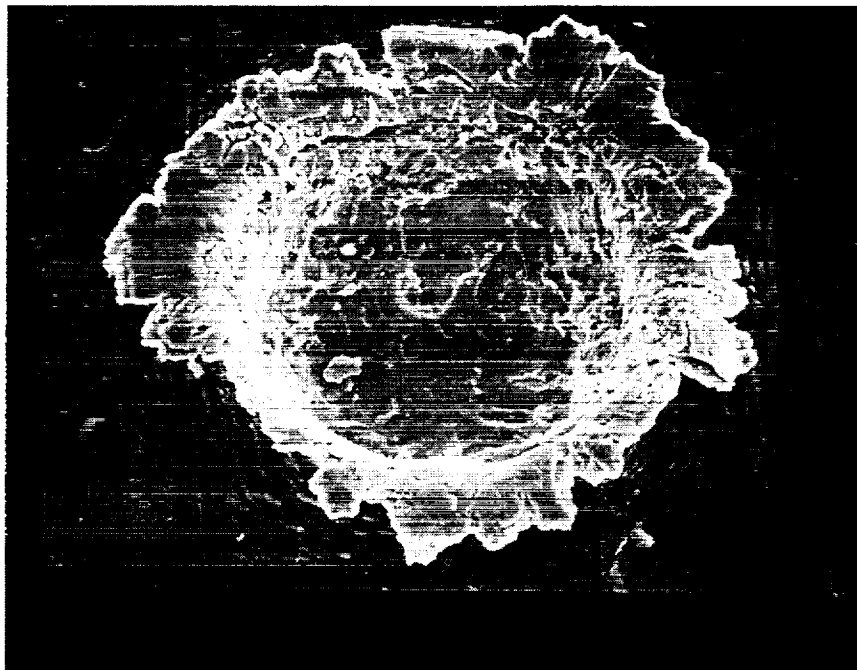
CLAMP NUMBER A01 CO3

<u>IMPACT NUMBER</u>	<u>DIAMETER</u>	<u>GENERAL COMPONENTS</u>
001	120	Contamination
002	230	Mg, Si, Ca, Fe

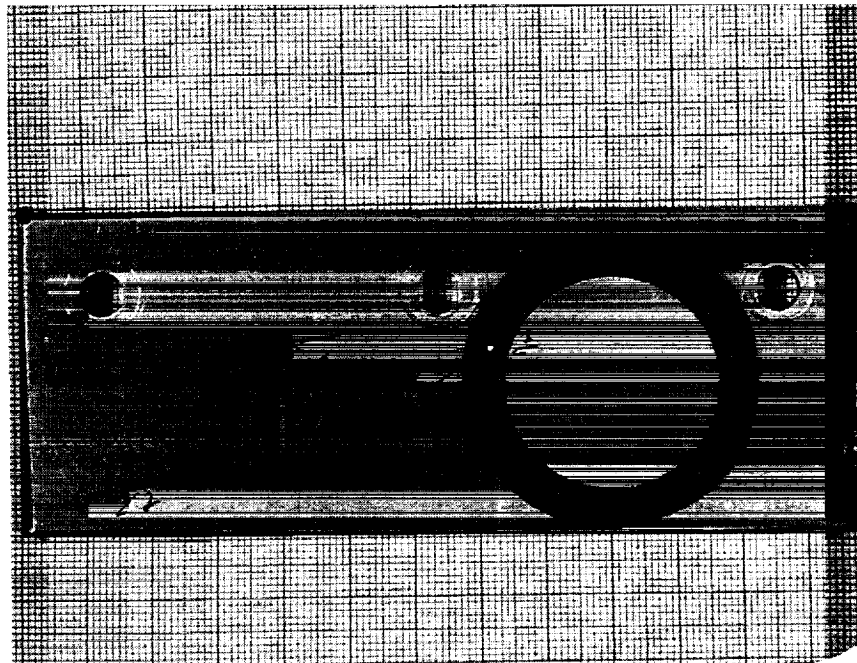
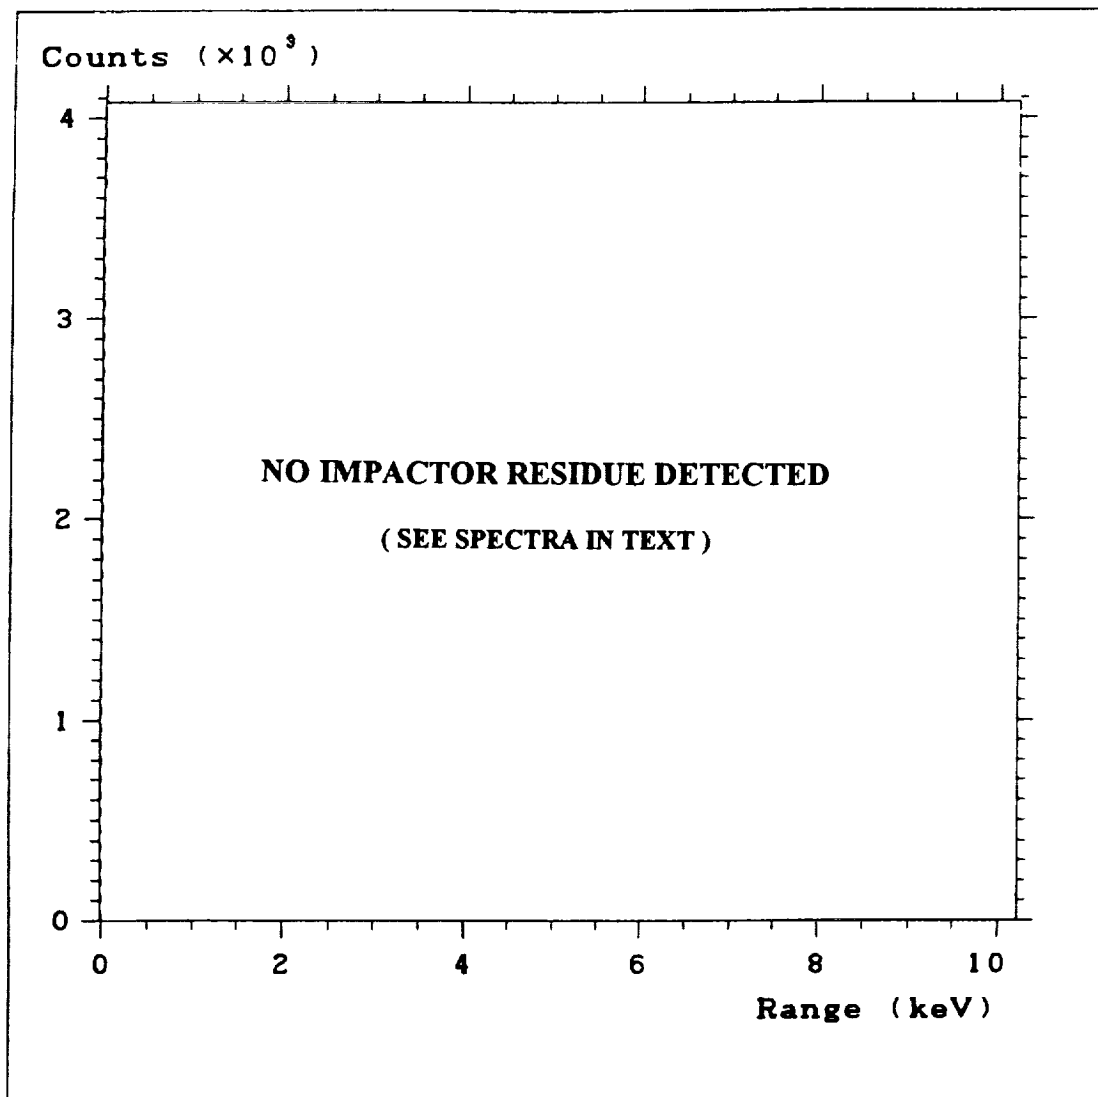
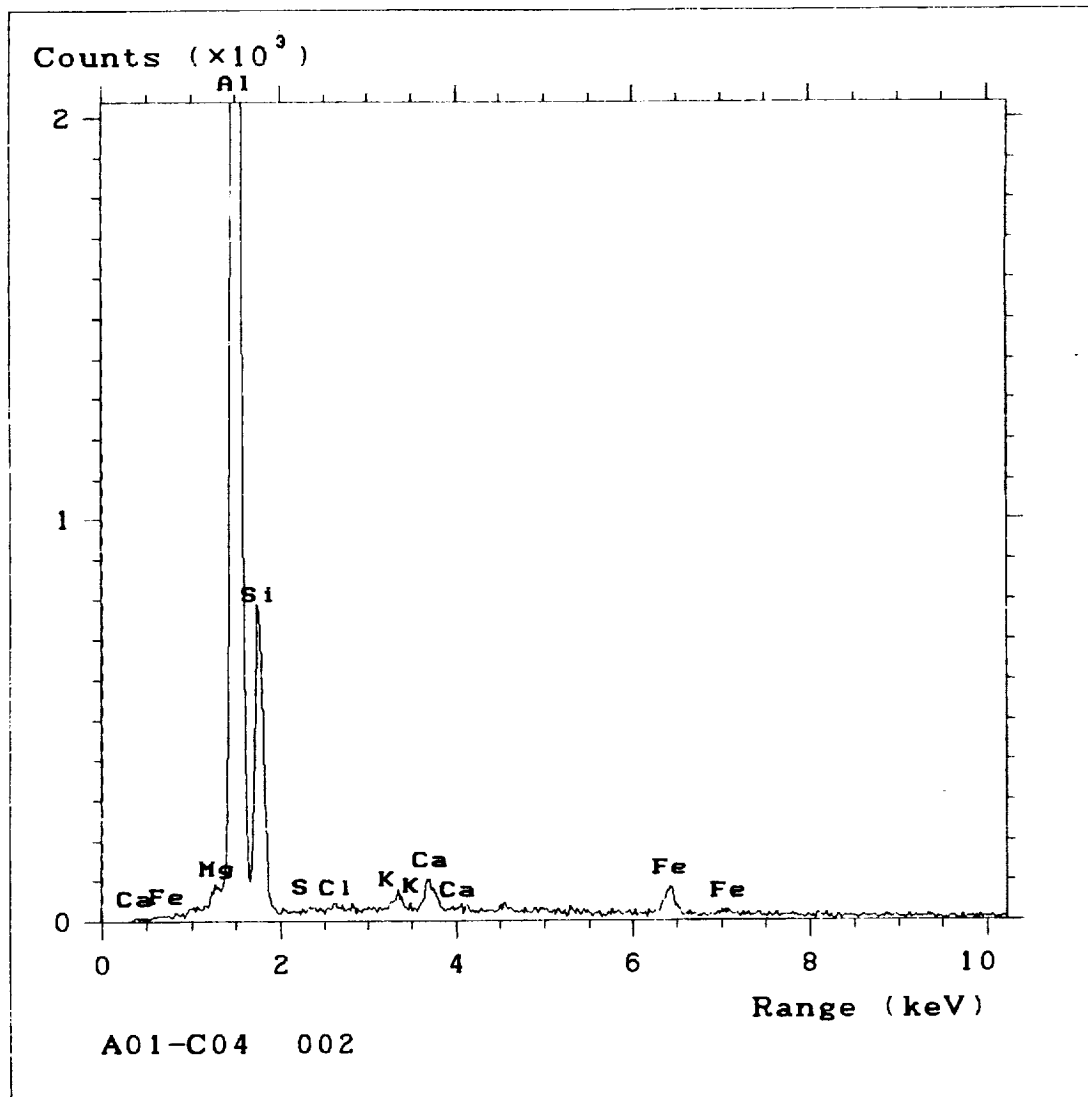
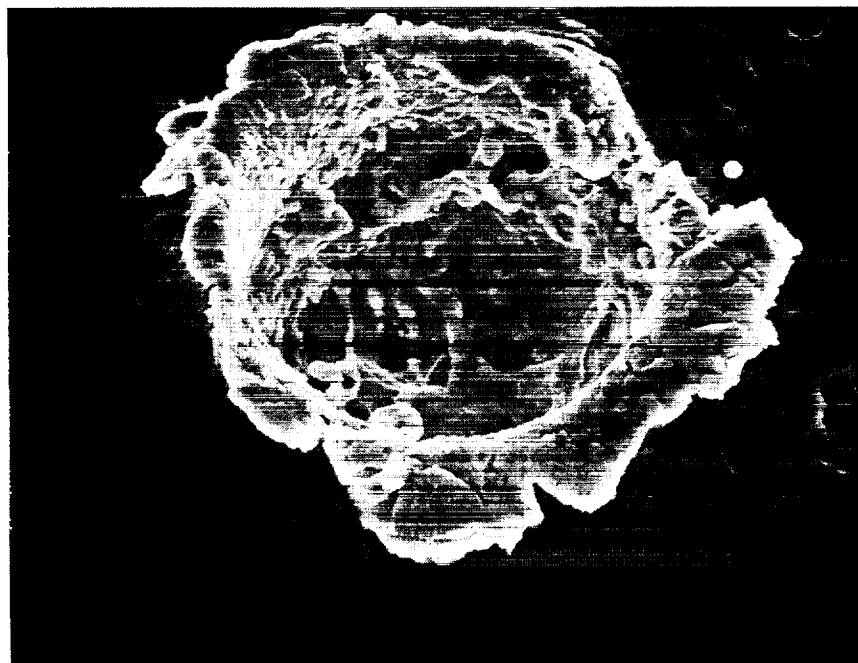
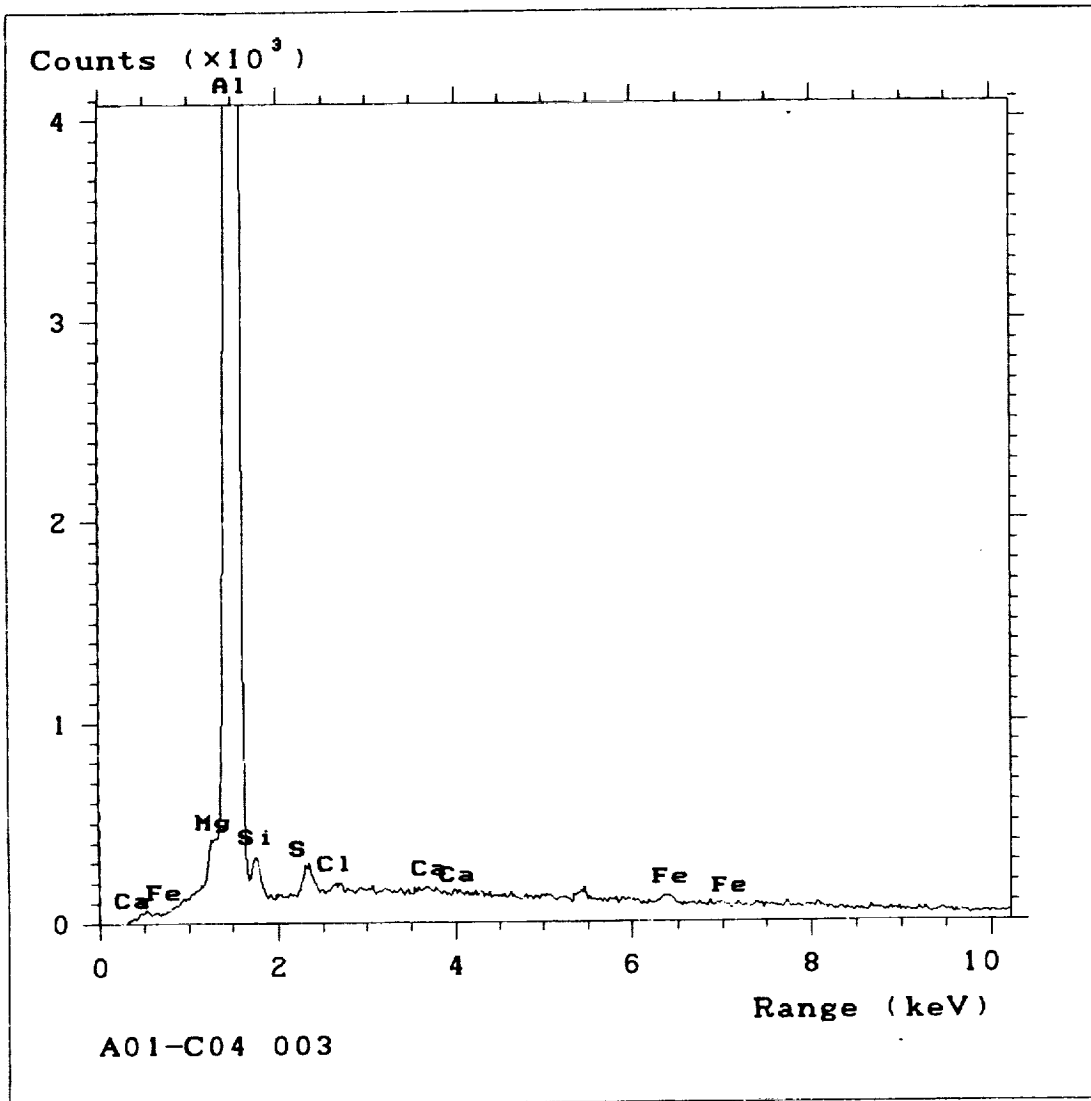
CLAMP NUMBER A01 C04

<u>IMPACT NUMBER</u>	<u>DIAMETER</u>	<u>GENERAL COMPONENTS</u>
001	100	Paint Patch
002	180	Trace
003	140	Unknown

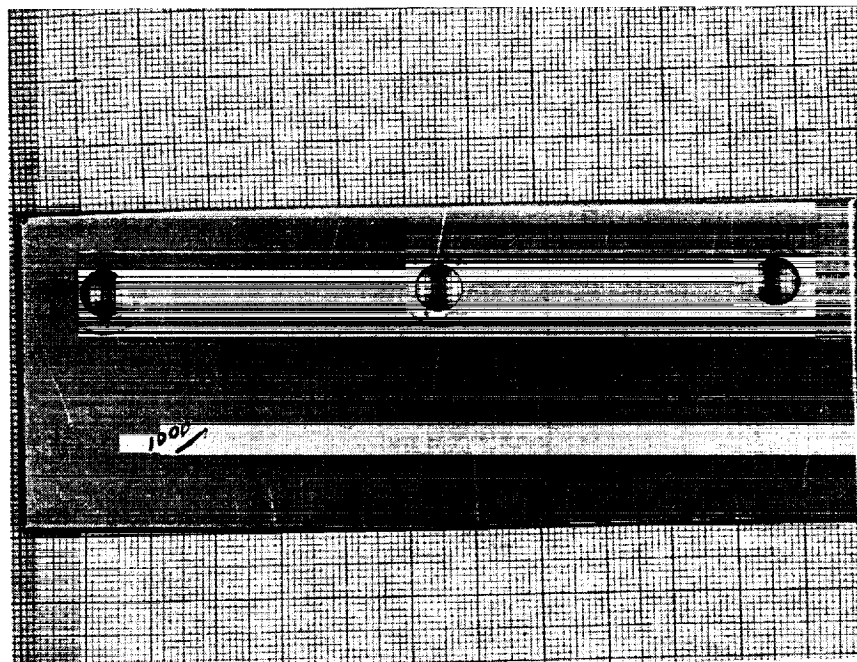
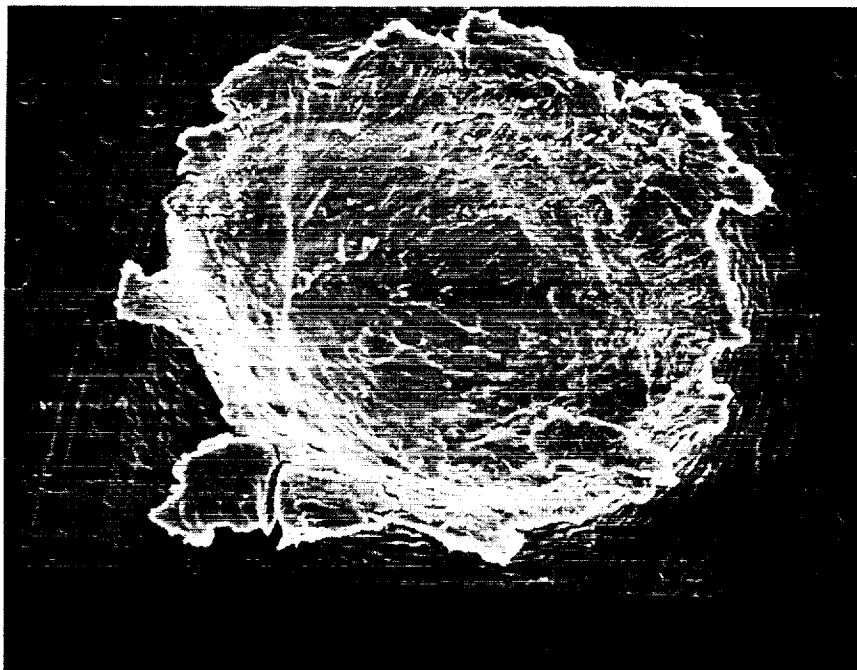
CLAMP NUMBER A01 CO8

<u>IMPACT NUMBER</u>	<u>DIAMETER</u>	<u>GENERAL COMPONENTS</u>
001	370	Mg, Si, Ca, Fe

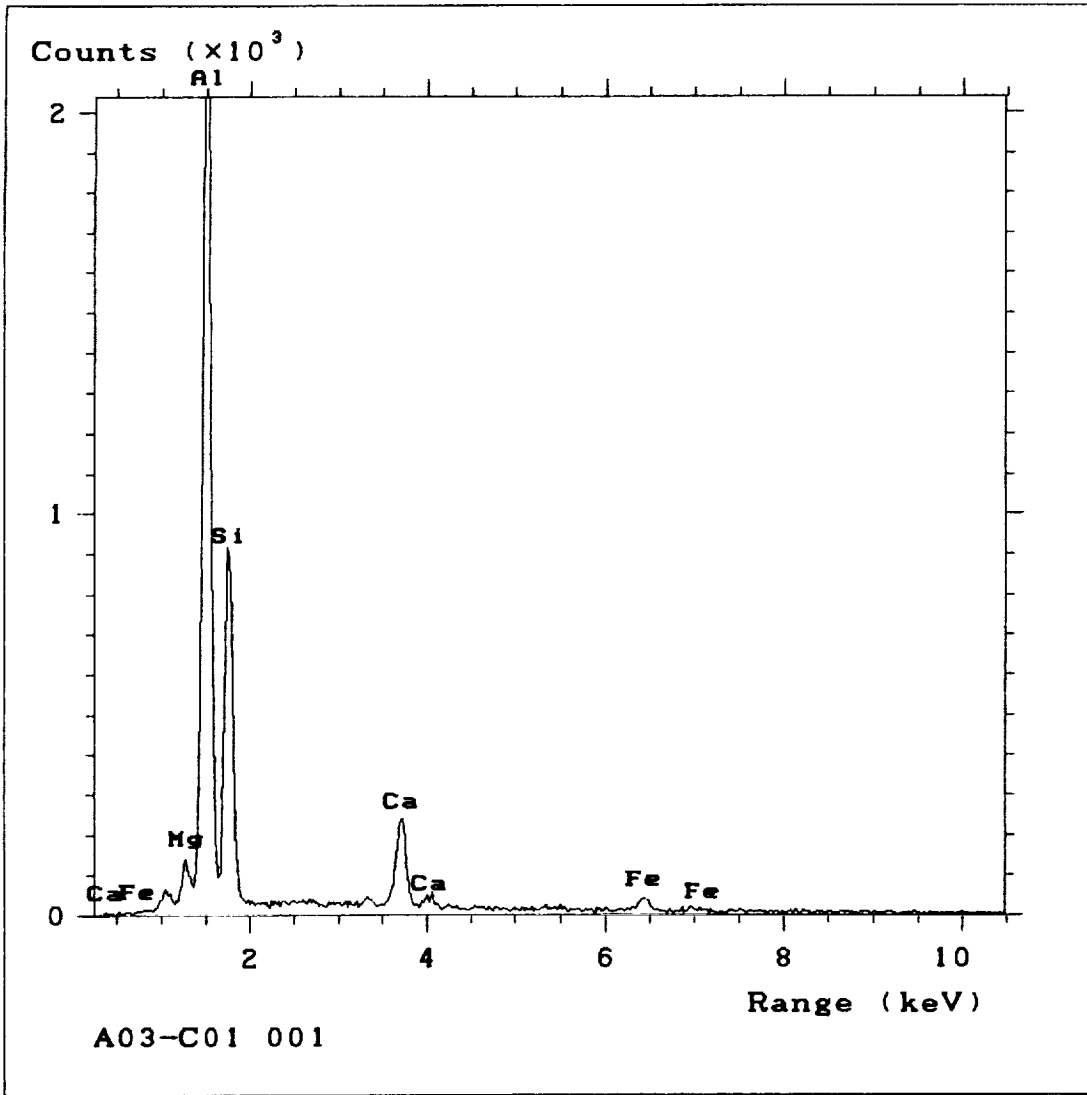
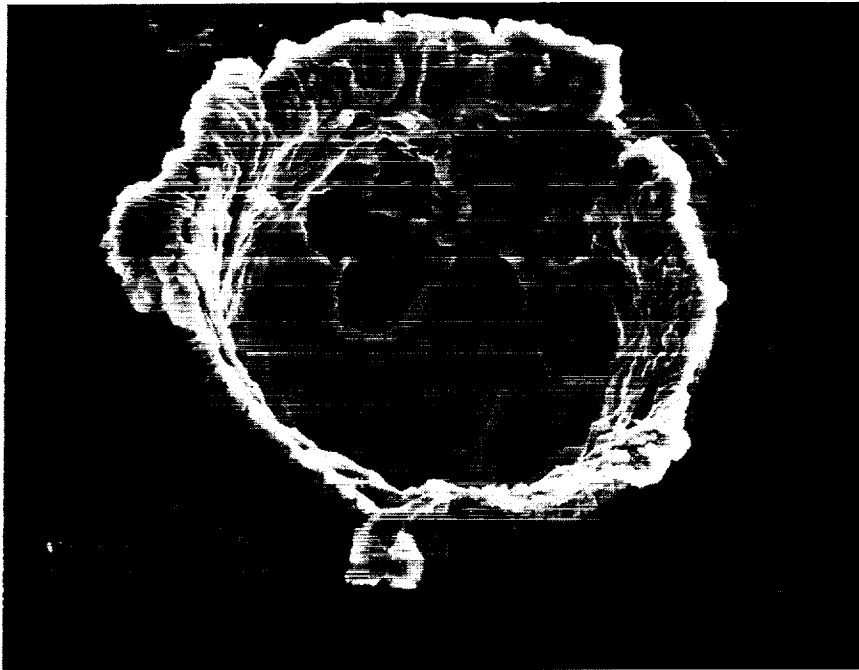
CLAMP NUMBER A03 CO1

<u>IMPACT NUMBER</u>	<u>DIAMETER</u>	<u>GENERAL COMPONENTS</u>
001	150	Mg, Si, Ca, Fe

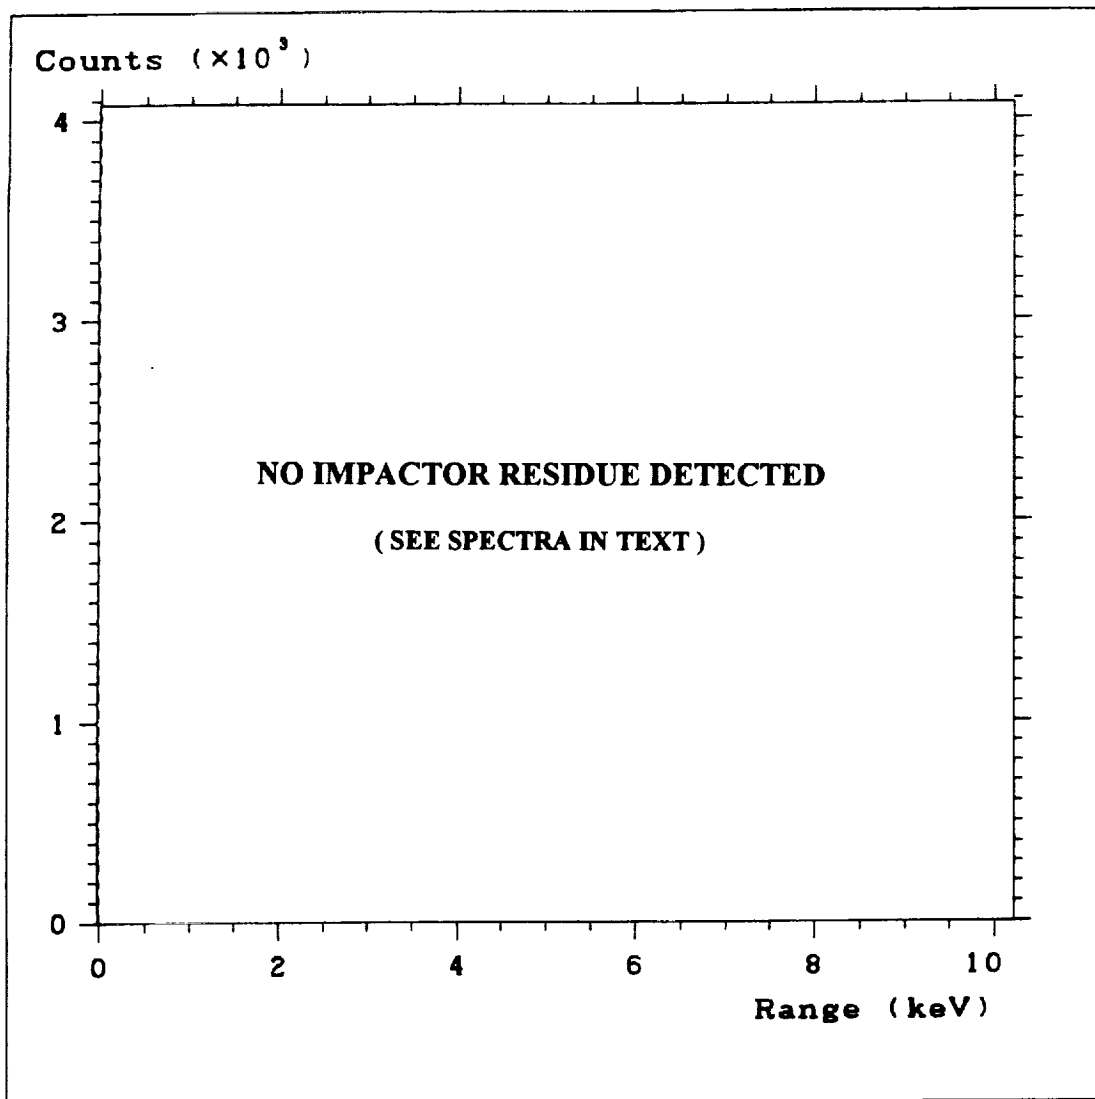
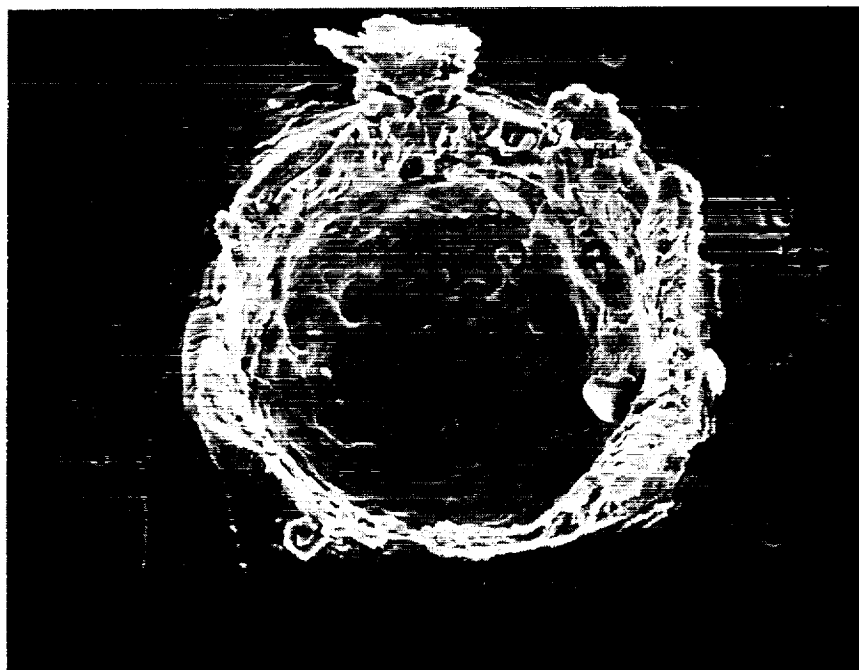
CLAMP NUMBER A03 C03

<u>IMPACT NUMBER</u>	<u>DIAMETER</u>	<u>GENERAL COMPONENTS</u>
001	220	Unkown

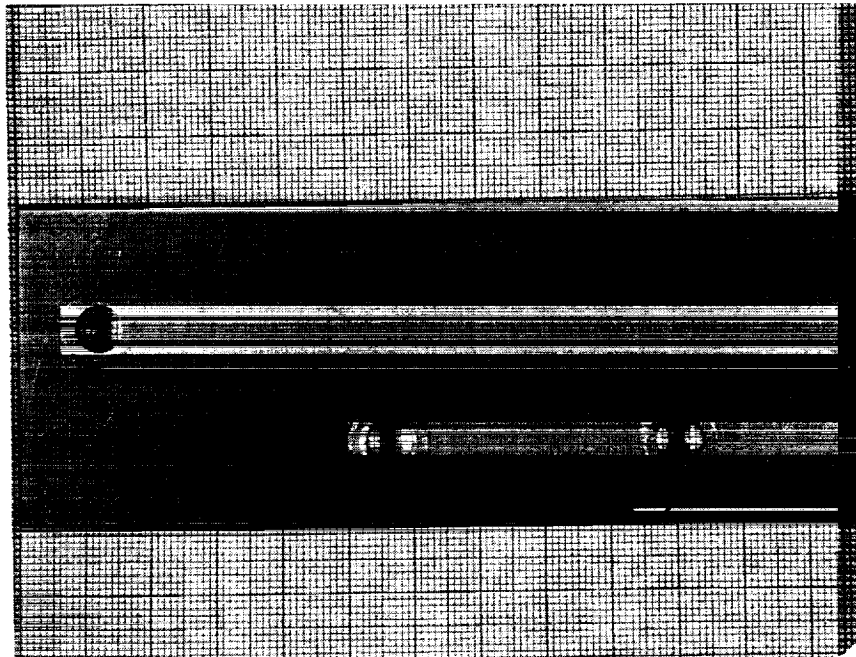
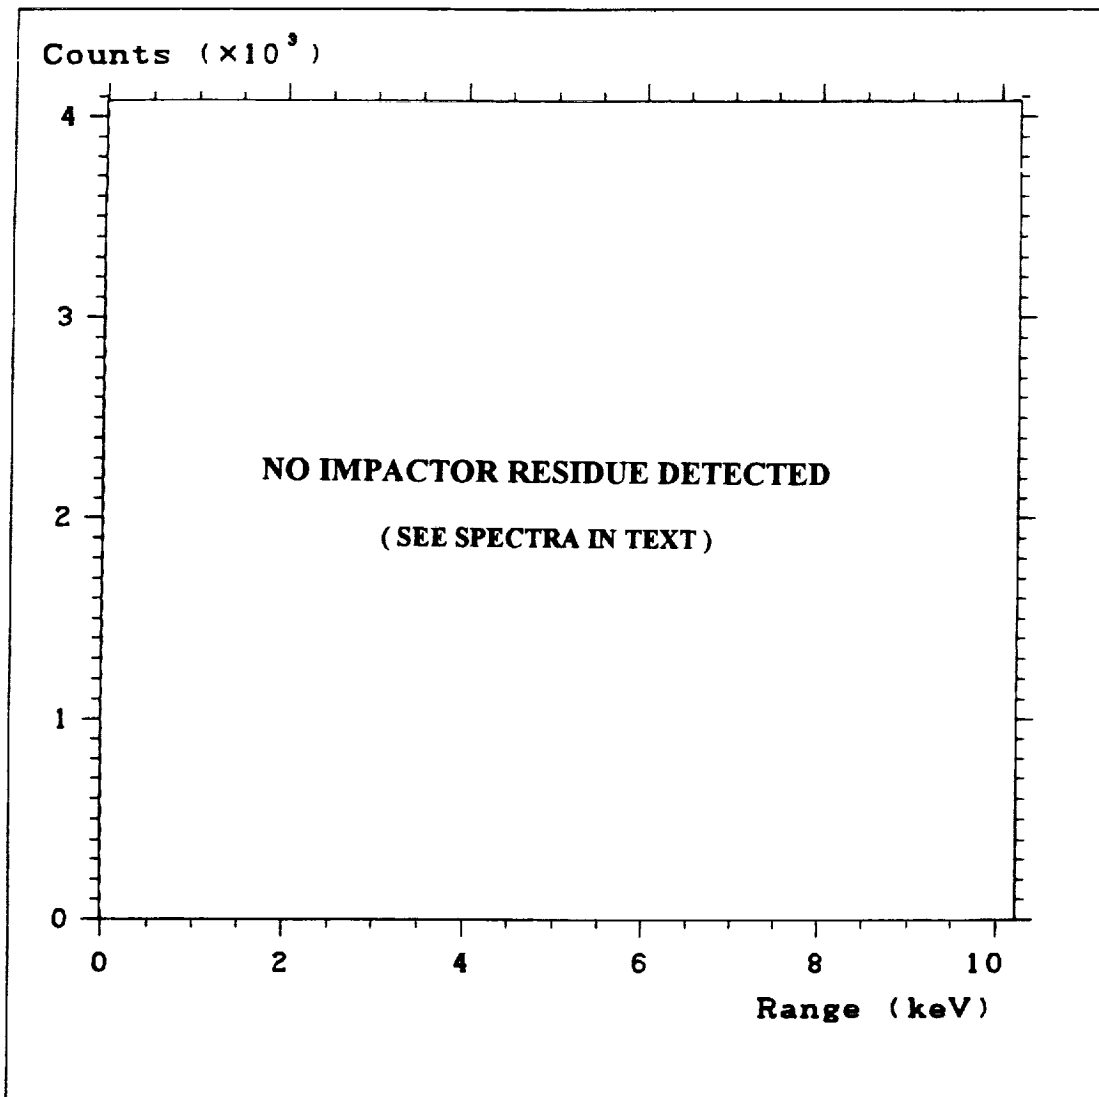
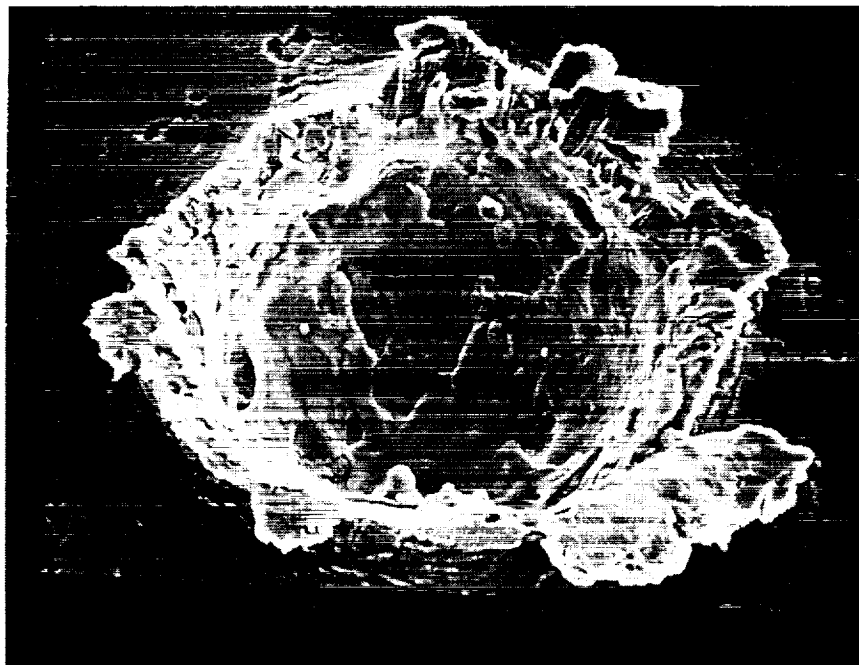
CLAMP NUMBER A04 C03

<u>IMPACT NUMBER</u>	<u>DIAMETER</u>	<u>GENERAL COMPONENTS</u>
001	260	Unkown
