NASA Technical Memorandum 104759

Analysis of Impactor Residues in Tray Clamps from the Long Duration Exposure Facility

Part 1: Clamps from Bay "A" of the Satellite

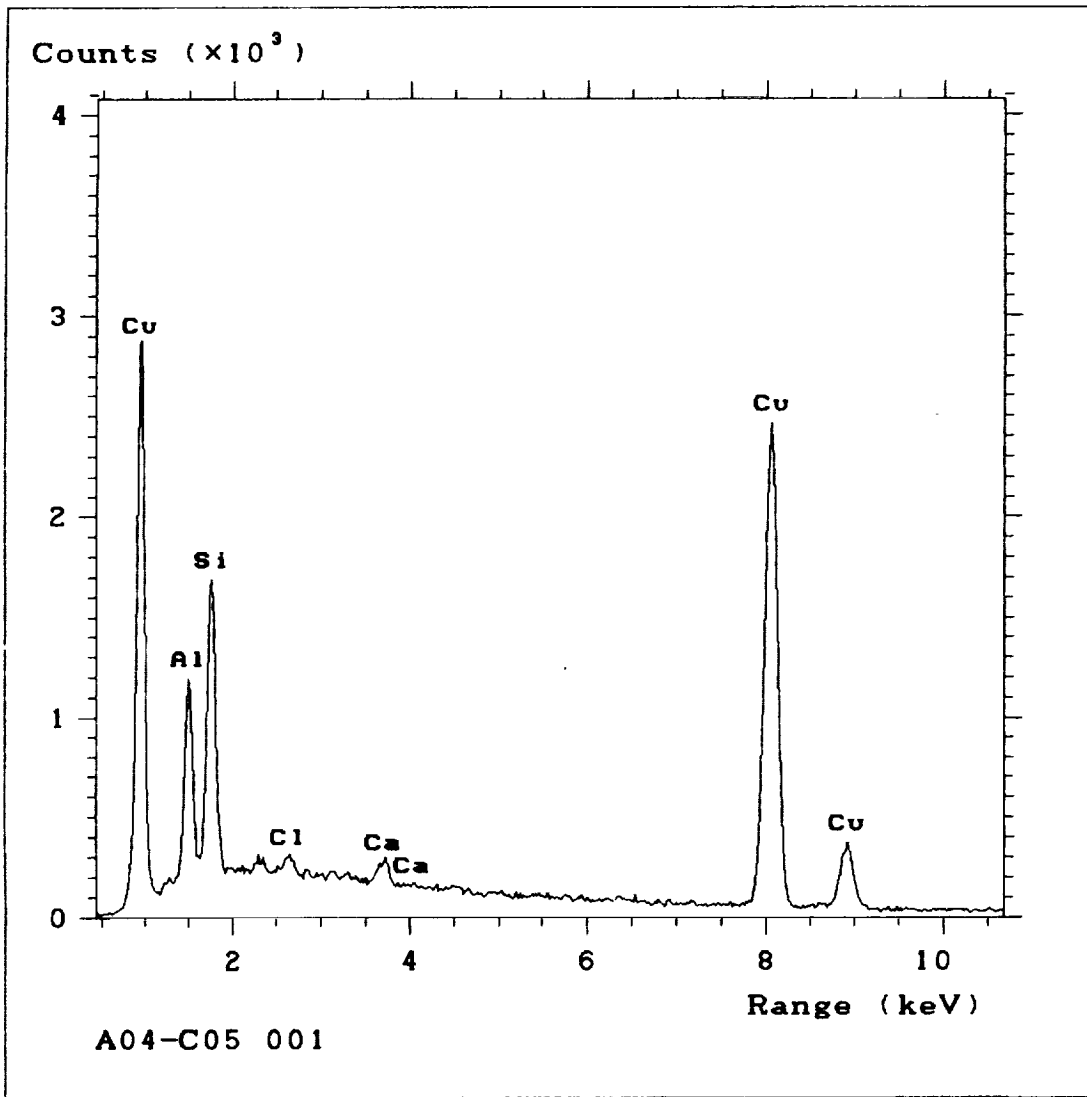
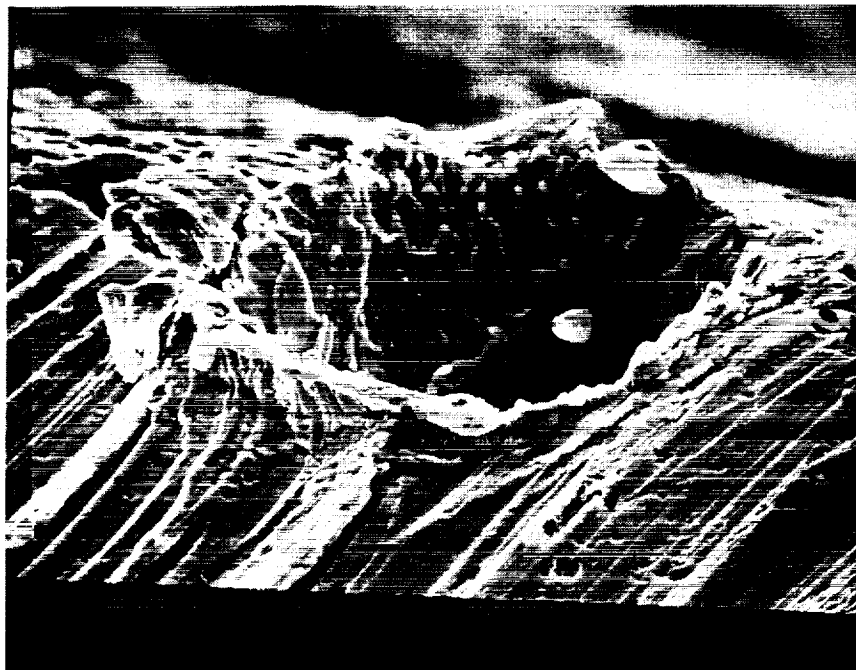
CLAMP NUMBER A04 C05

<u>IMPACT NUMBER</u>	<u>DIAMETER</u>	<u>GENERAL COMPONENTS</u>
001	210	Contamination
002	120	Fe, Ni, Cr

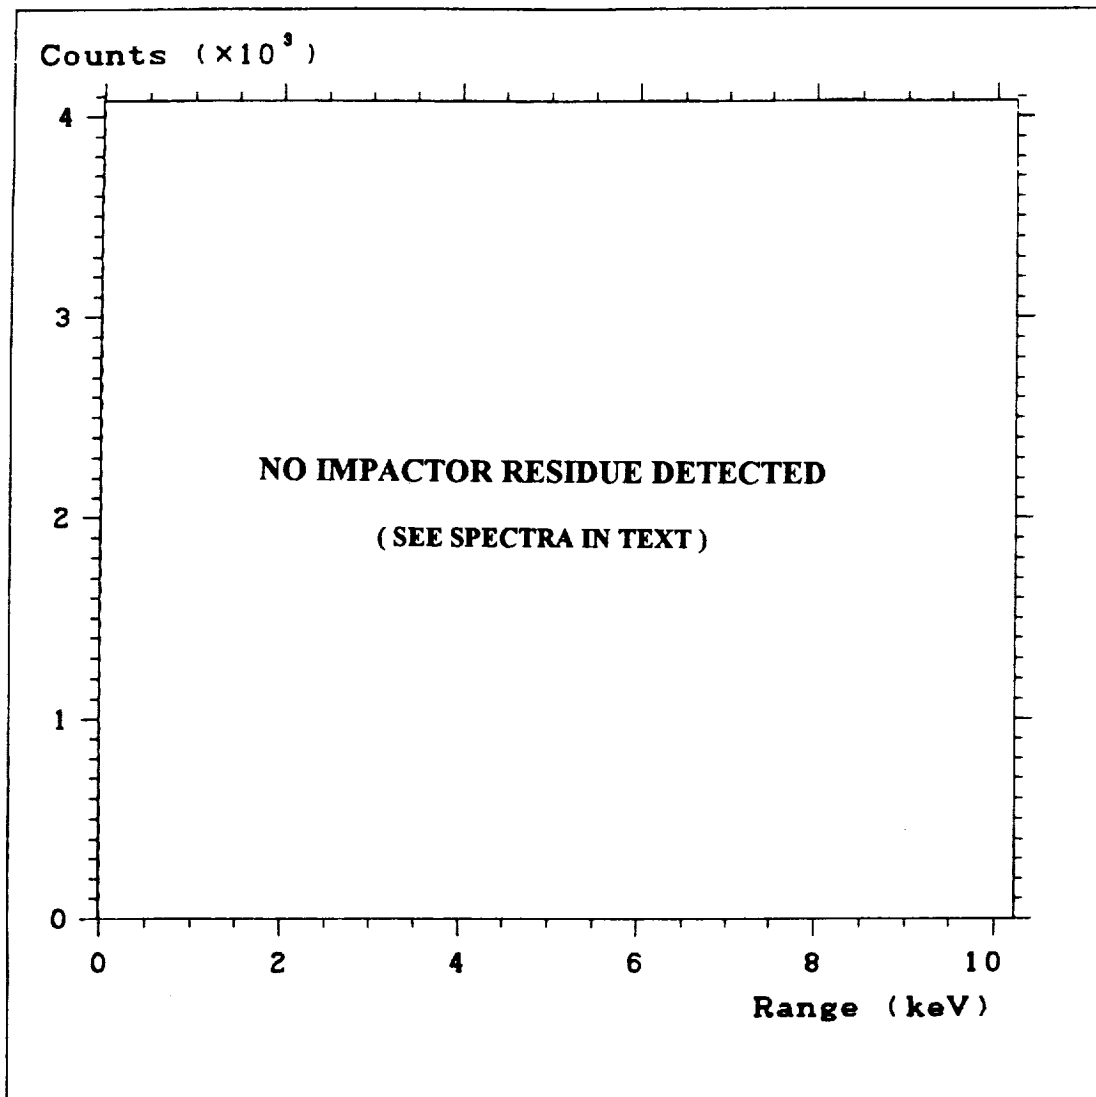
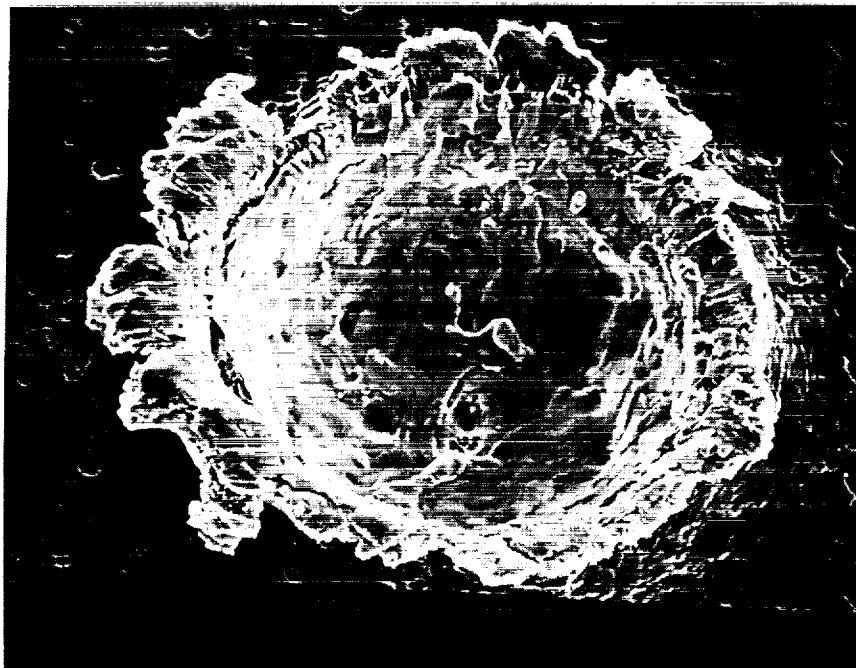
CLAMP NUMBER A05 C03

<u>IMPACT NUMBER</u>	<u>DIAMETER</u>	<u>GENERAL COMPONENTS</u>
001	180	Unkown

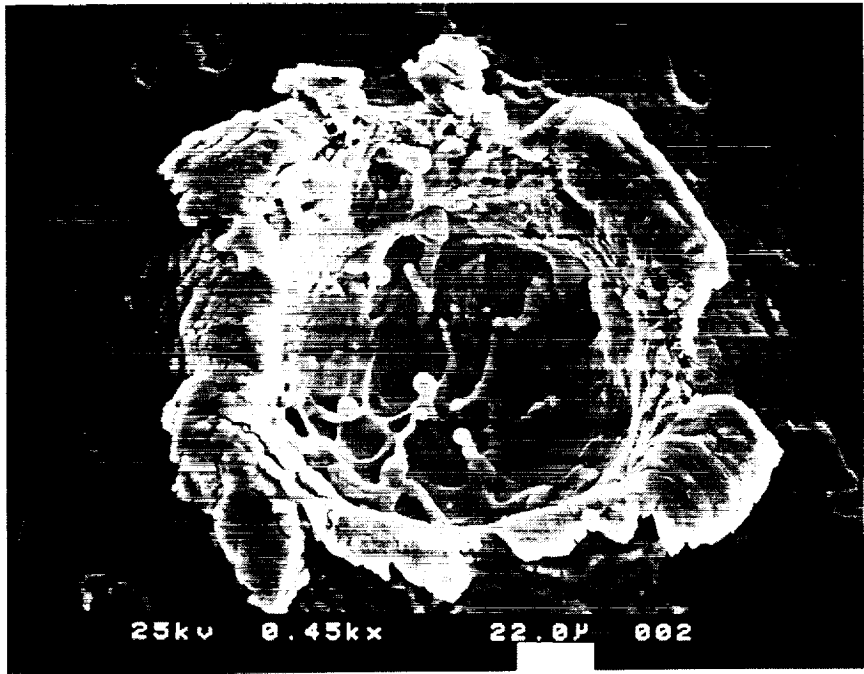
CLAMP NUMBER A05 C06

<u>IMPACT NUMBER</u>	<u>DIAMETER</u>	<u>GENERAL COMPONENTS</u>
001	250	Si, Ca, S, K, Fe
002	70	Unkown
003	140	Trace
004	50	Unkown
005	90	Unkown

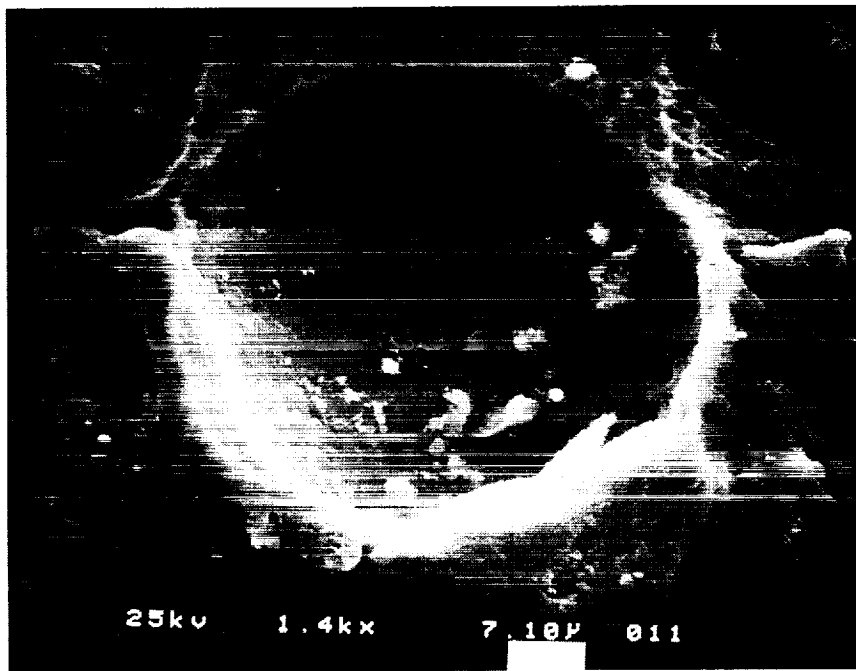
CLAMP NUMBER A06 C05

<u>IMPACT NUMBER</u>	<u>DIAMETER</u>	<u>GENERAL COMPONENTS</u>
001	70	Clamp Flaw
002	200	Trace

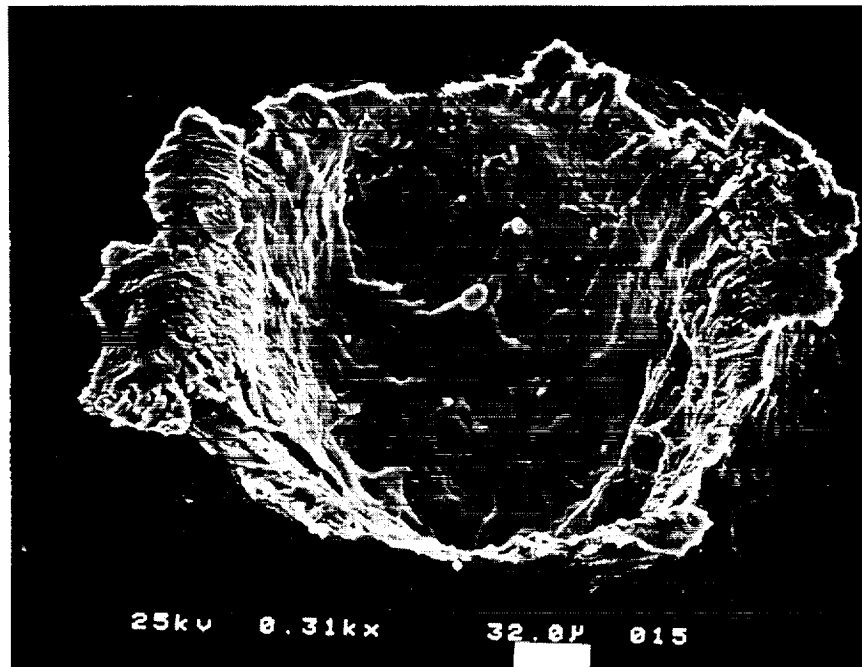
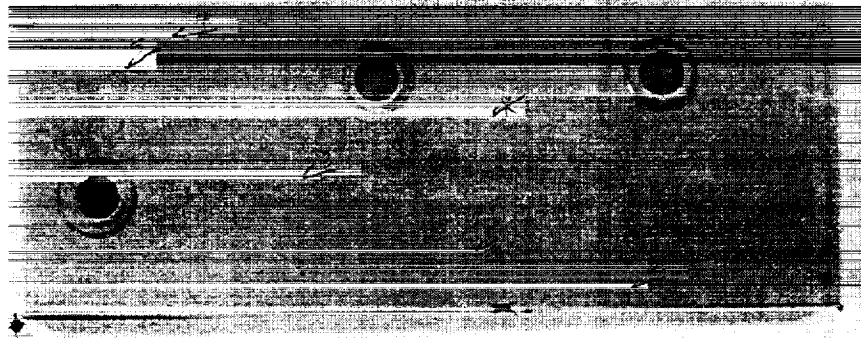
CLAMP NUMBER A07 CO1

<u>IMPACT NUMBER</u>	<u>DIAMETER</u>	<u>GENERAL COMPONENTS</u>
001	210	Unkown
002	120	Si, Ca, Fe
003	110	Si, Ca, S, Fe
004	210	Unkown
005	130	Trace

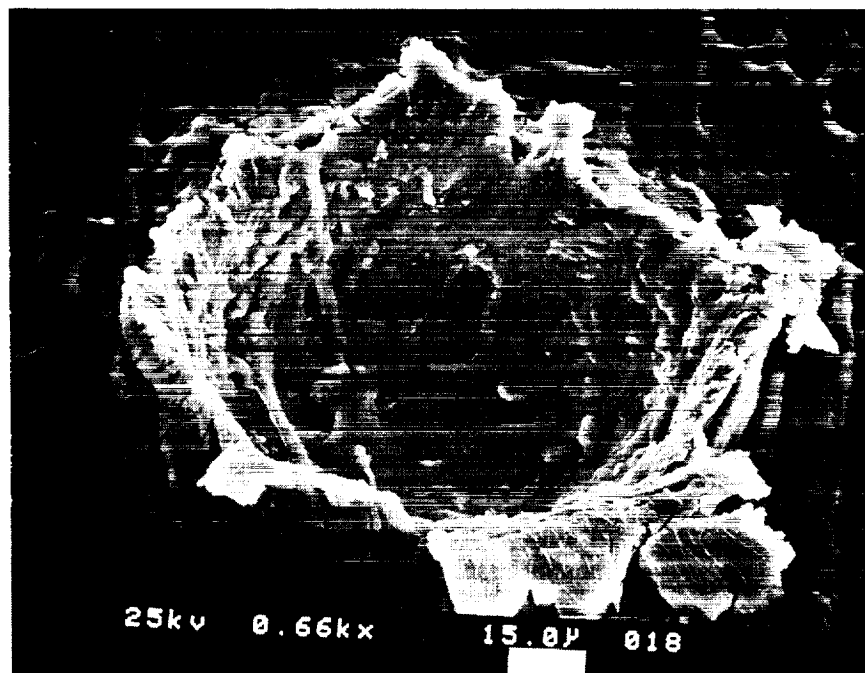
CLAMP NUMBER A07 CO3

<u>IMPACT NUMBER</u>	<u>DIAMETER</u>	<u>GENERAL COMPONENTS</u>
001	380	Unkown
002	260	Contamination
003	N/A	No Impact
004	40	Unkown
005	180	Paint
006	400	Unkown
007	40	Contamination

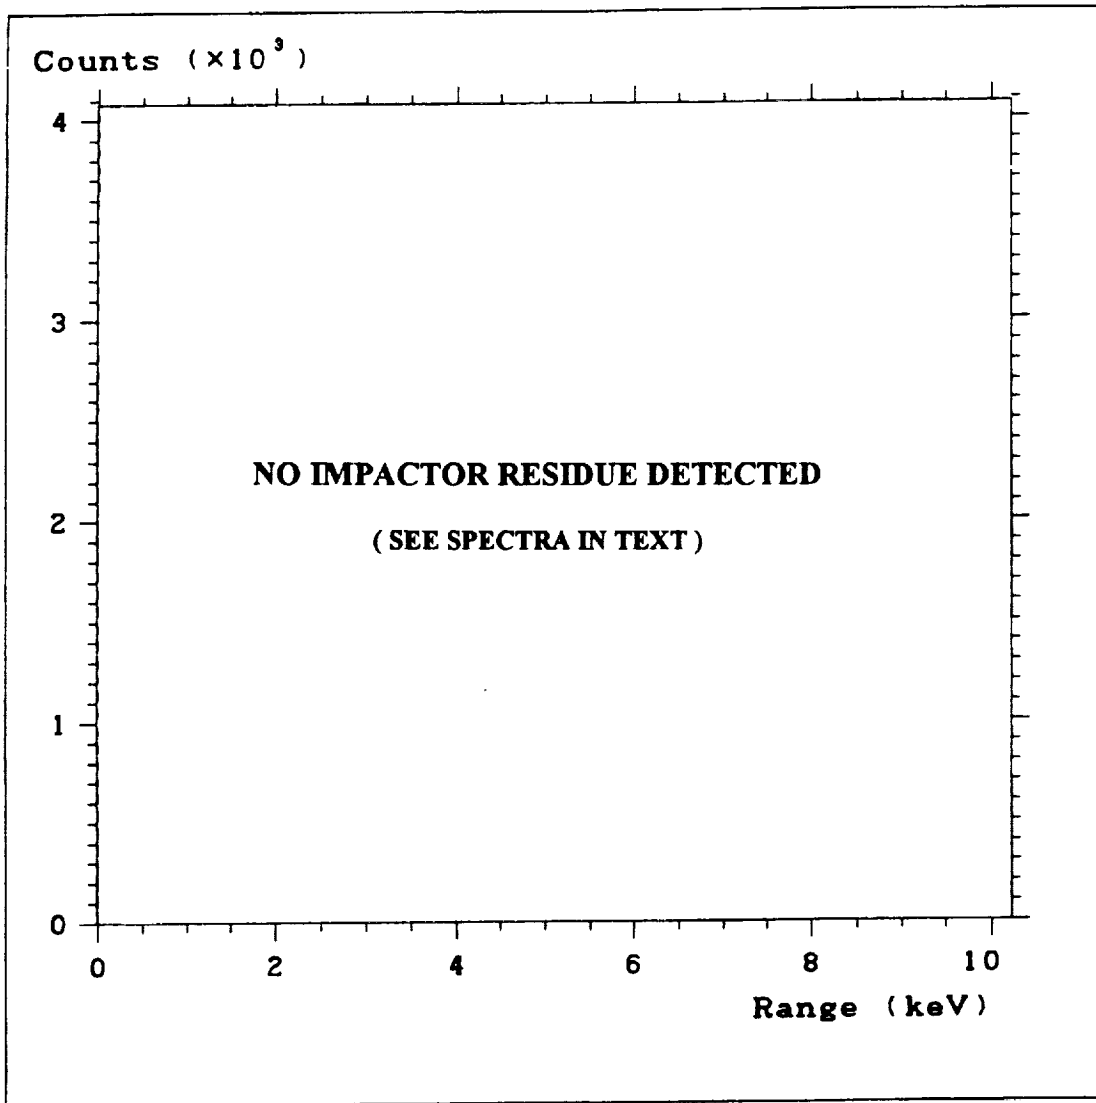
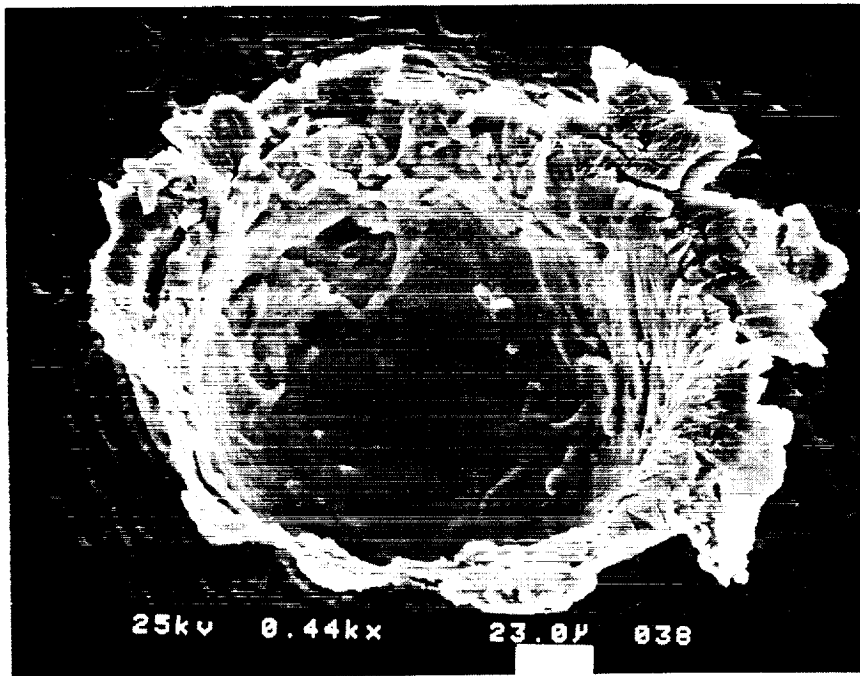
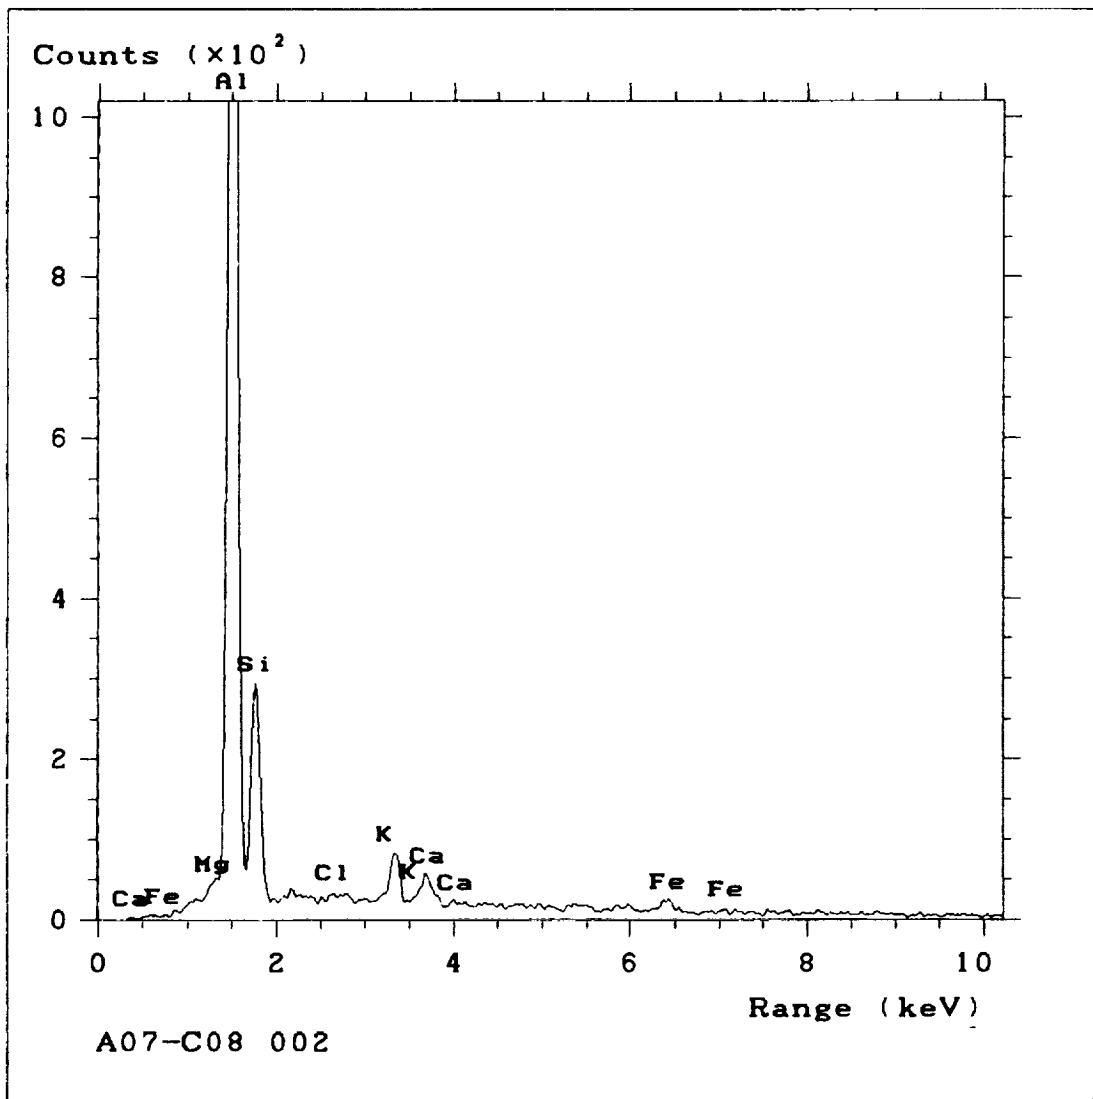
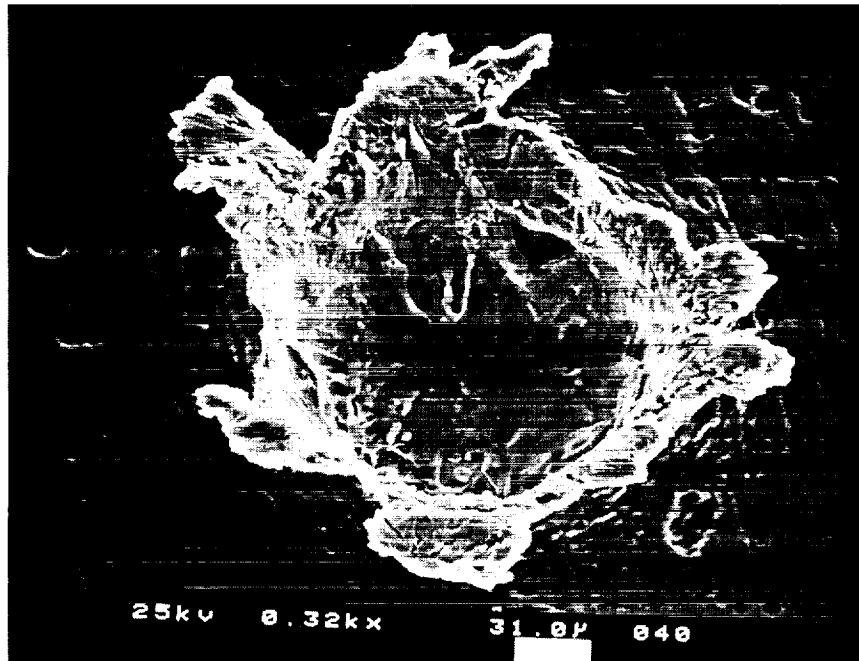
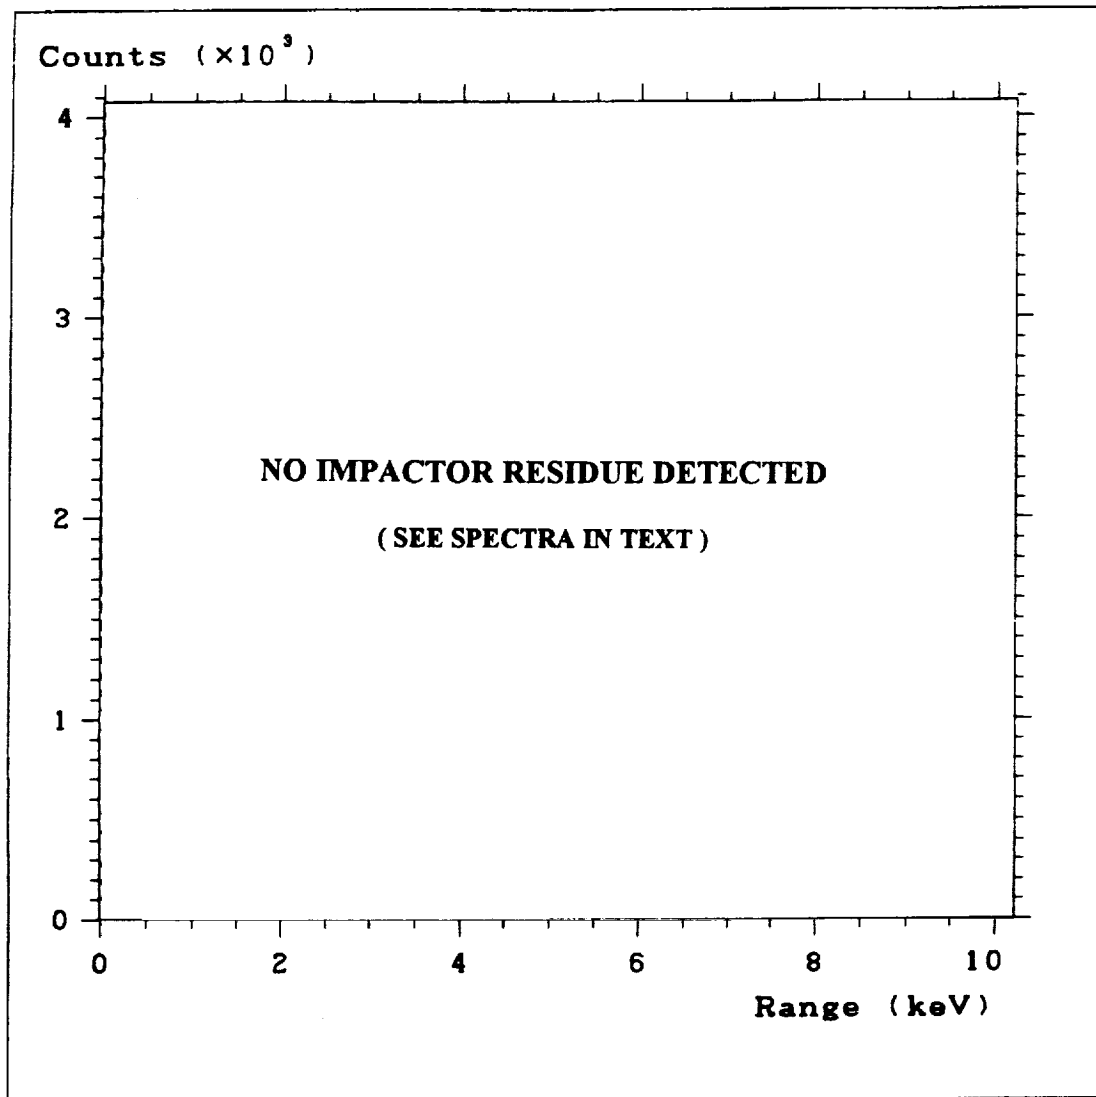
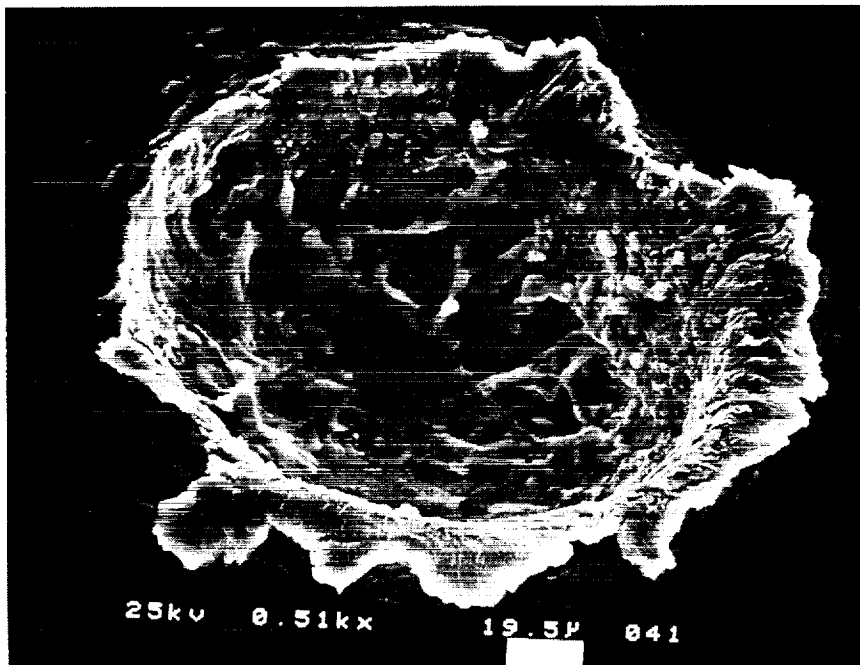
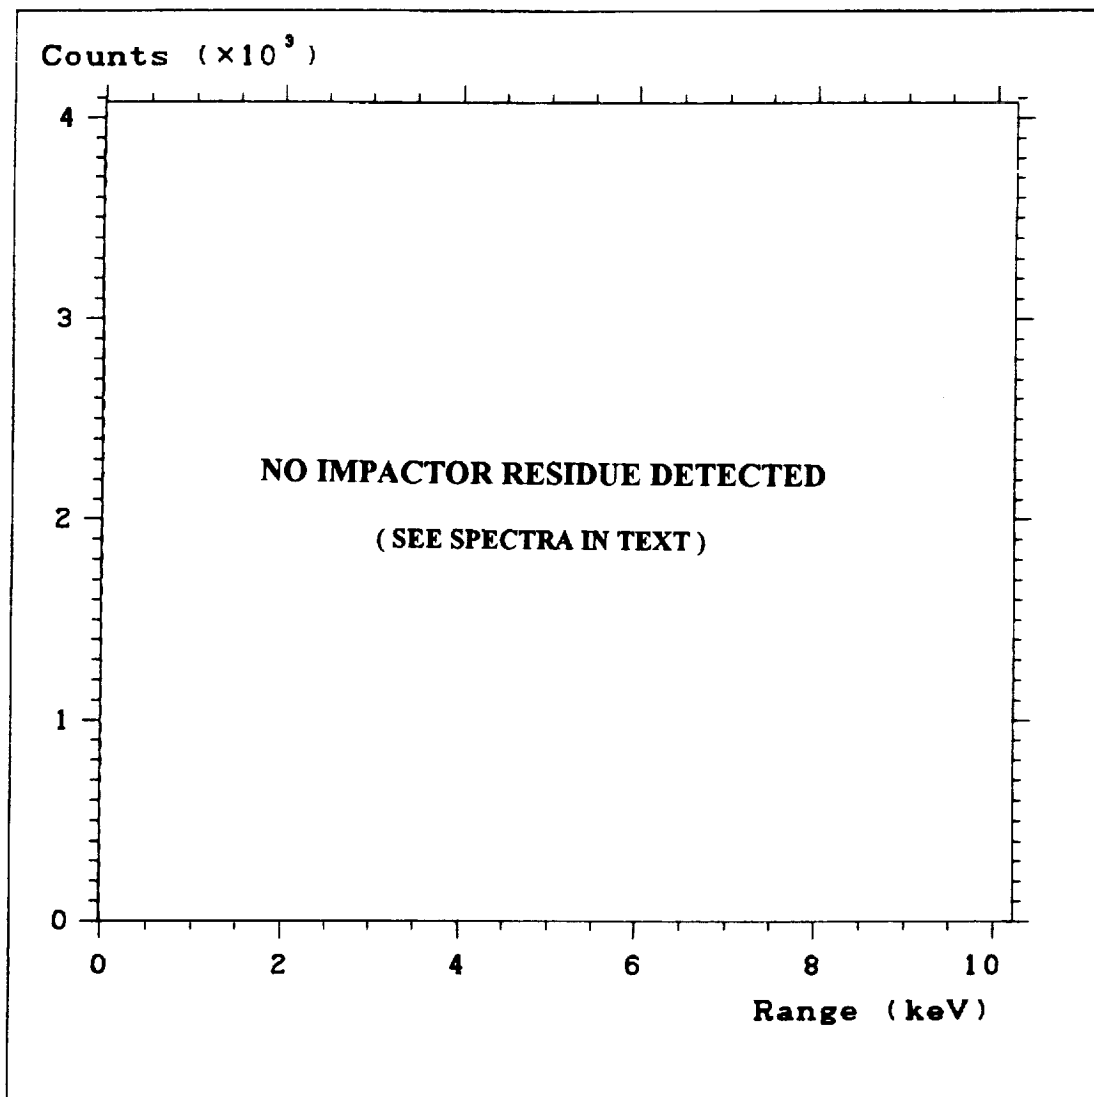
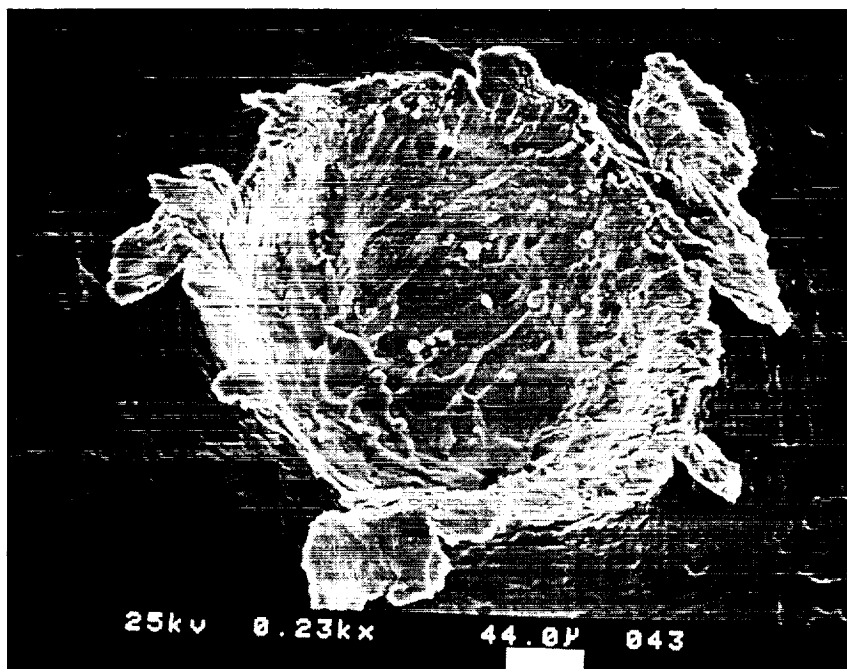
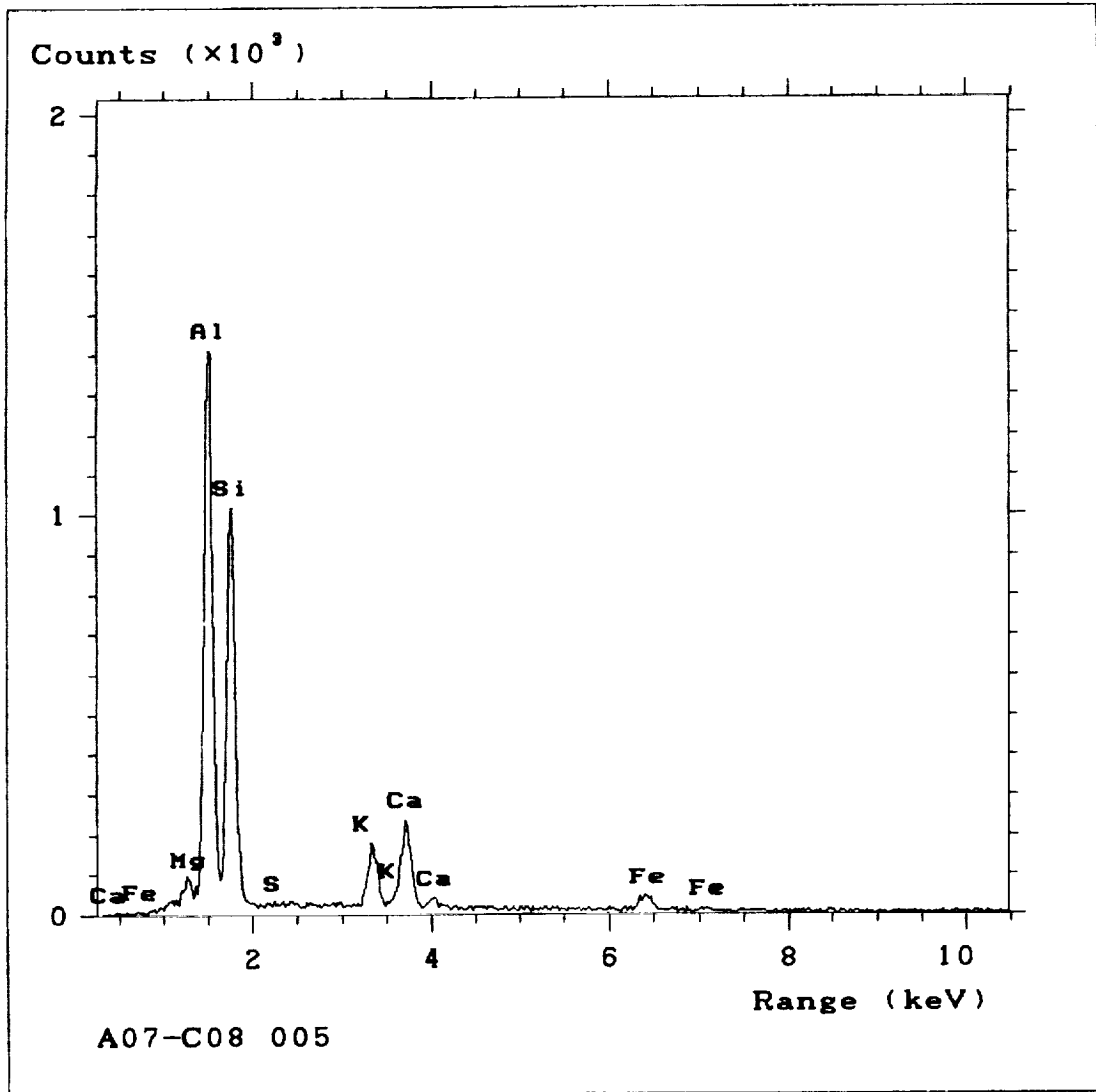
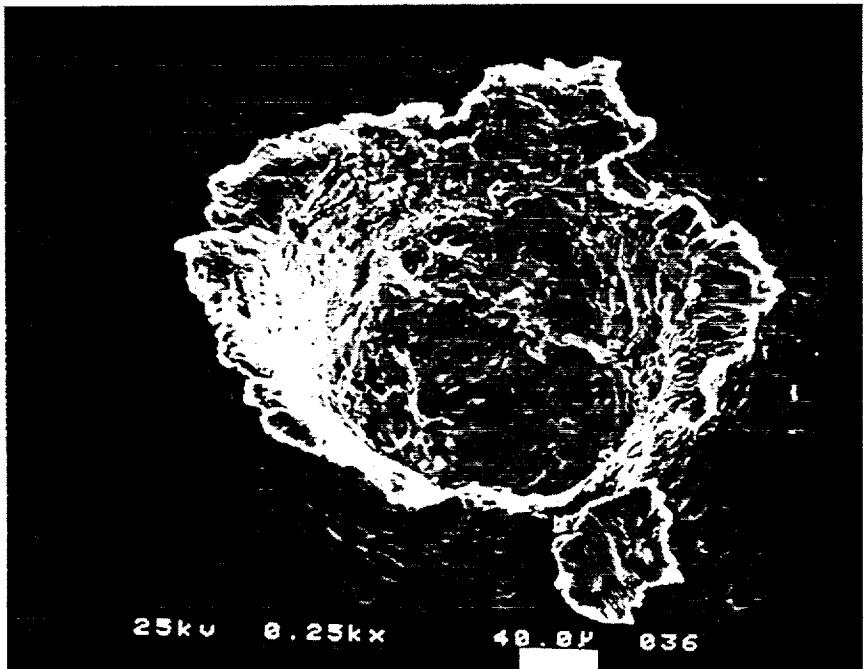
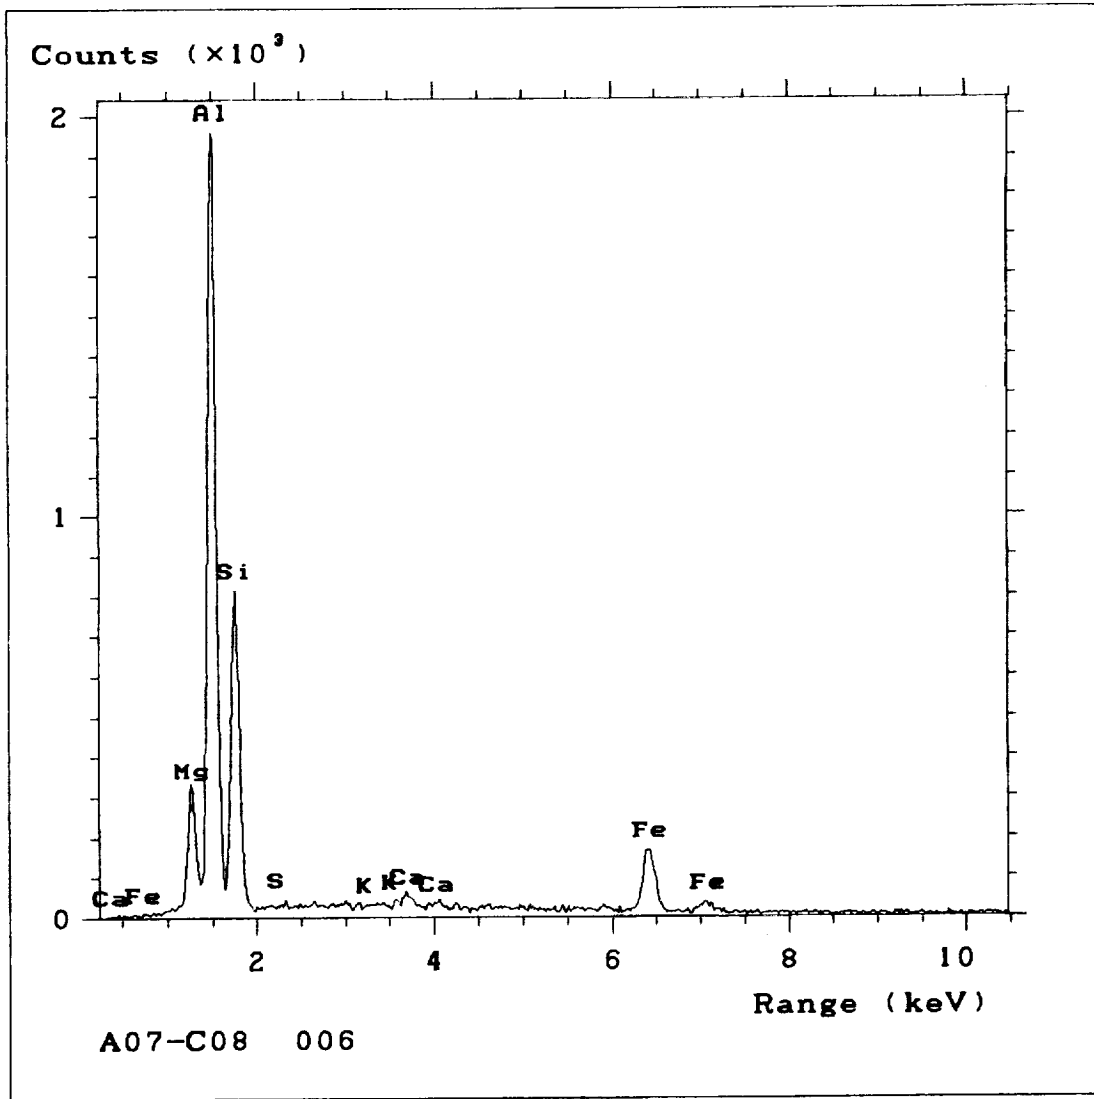
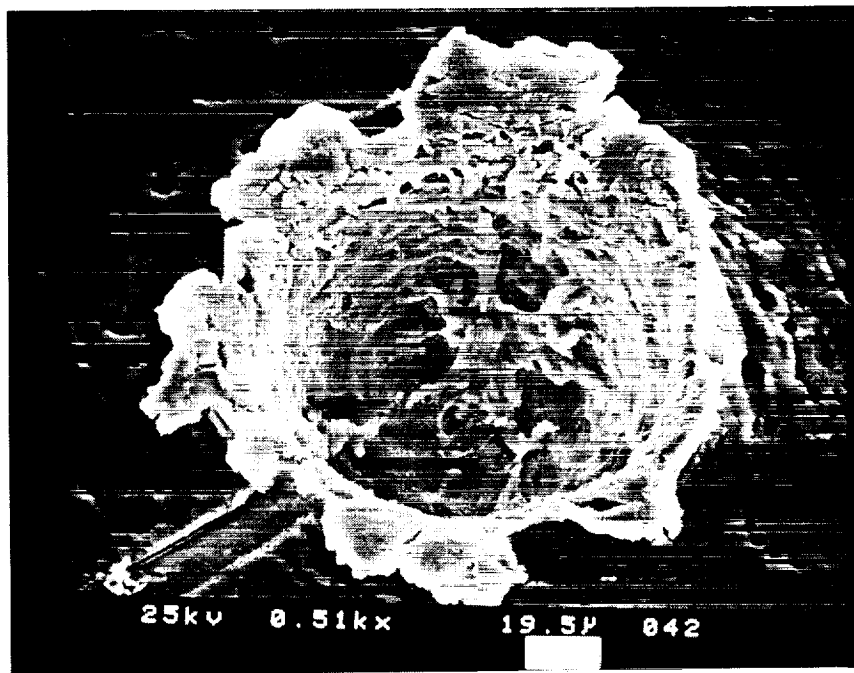
CLAMP NUMBER A08 CO1

<u>IMPACT NUMBER</u>	<u>DIAMETER</u>	<u>GENERAL COMPONENTS</u>
001	900	Si, Mg, Ca, Fe
002	130	Mg, Si, Ca, Fe
003	250	Trace
004	140	Unknown
005	200	Si, Mg, K
006	80	Si, Mg, Fe, Ca
007	100	Unkown
008	110	Unkown
