NASA Technical Memorandum 104759

Analysis of Impactor Residues in Tray Clamps from the Long Duration Exposure Facility

Part 1: Clamps from Bay "A" of the Satellite

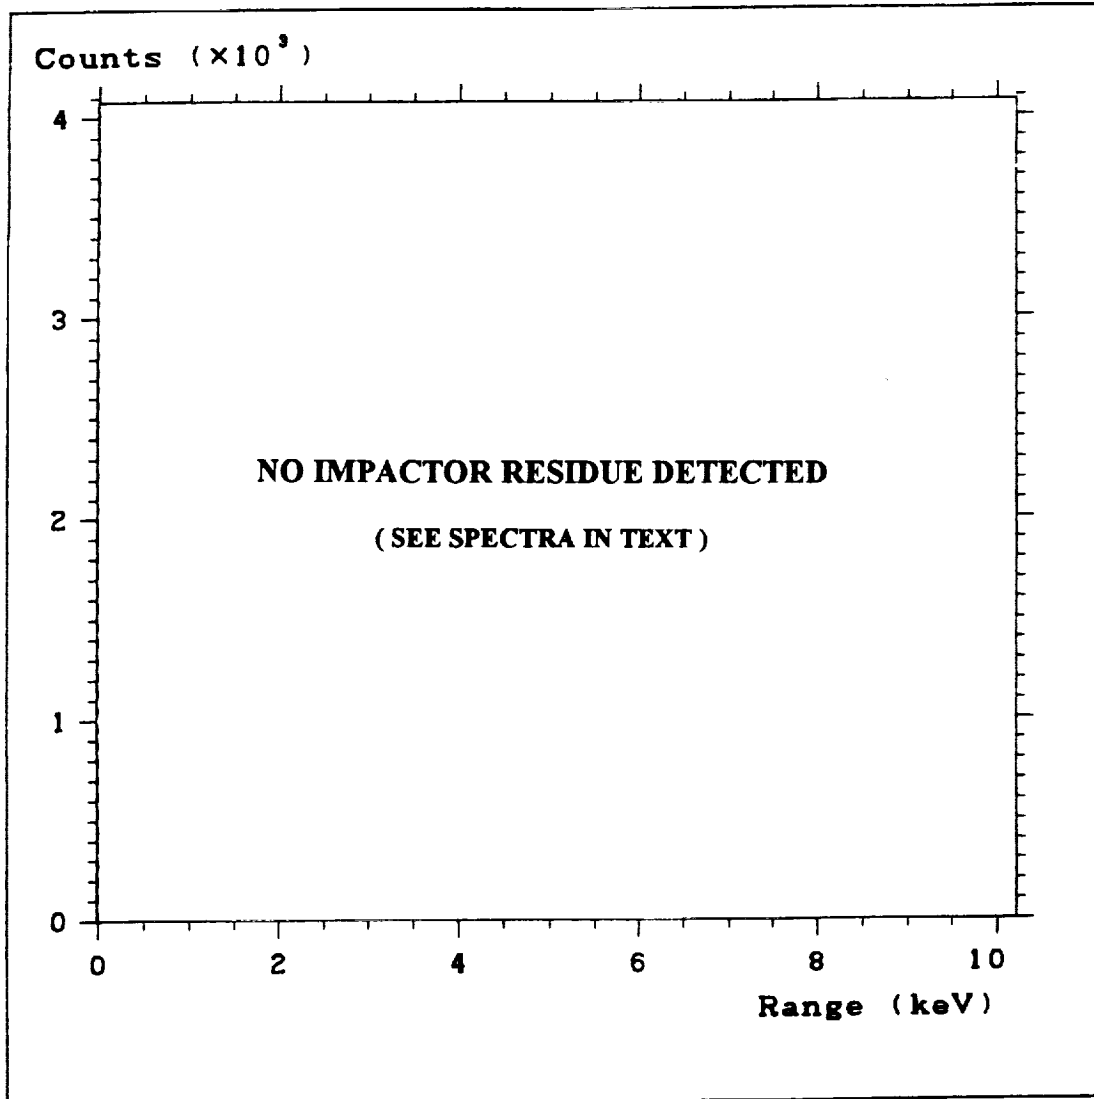
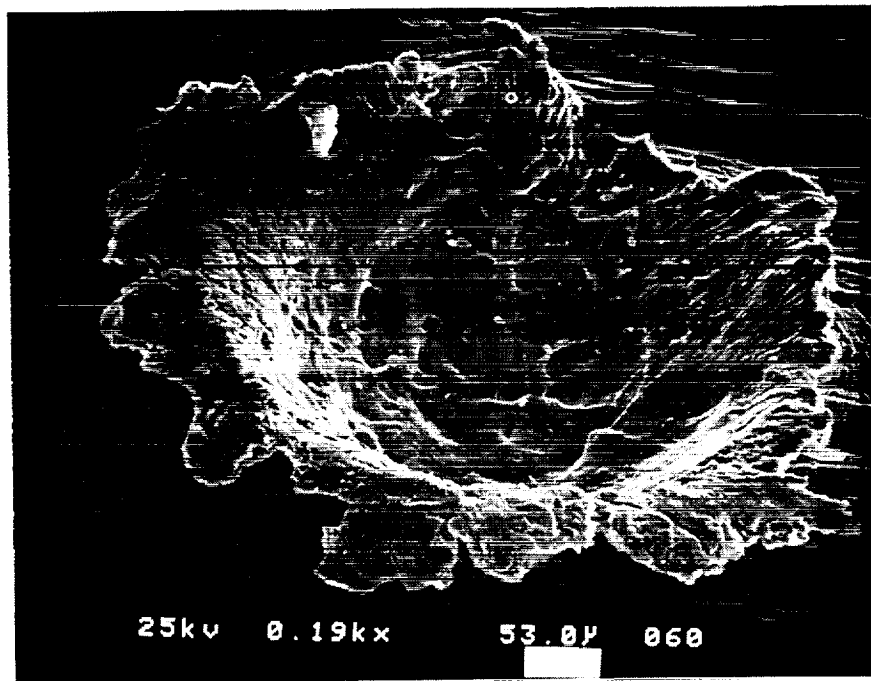
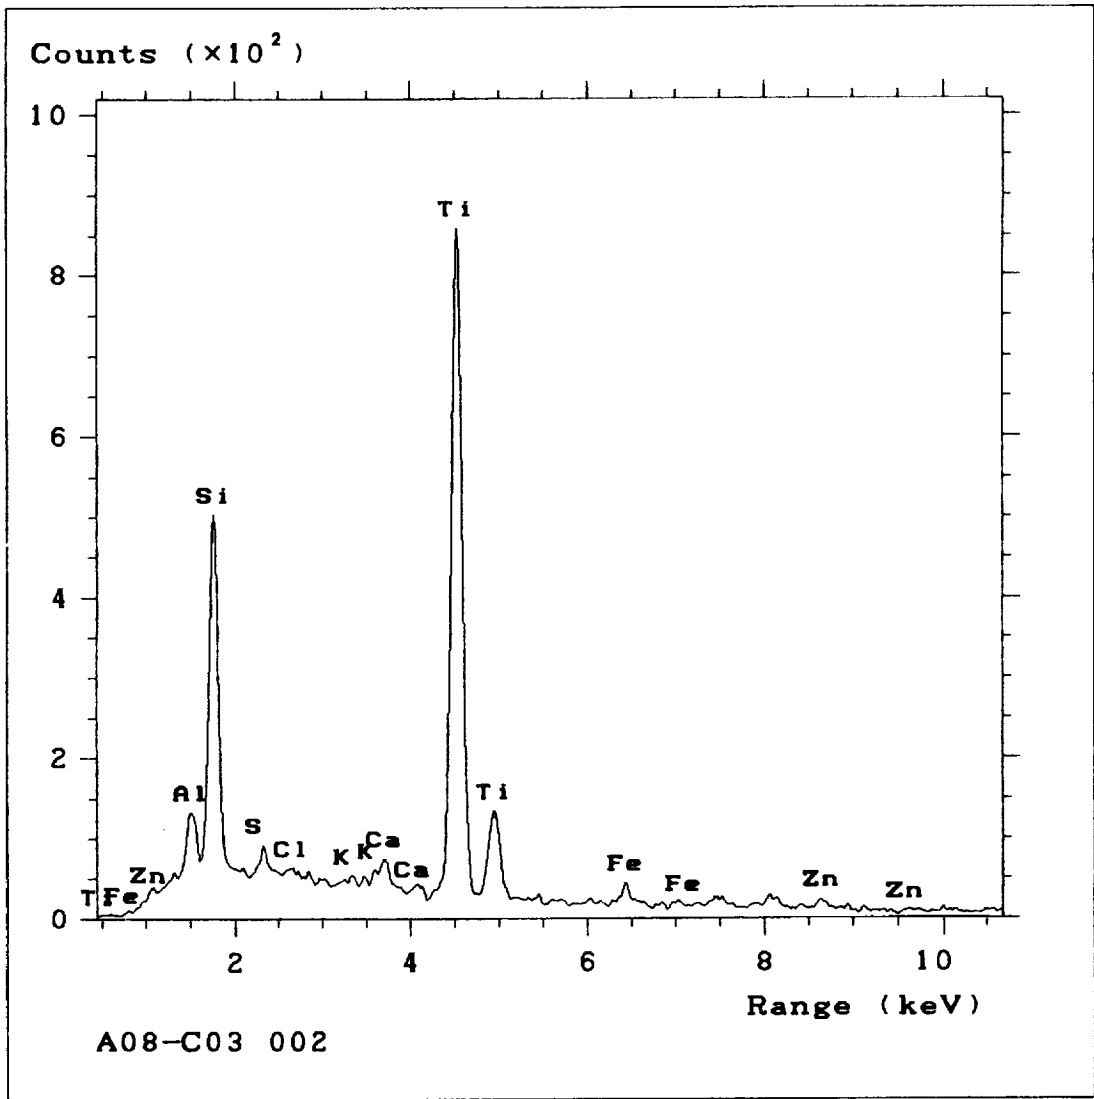
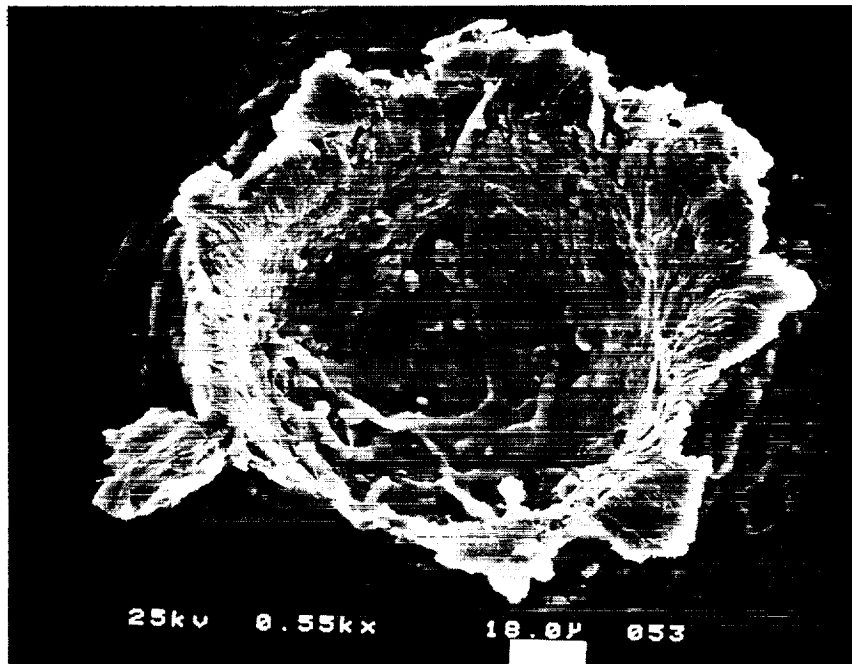
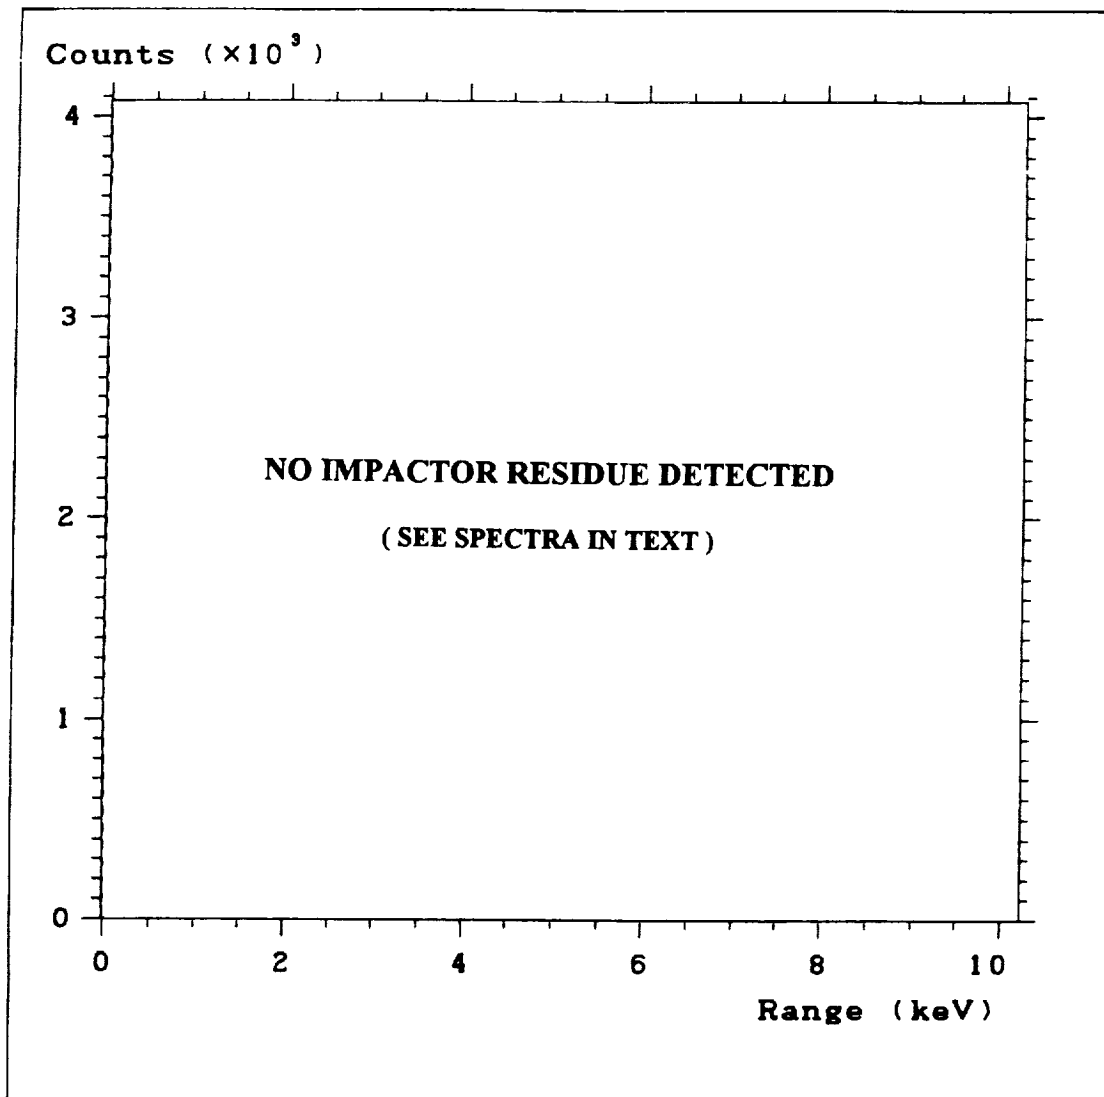
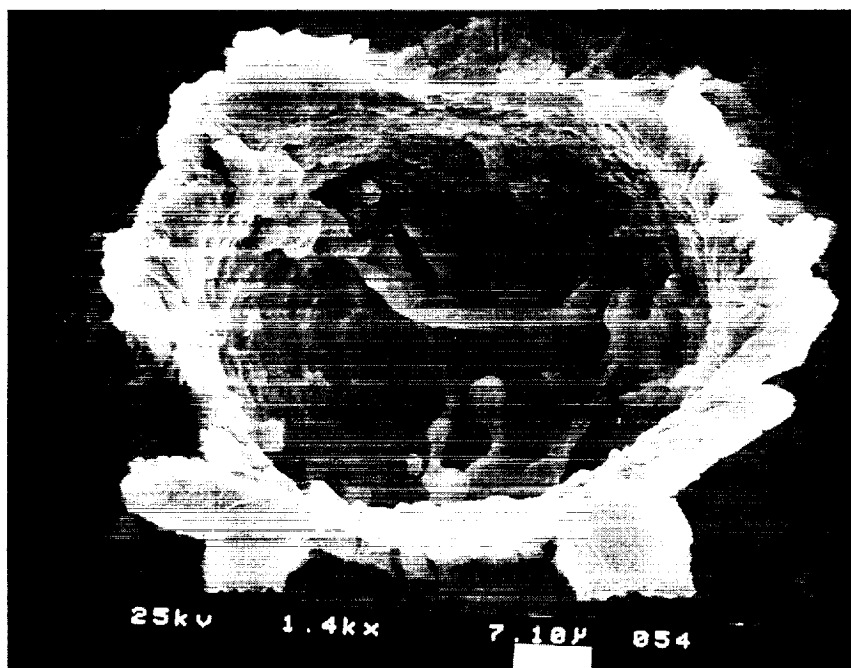
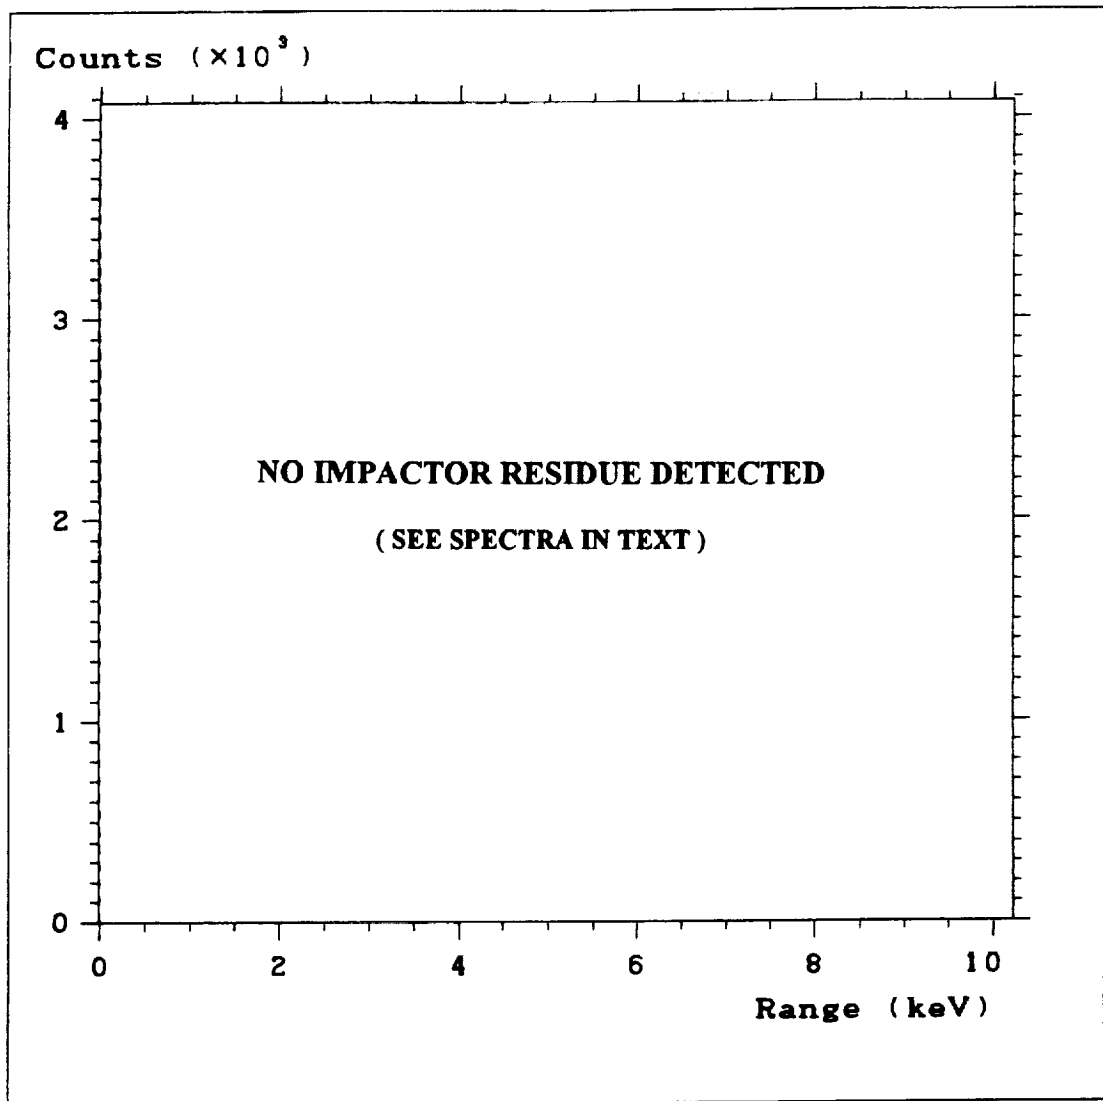
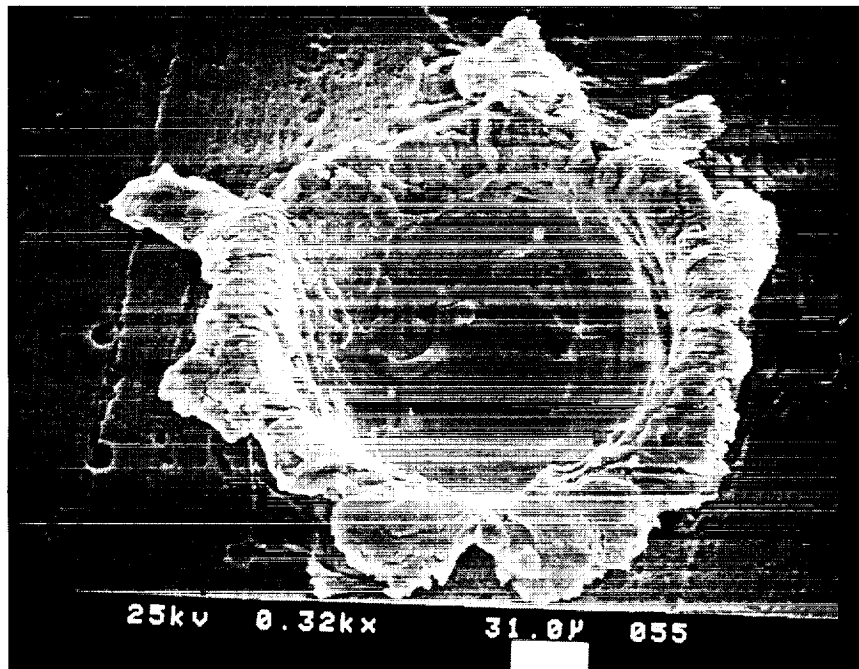
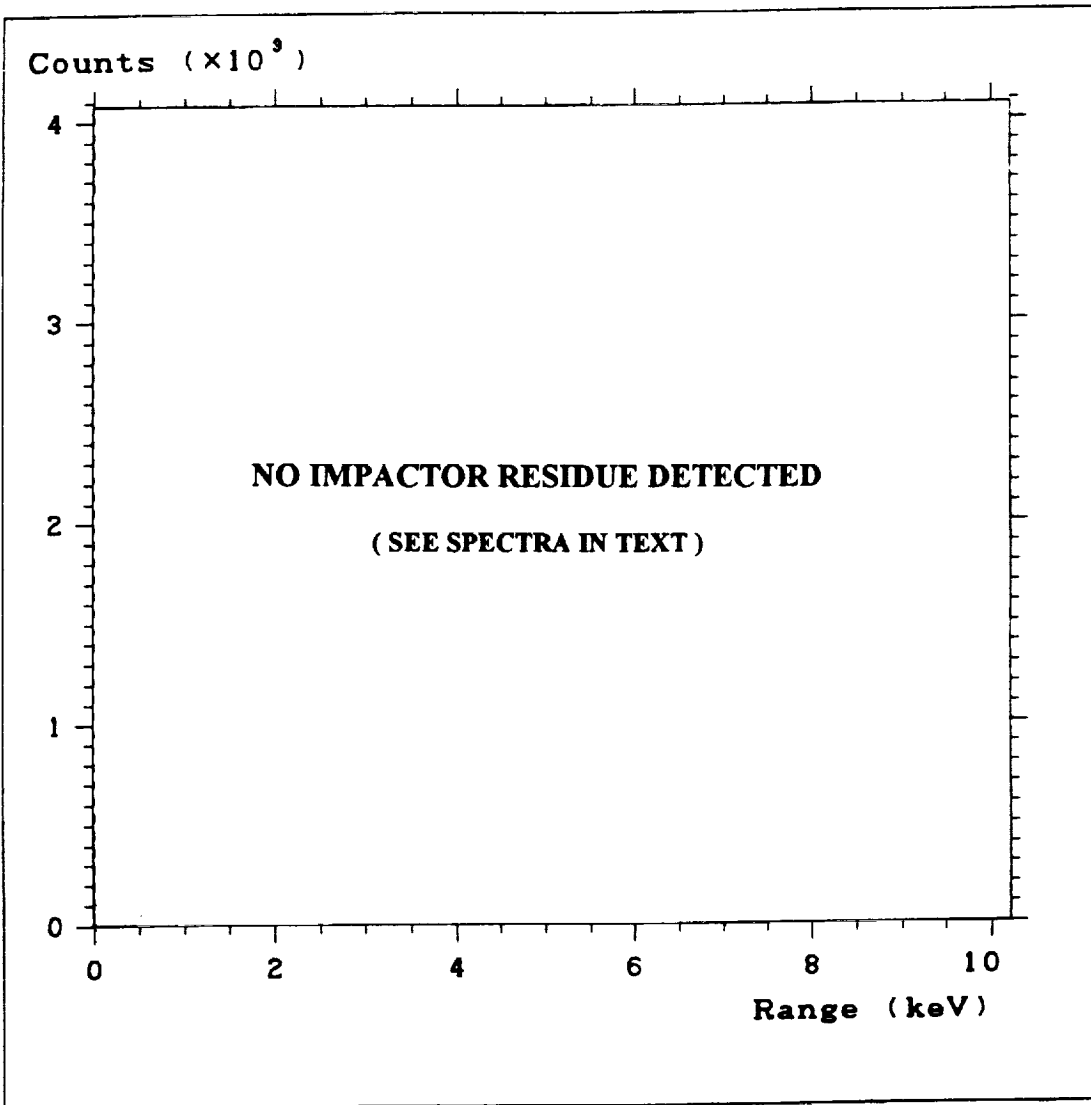
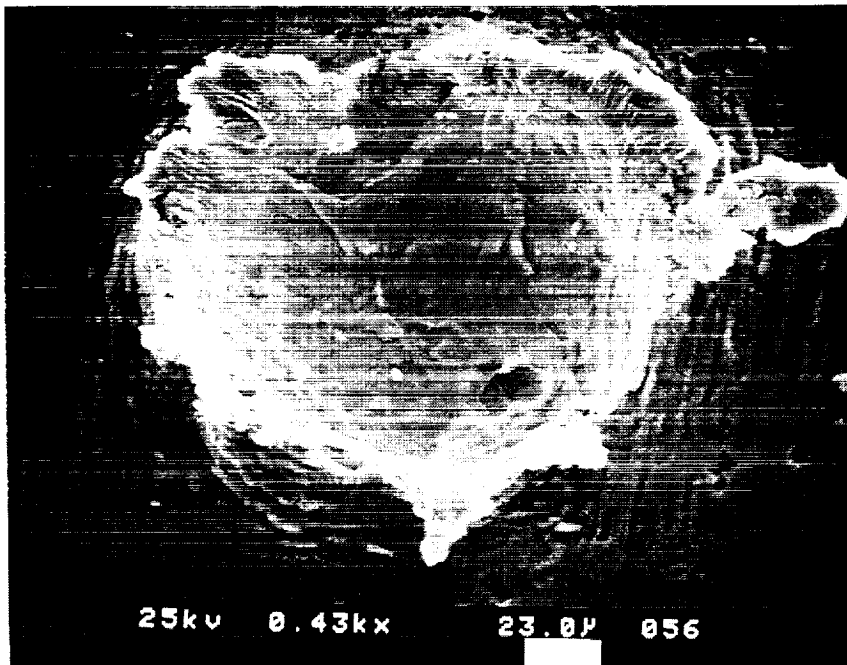
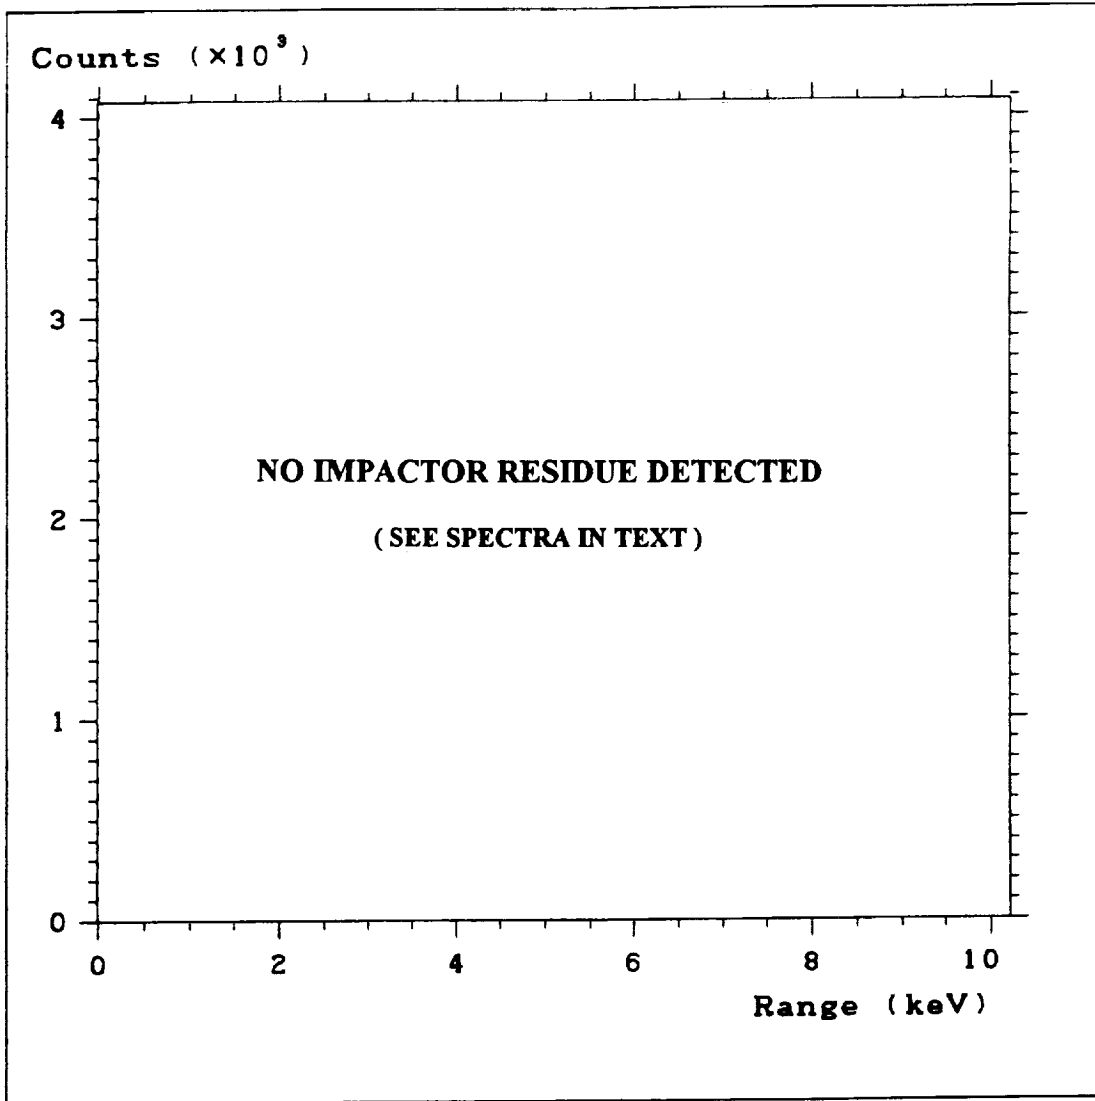
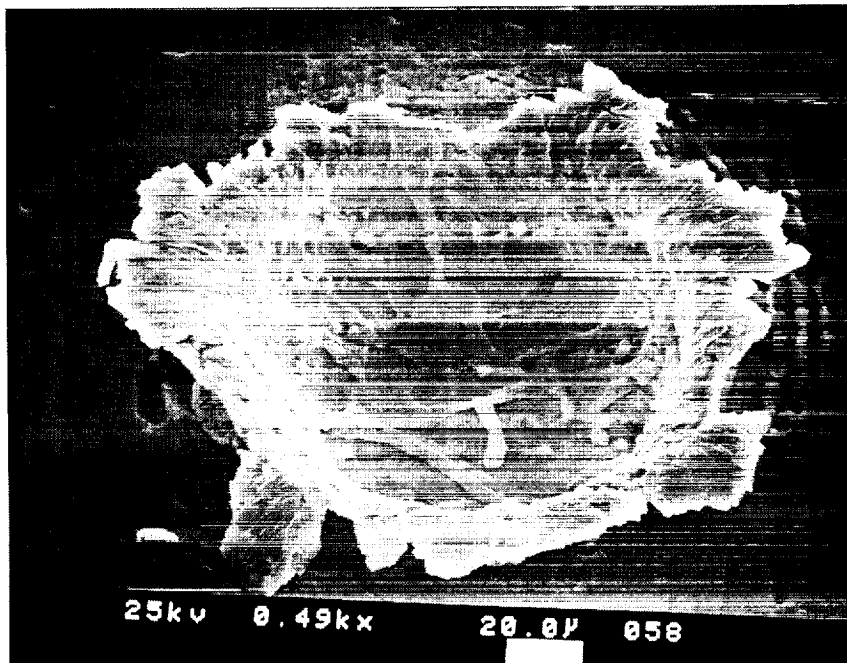
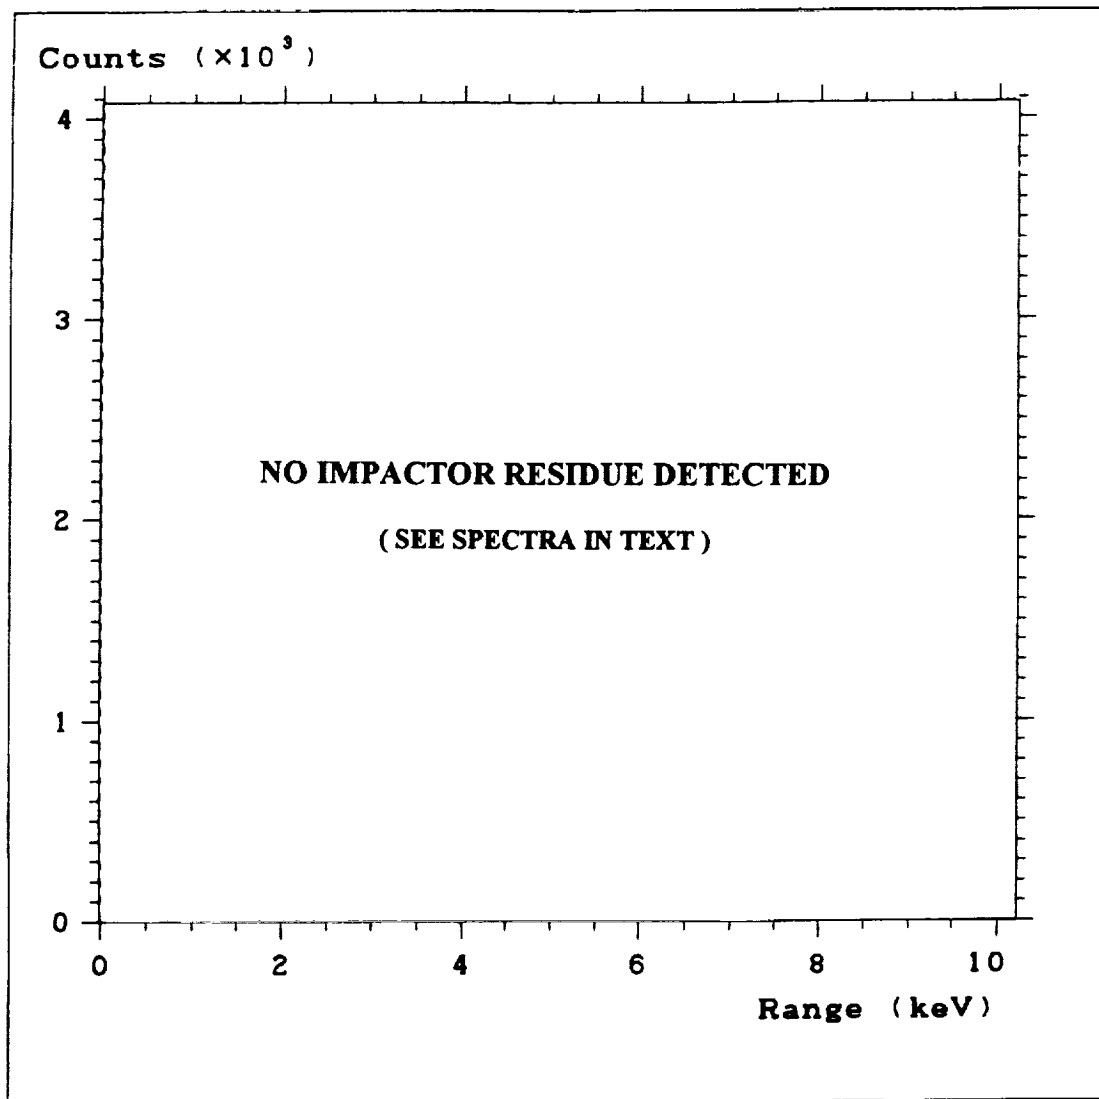
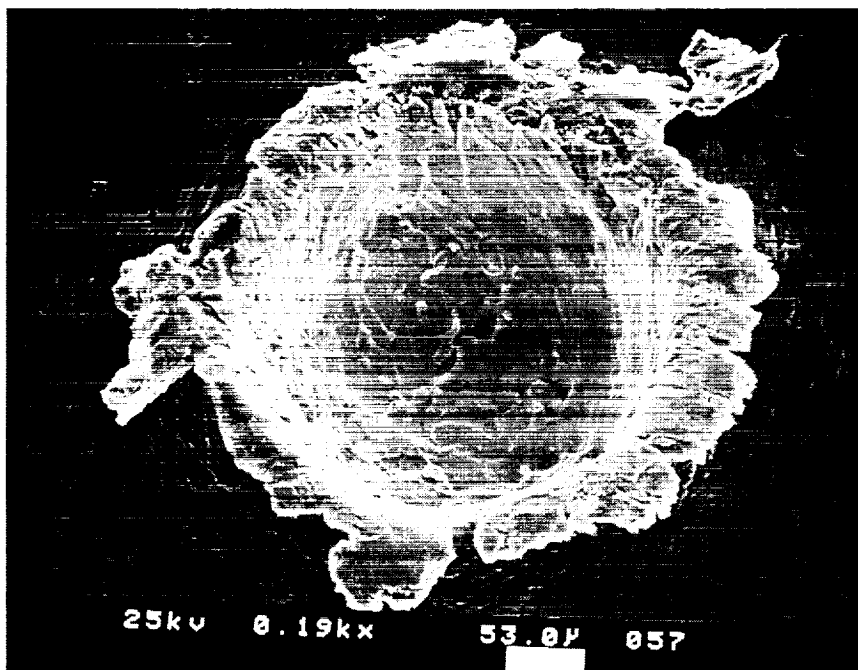
CLAMP NUMBER A08 CO3

<u>IMPACT NUMBER</u>	<u>DIAMETER</u>	<u>GENERAL COMPONENTS</u>
001	400	Unkown
002	140	Paint
003	80	Unkown
004	200	Unkown
005	160	Unkown
006	150	Unkown
007	380	Unkown

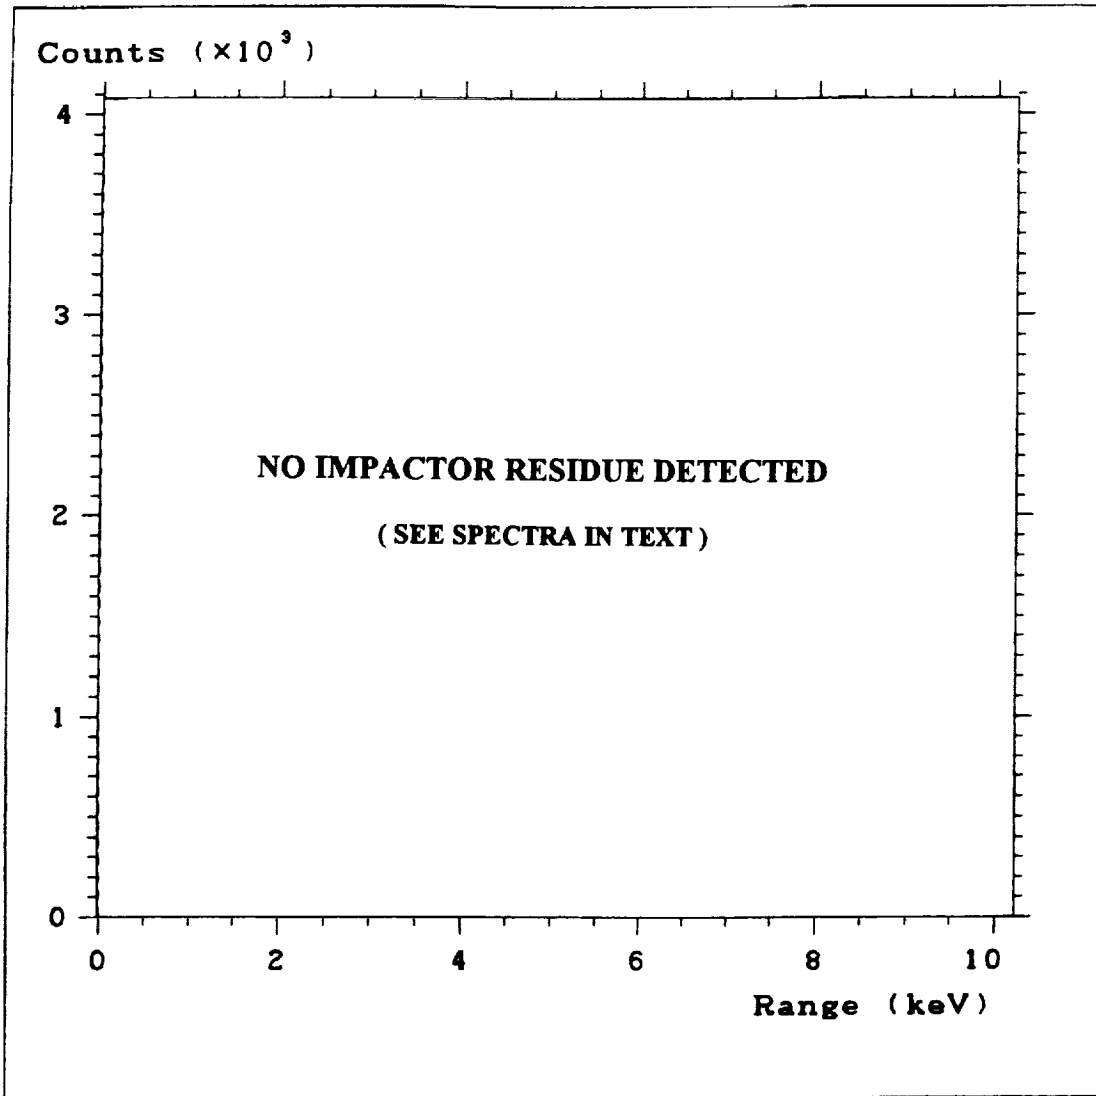
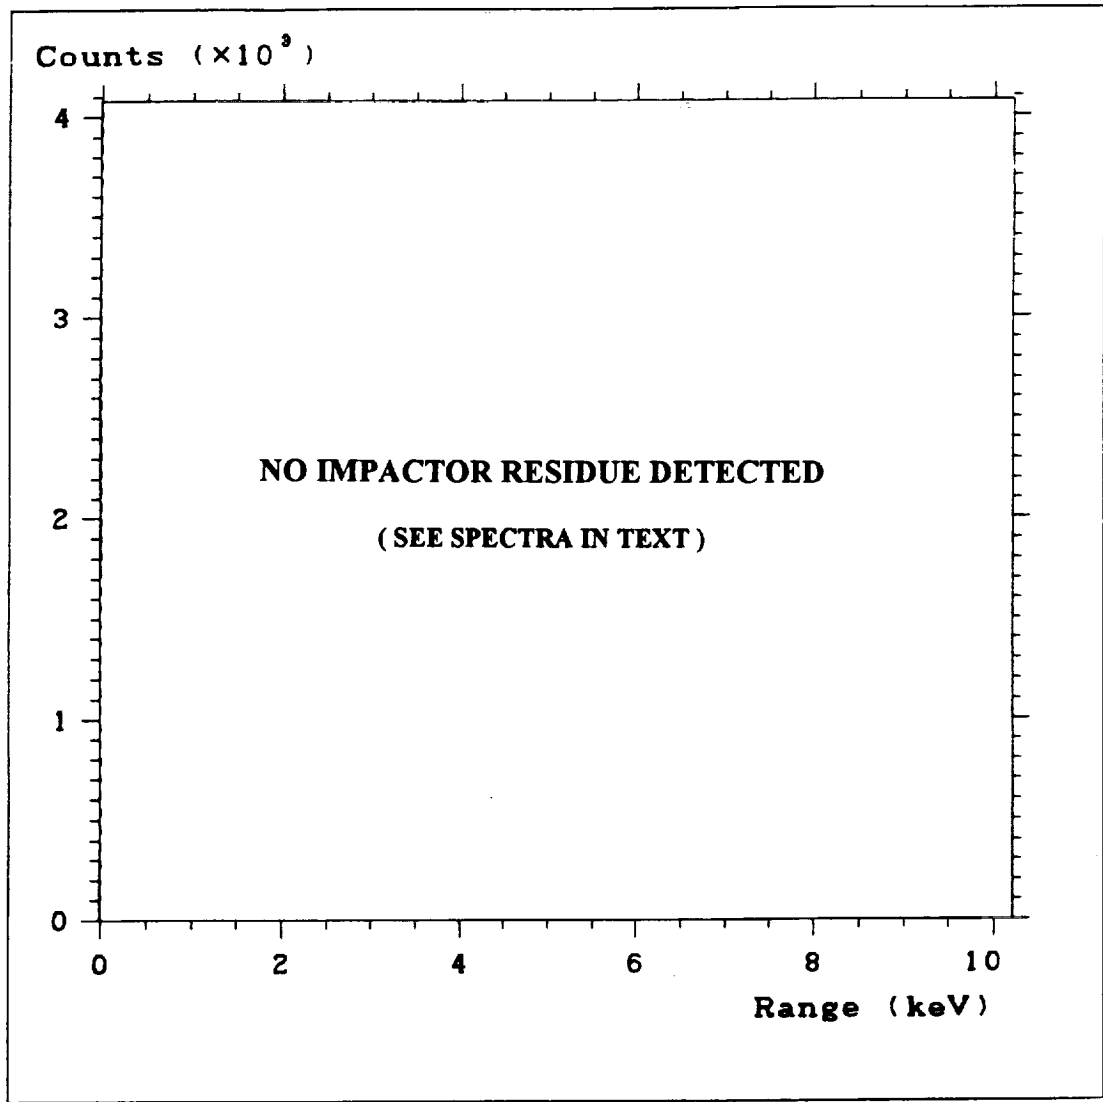
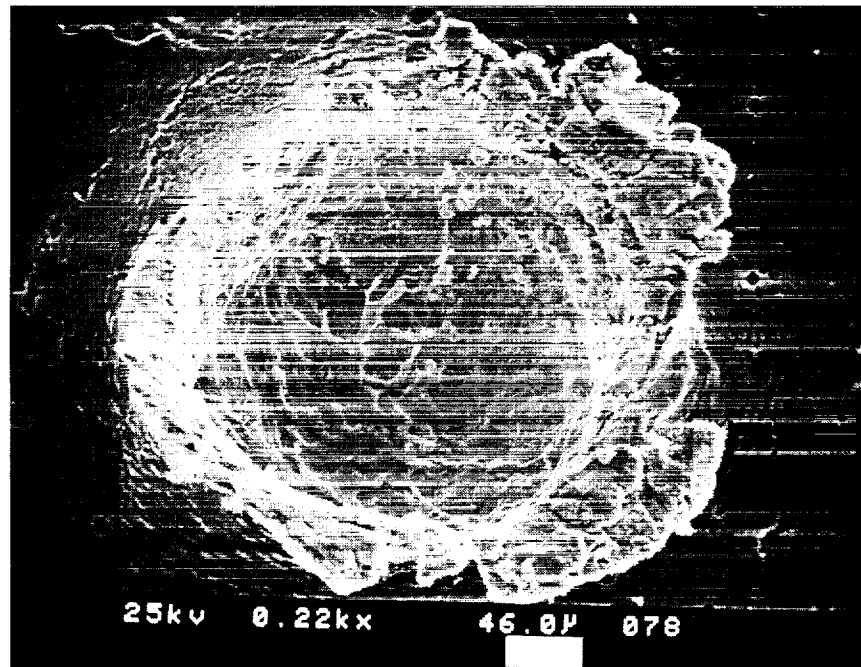
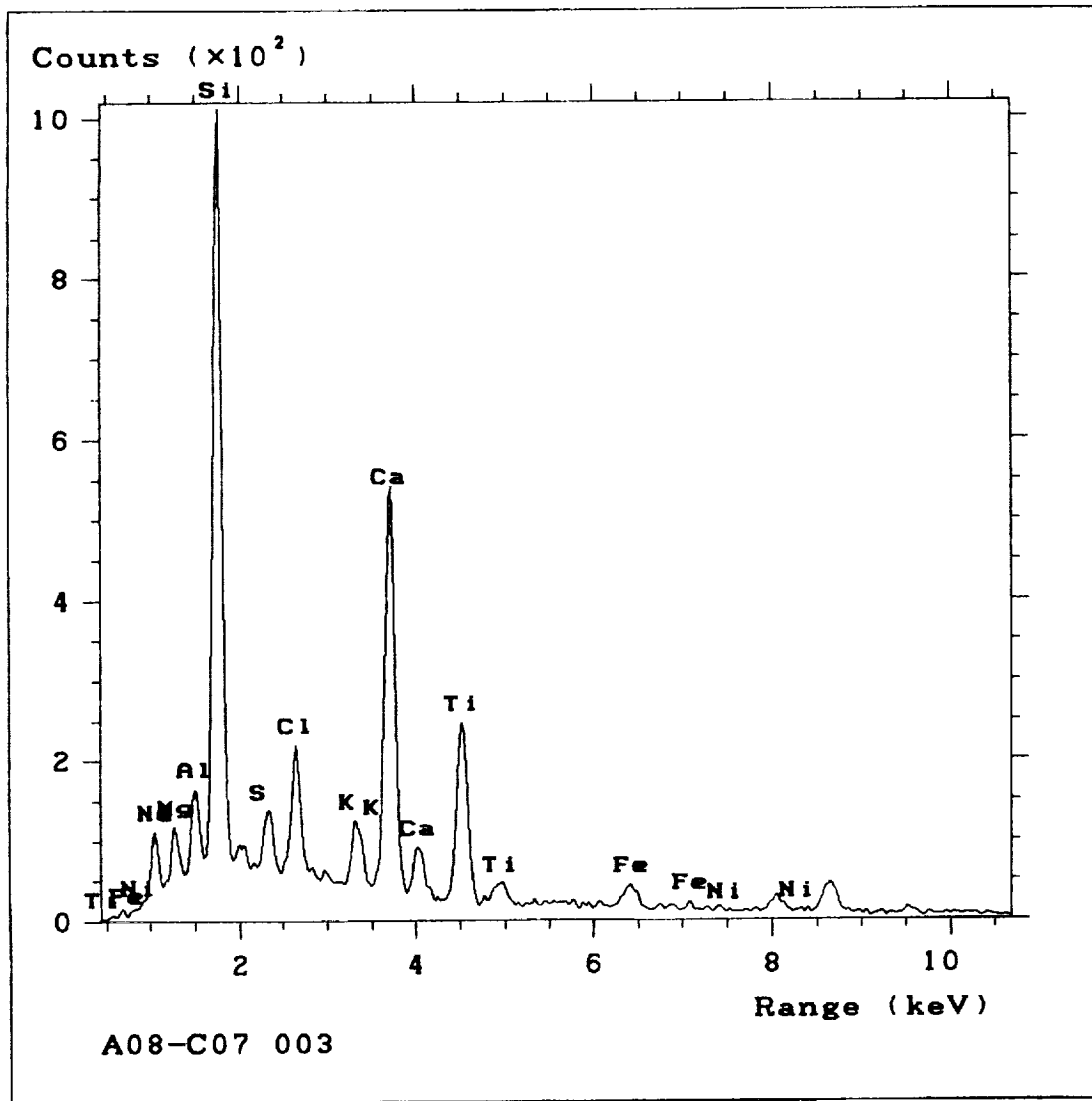
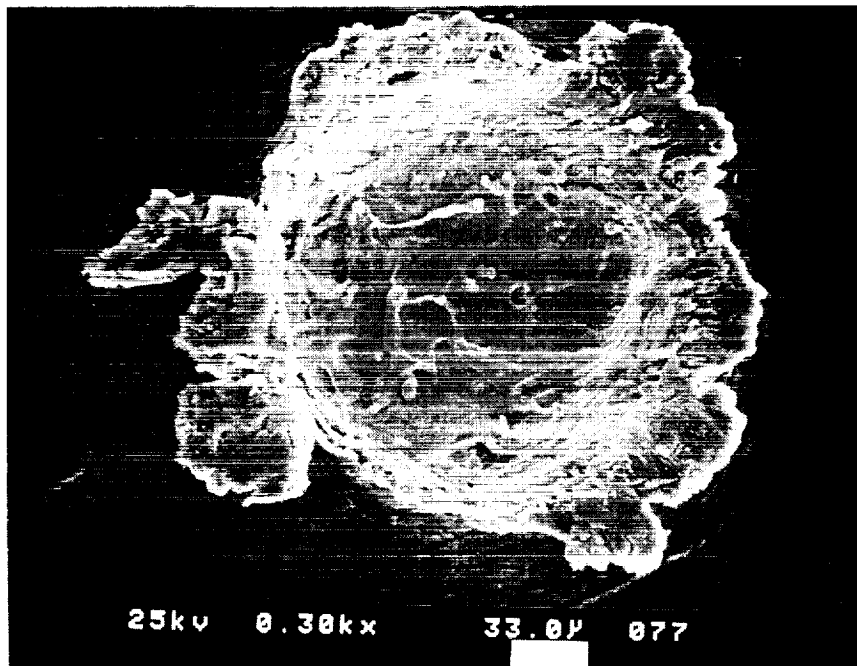
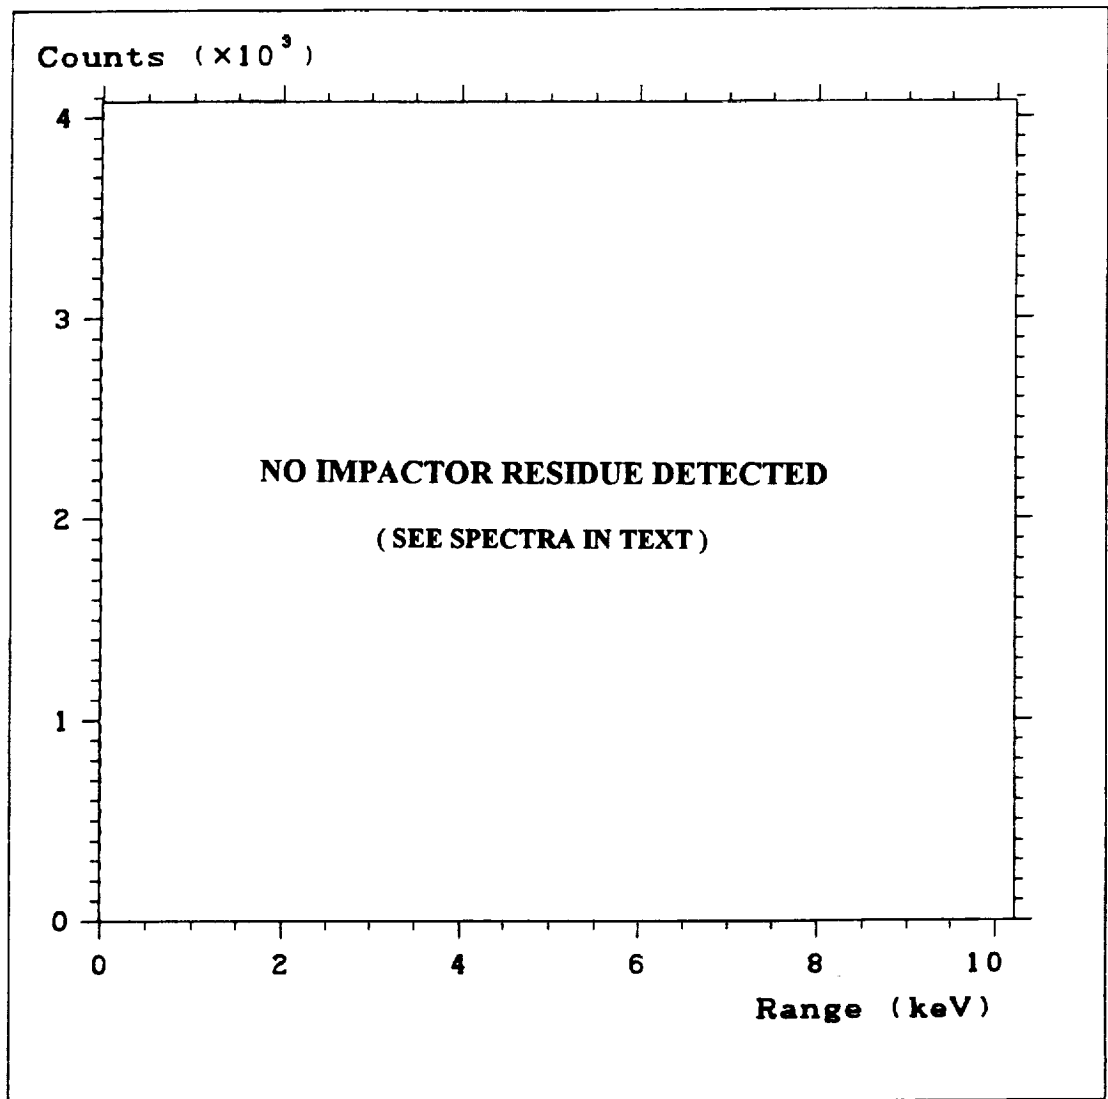
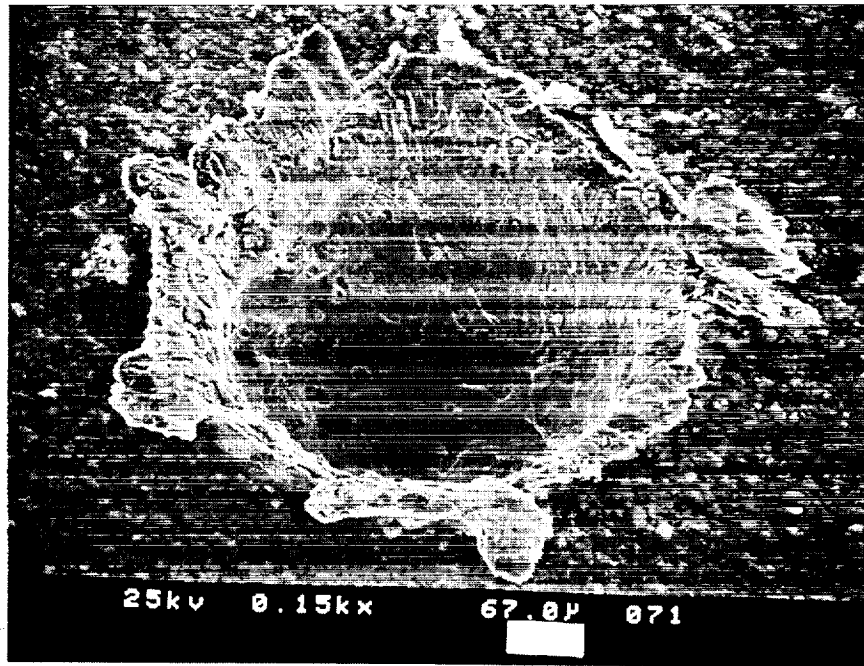
CLAMP NUMBER A08 CO7

<u>IMPACT NUMBER</u>	<u>DIAMETER</u>	<u>GENERAL COMPONENTS</u>
001	360	Paint Patch
002	350	Unkown
003	270	Paint
004	470	Unkown
005	130	Si, Mg, Ca, Fe
006	60	Unkown
007	160	Contamination
008	60	Paint Patch
009	130	Unkown
010	170	Unkown
011	140	Paint Patch
012	230	Paint Patch
013	40	Paint Patch
014	100	Unkown
