NASA Technical Memorandum 104759

Analysis of Impactor Residues in Tray Clamps from the Long Duration Exposure Facility

Part 1: Clamps from Bay "A" of the Satellite

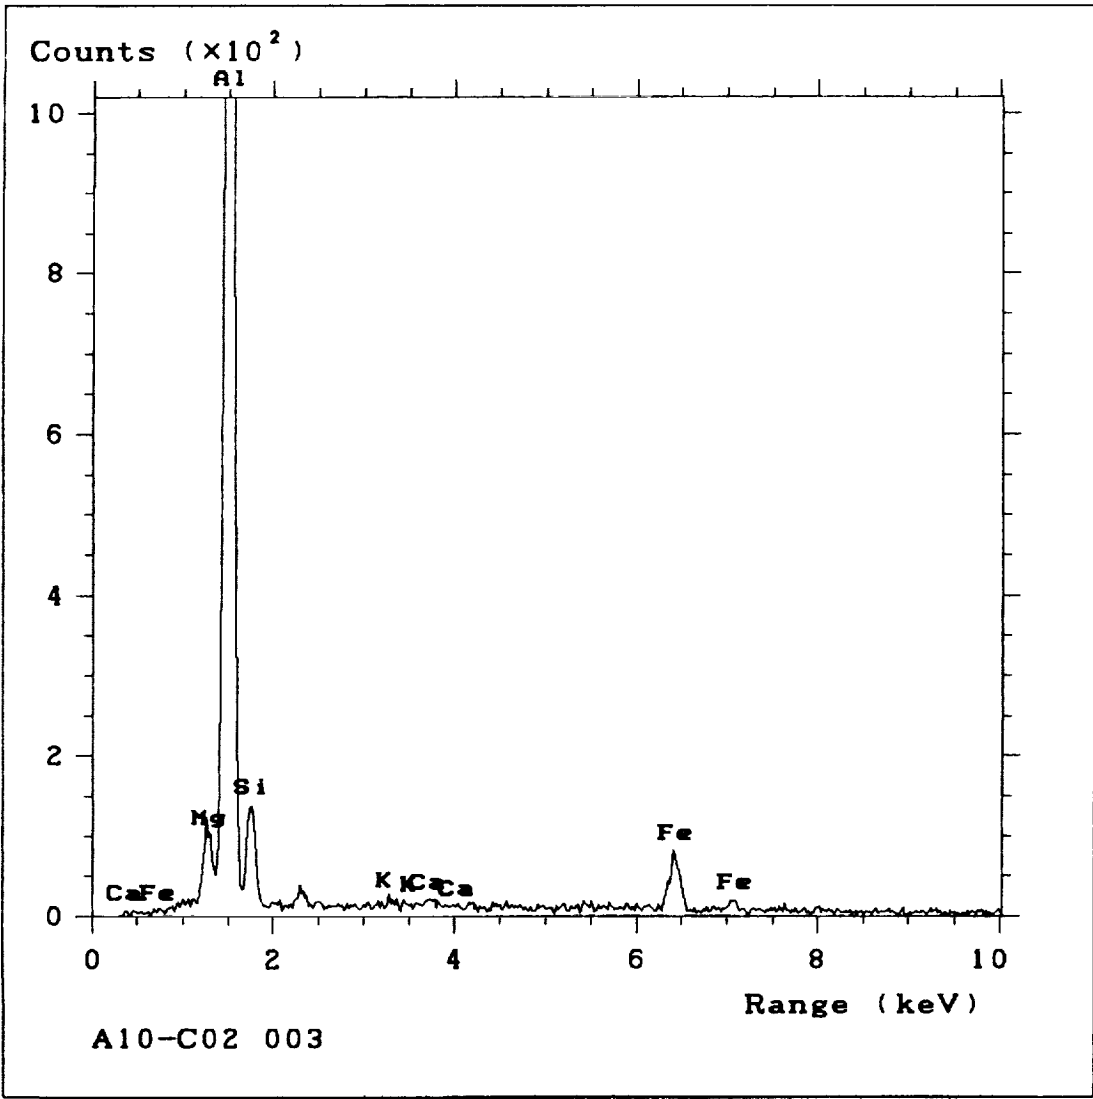
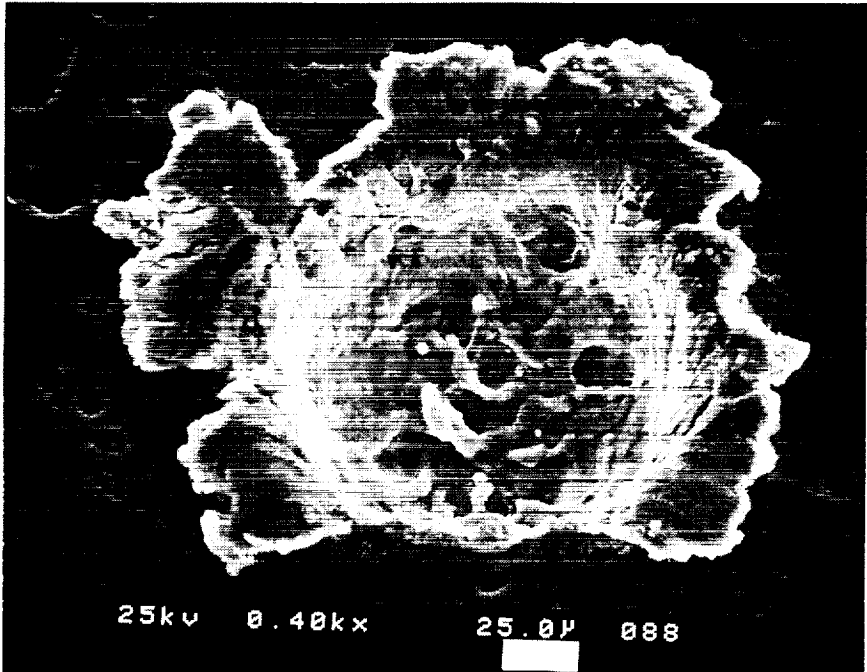
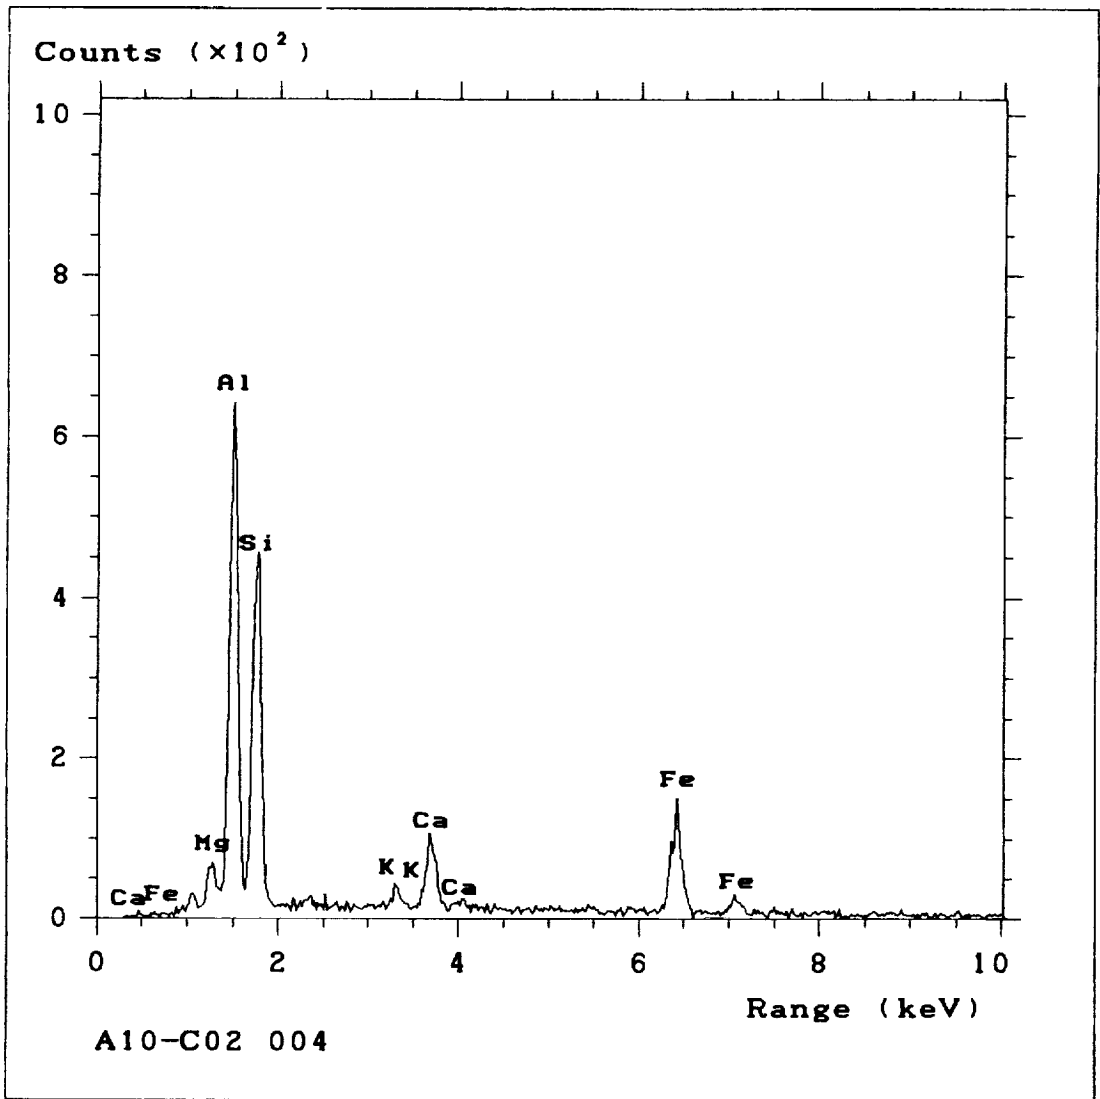
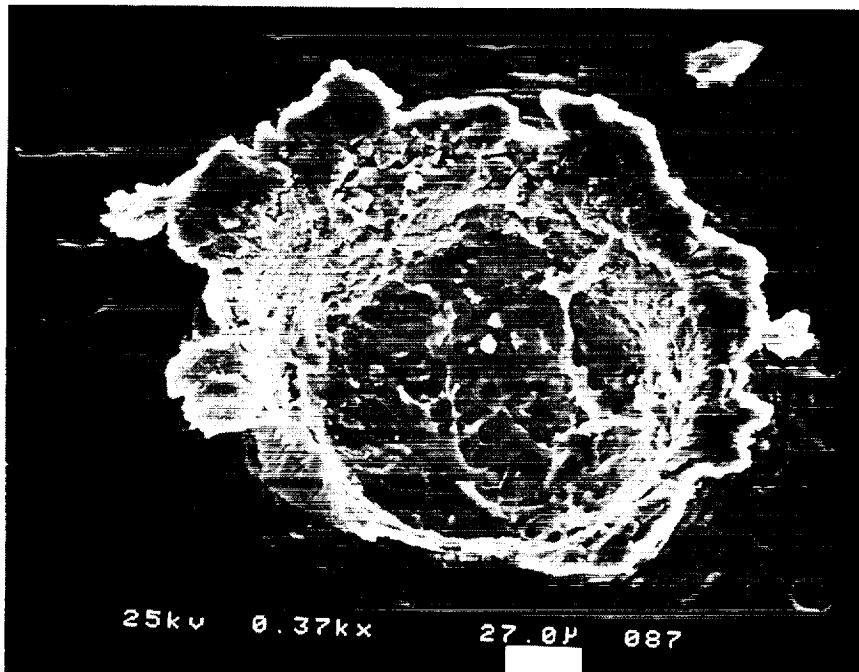
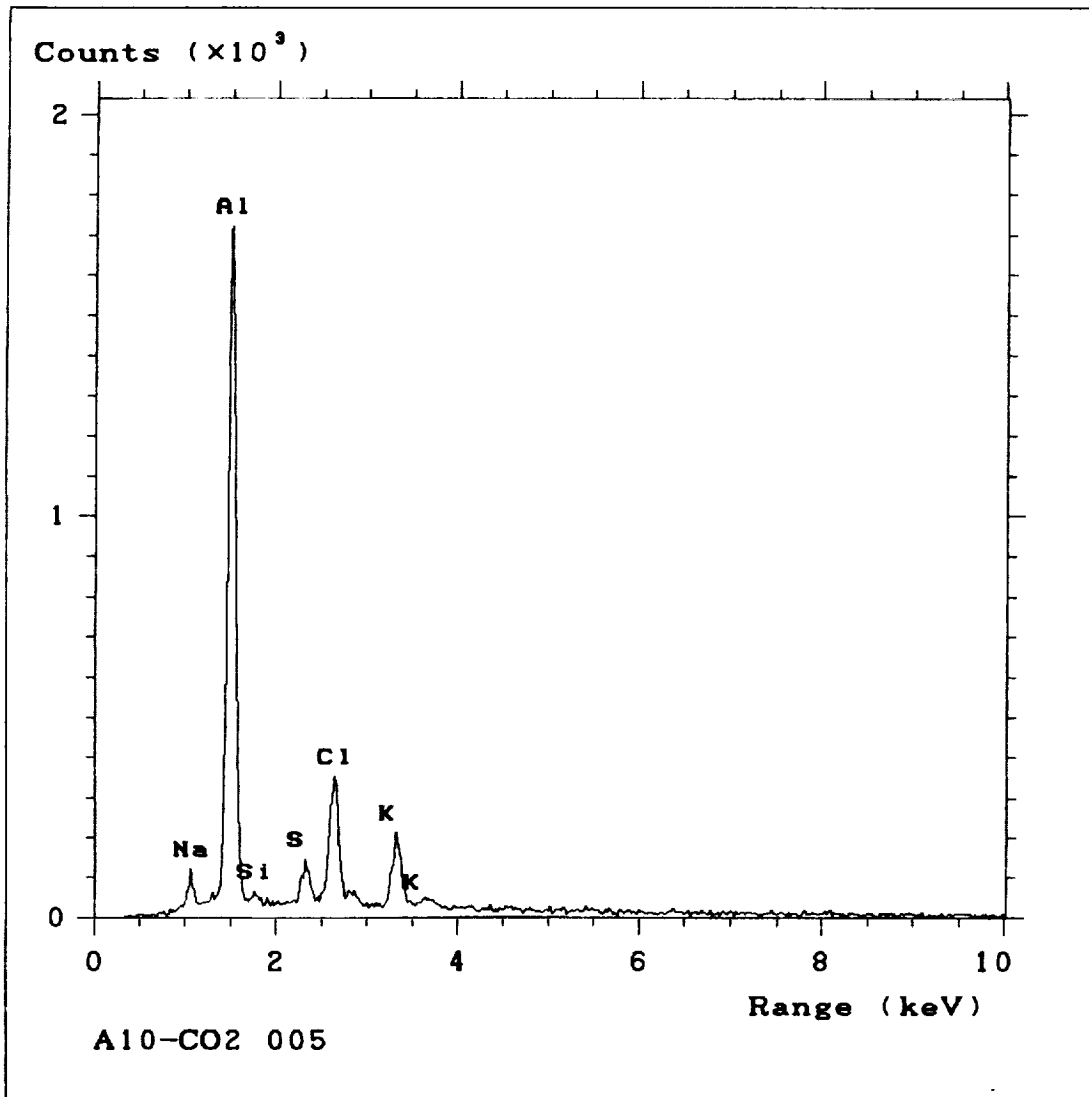
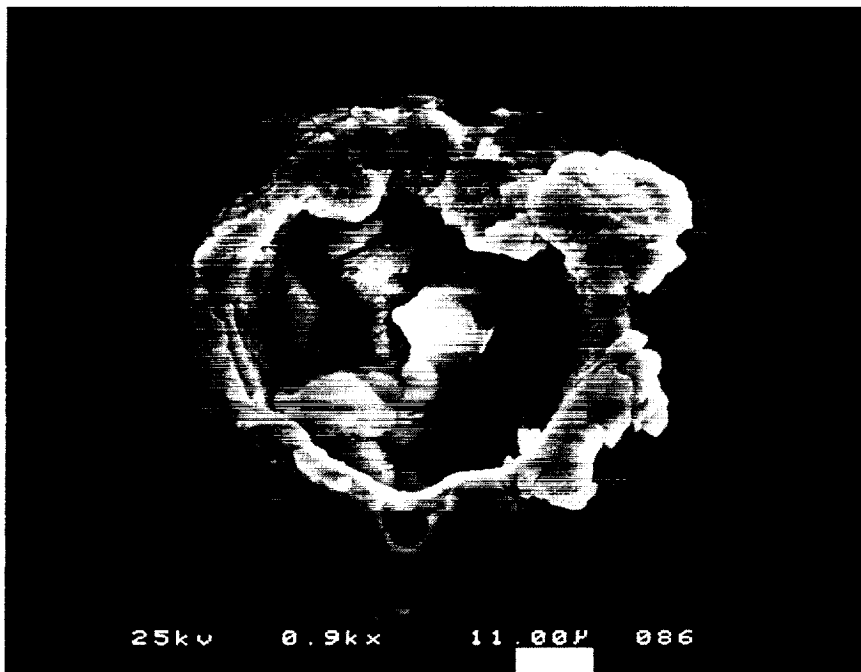
CLAMP NUMBER A10 CO6

<u>IMPACT NUMBER</u>	<u>DIAMETER</u>	<u>GENERAL COMPONENTS</u>
001	2800	Mg
002	200	Si, Mg, Fe
003	100	Unknown
004	120	Trace
005	150	Unknown
006	170	Unknown
007	80	Unknown
008	470	Unknown
009	200	Unknown

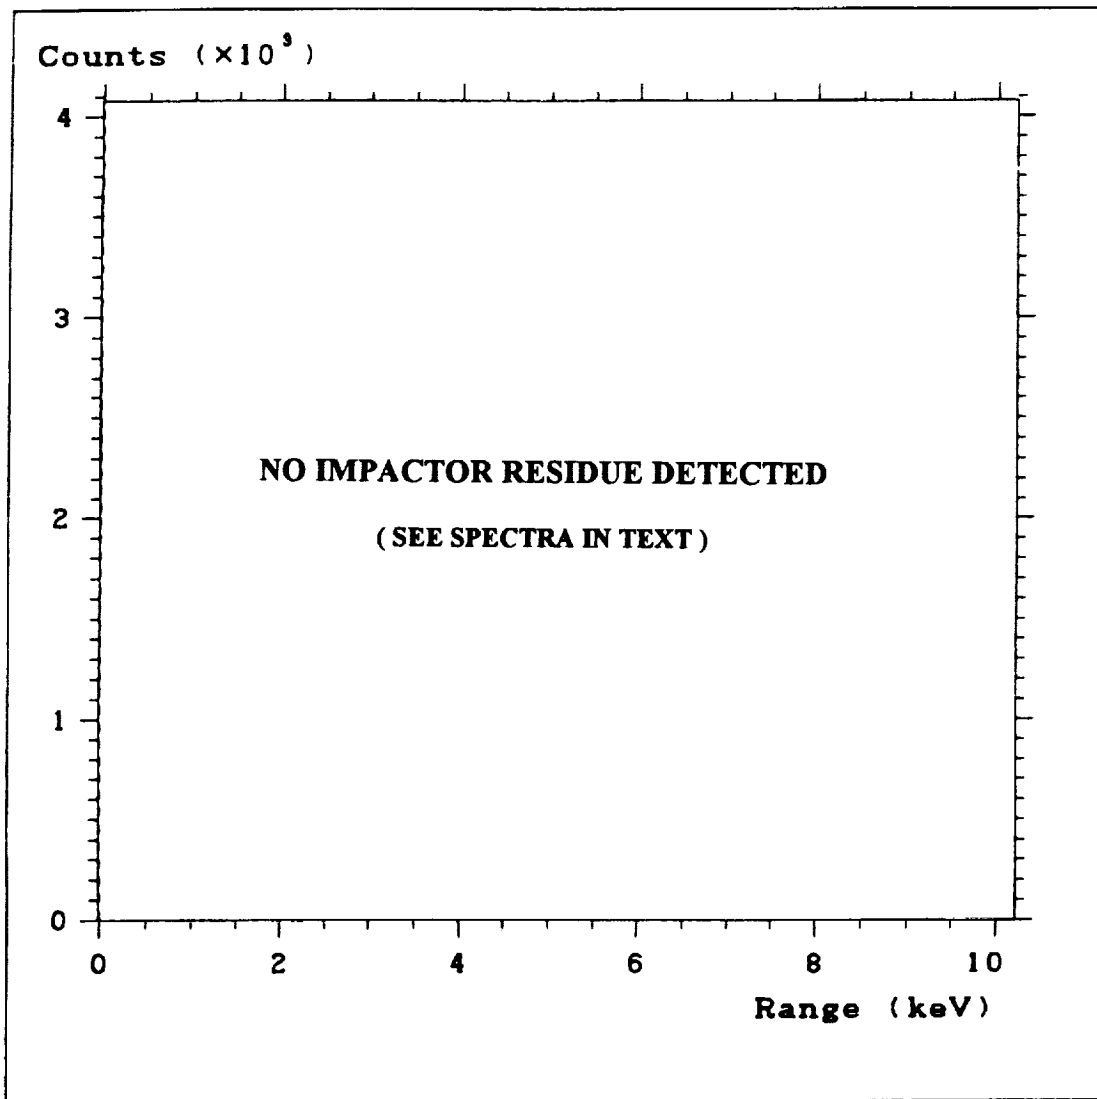
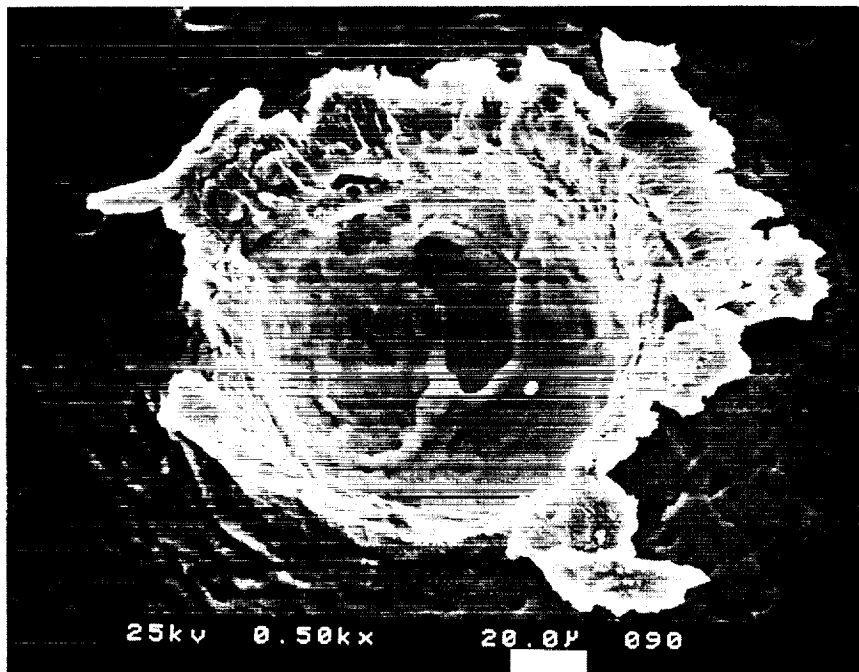
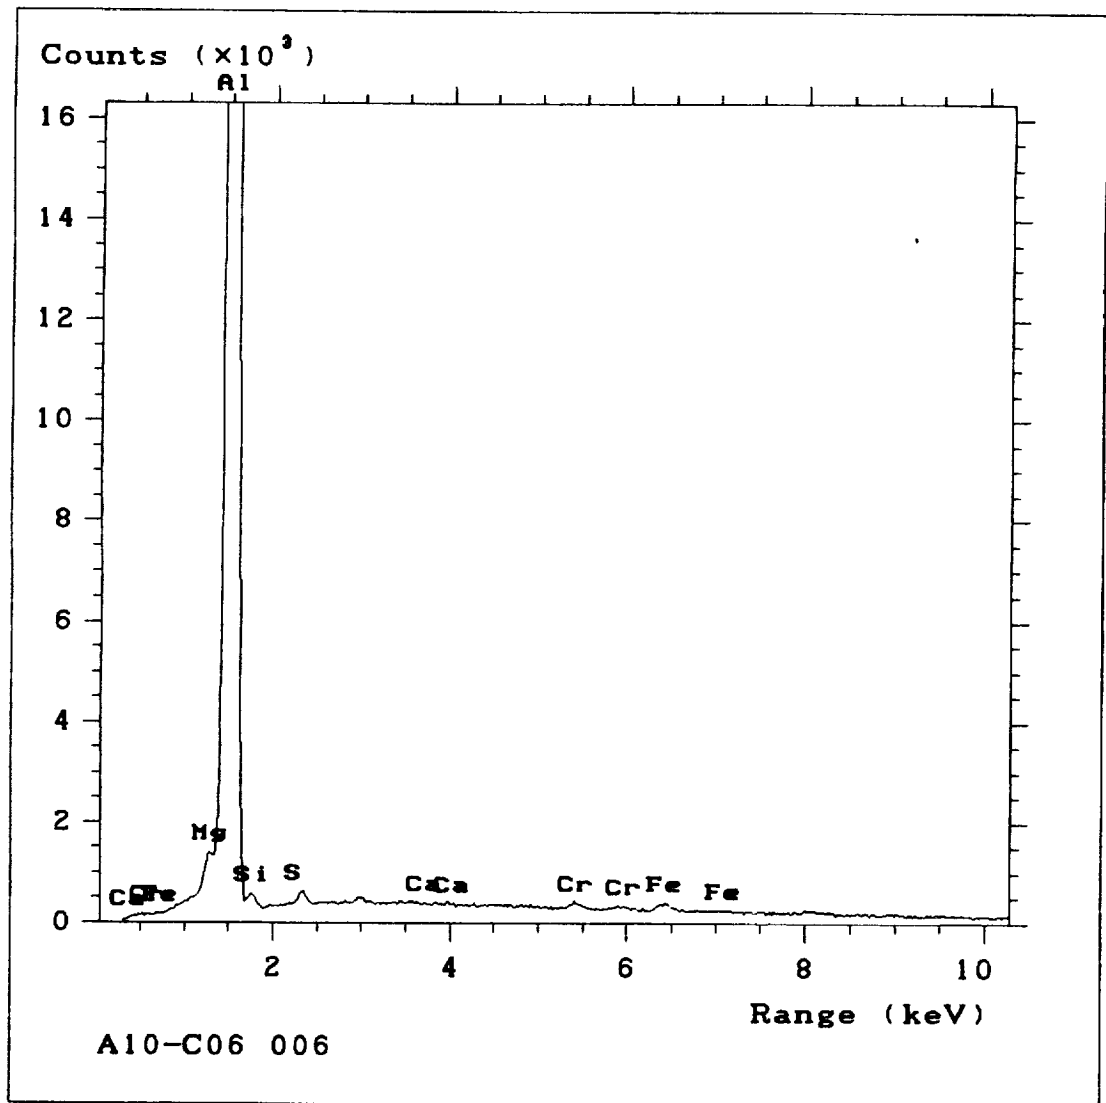
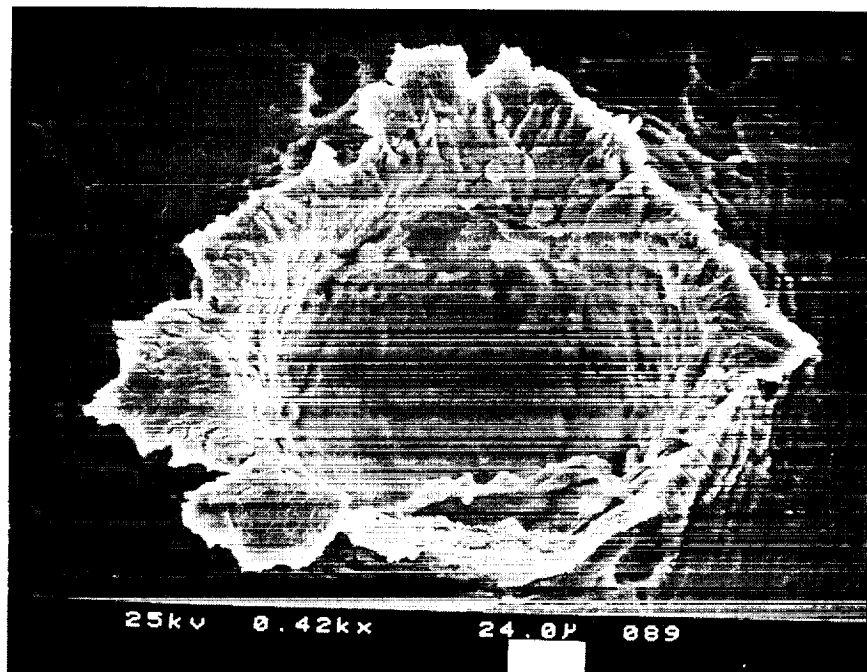
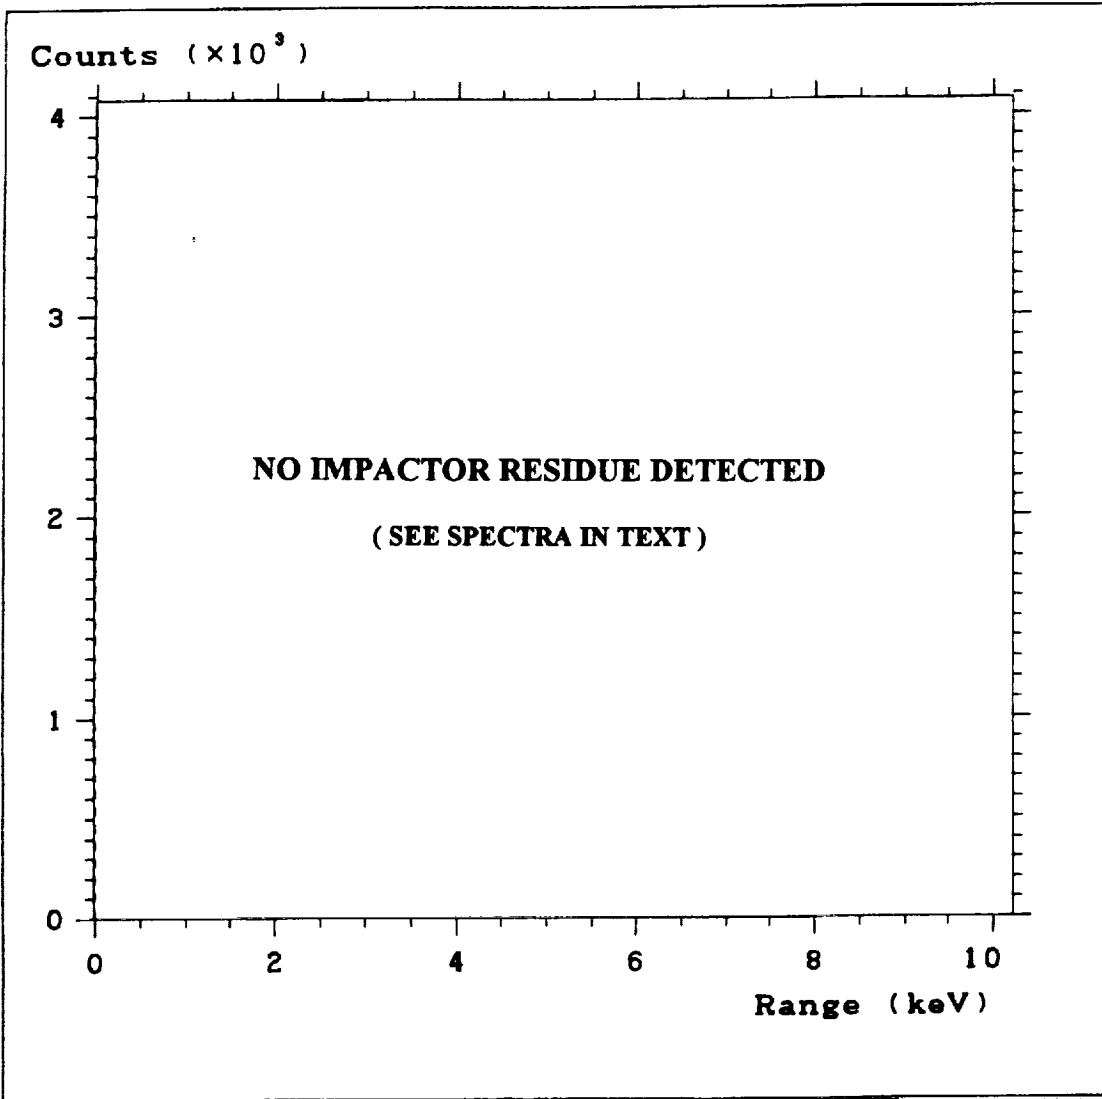
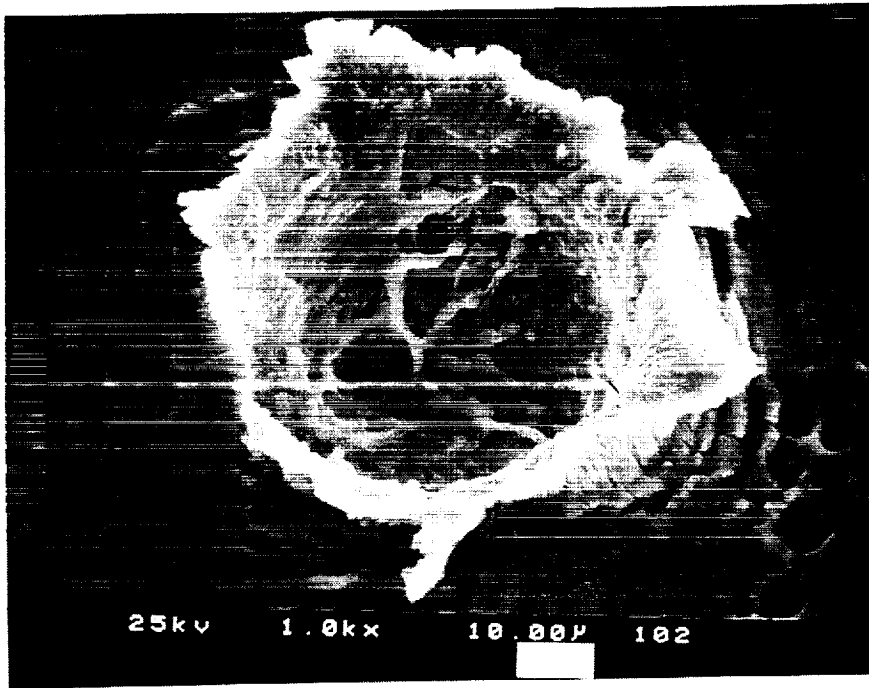
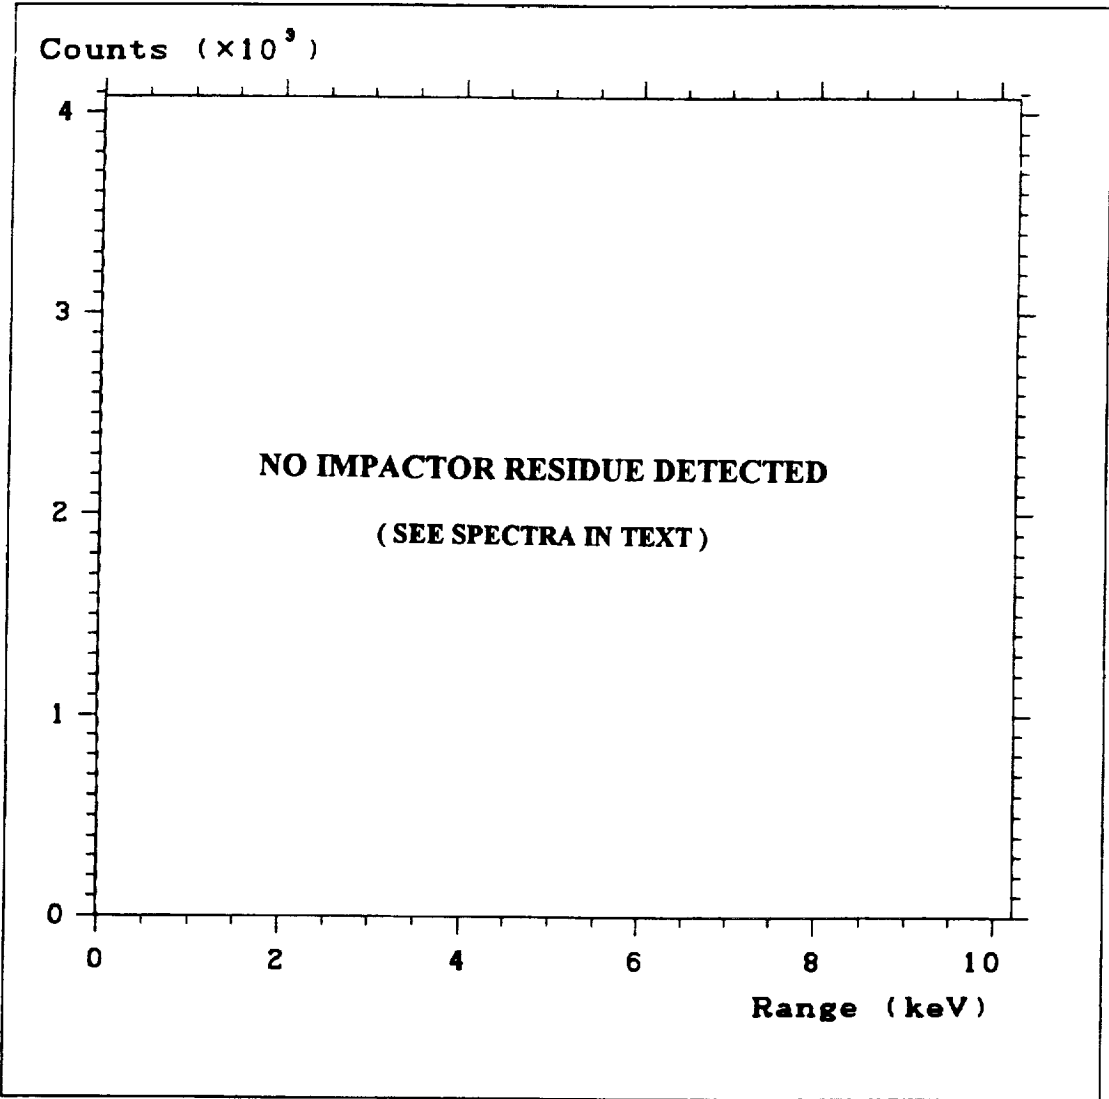
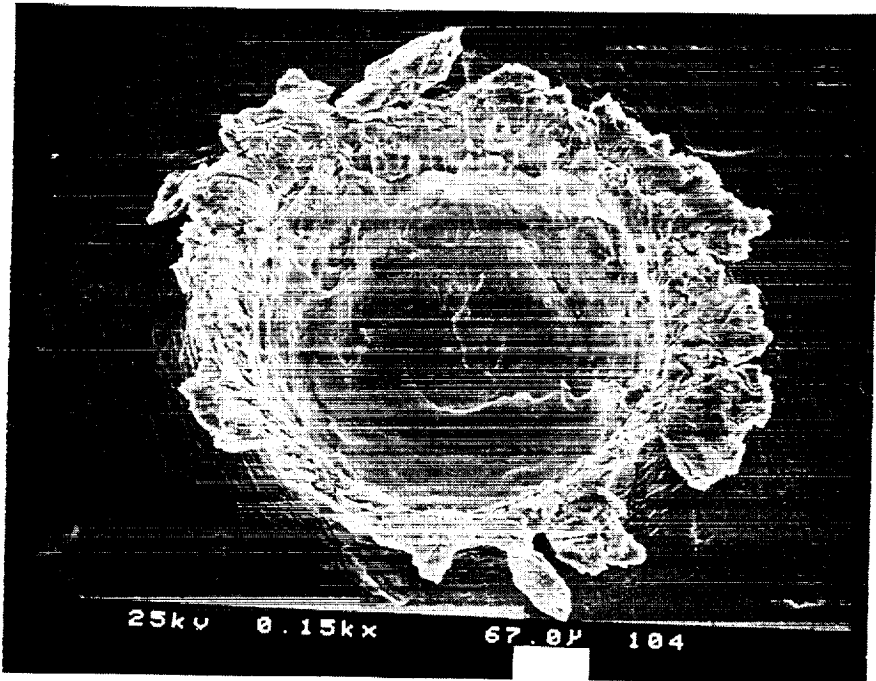
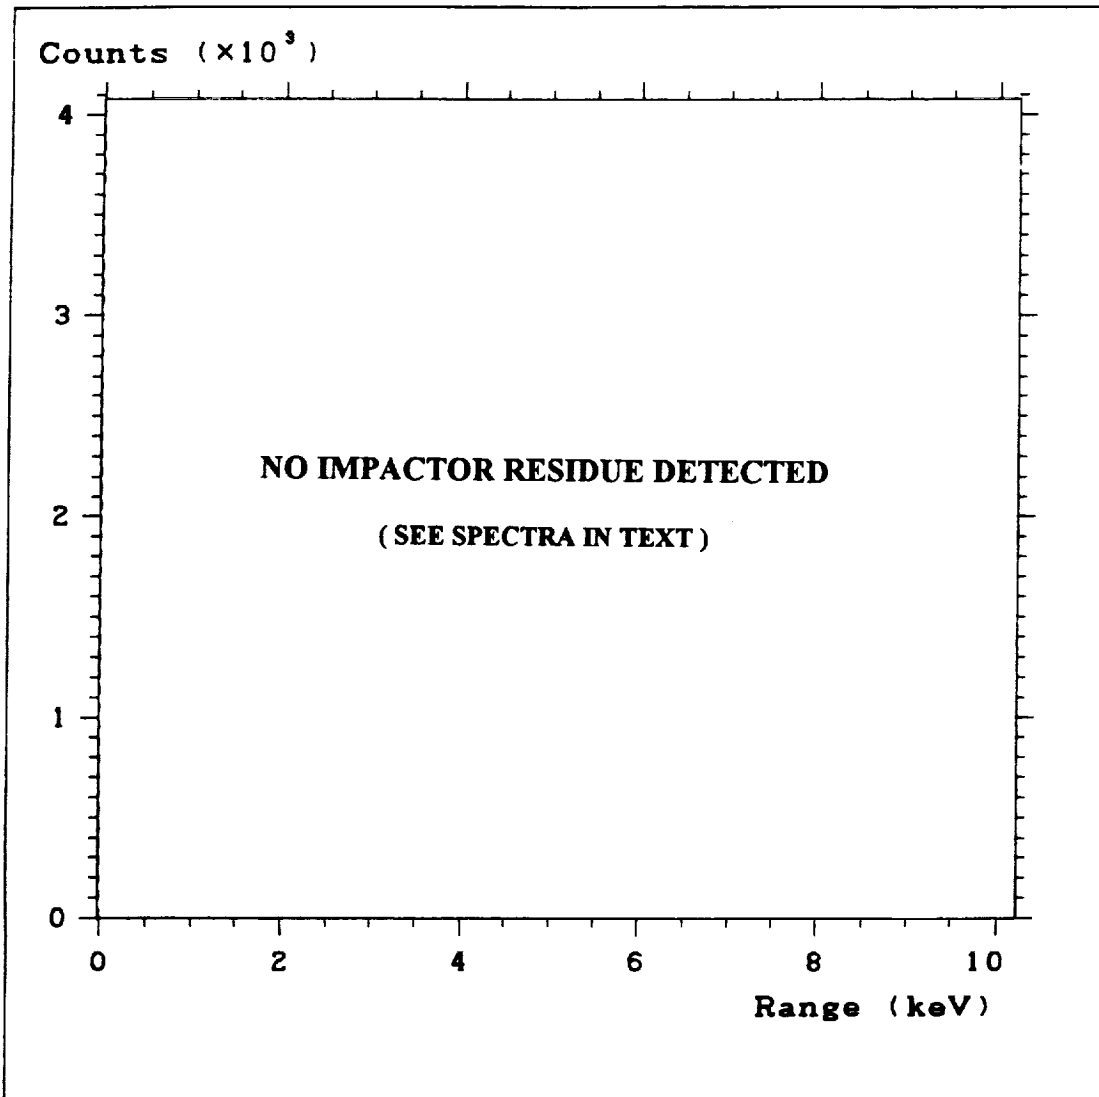
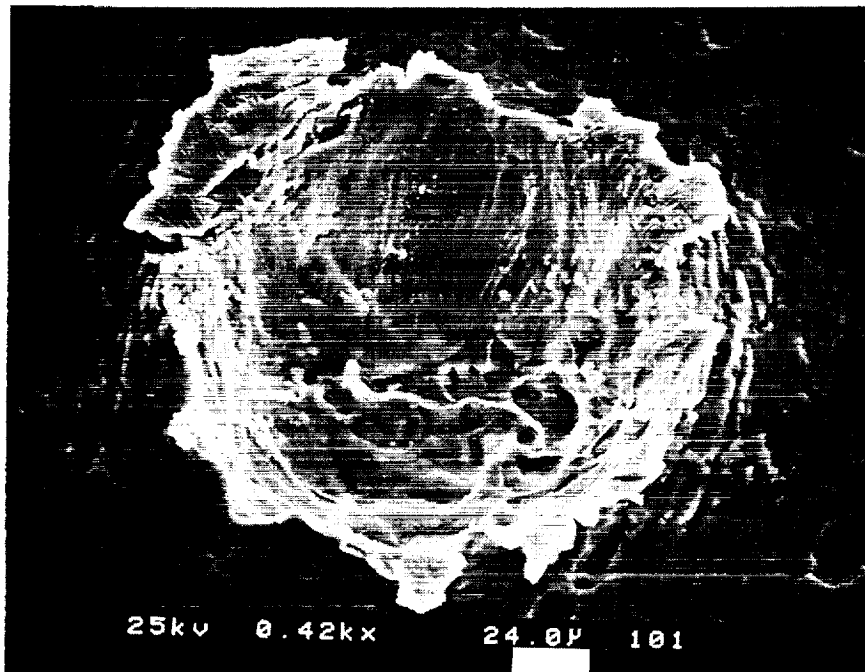
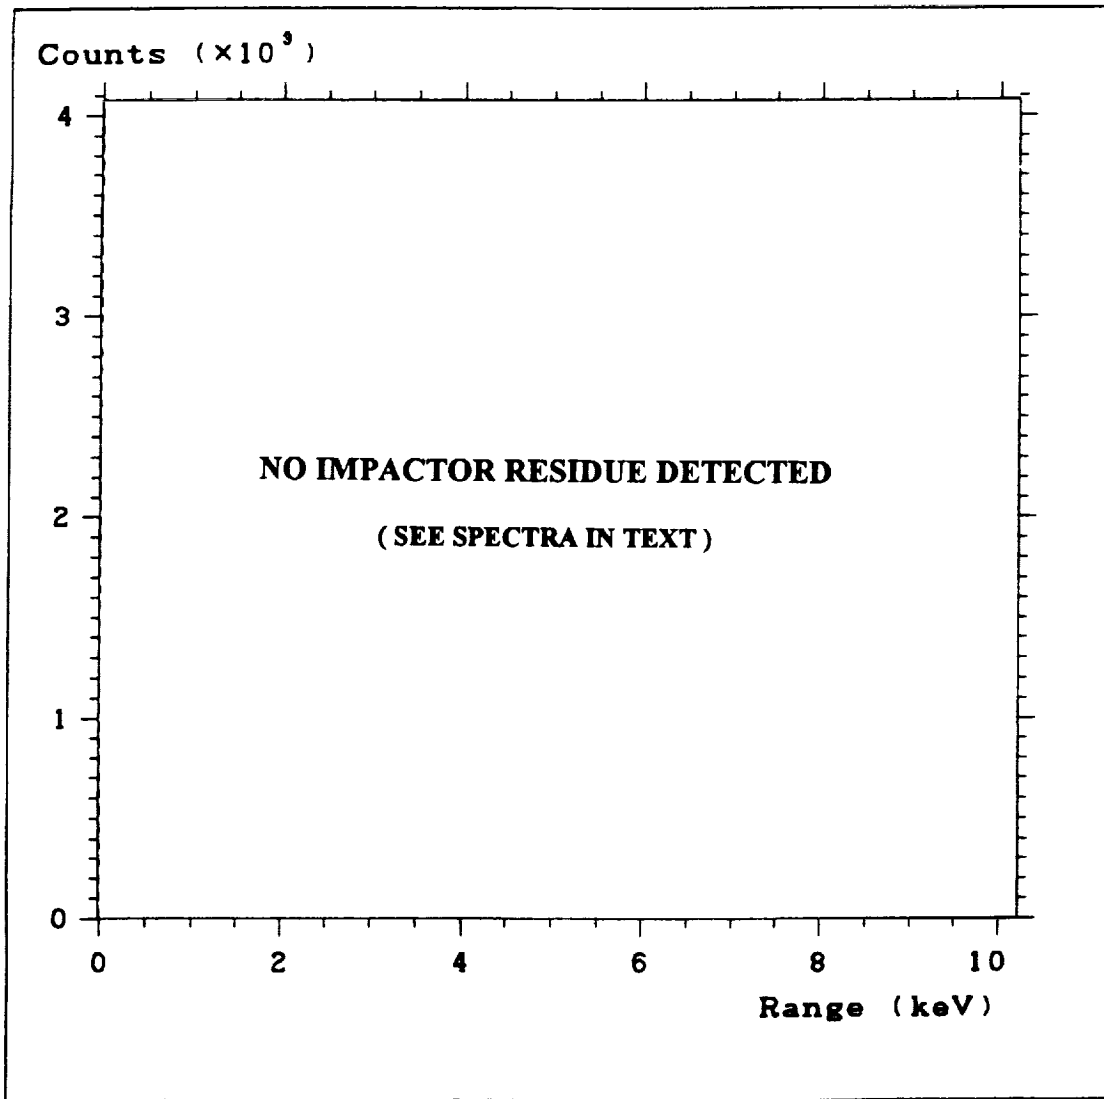
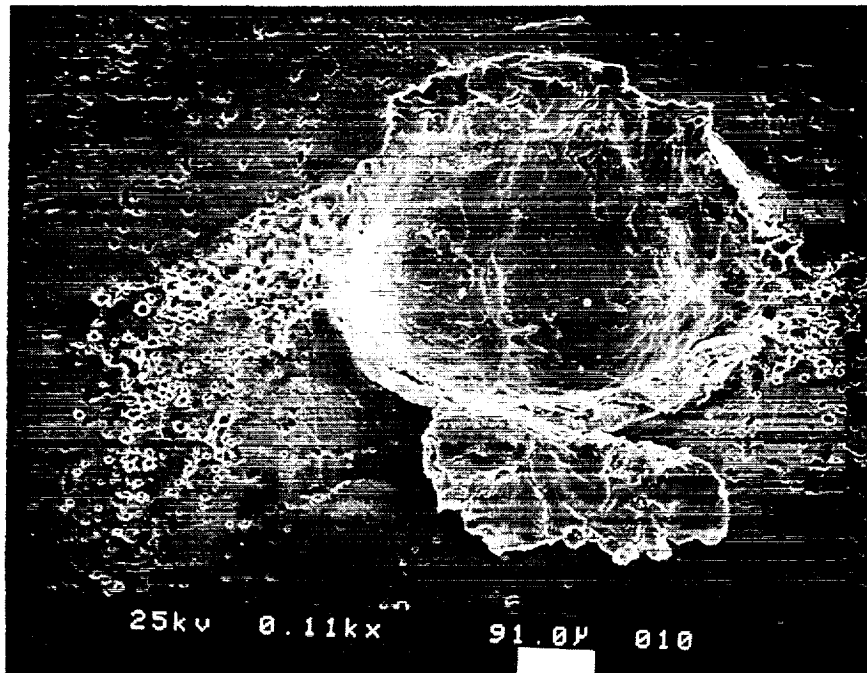
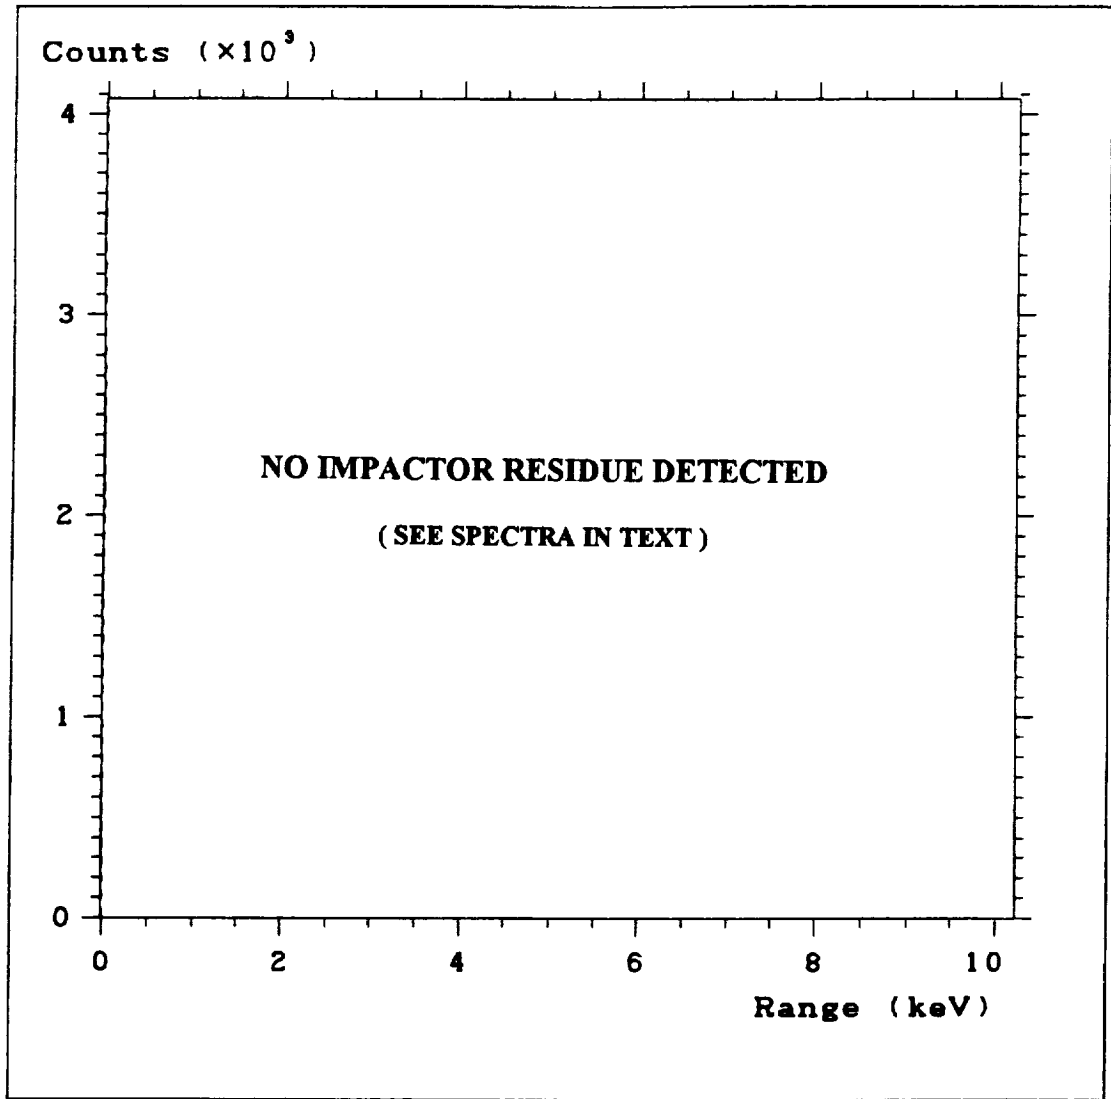
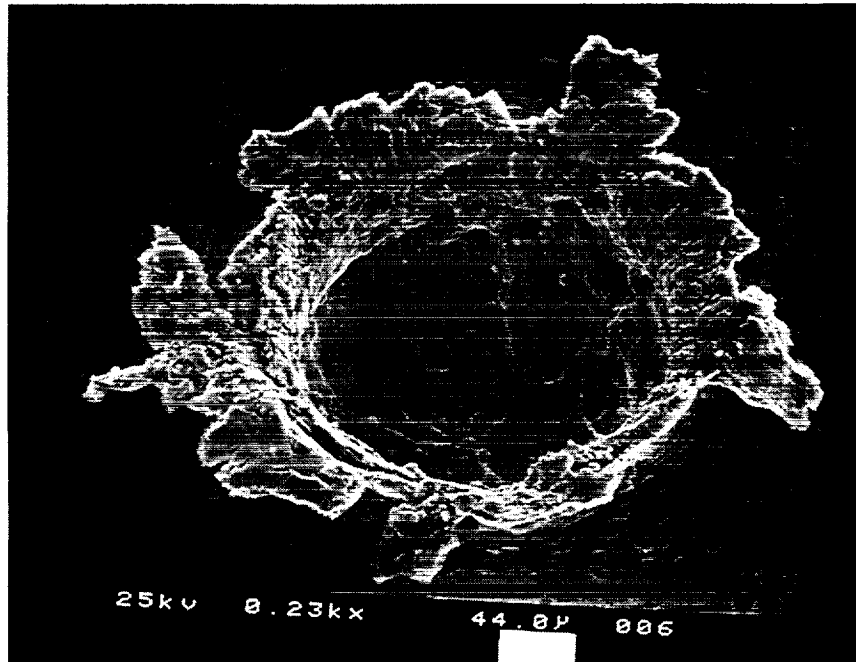
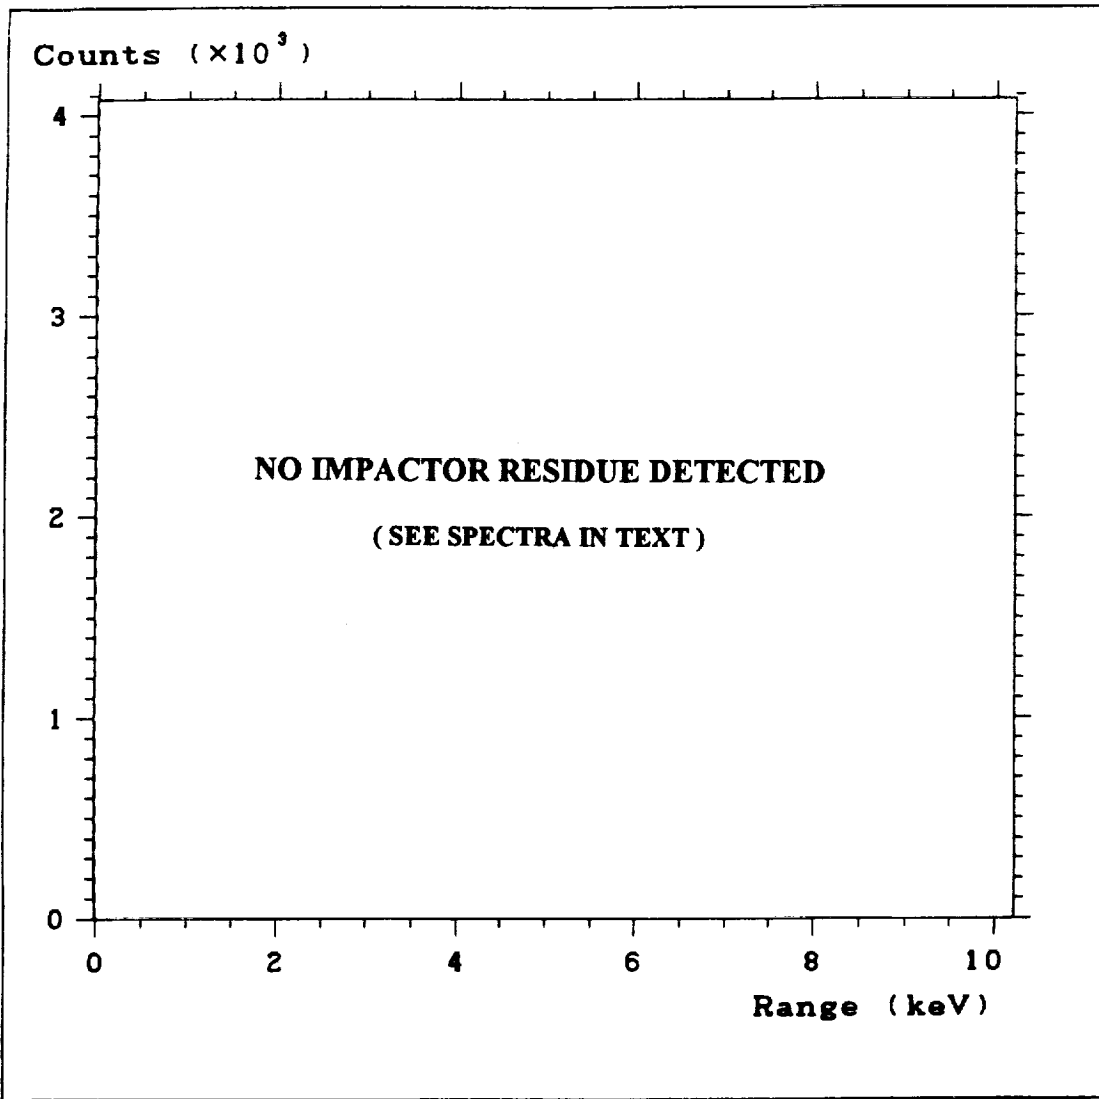
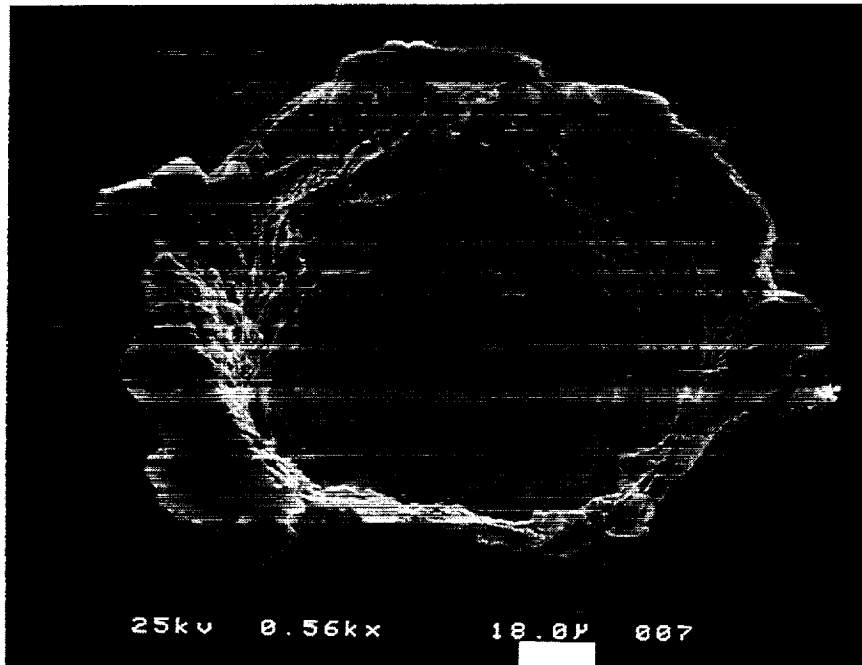
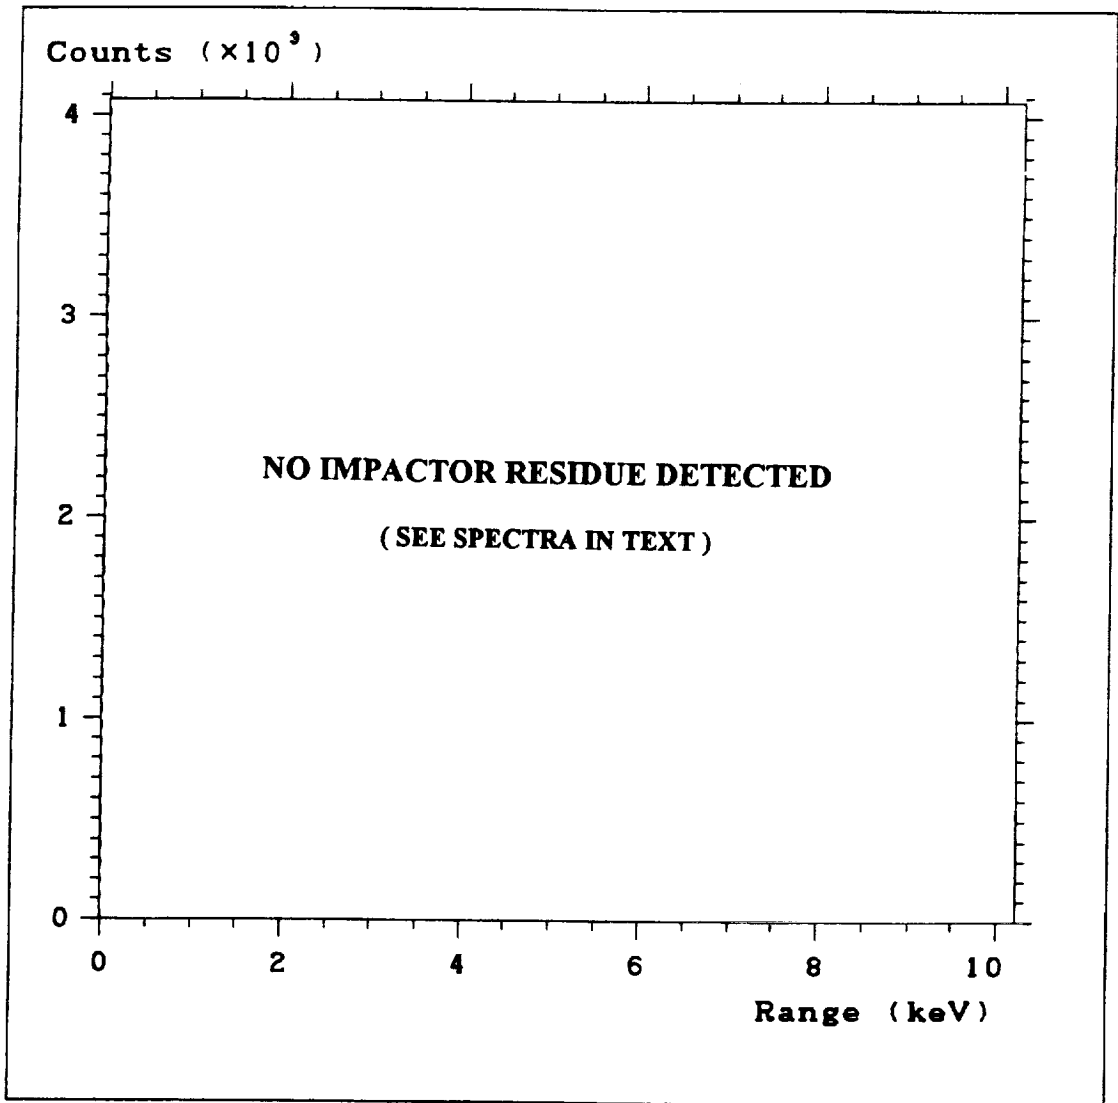
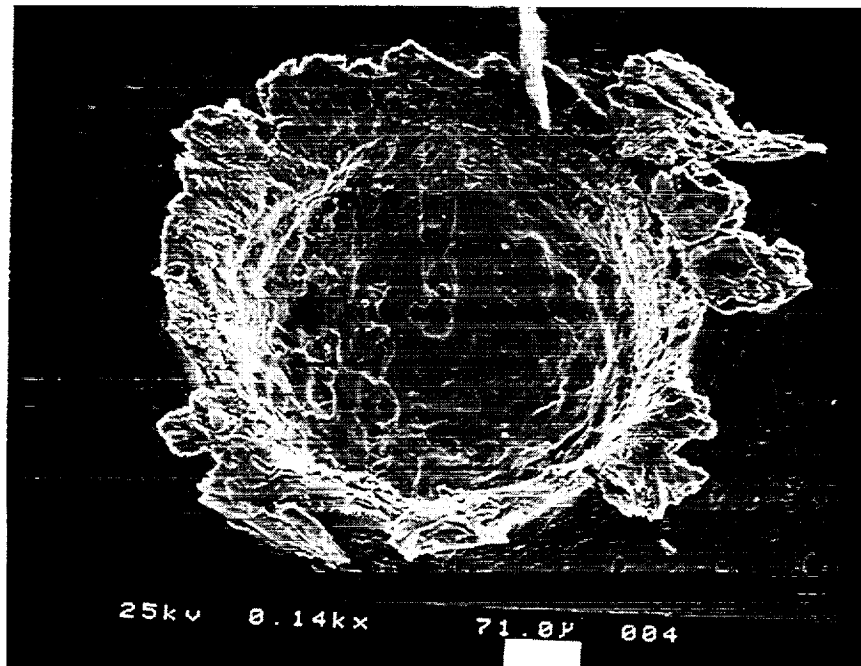
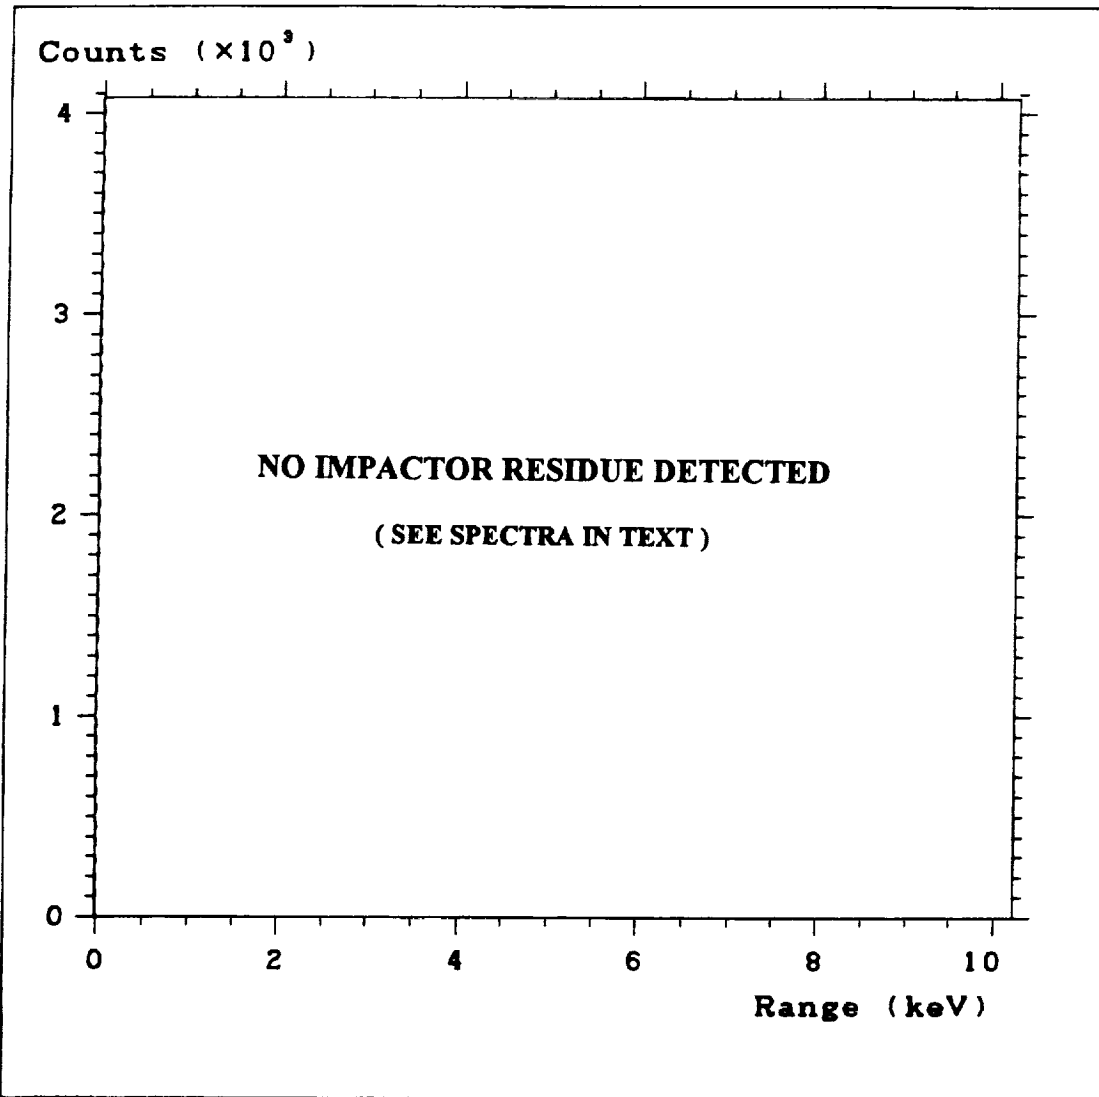
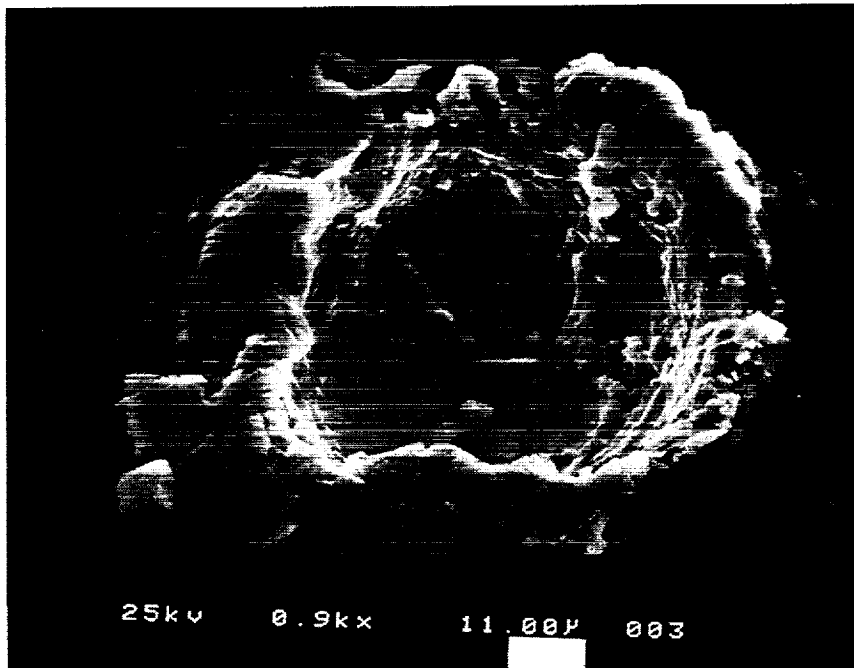
CLAMP NUMBER A10 CO8

<u>IMPACT NUMBER</u>	<u>DIAMETER</u>	<u>GENERAL COMPONENTS</u>
001	500	Unknown
002	260	Unknown
003	140	Unknown
004	500	Unknown
005	100	Unknown
006	120	Unknown
007	140	Unknown
008	70	Unknown
