NASA Technical Memorandum 104759

Analysis of Impactor Residues in Tray Clamps from the Long Duration Exposure Facility

Part 1: Clamps from Bay "A" of the Satellite

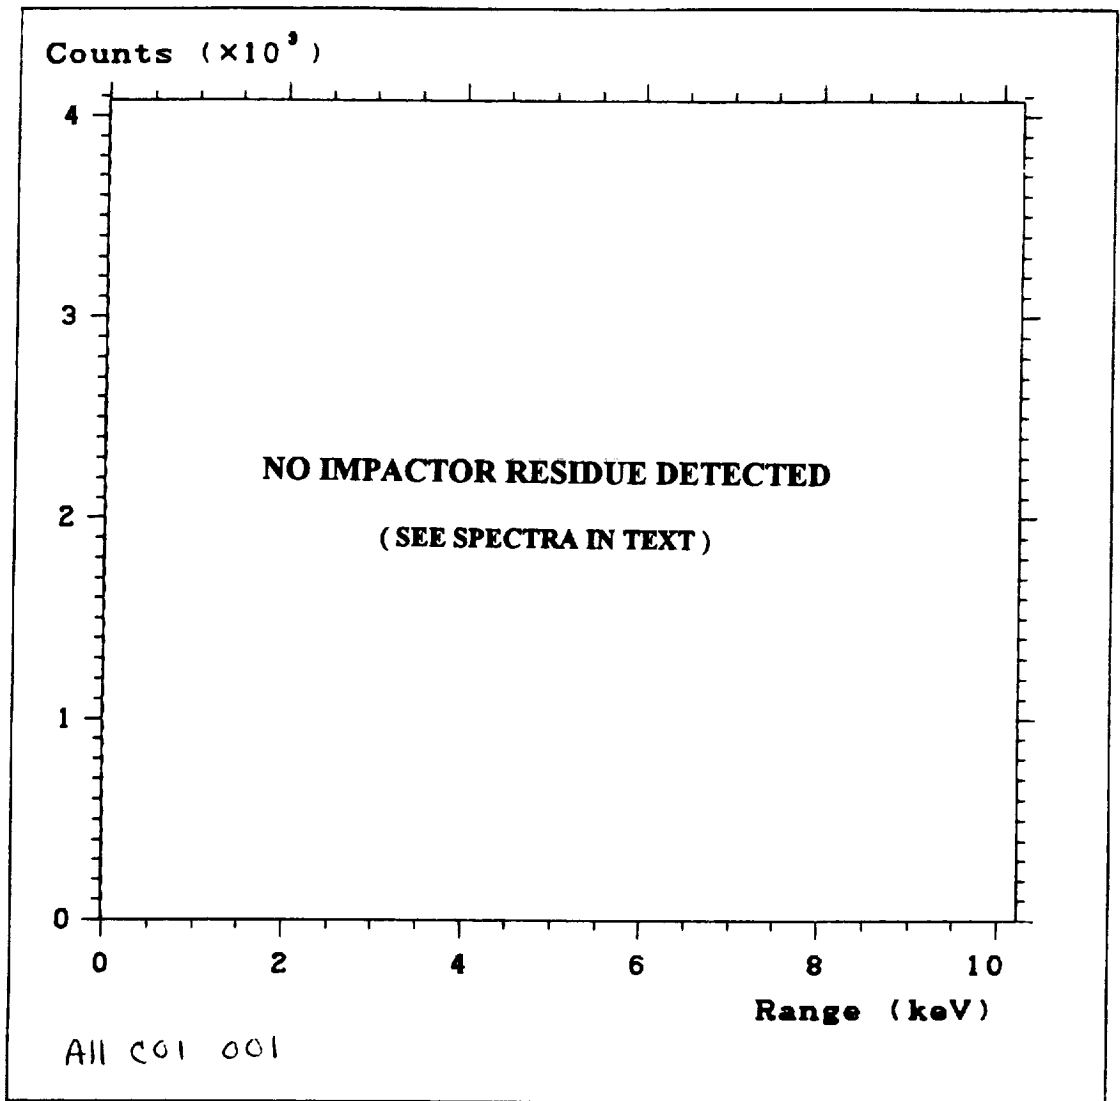
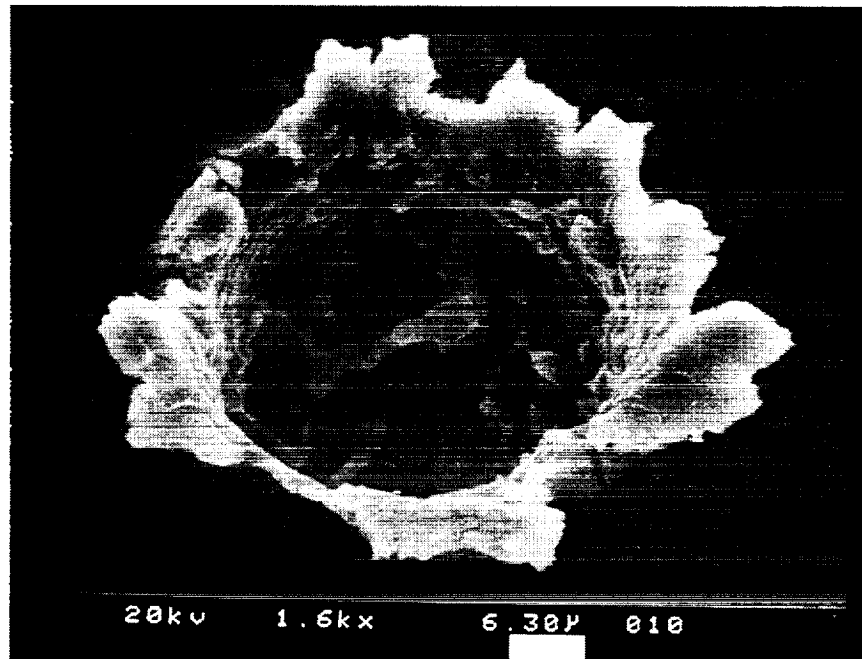
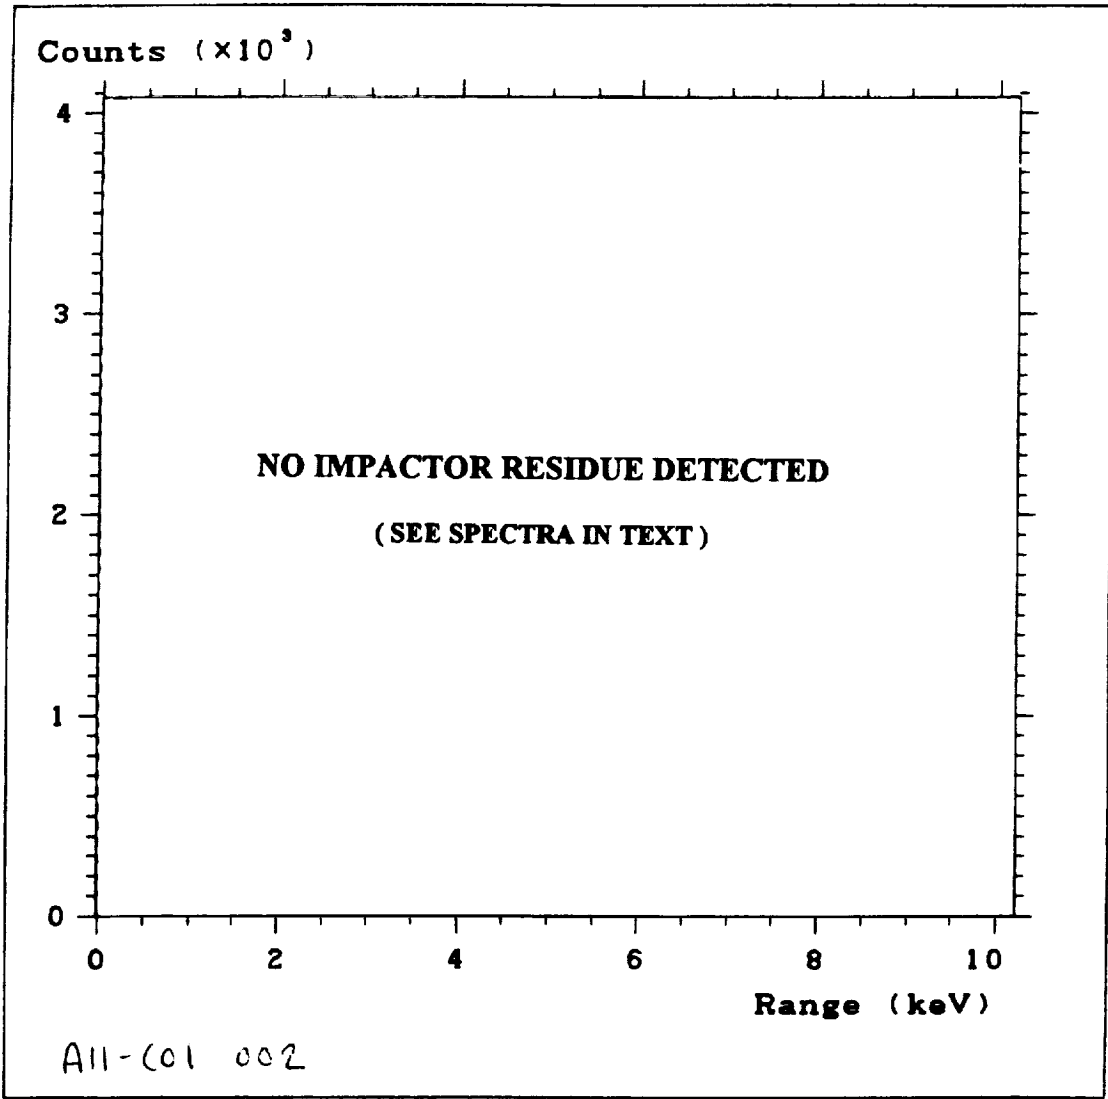
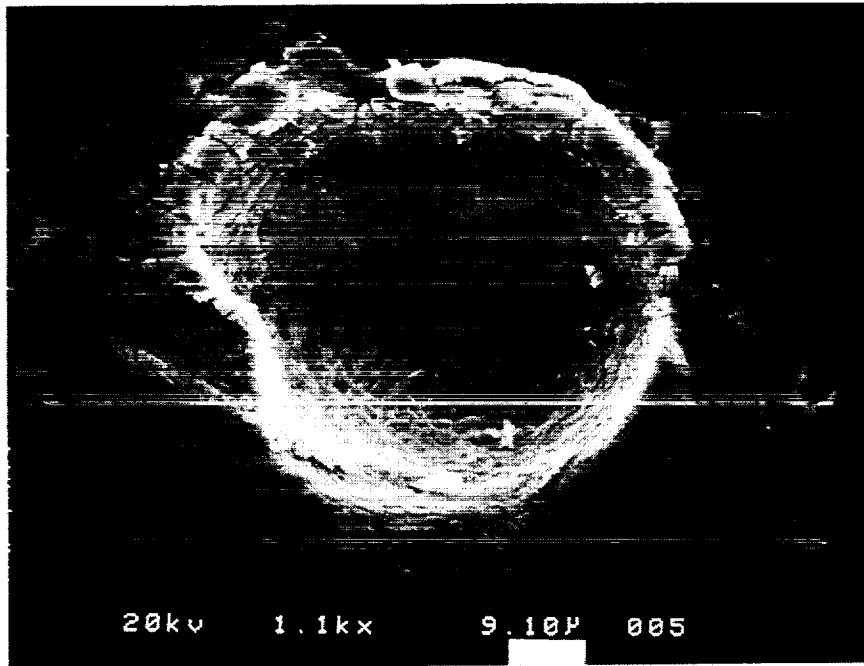
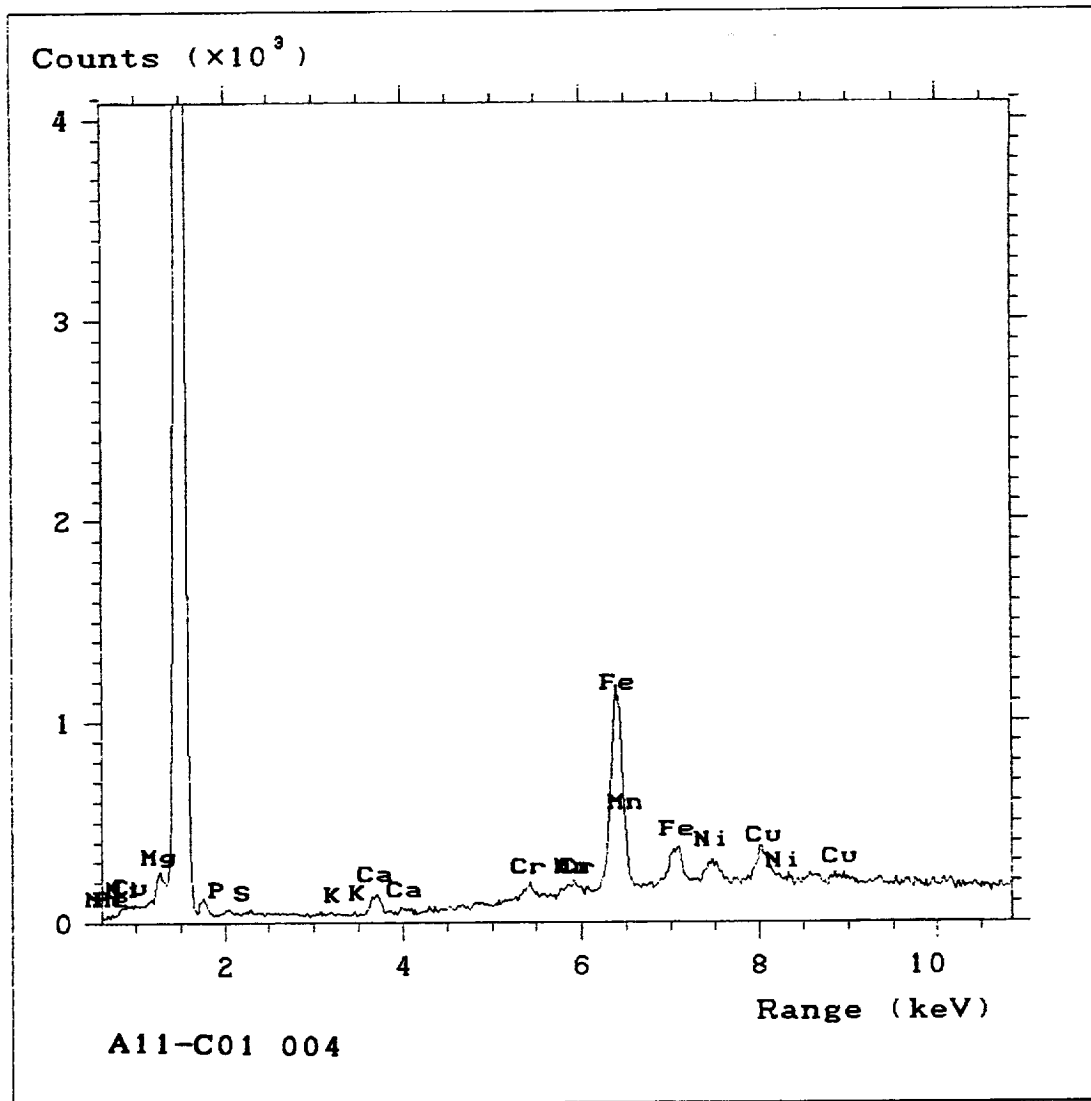
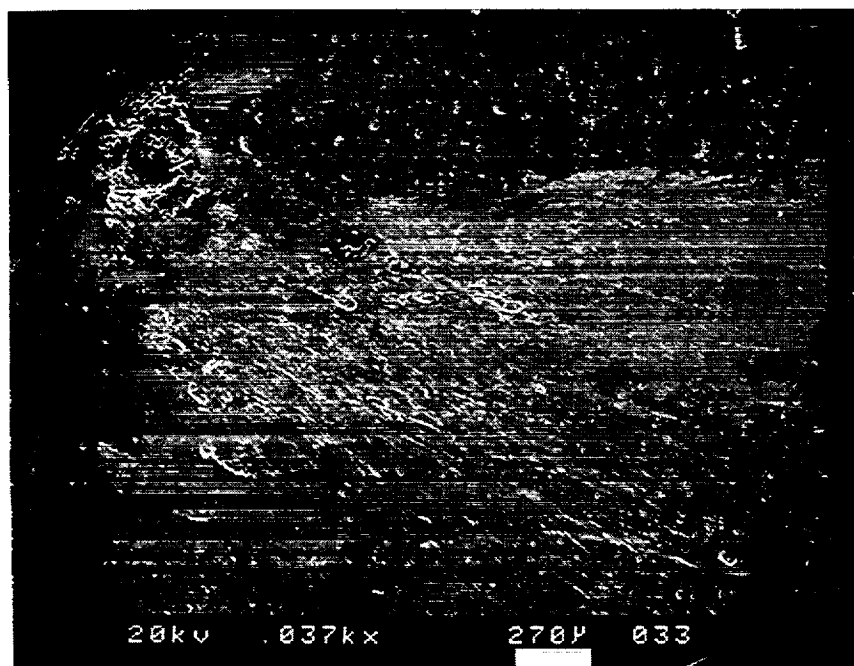
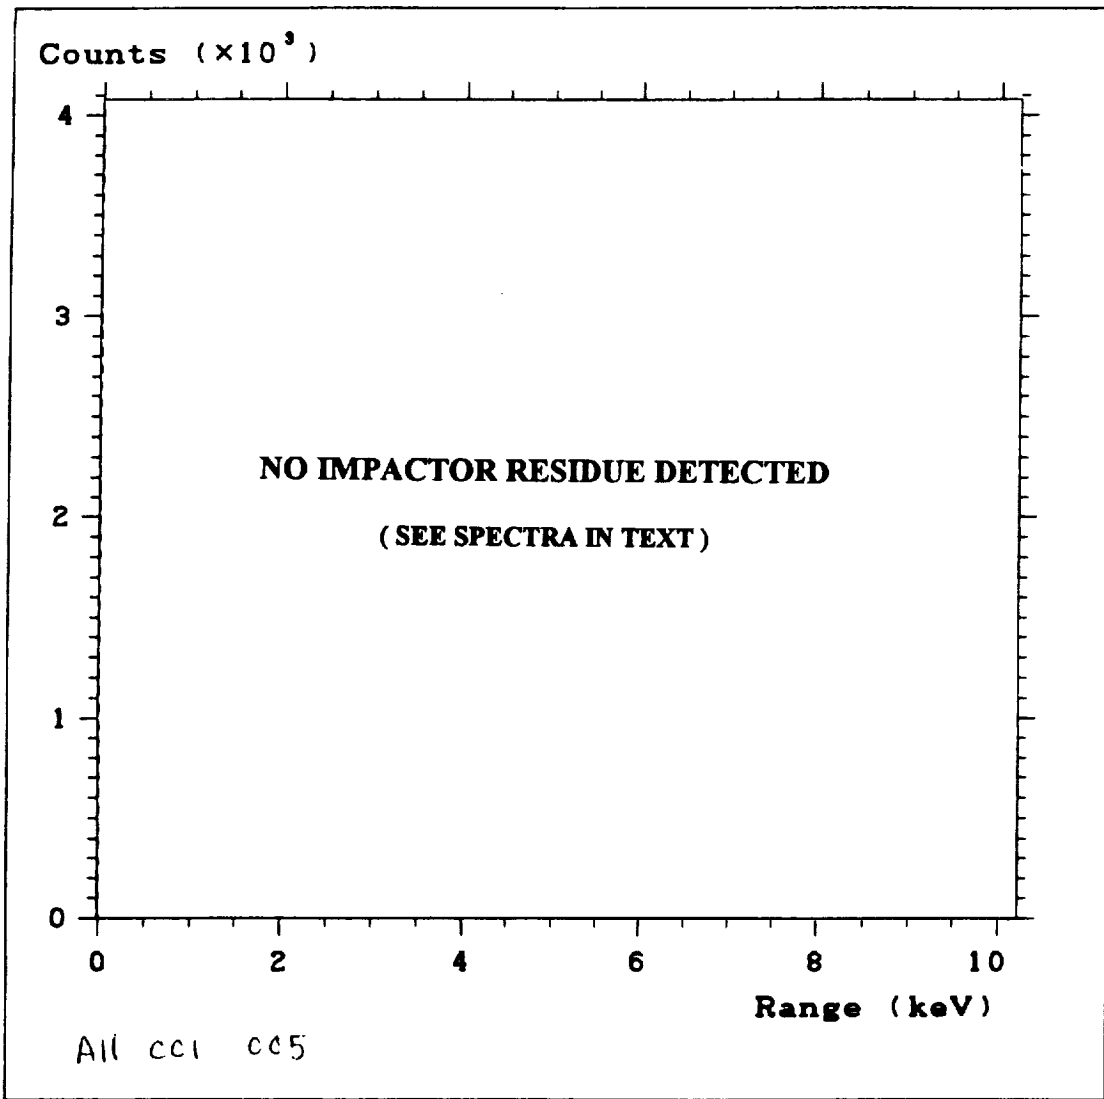
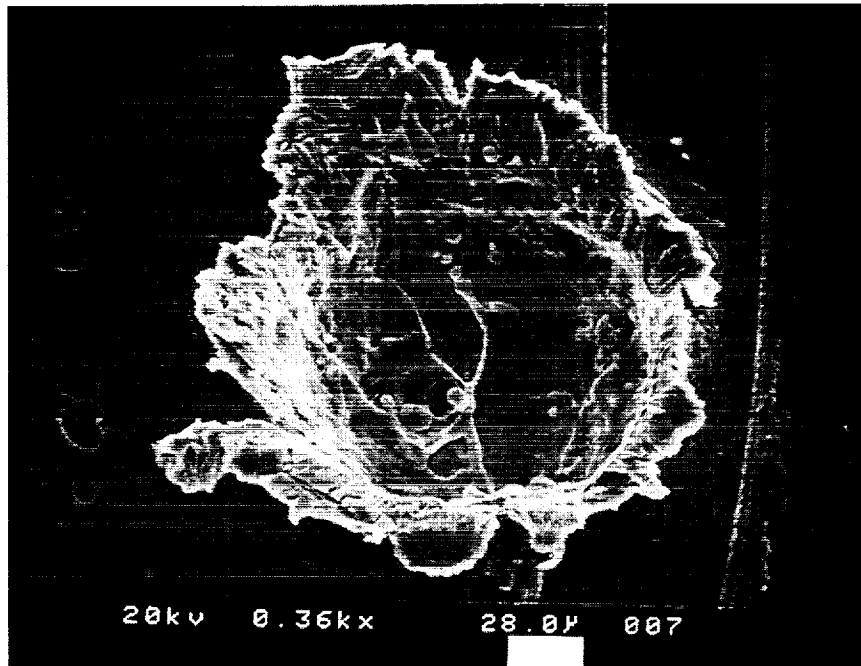
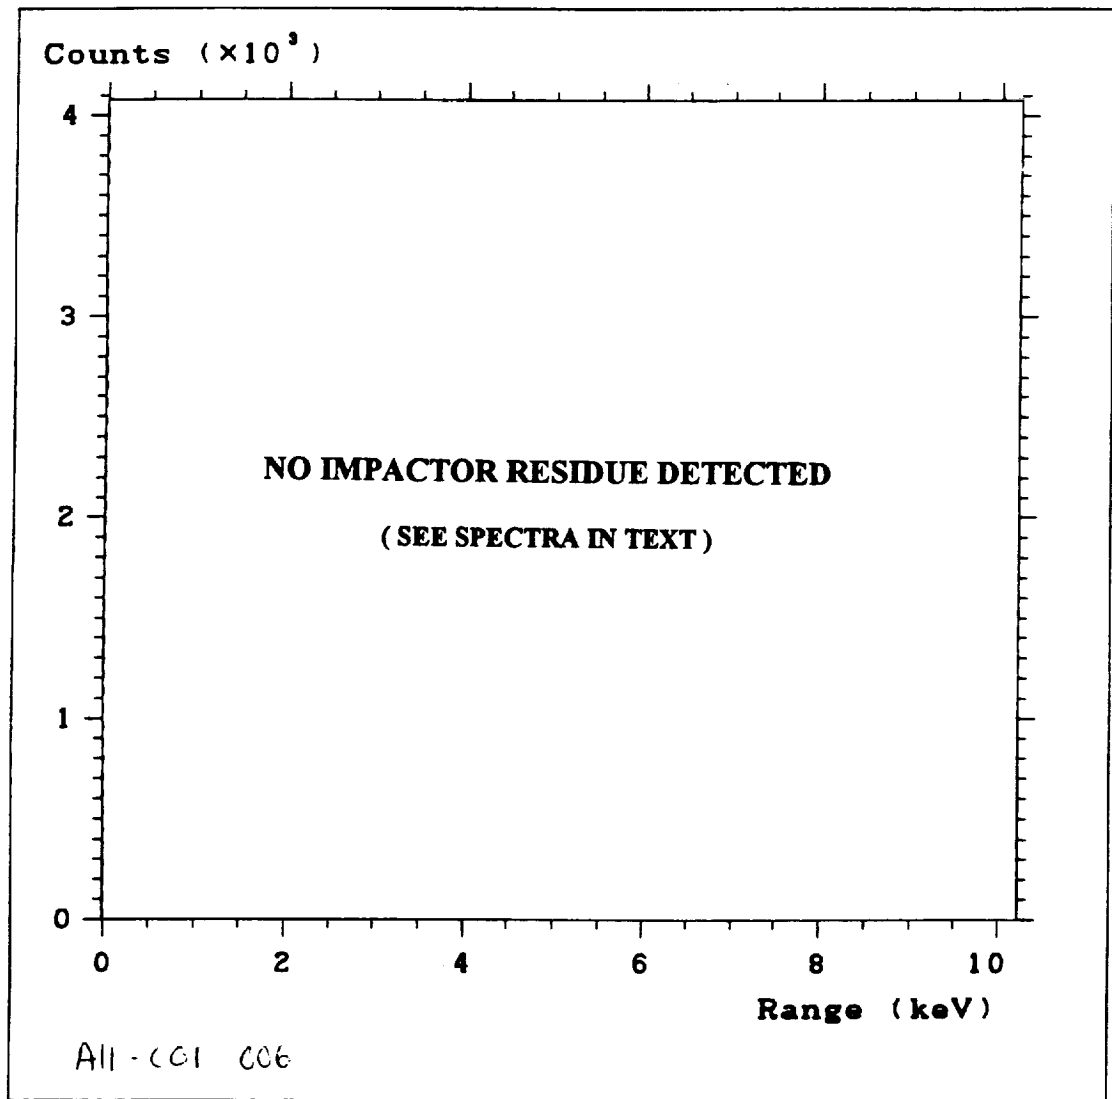
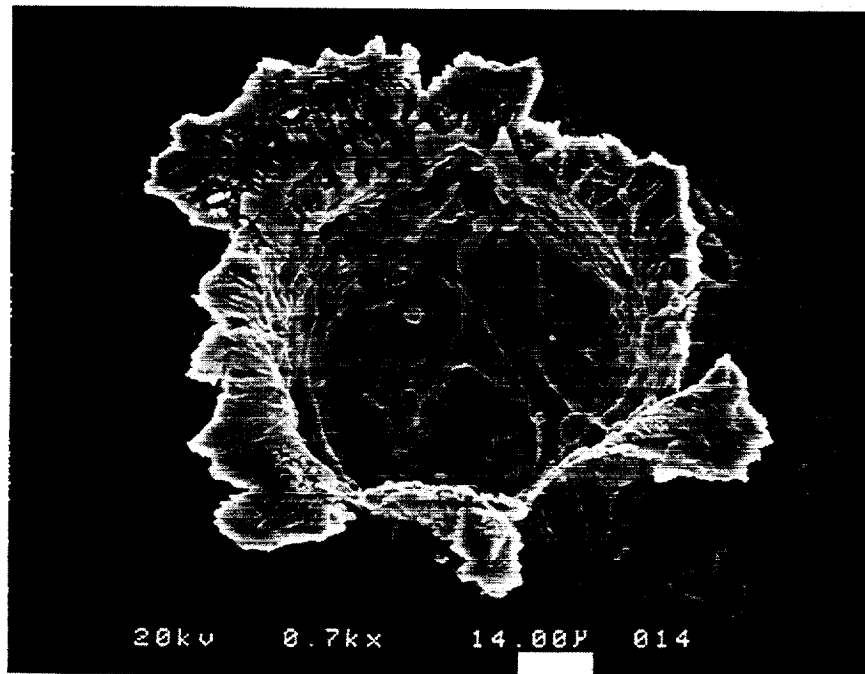
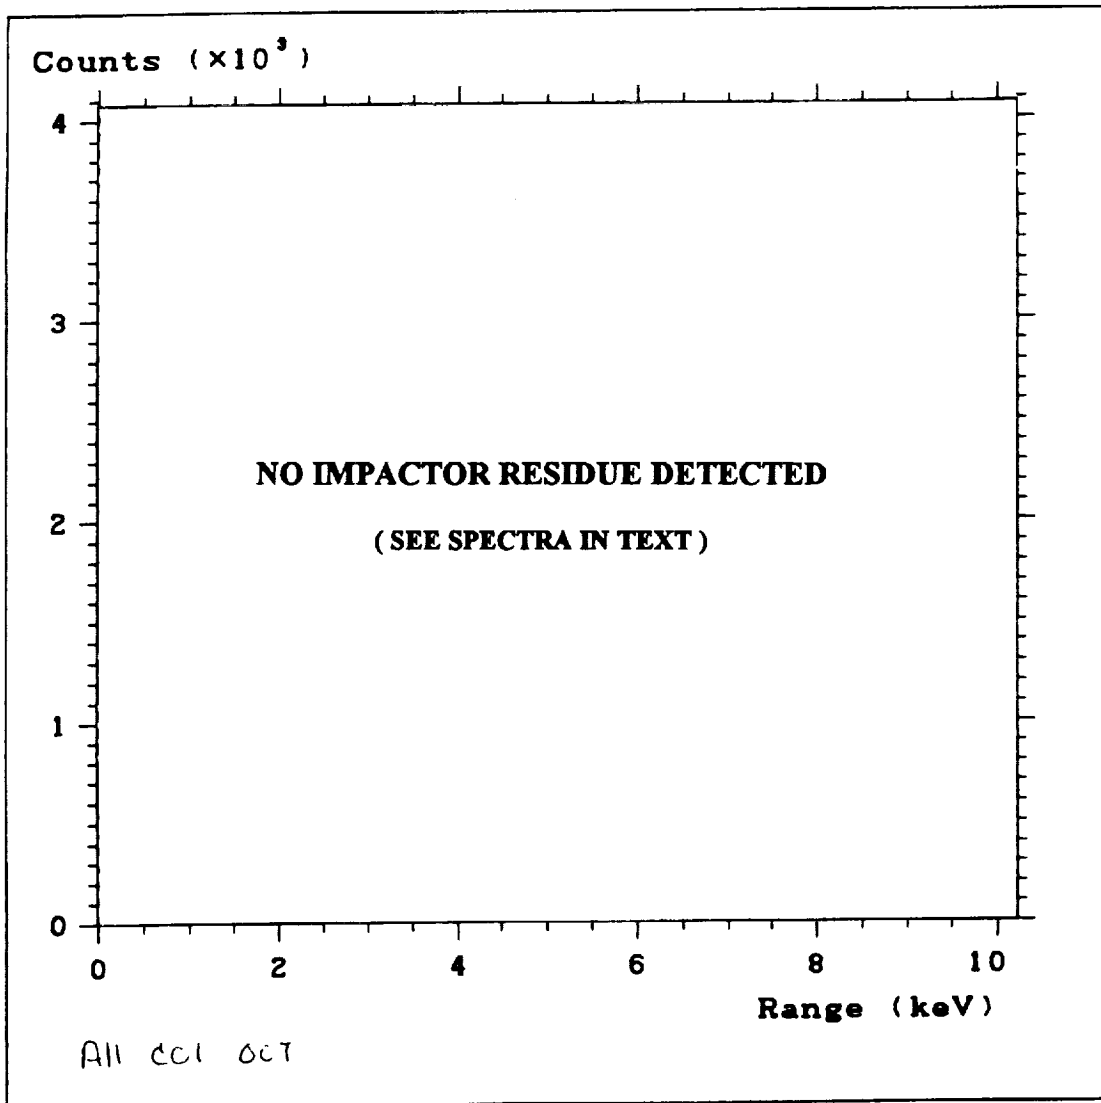
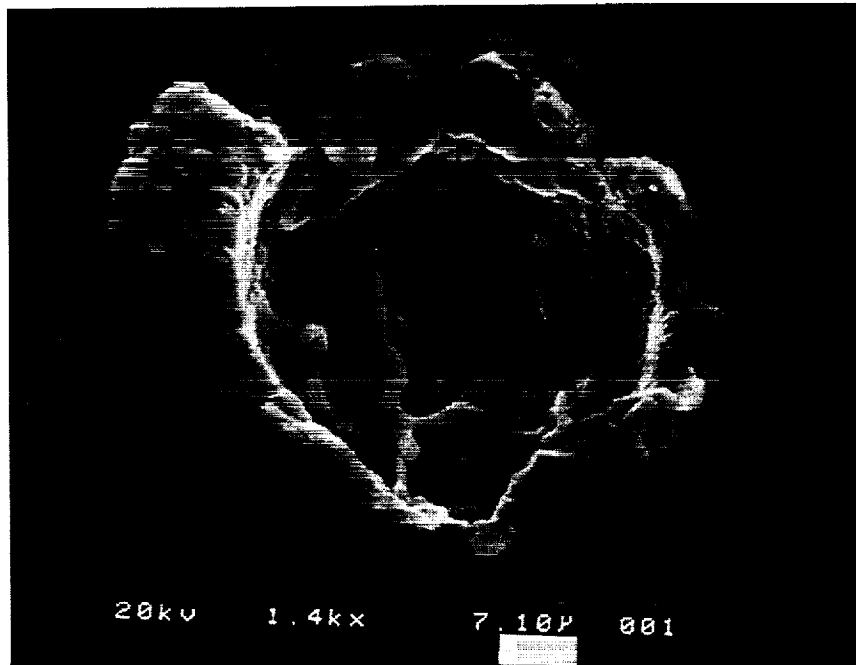
CLAMP NUMBER A11 C01

<u>IMPACT NUMBER</u>	<u>DIAMETER</u>	<u>GENERAL COMPONENTS</u>
001	60	Unknown
002	50	Flaw
003	60	Unknown
004	130	Bolt Spray
005	180	Unknown
006	140	Unknown
007	60	Unknown
008	90	Unknown

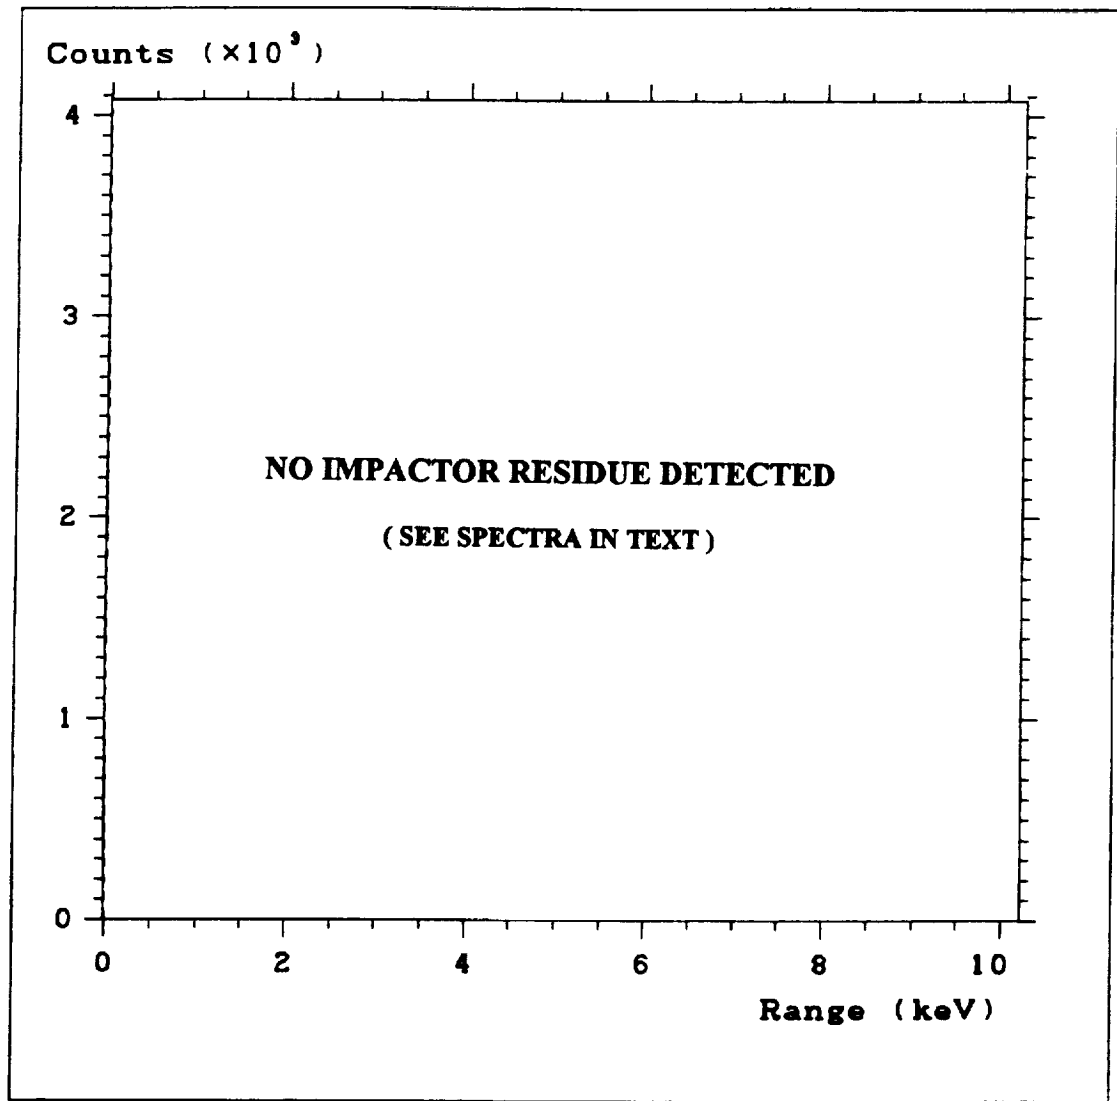
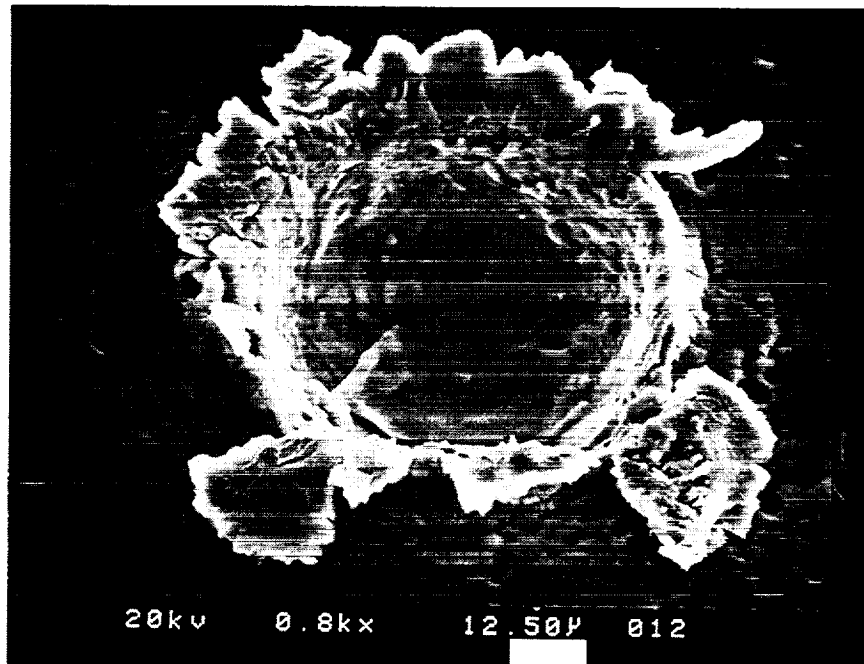
CLAMP NUMBER A11 C05

<u>IMPACT NUMBER</u>	<u>DIAMETER</u>	<u>GENERAL COMPONENTS</u>
001	400	Unknown
002	120	Fe, Ni, Cr
003	100	Unknown
004	250	Trace
005	150	Unknown
006	120	Mg, Si, Ca, Fe
