Debris/Ice/TPS Assessment And Integrated Photographic Analysis For Shuttle Mission STS-53

January 1993

DEBRIS/ICE/TPS ASSESSMENT
AND
PHOTOGRAPHIC ANALYSIS
OF
SHUTTLE MISSION STS-53

December 2, 1992

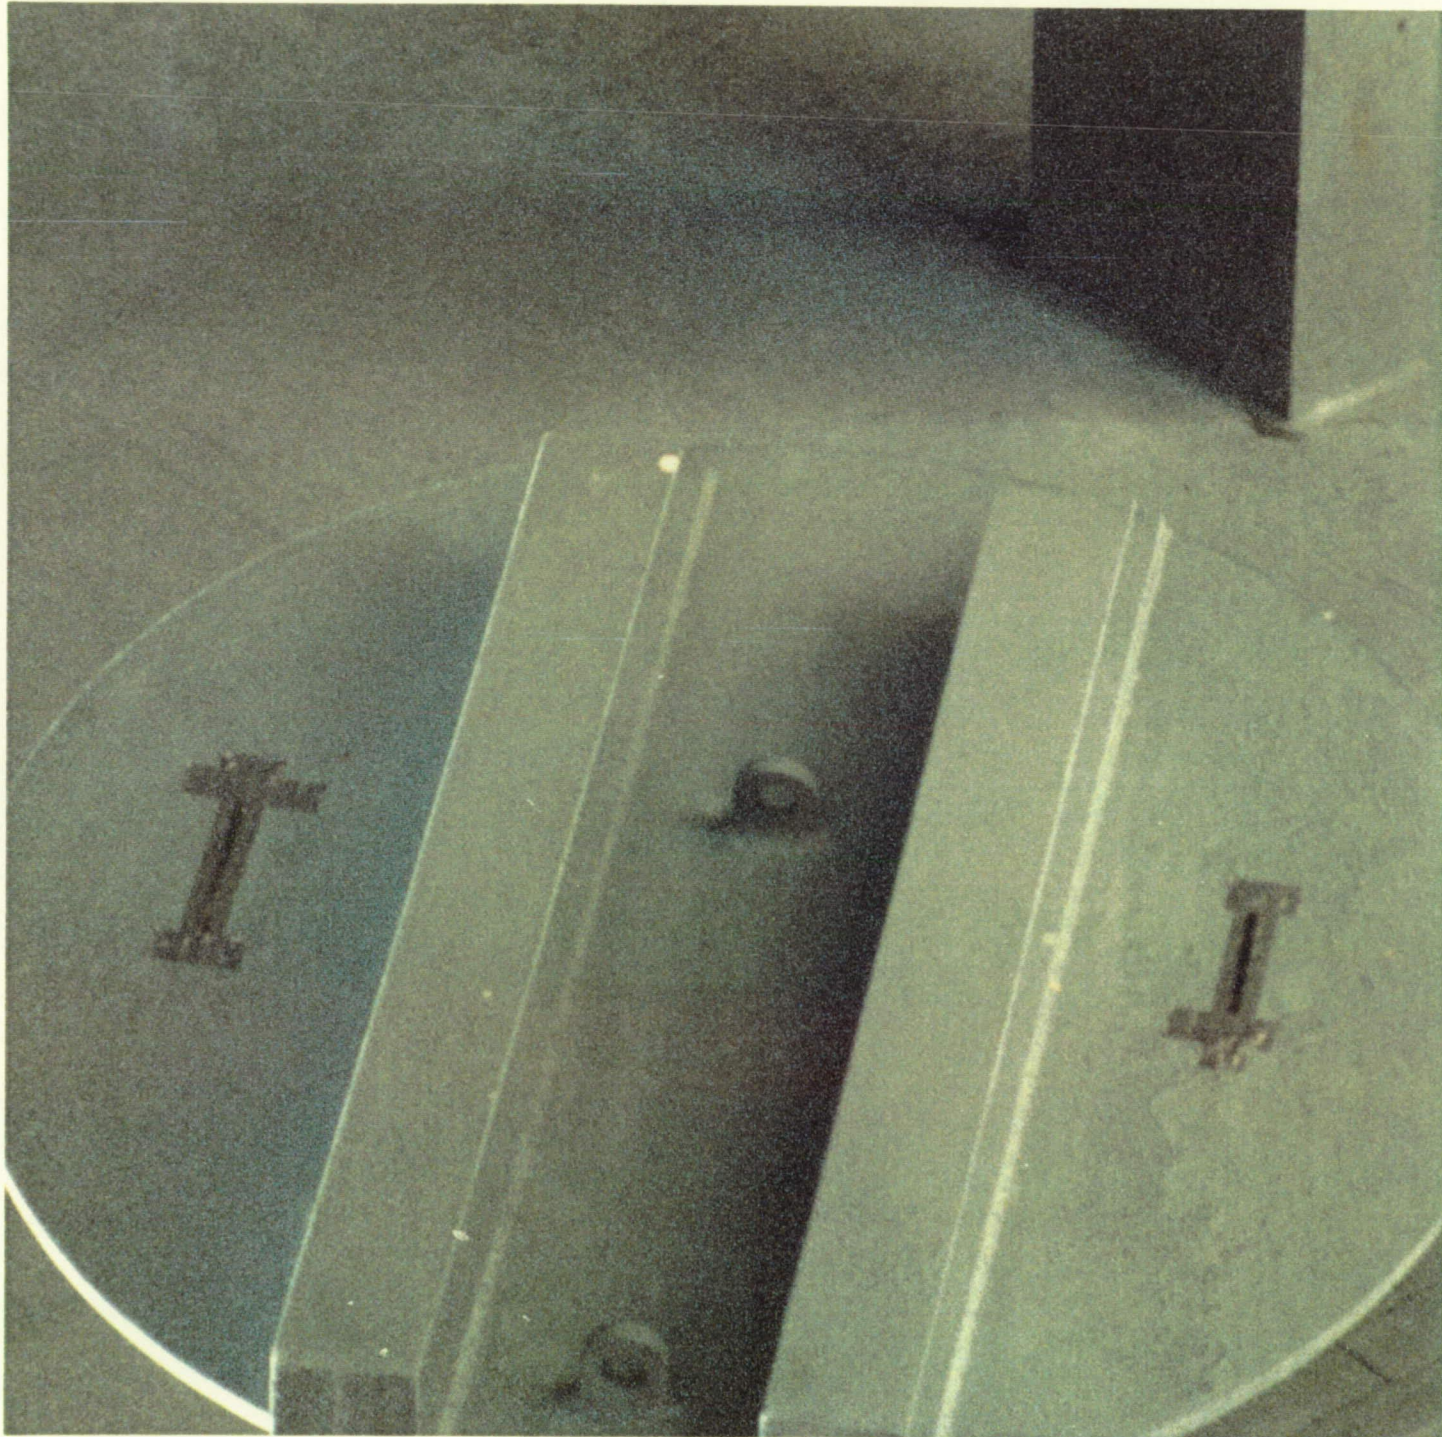
Flat, foil-like, particulate collectors had been taped to the top of each rainbird water deflector as part of an SRB plume study. The foil/tape was not a debris threat to the vehicle.

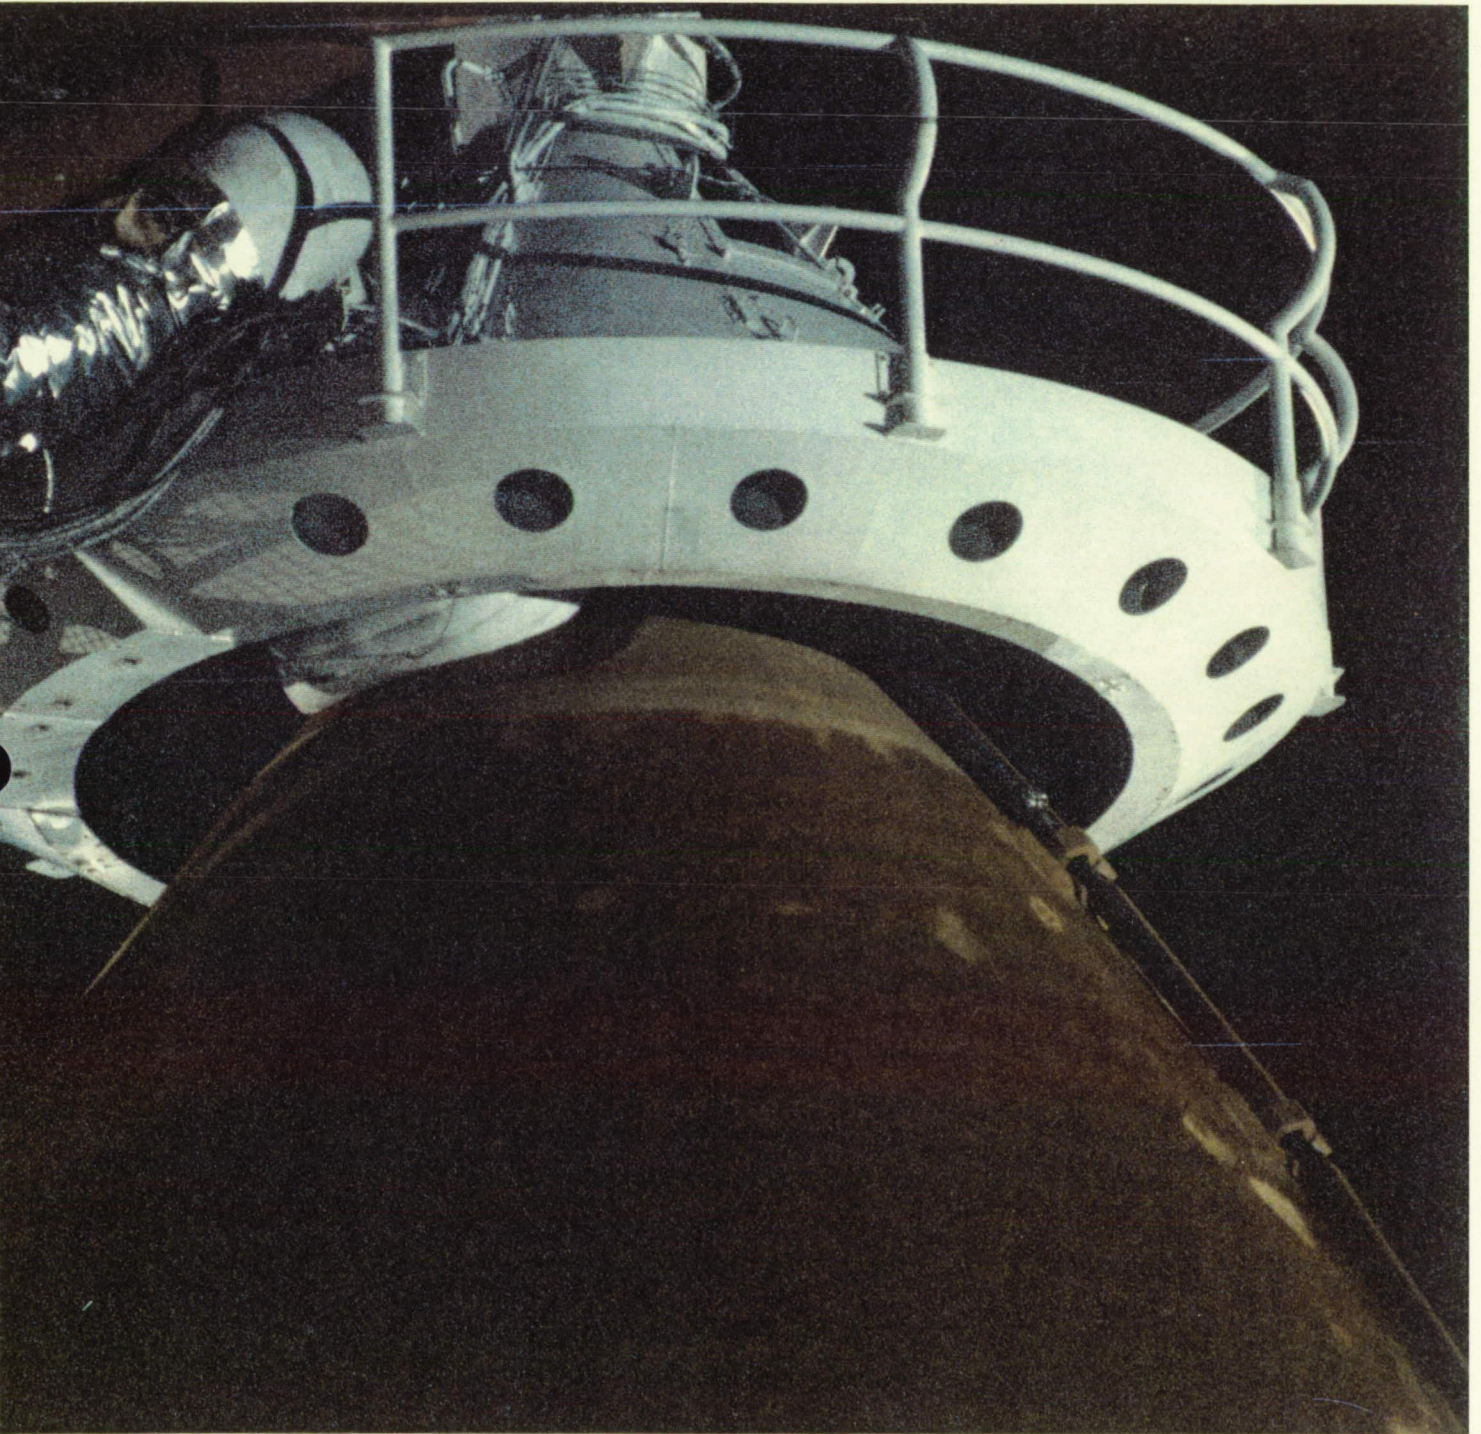
At the time of the Ice Inspection, condensate on the LO2 tank barrel section +Y+Z quadrant was freezing and changing to ice with a frost covering. The ice thickness exceeded the 1/16 inch allowed in the LCC.

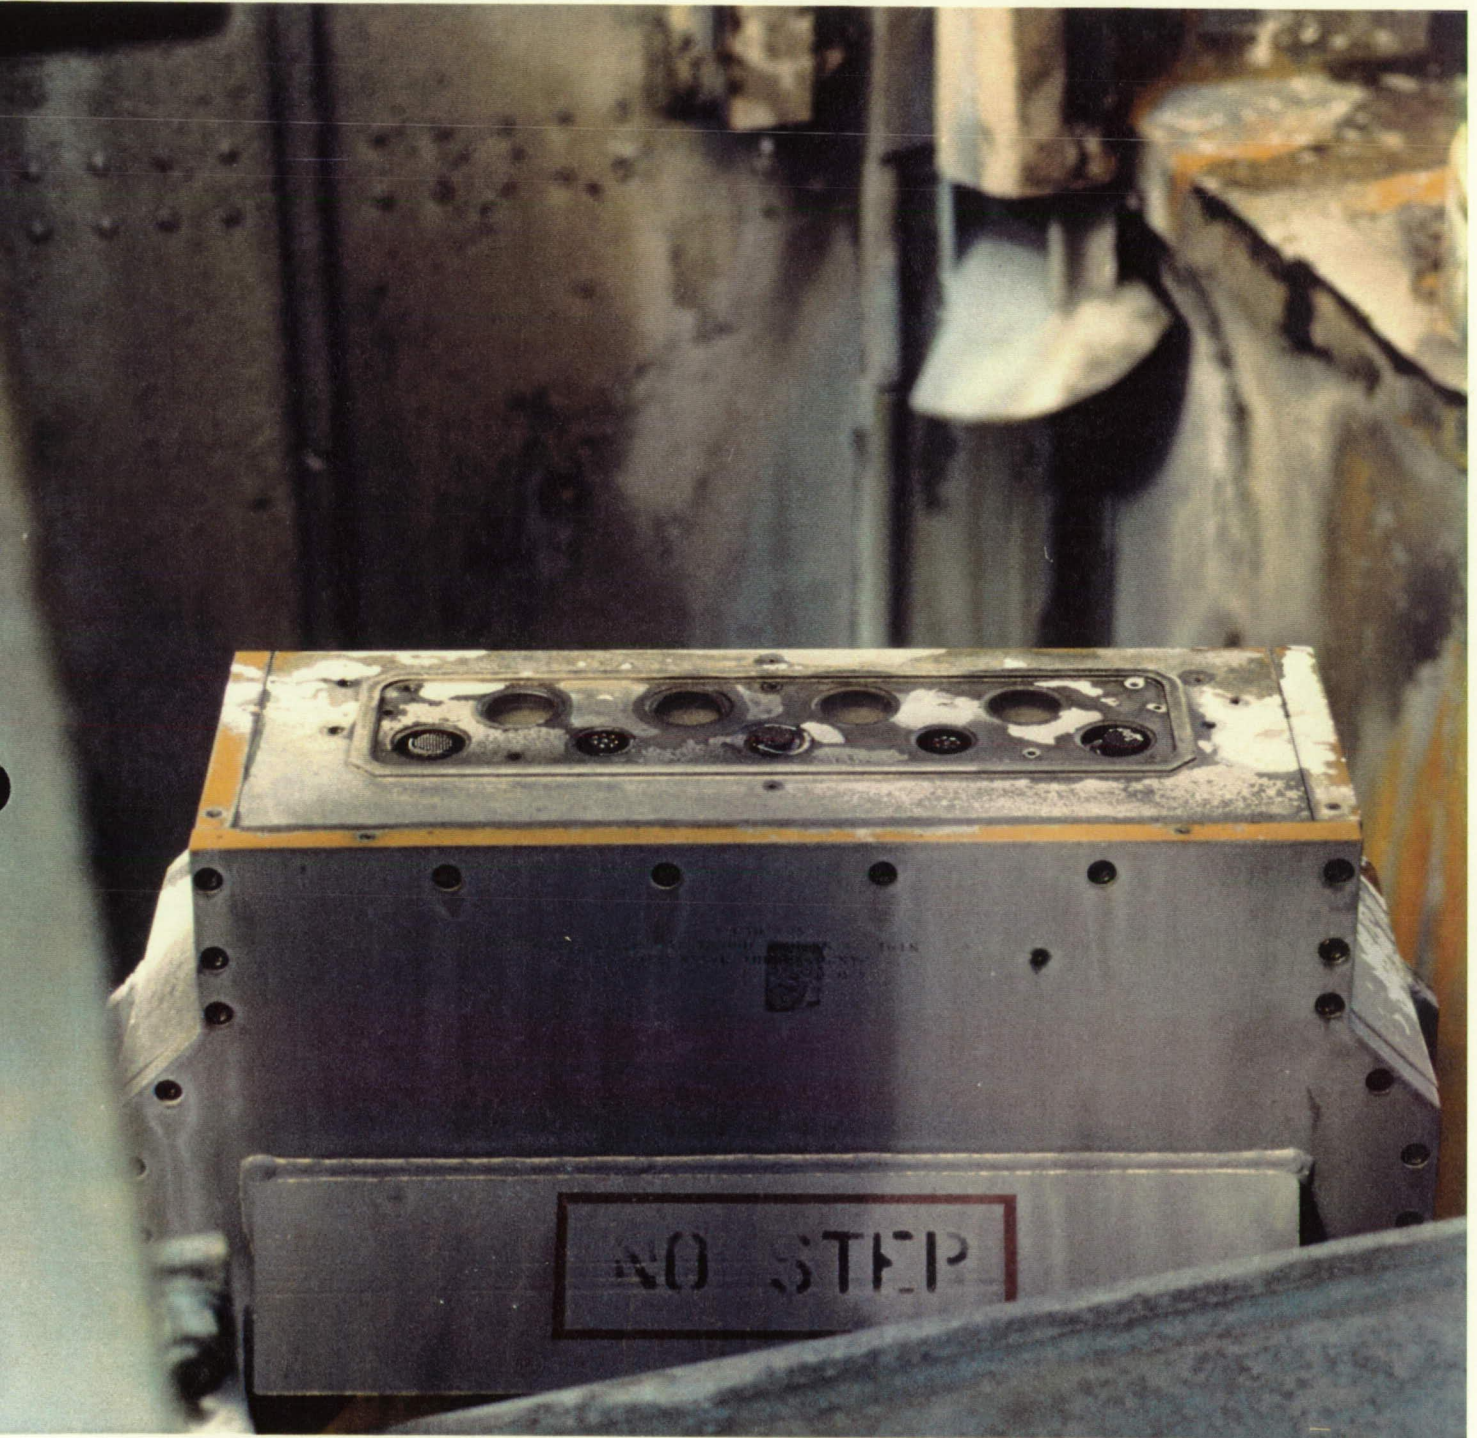
Deletion of aft skirt strain gauges resulted in less electrical connector sacrificial pieces on the SRB T-0 umbilical exposed to the SRB plume.

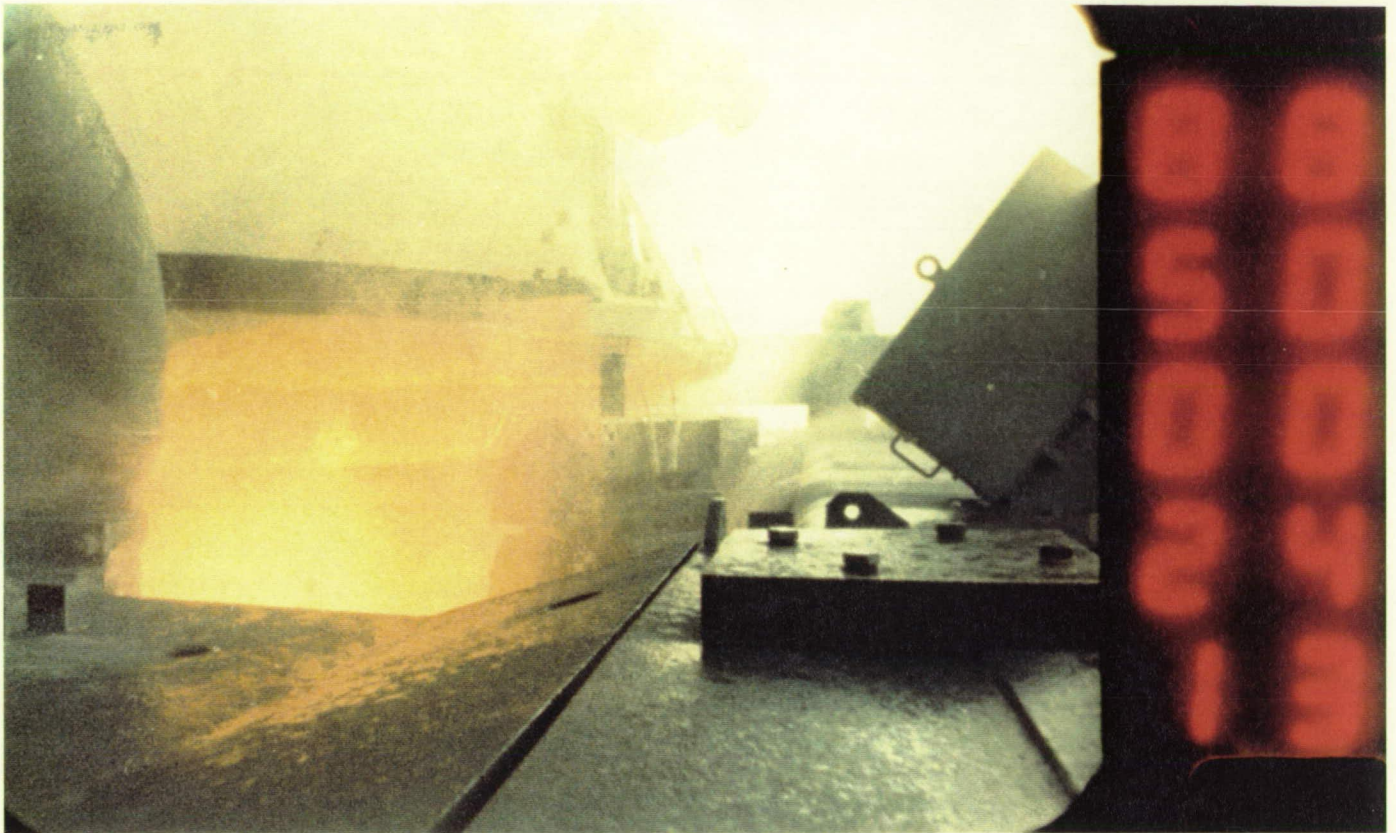
A stud hang-up occurred on HDP #1. One piece of ordnance debris fell from the DCS/stud hole into the HDP haunch area and may have been a frangible nut web.

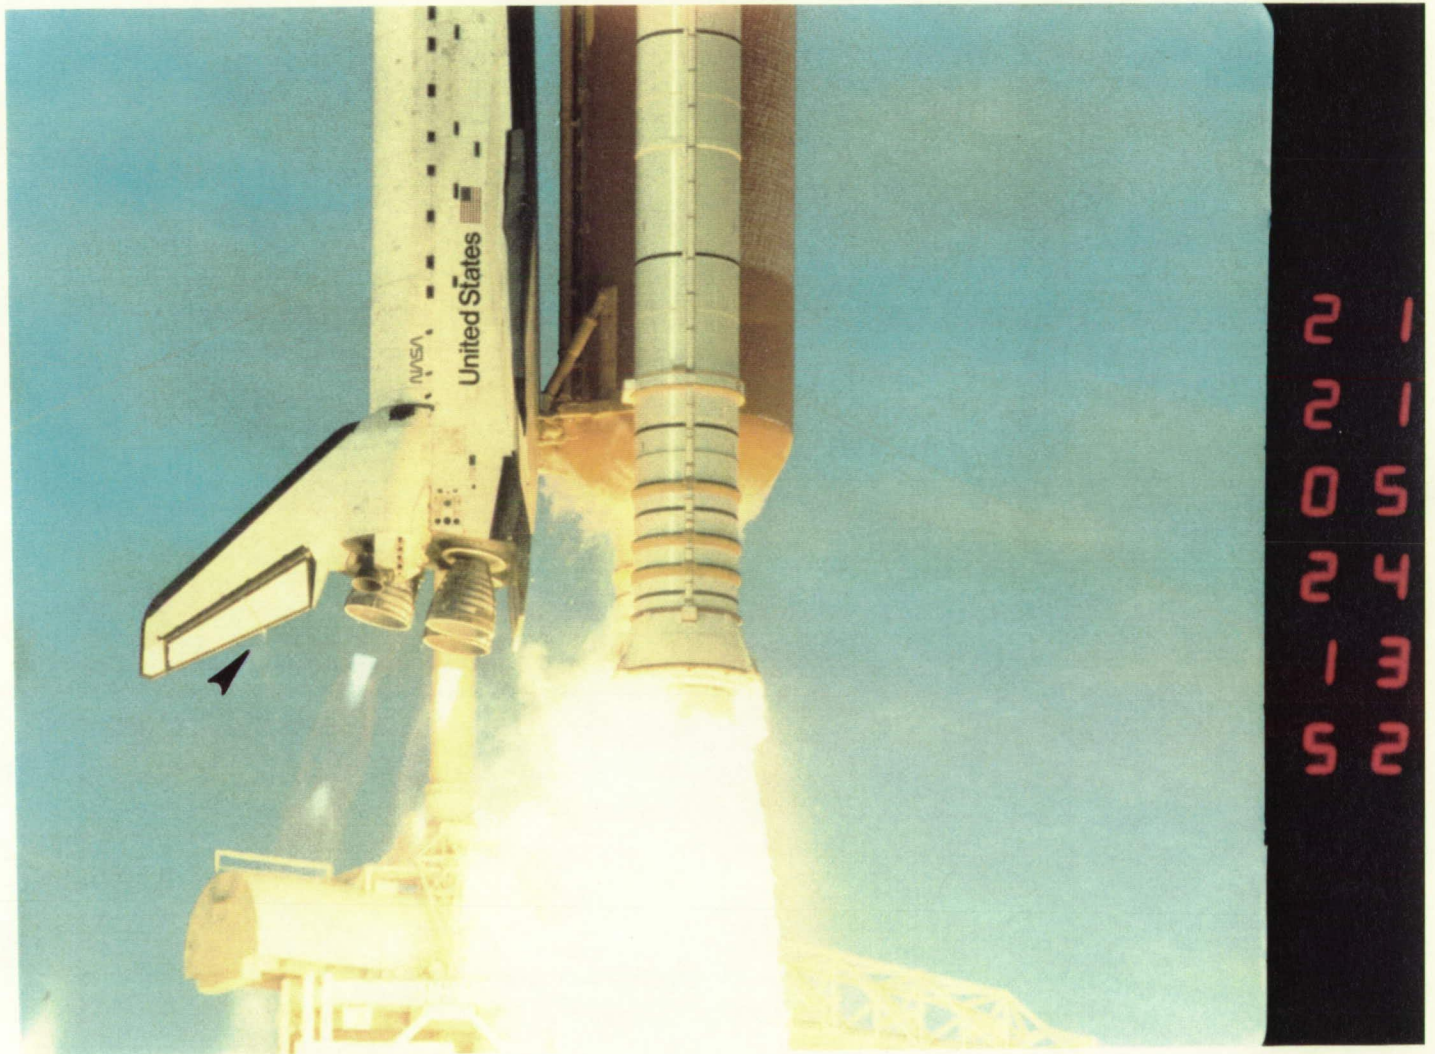
Water vapor/condensate trailed from the split rudder
speed brake drain hole after liftoff

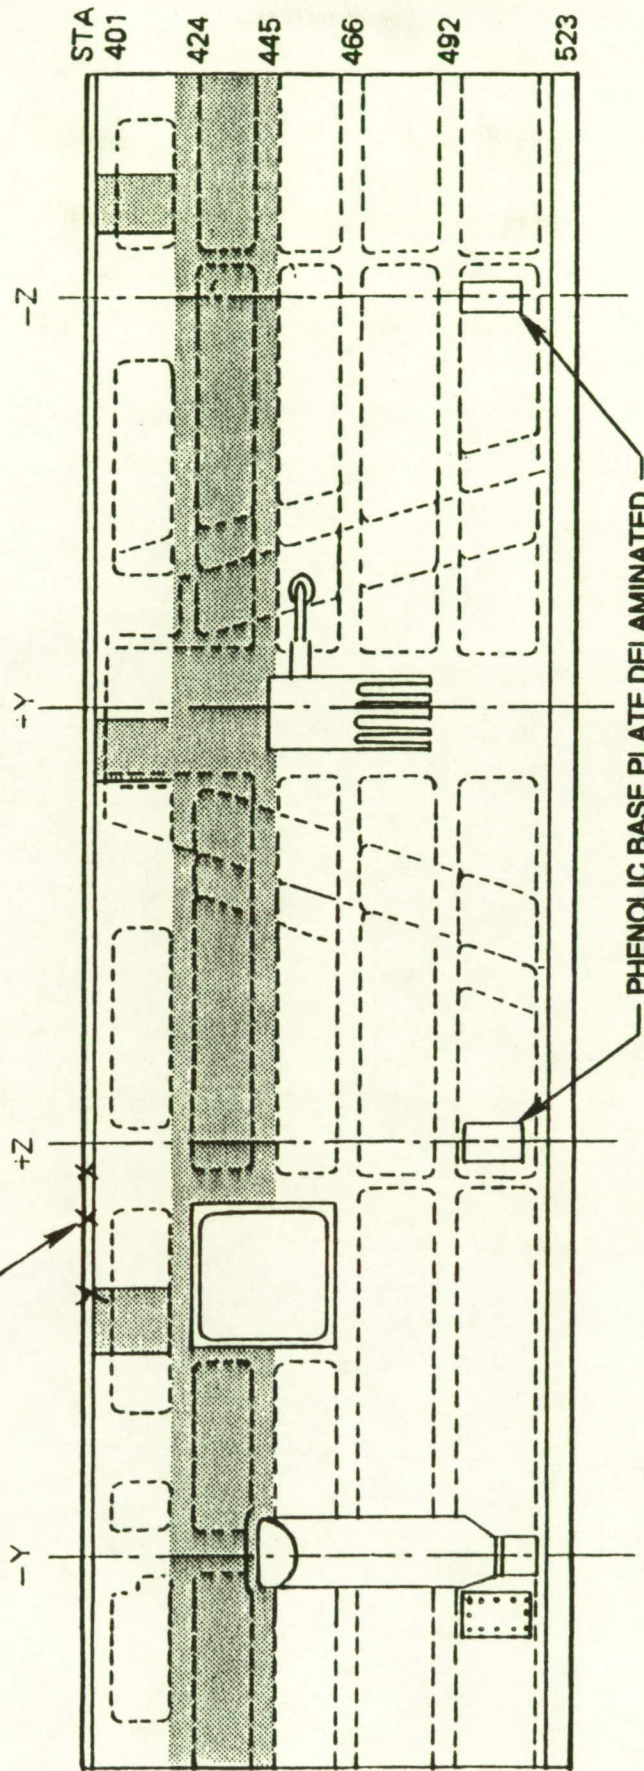
LEFT SRB FWD SKIRT

3 FRUSTUM SEVERANCE
RING PINS MISSING

TPS MISSING
NONE

DEBONDS
NONE

MINOR BLISTERING OF
HYPALON PAINT ON SYSTEMS
TUNNEL COVER AND AROUND
ET/SRB FITTING

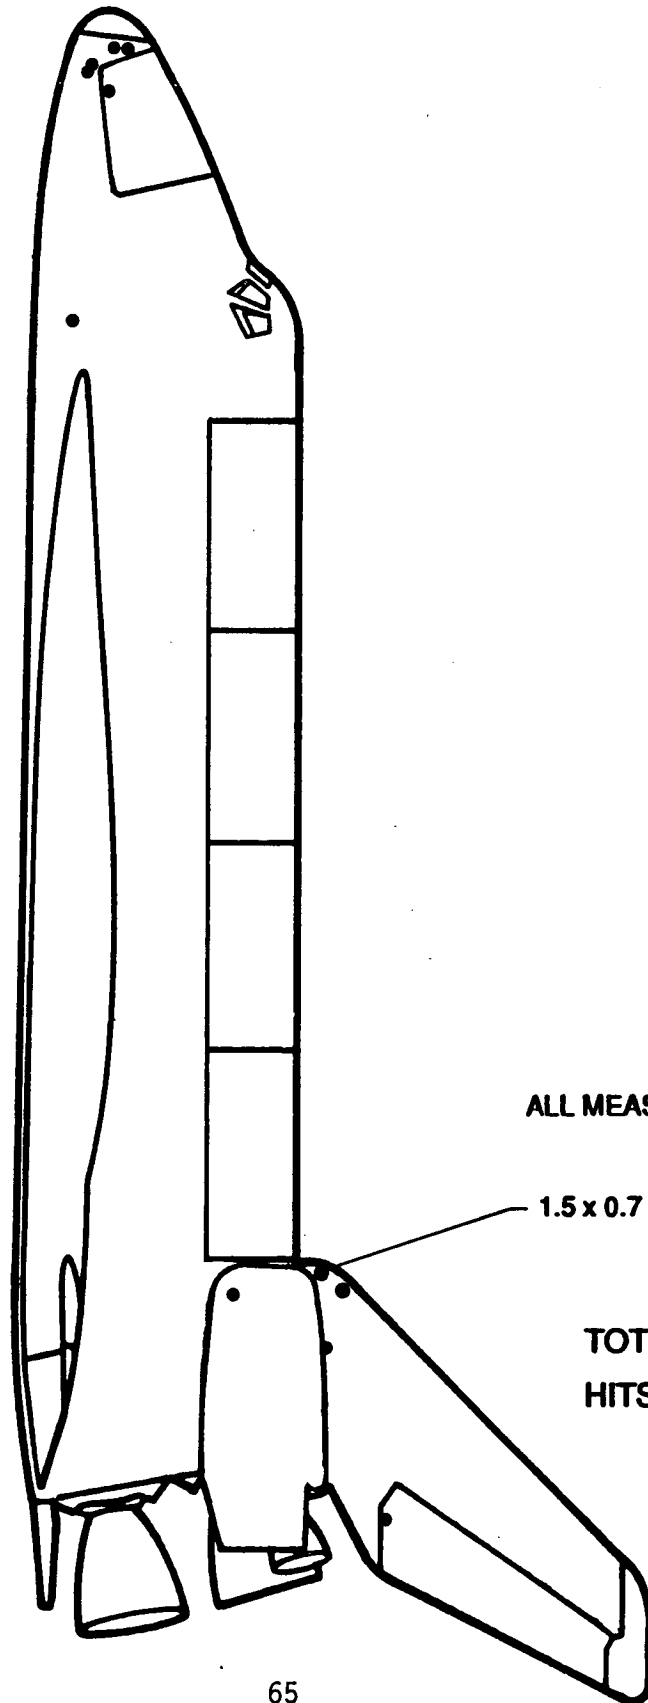
Figure 11. **DEBRIS DAMAGE LOCATIONS**

1.5 x 0.7 x 0.1

The tiles on the left OMS pod leading edge sustained more damage than usual. Access to this area was not available at Dryden, therefore the number of impact sites and dimensions shown in Figure 11 are approximate. The cause of this damage is still undetermined.

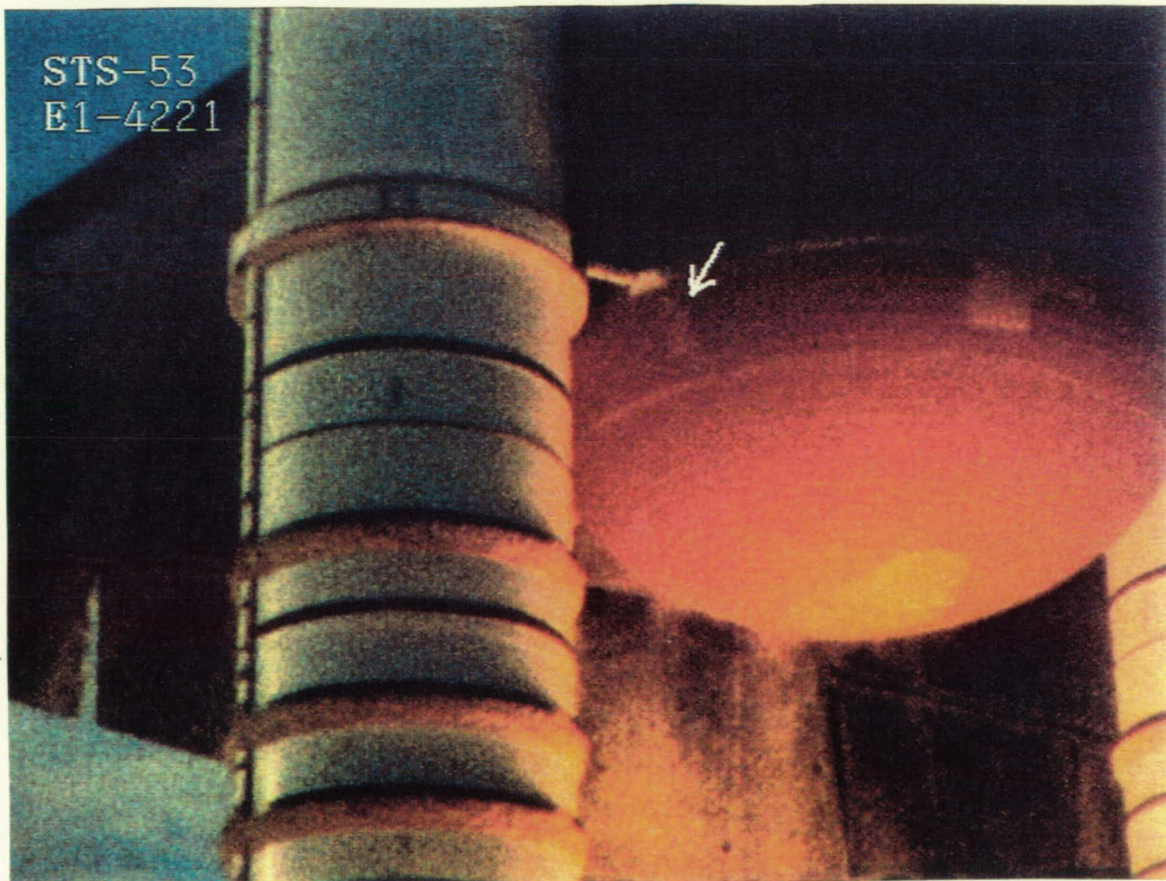
White debris, probably ice, originated from the north side of the ET/RSRB and the ET/LSRB aft attach struts and fell aft prior to and during liftoff. No further photographic analysis has been requested.

Figure 2.1.1.3 White Debris from the North Side of the ET SRB Aft Attach Struts

Figure 2.1.1.3 shows the white debris falling from the north side of the RSRB/ET aft attach strut. The debris falls aft and south between the SRBs but did not appear to strike the SLV.

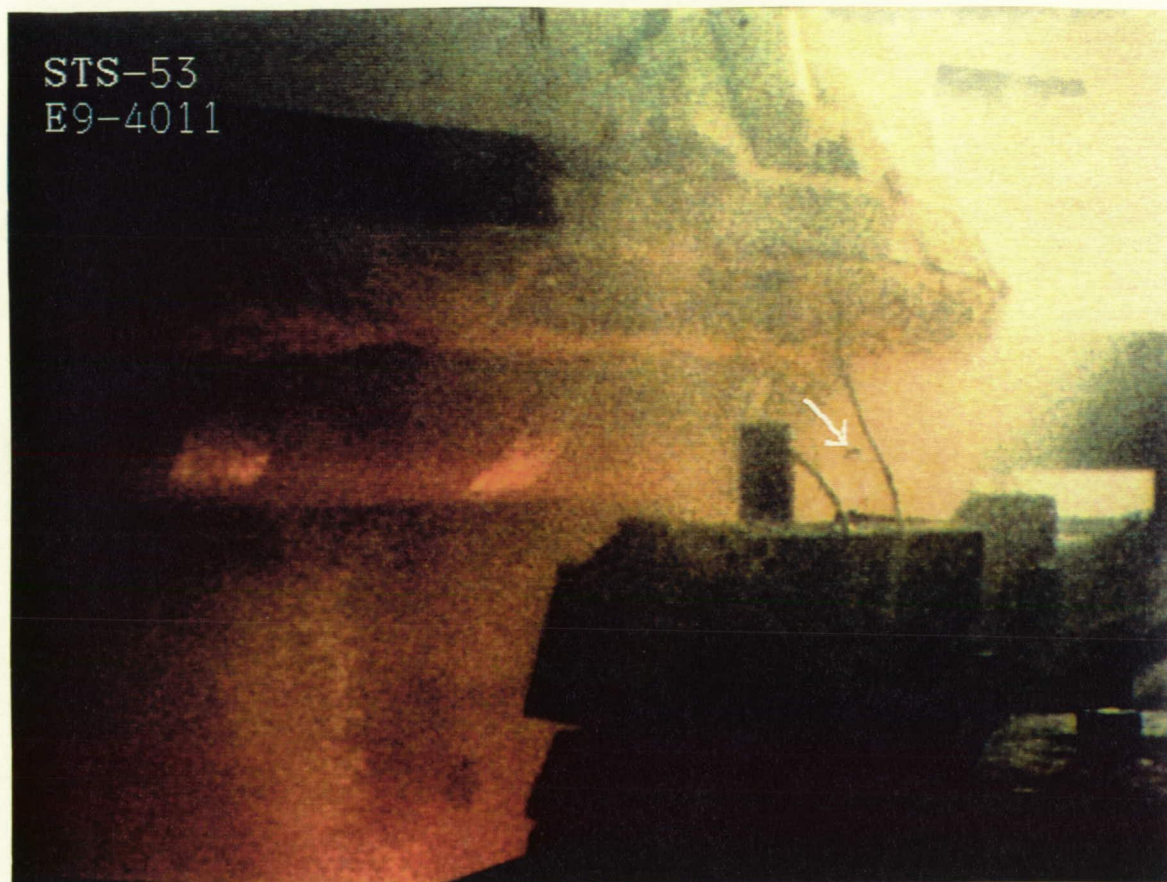
A single dark, curved piece of debris was seen at the time of the bolt release at HDP #M-1 (camera E-9). This piece of debris fell on to the holddown post shoe and then into the RSRB flame duct. No further photographic analysis has been requested.

Figure 2.1.2.1 Debris First Seen Near the Holddown Post Area

Figure 2.1.2.1 shows a piece of debris falling from the HDP #M-1 area. This debris seen between the pyrotechnic initiation controller (PIC) wires was first seen as the bolt released from the DCS hole.

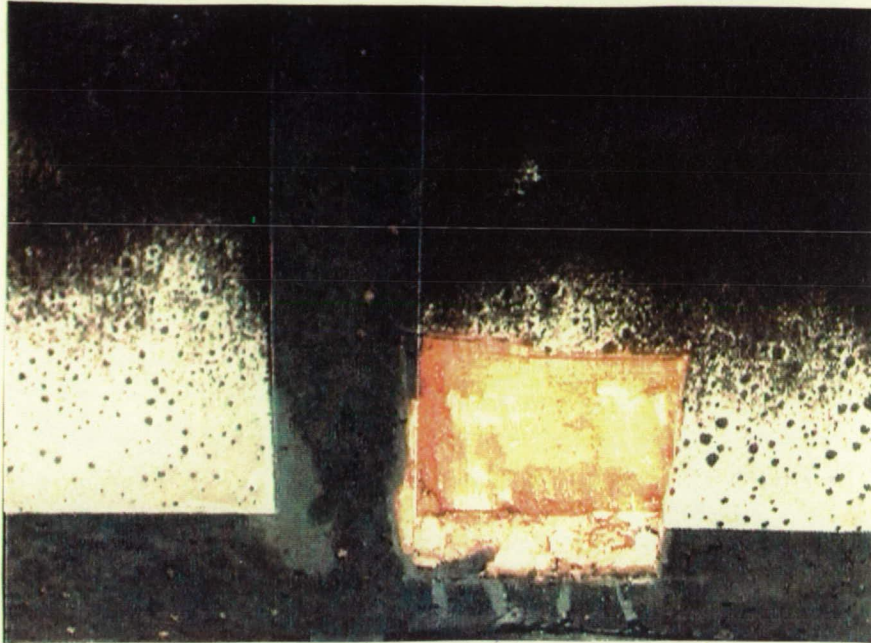
Figure 2.1.4b RSRB Aft BSM Triple Motor Housing without Protective Insulation

Figure 2.1.4b is aligned in the same manner as Figure 2.1.4a with the aft end of the RSRB toward the bottom of the frame. The protective insulation had been removed and sent to two independent laboratories. The elliptical scar is not visible in this view.

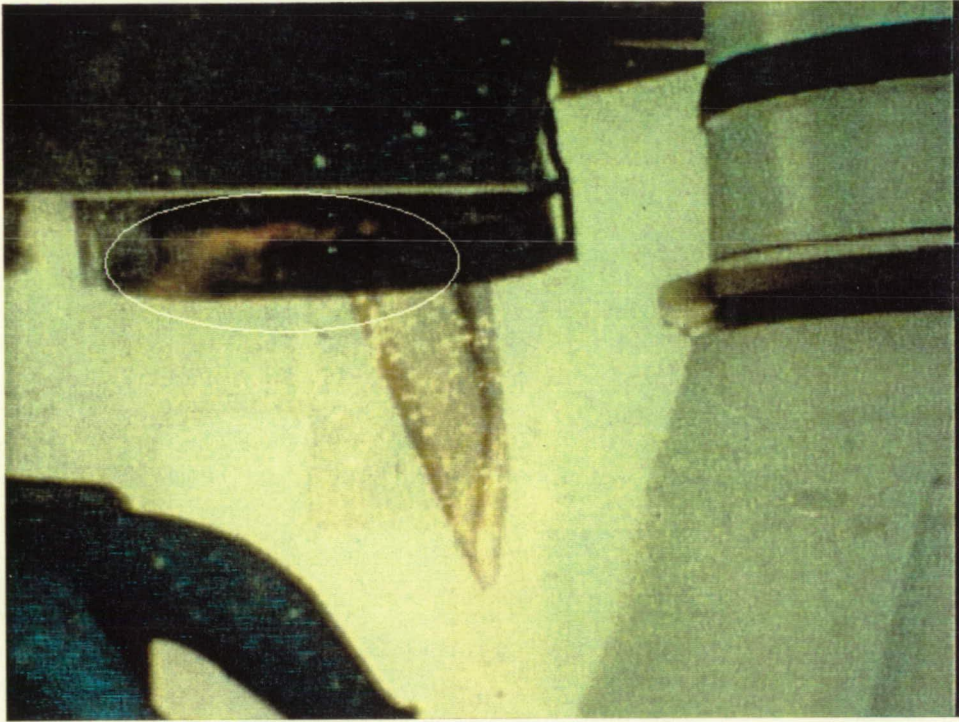
Figure 2
Holddown Post M-1 Stud Hang Up

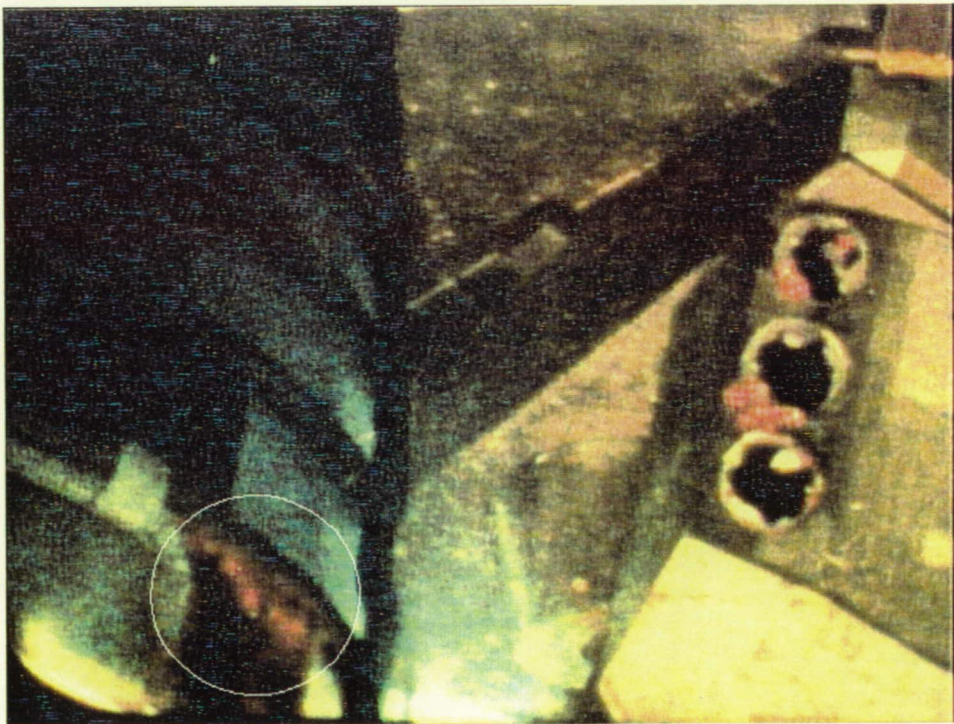
Figure 3

Flame Noted on SSME #2, Camera E-16
