Debris/Ice/TPS Assessment and Integrated Photographic Analysis for Shuttle Mission STS-55

(NASA-TM-107559) DEBRIS/ICE/TPS
ASSESSMENT AND INTEGRATED
PHOTOGRAPHIC ANALYSIS FOR SHUTTLE
MISSION STS-55 Final Report, 22
Mar. - 7 May 1993 (NASA) 136 p

Gregory N. Katnik
NASA/Kennedy Space Center

DEBRIS/ICE/TPS ASSESSMENT
AND
PHOTOGRAPHIC ANALYSIS
OF
SHUTTLE MISSION STS-55

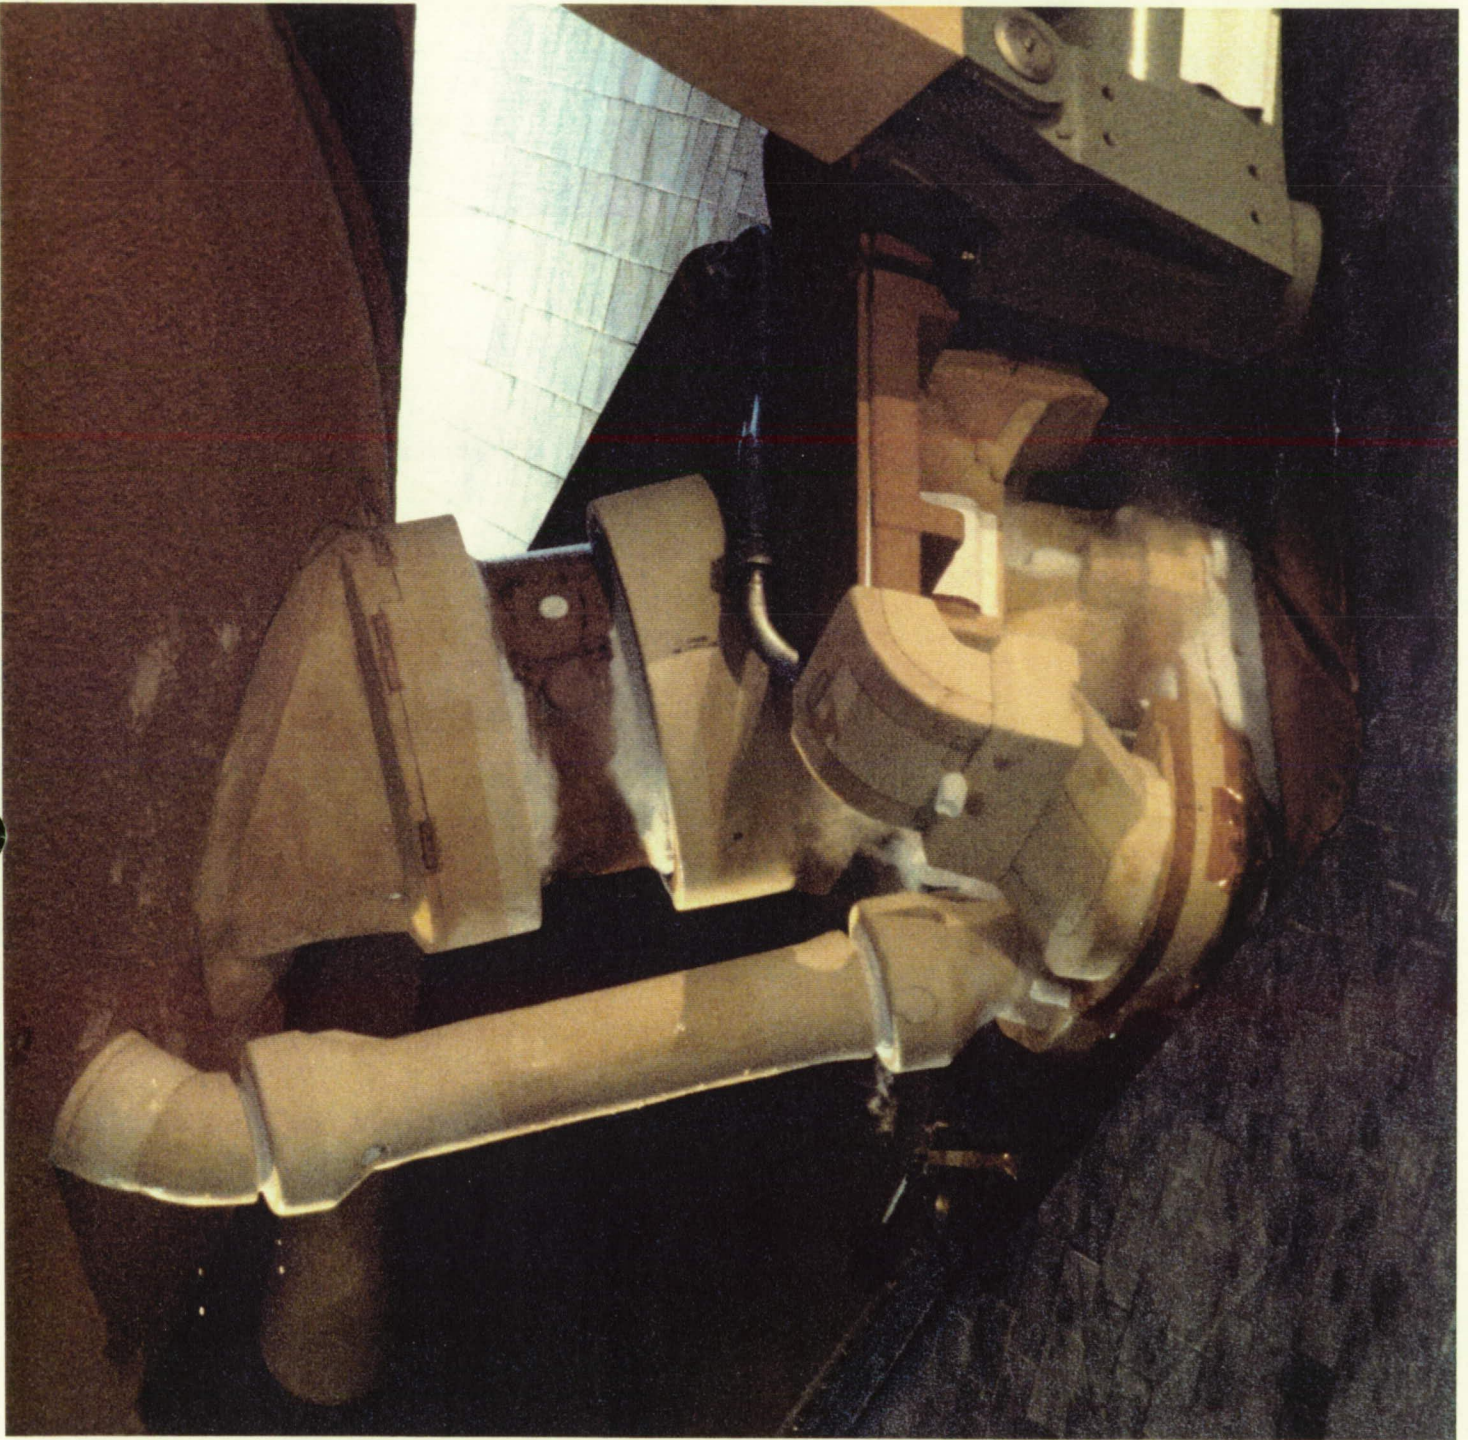
A coating of black paint was missing from three tiles
on the right wing leading edge extension

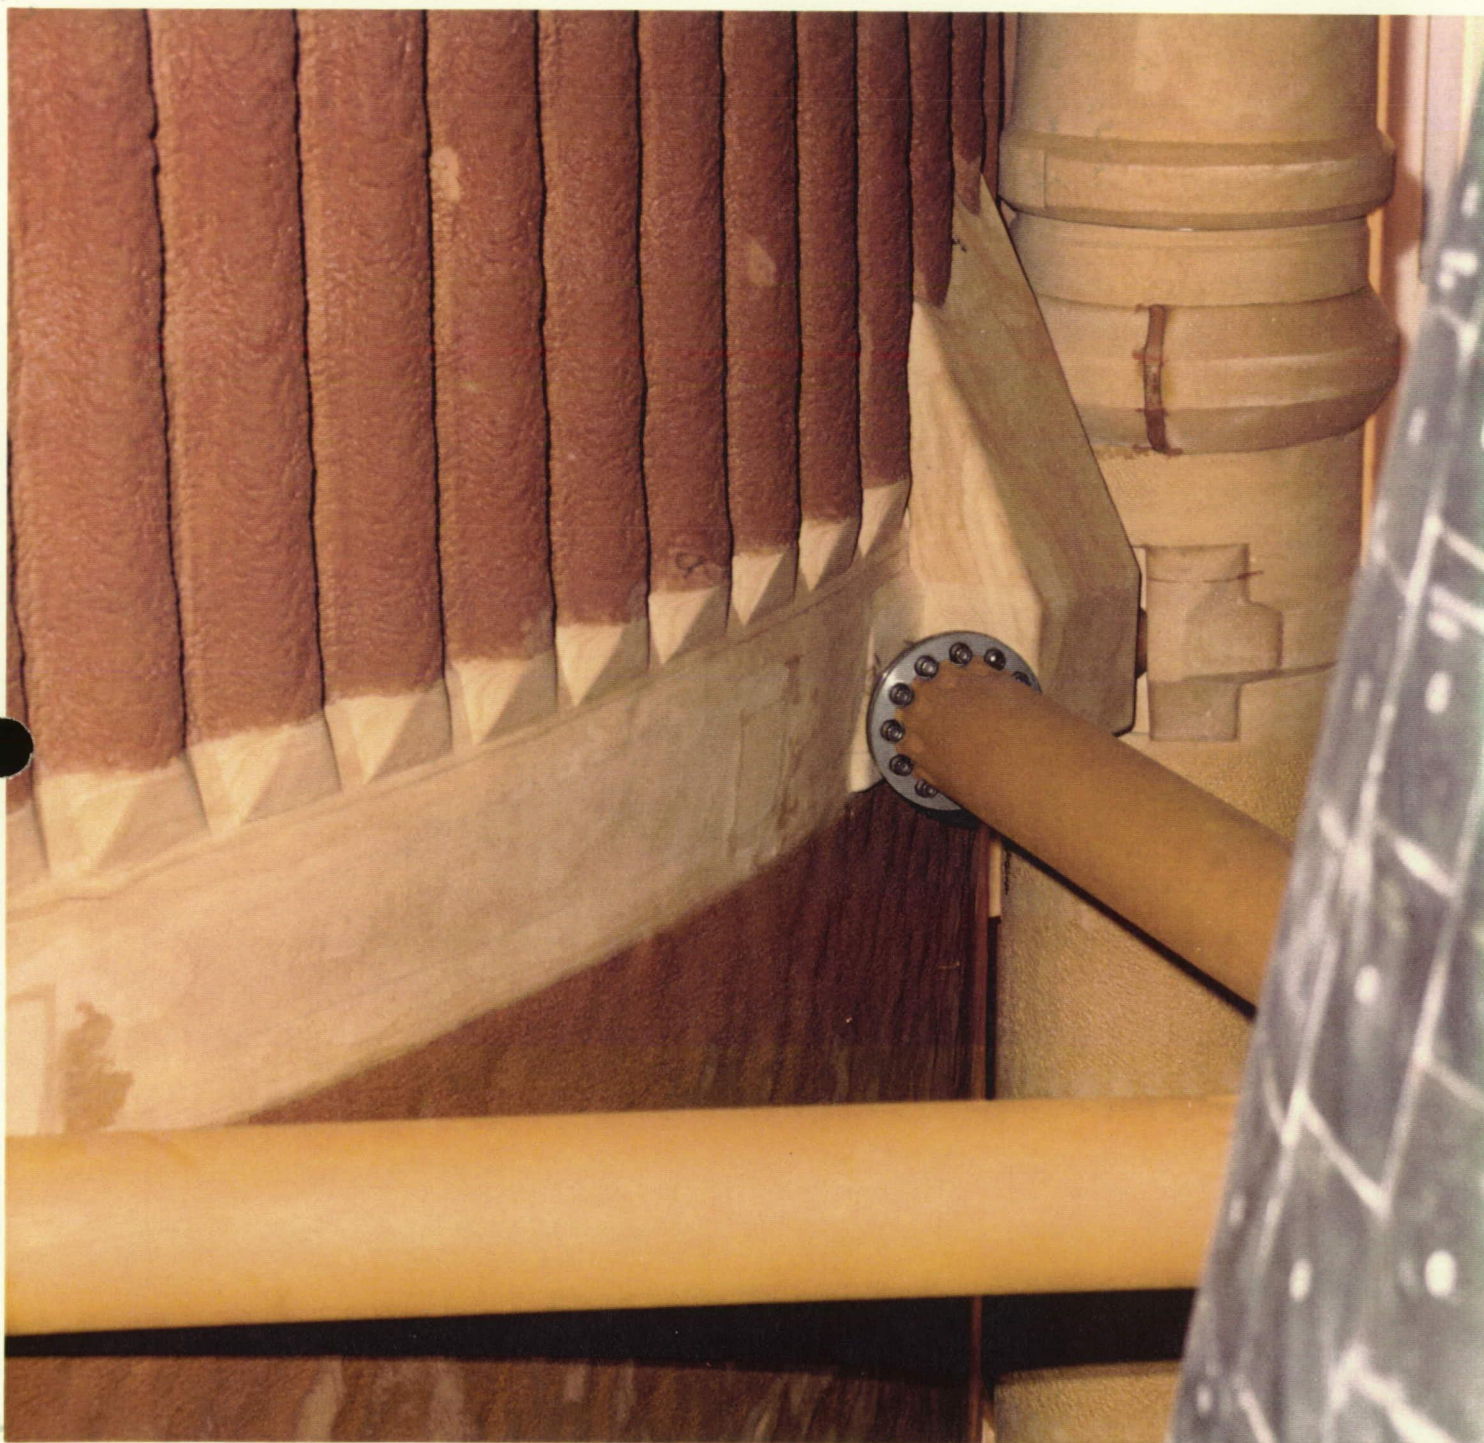
Pre-launch configuration of the bipod jack pad closeouts
after one cryogenic loading

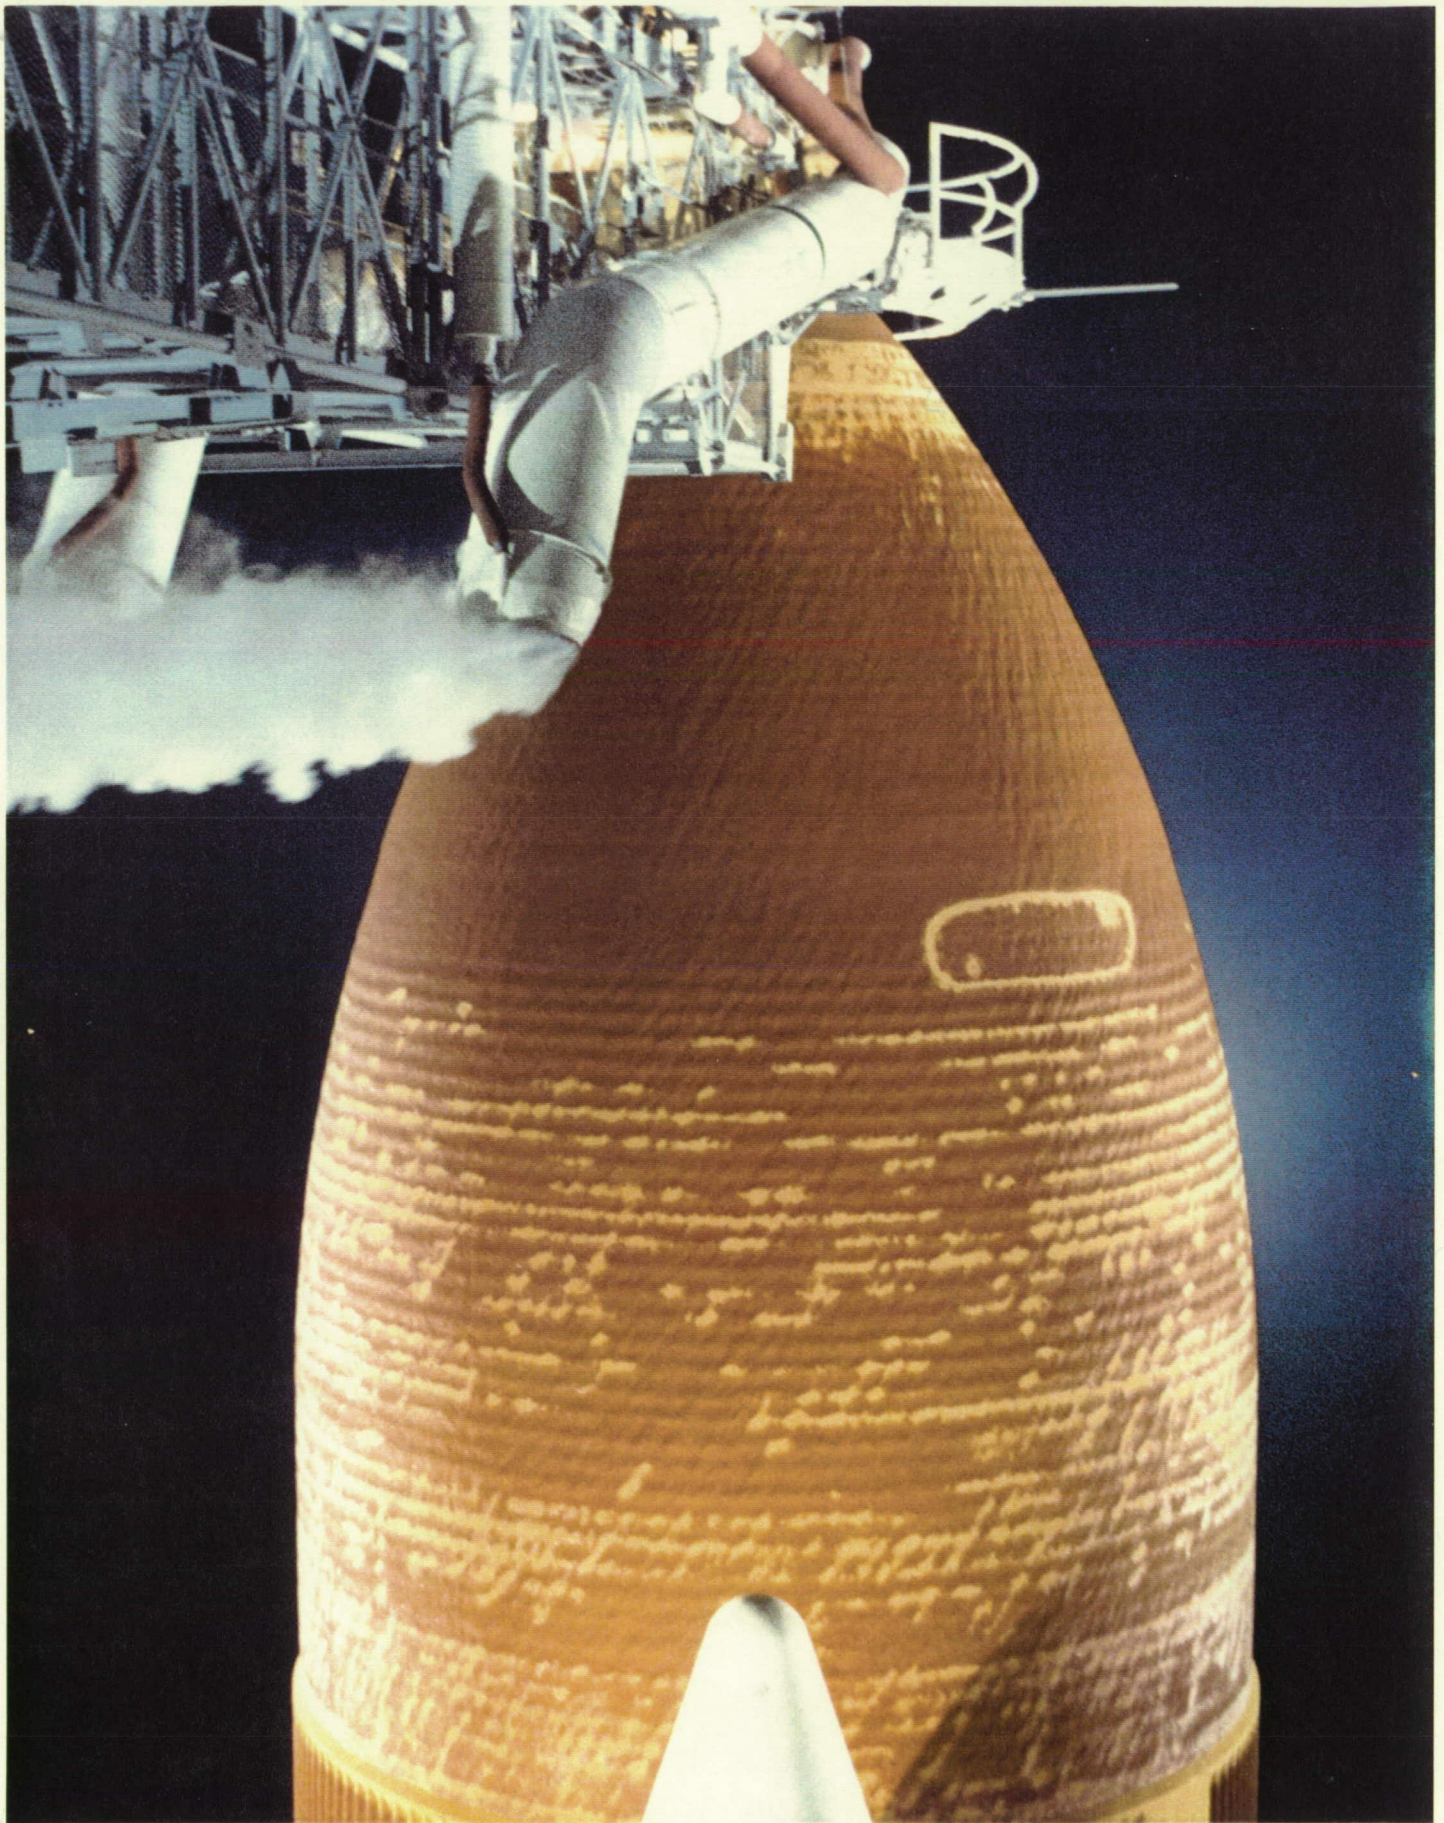
There was no condensate or ice/frost accumulations on the L02 tank ogive. Light condensate was present on the barrel section. There were no problems with the oval TPS repair.

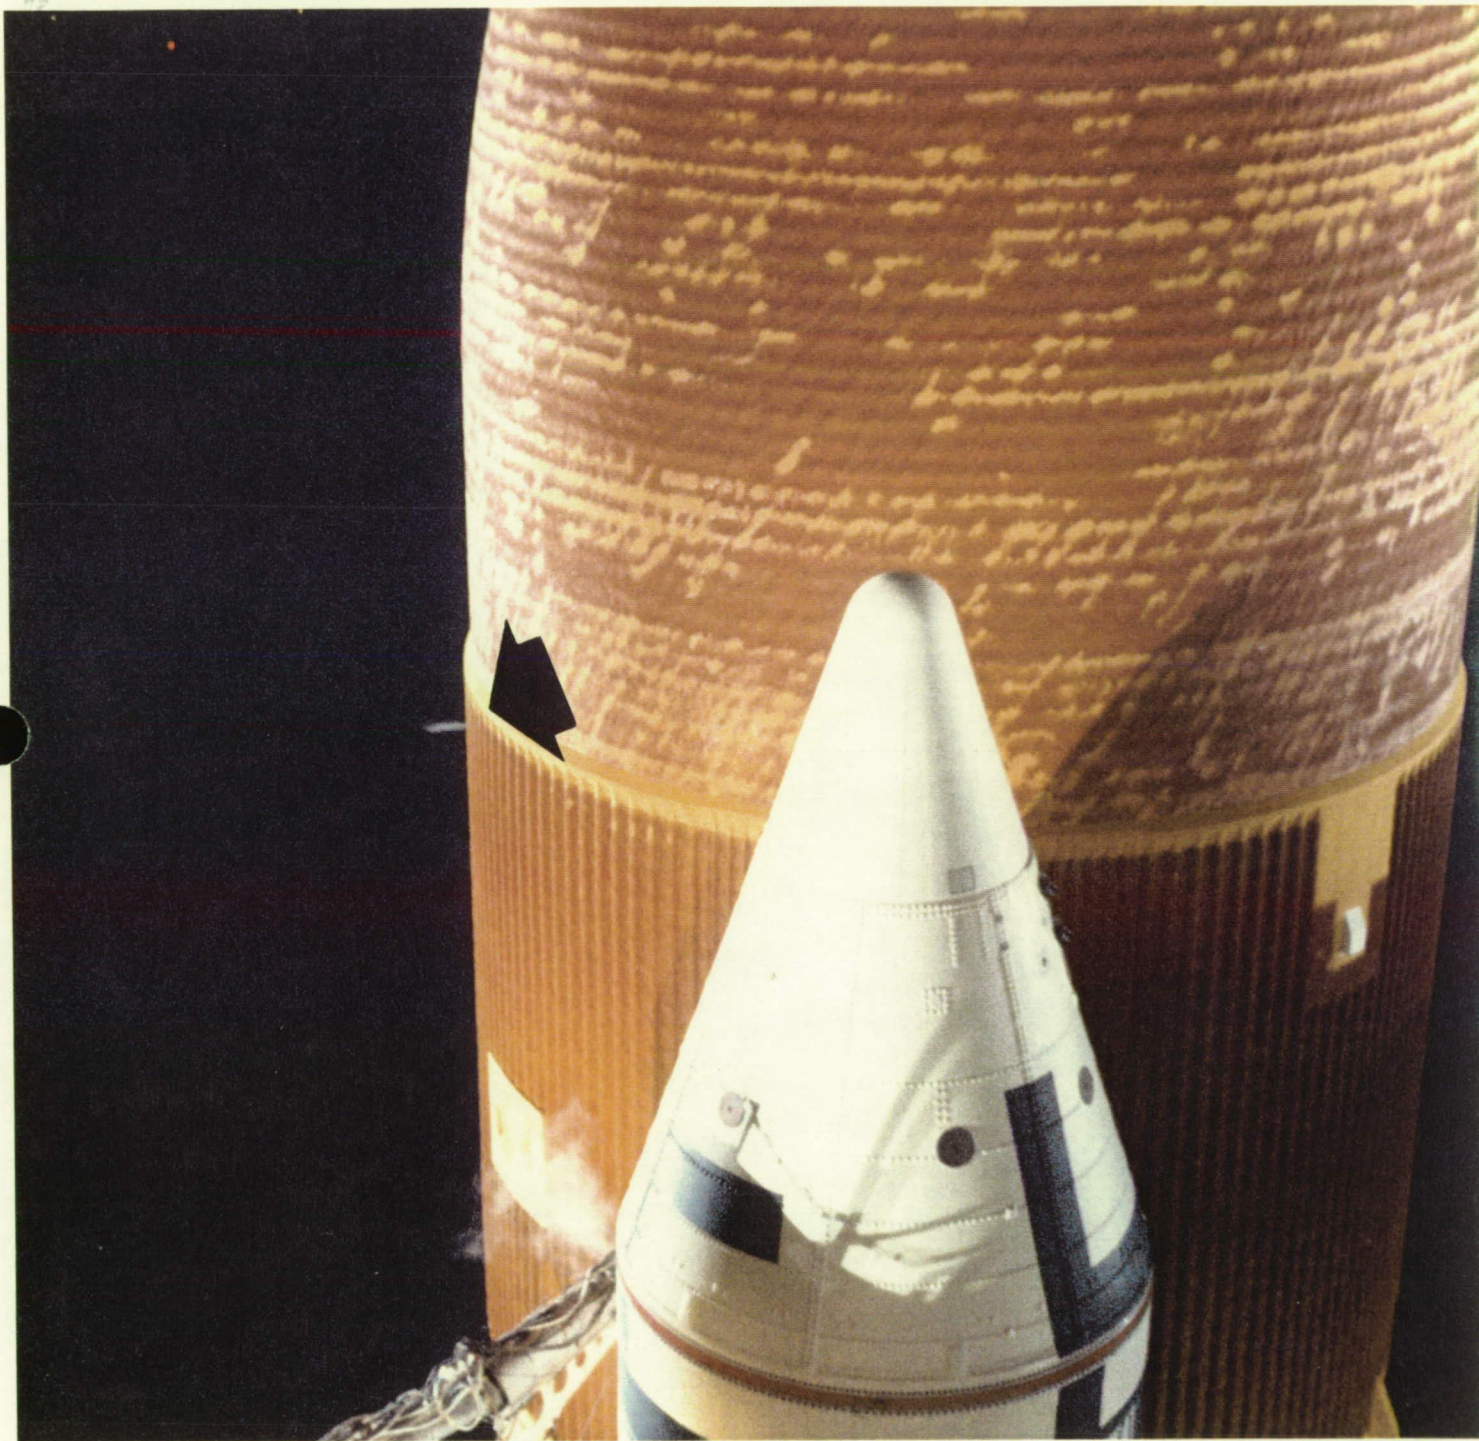
Cold purge gas vapor was visible venting from the intertank

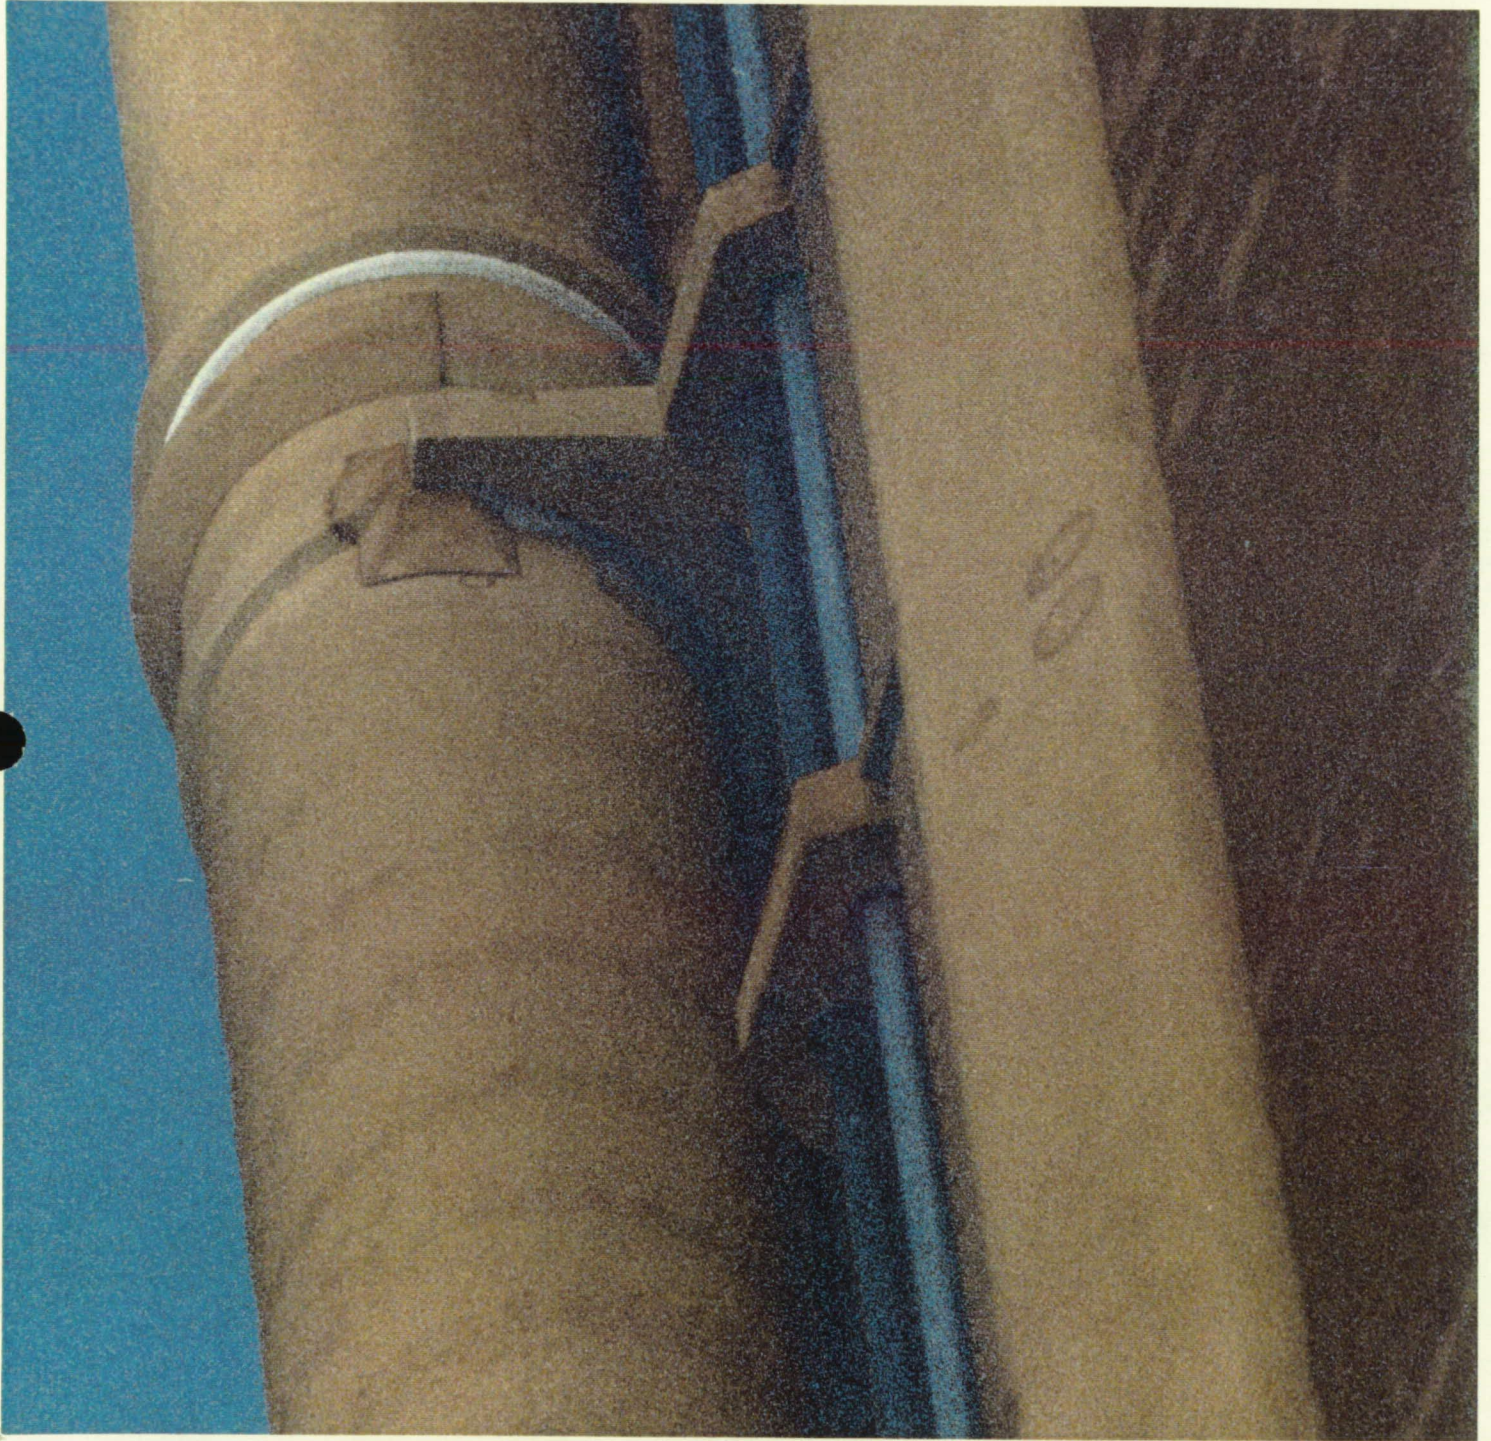
Typical amounts of ice and frost had formed in the
L02 feedline bellows and support brackets.

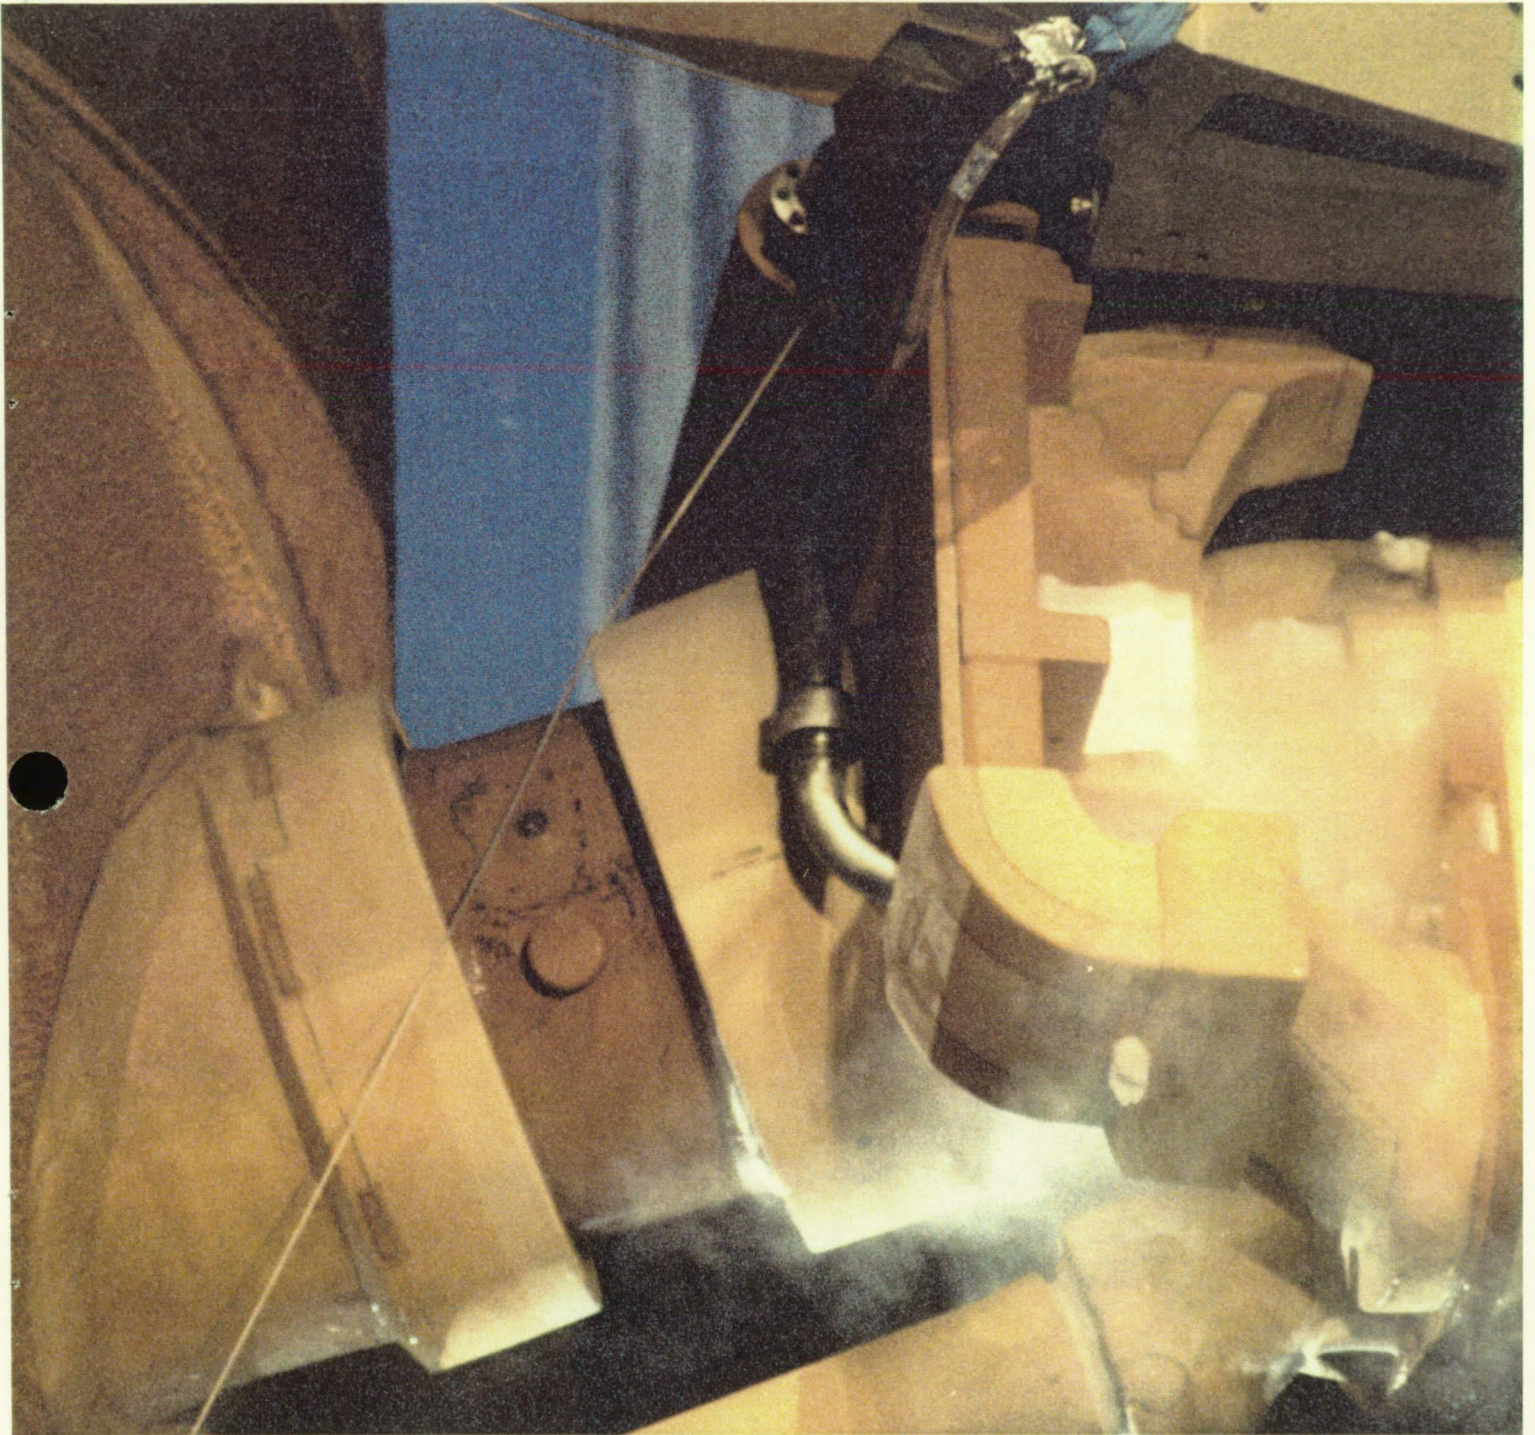
A small crack in the TPS with associated ice/frost formation was present at both +Y and -Y vertical strut-to-tank interface aft edges.

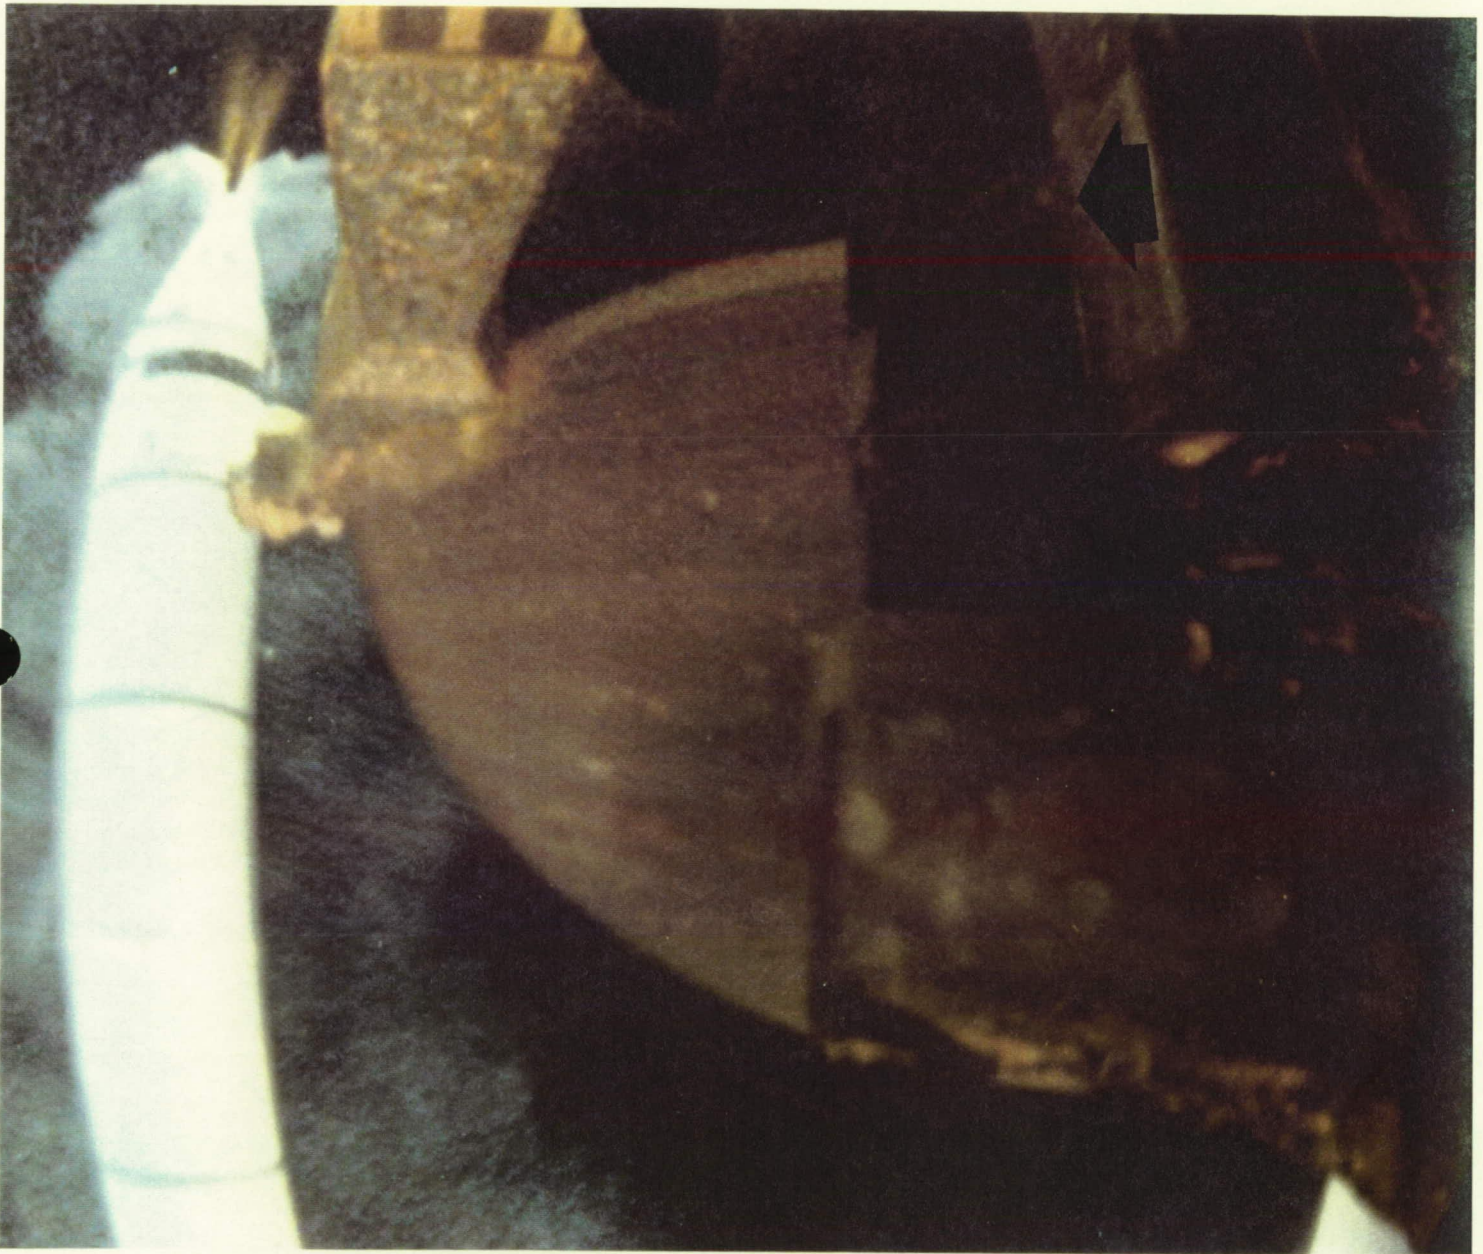
SRB separation from the ET was nominal. Tailoff of the Booster Separation Motors in the LH frustum is still visible. Erosion and charring of TPS on the aft surfaces of the LH2 umbilical support structure and cable tray was typical. Note intact piece of hydrogen fire detection paper still attached by one side of the adhesive (arrow).

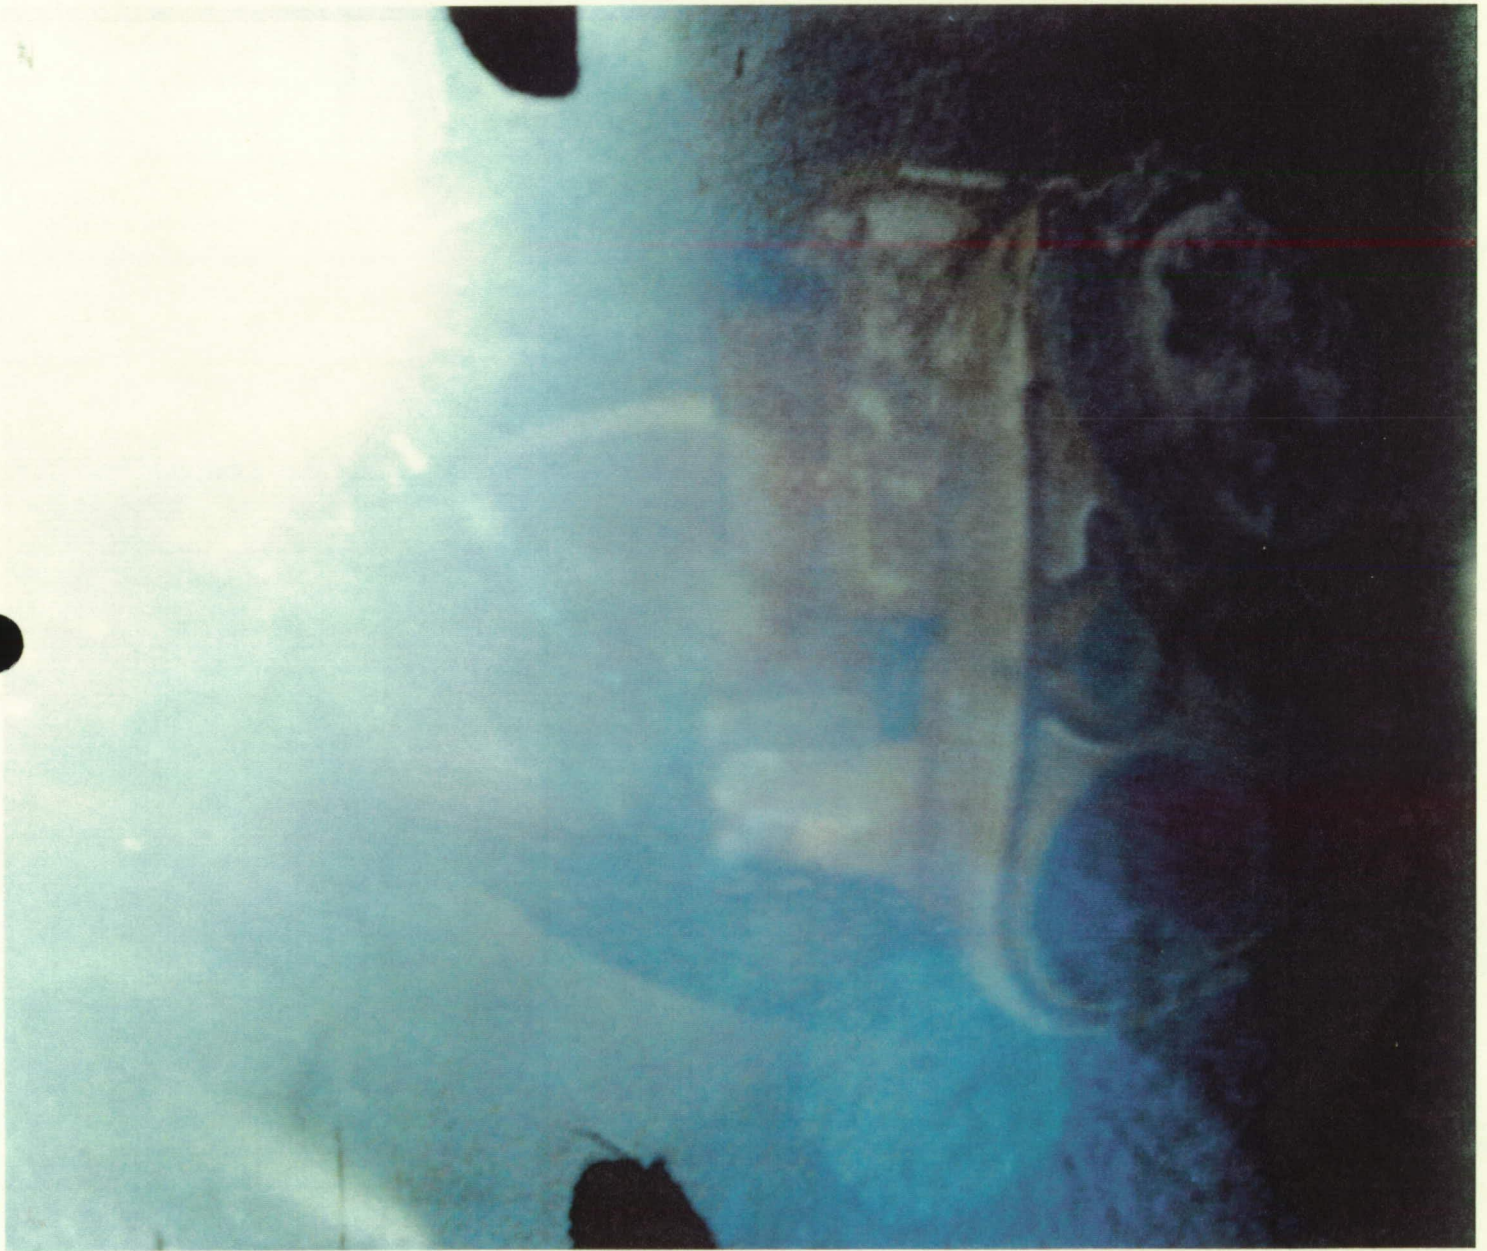
Frozen hydrogen, but no TPS or structural damage, was visible on the LH2 ET/ORB umbilical interface. There appeared to be no anomalies or venting of gaseous hydrogen from the recirculation line 4-inch valve (ET side).

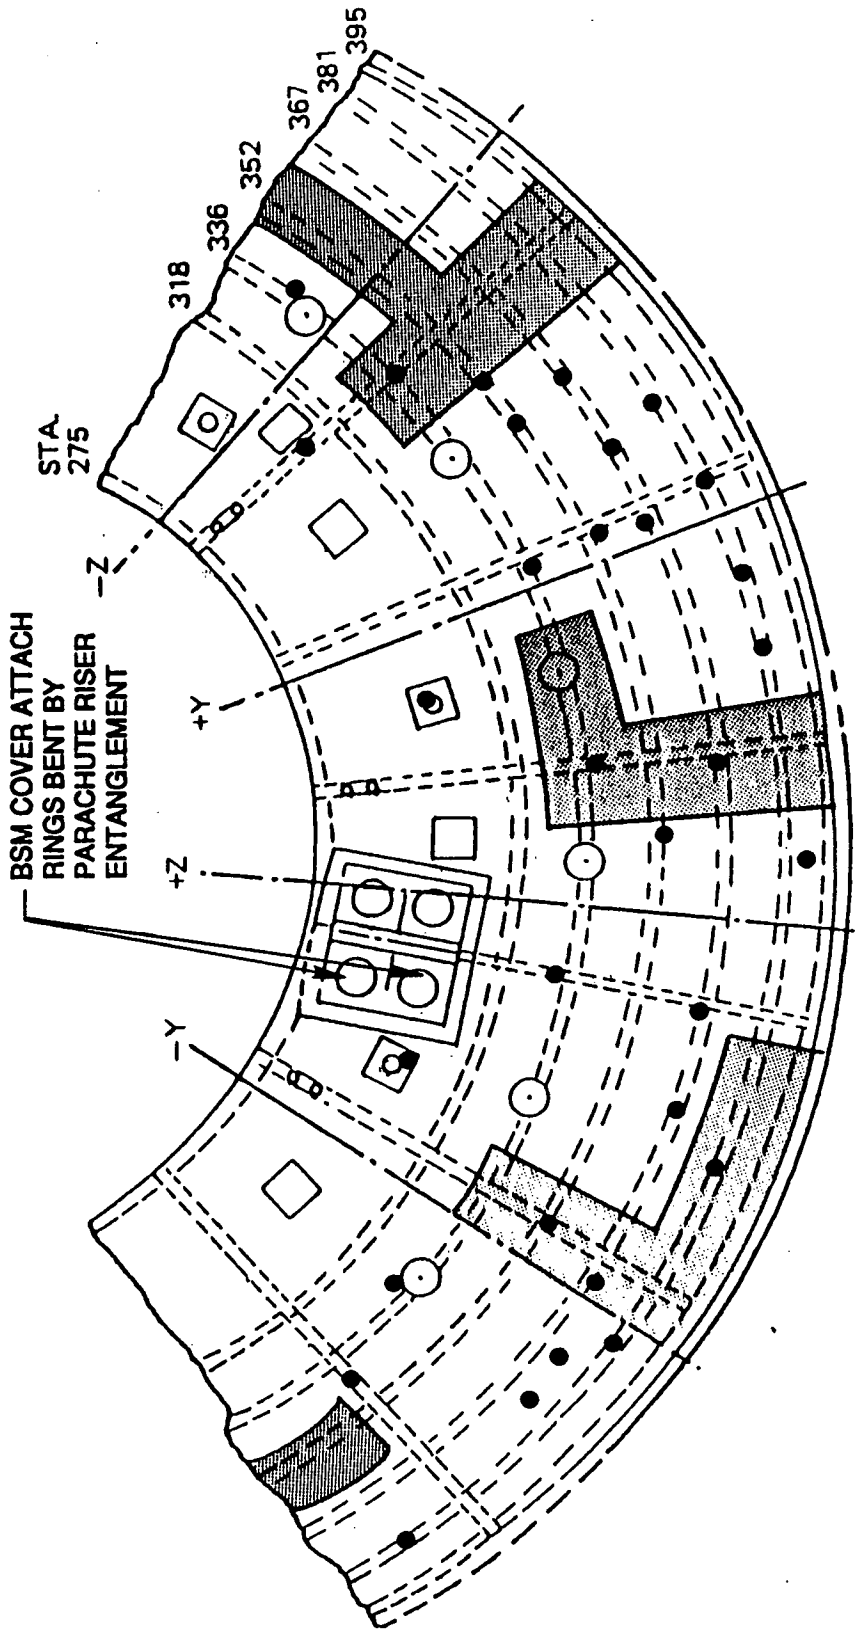
FIGURE 7. RIGHT SRB FRUSTUM

The RH frustum was missing no TPS, but had 32 MSA-2 debonds over fasteners. Minor localized blistering of the Hypalon paint had occurred along the 395 ring (Figure 7). All BSM aero heatshield covers were locked in the fully opened position, though the two left cover attach rings had been bent by parachute riser entanglement.

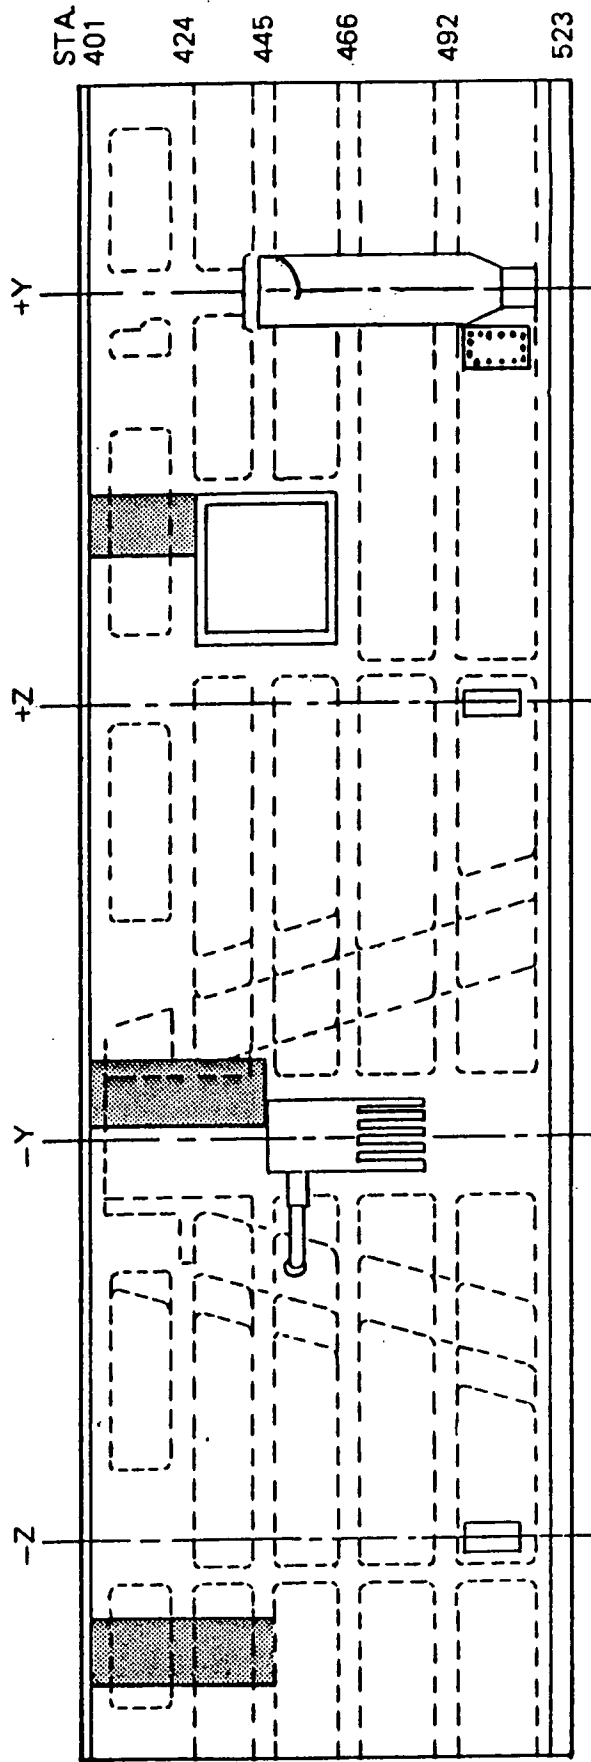
FIGURE 8. RIGHT SRB FWD SKIRT

The RH forward skirt acreage exhibited no debonds or missing TPS. Both RSS antennae covers/phenolic base plates were intact. Minor blistering of the Hypalon paint occurred on the systems tunnel cover and around the ET/SRB attach point (Figure 8). No pins were missing from the frustum severance ring. The forward separation bolt appeared to have separated cleanly.

TYPICAL BLISTERING OF
HYPALON PAINT ON THE
SYSTEMS TUNNEL COVER
AND AROUND ET/SRB
ATTACH FITTING

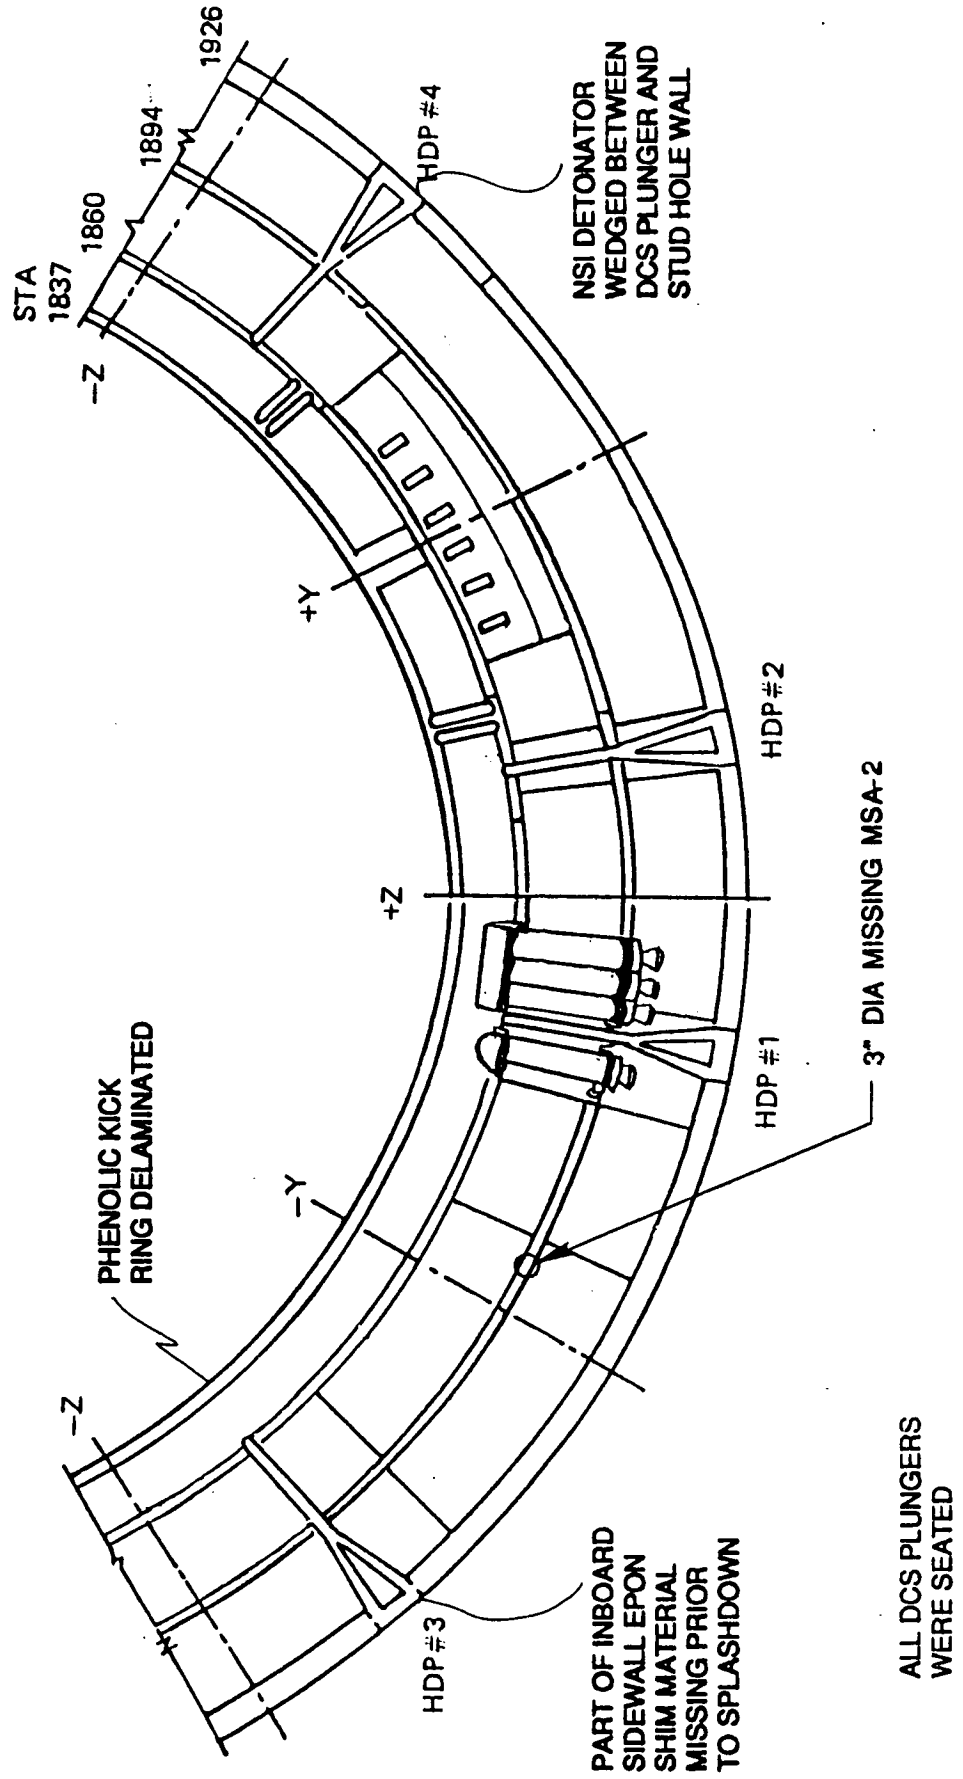
FIGURE 9. RIGHT SRB AFT SKIRT EXTERIOR TPS

The phenolic material on the kick ring was delaminated. The K5NA closeouts (protective domes) on the kick ring forward and aft fasteners are no longer used. RTV-133 has replaced the K5NA over the forward fasteners. The aft skirt acreage TPS was generally in good condition but was missing a 3-inch diameter piece of MSA-2 on ring frame 1894 fasteners near the -Y axis (Figure 9).
