Debris/Ice/TPS Assessment and Integrated Photographic Analysis for Shuttle Mission STS-55

(NASA-TM-107559) DEBRIS/ICE/TPS
ASSESSMENT AND INTEGRATED
PHOTOGRAPHIC ANALYSIS FOR SHUTTLE
MISSION STS-55 Final Report, 22
Mar. - 7 May 1993 (NASA) 136 p

Gregory N. Katnik
NASA/Kennedy Space Center

DEBRIS/ICE/TPS ASSESSMENT
AND
PHOTOGRAPHIC ANALYSIS
OF
SHUTTLE MISSION STS-55

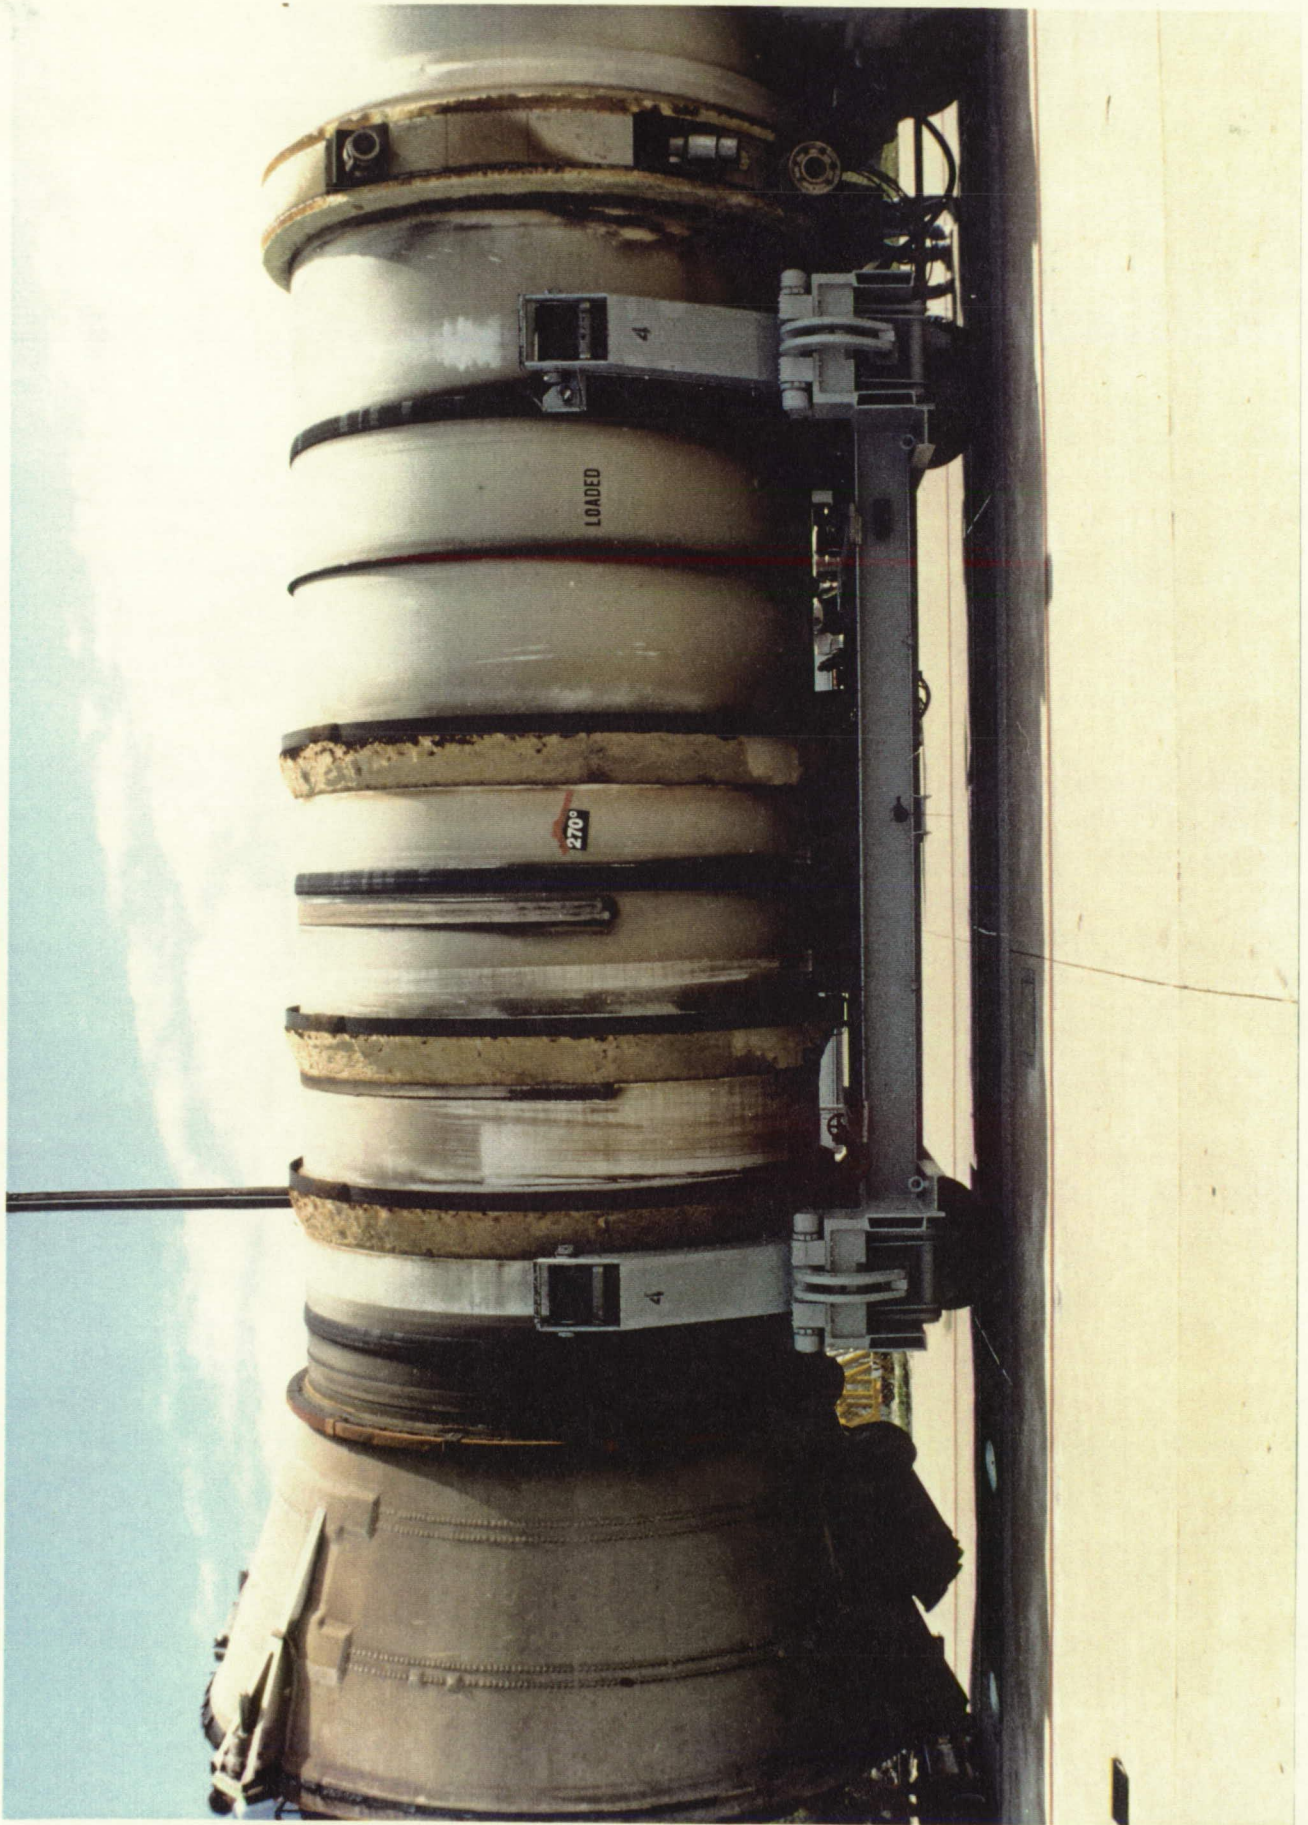
The RH forward skirt acreege MSA-2 exhibited no debonds or missing TPS. Both RSS antenna covers/phenolic base plates were intact.

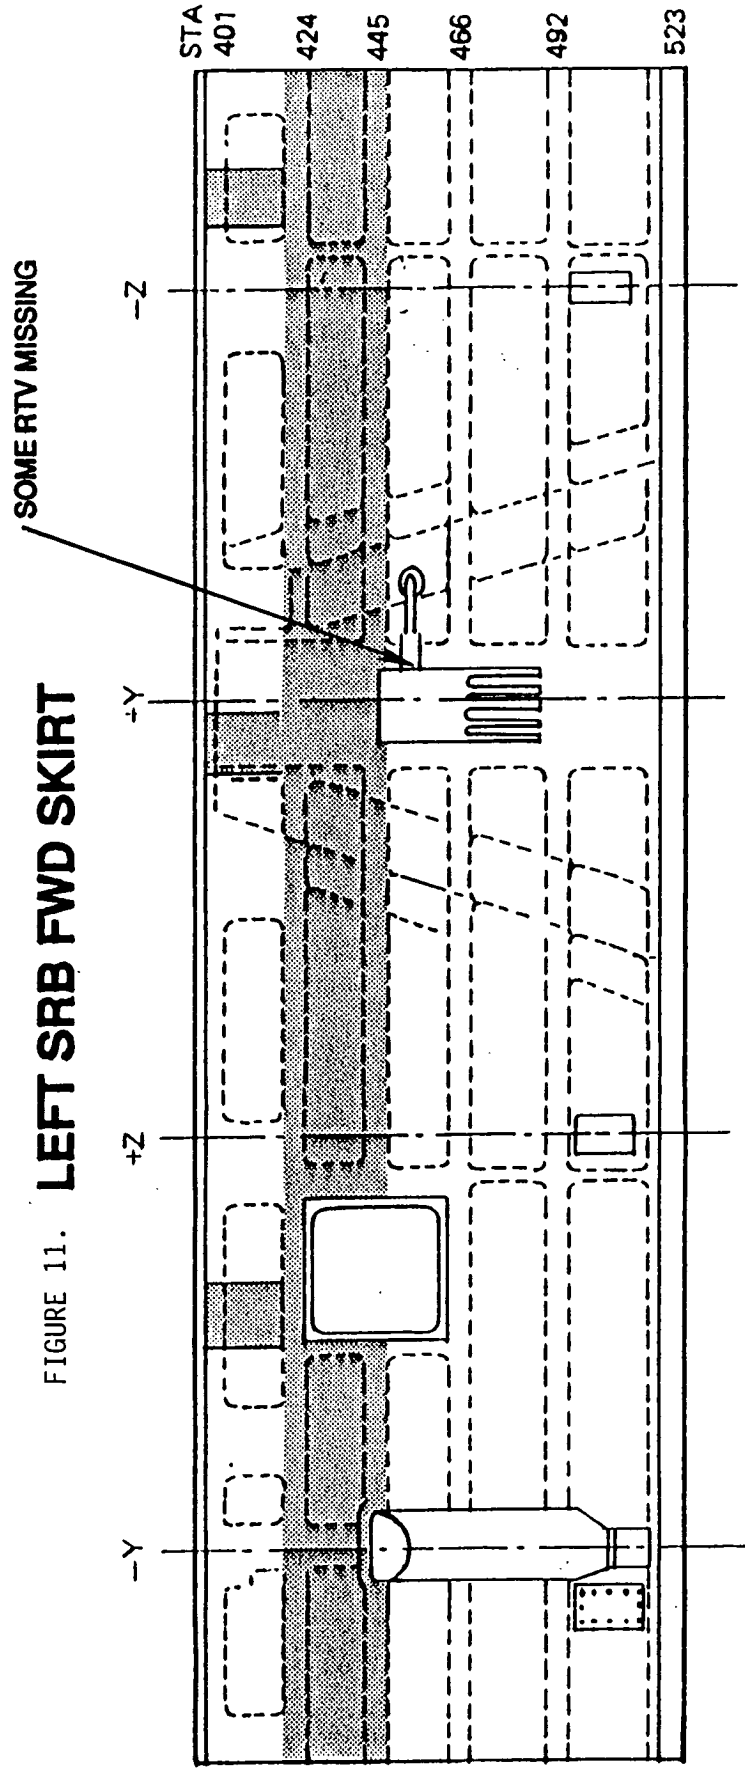
FIGURE 11. **LEFT SRB FWD SKIRT**

The LH forward skirt acreage exhibited no debonds or missing TPS. Both RSS antennae covers/phenolic base plates were intact. Minor blistering of the Hypalon paint occurred near the ET/SRB attach point and on the systems tunnel cover (Figure 11). No pins were missing from the frustum severance ring. The forward separation bolt appeared to have separated cleanly.

TYPICAL BLISTERING OF
HYALON PAINT ON
SYSTEMS TUNNEL COVER
AND AROUND ET/SRB ATTACH
FITTING

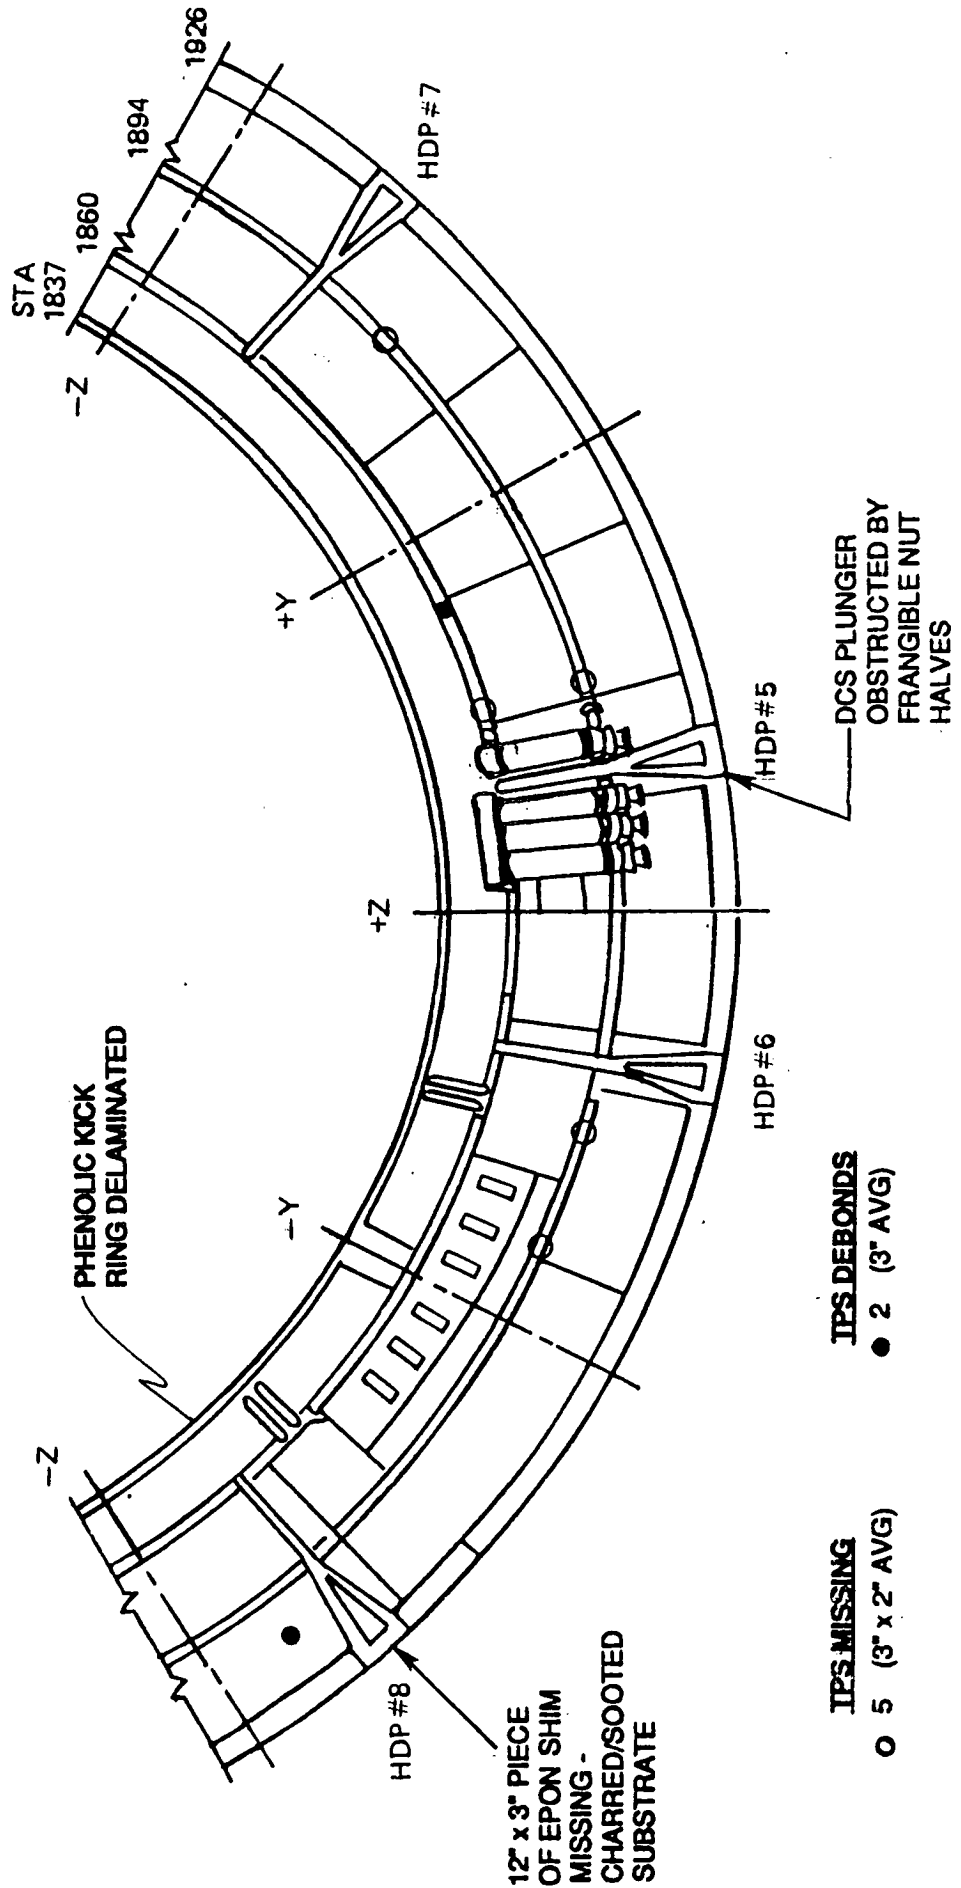
FIGURE 12. LEFT SRB AFT SKIRT EXTERIOR TPS

The phenolic material on the kick ring was delaminated. The K5NA closeouts (protective domes) on the kick ring forward and aft fasteners are no longer used. RTV-133 has replaced the K5NA over the forward fasteners. Five areas of MSA-2, the largest of which measured 3" x 2.5", were missing from the aft skirt acreage TPS. Two other 3 inch diameter areas of MSA-2 were debonded. Samples were removed for analysis (Figure 12).

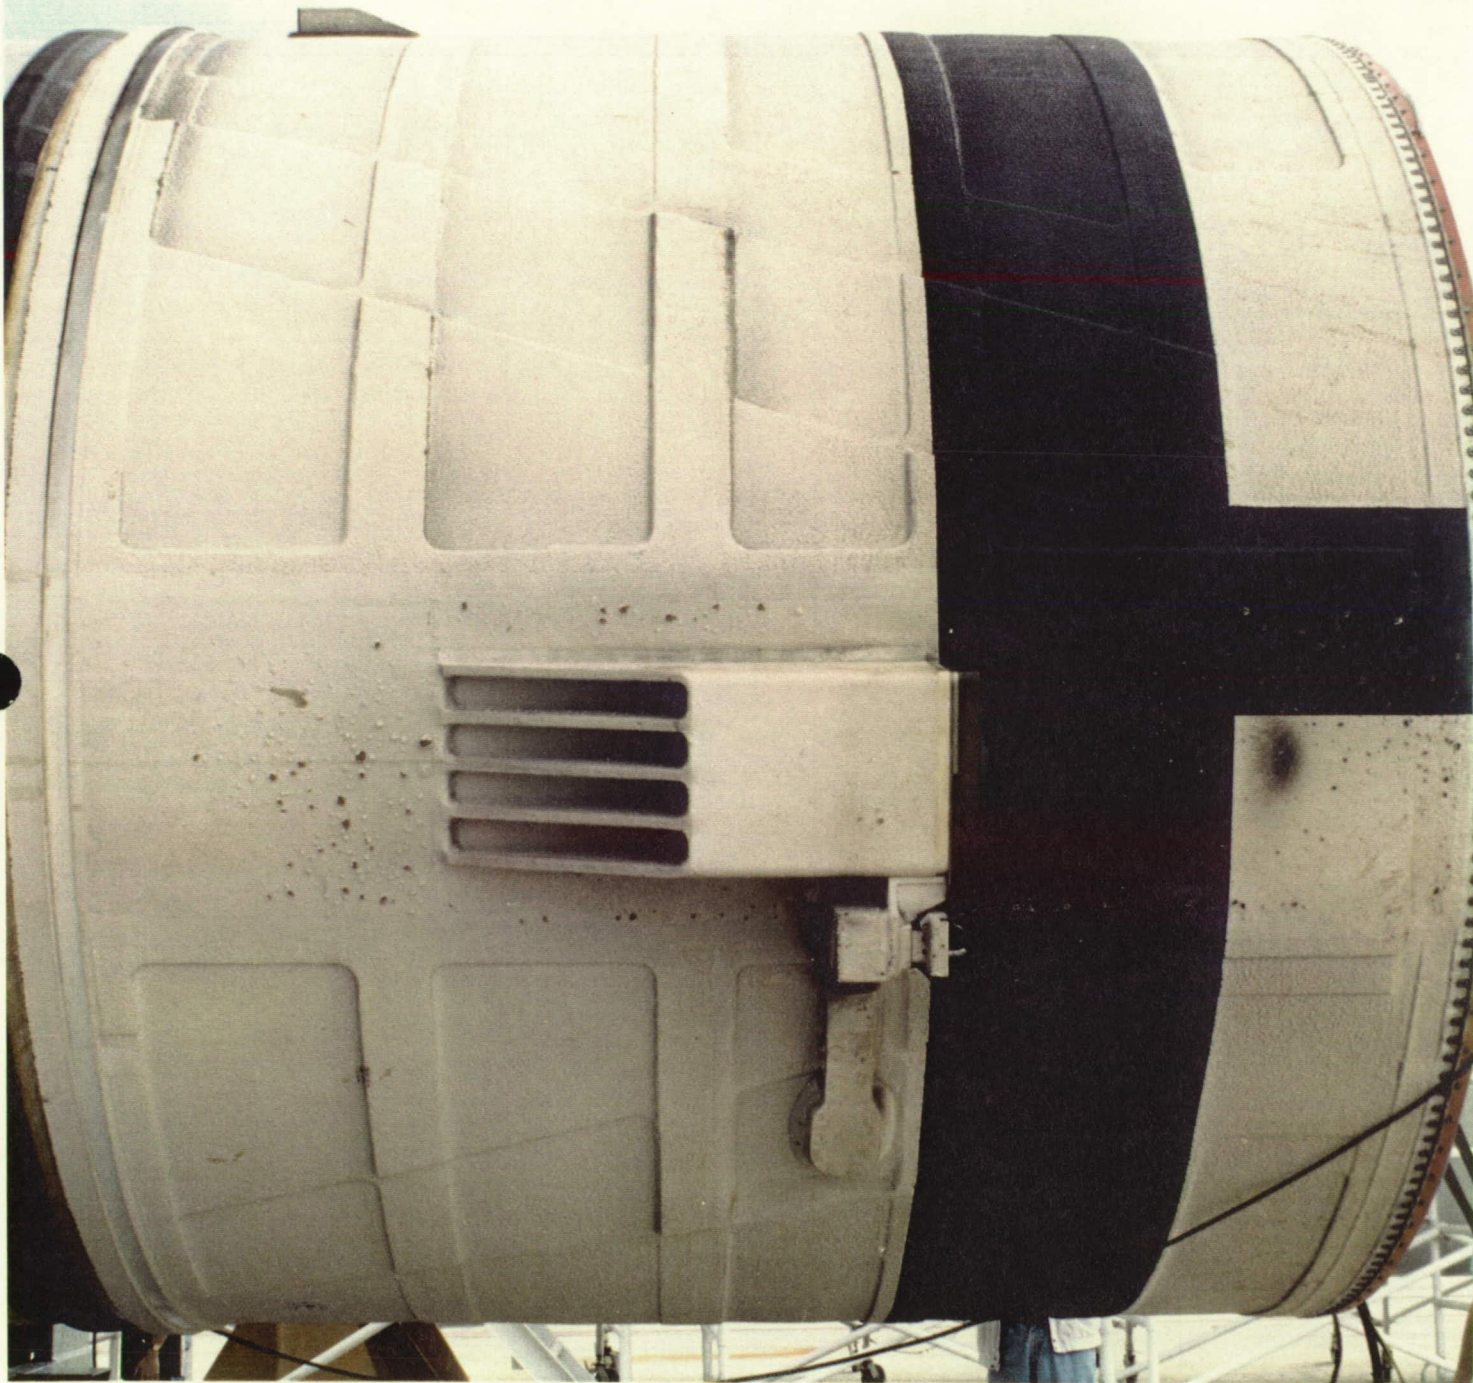
The LH frustum had a total of 21 MSA-2 debonds over fasteners. The BSM aero heat shield covers were locked in the fully opened position, though the two left cover attach rings had been bent by parachute riser entanglement.

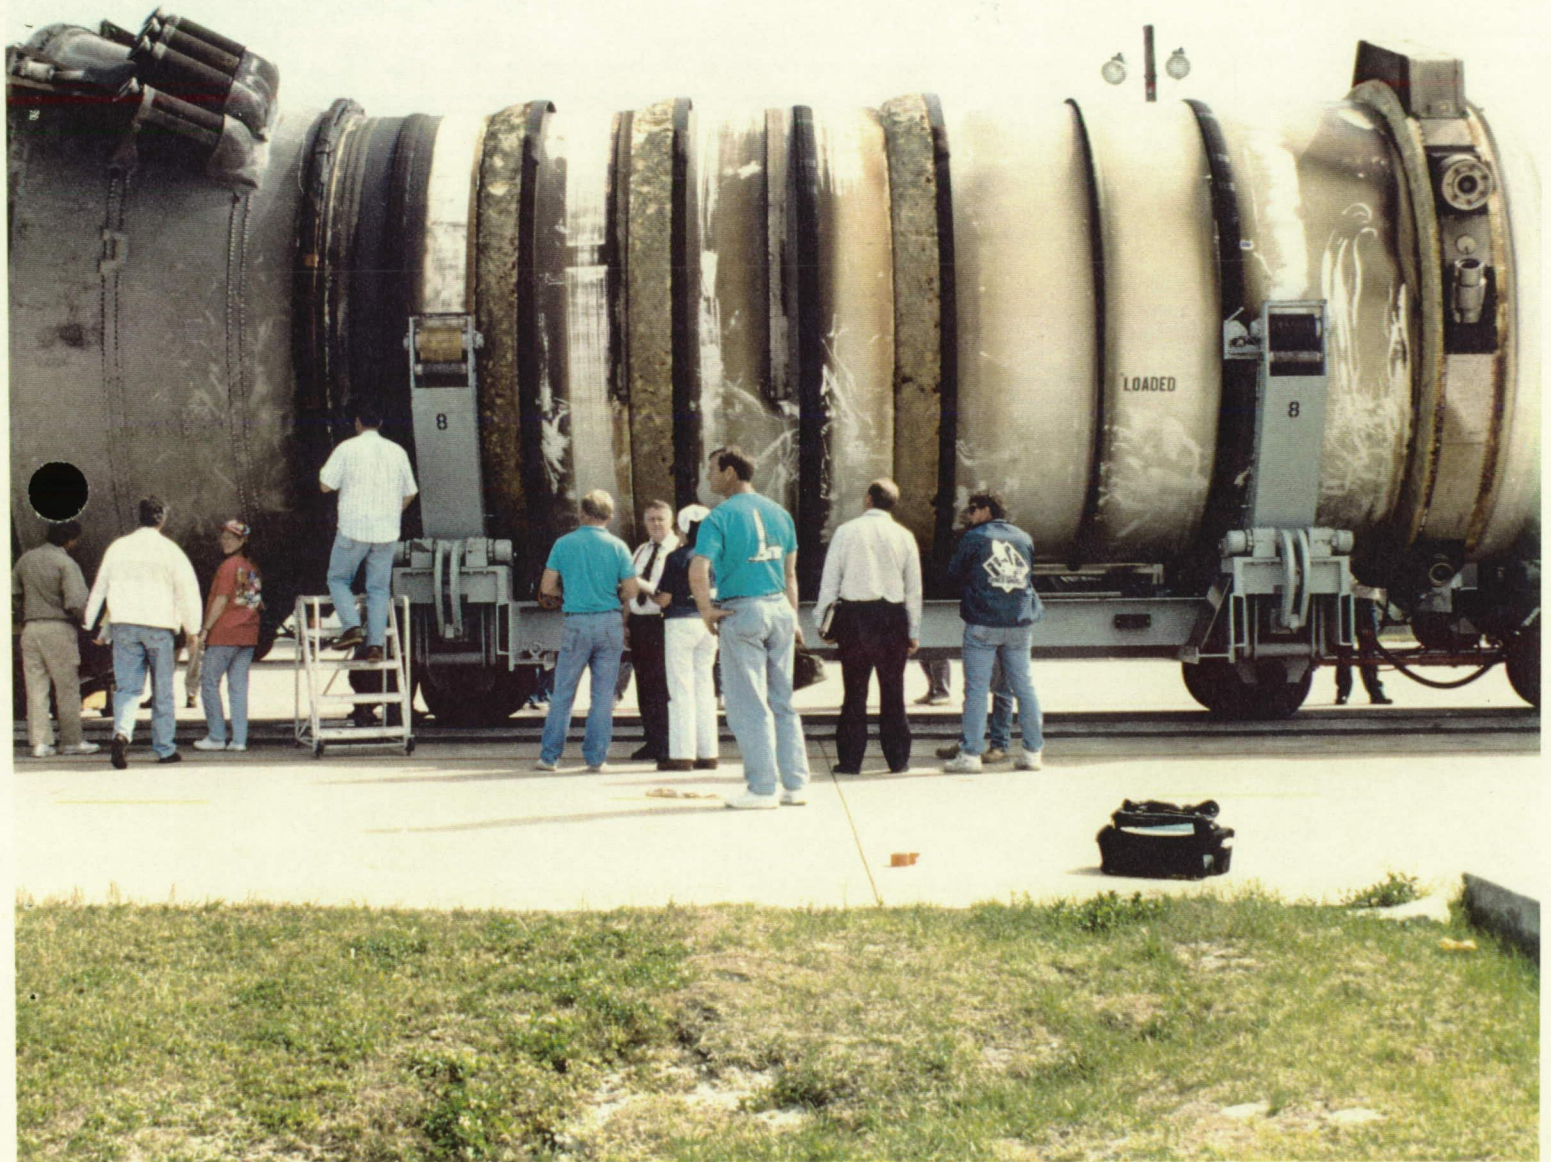
The LH forward skirt acreeage MSA-2 exhibited no debonds or missing TPS. Both RSS antenna covers/phenolic base plates were intact.

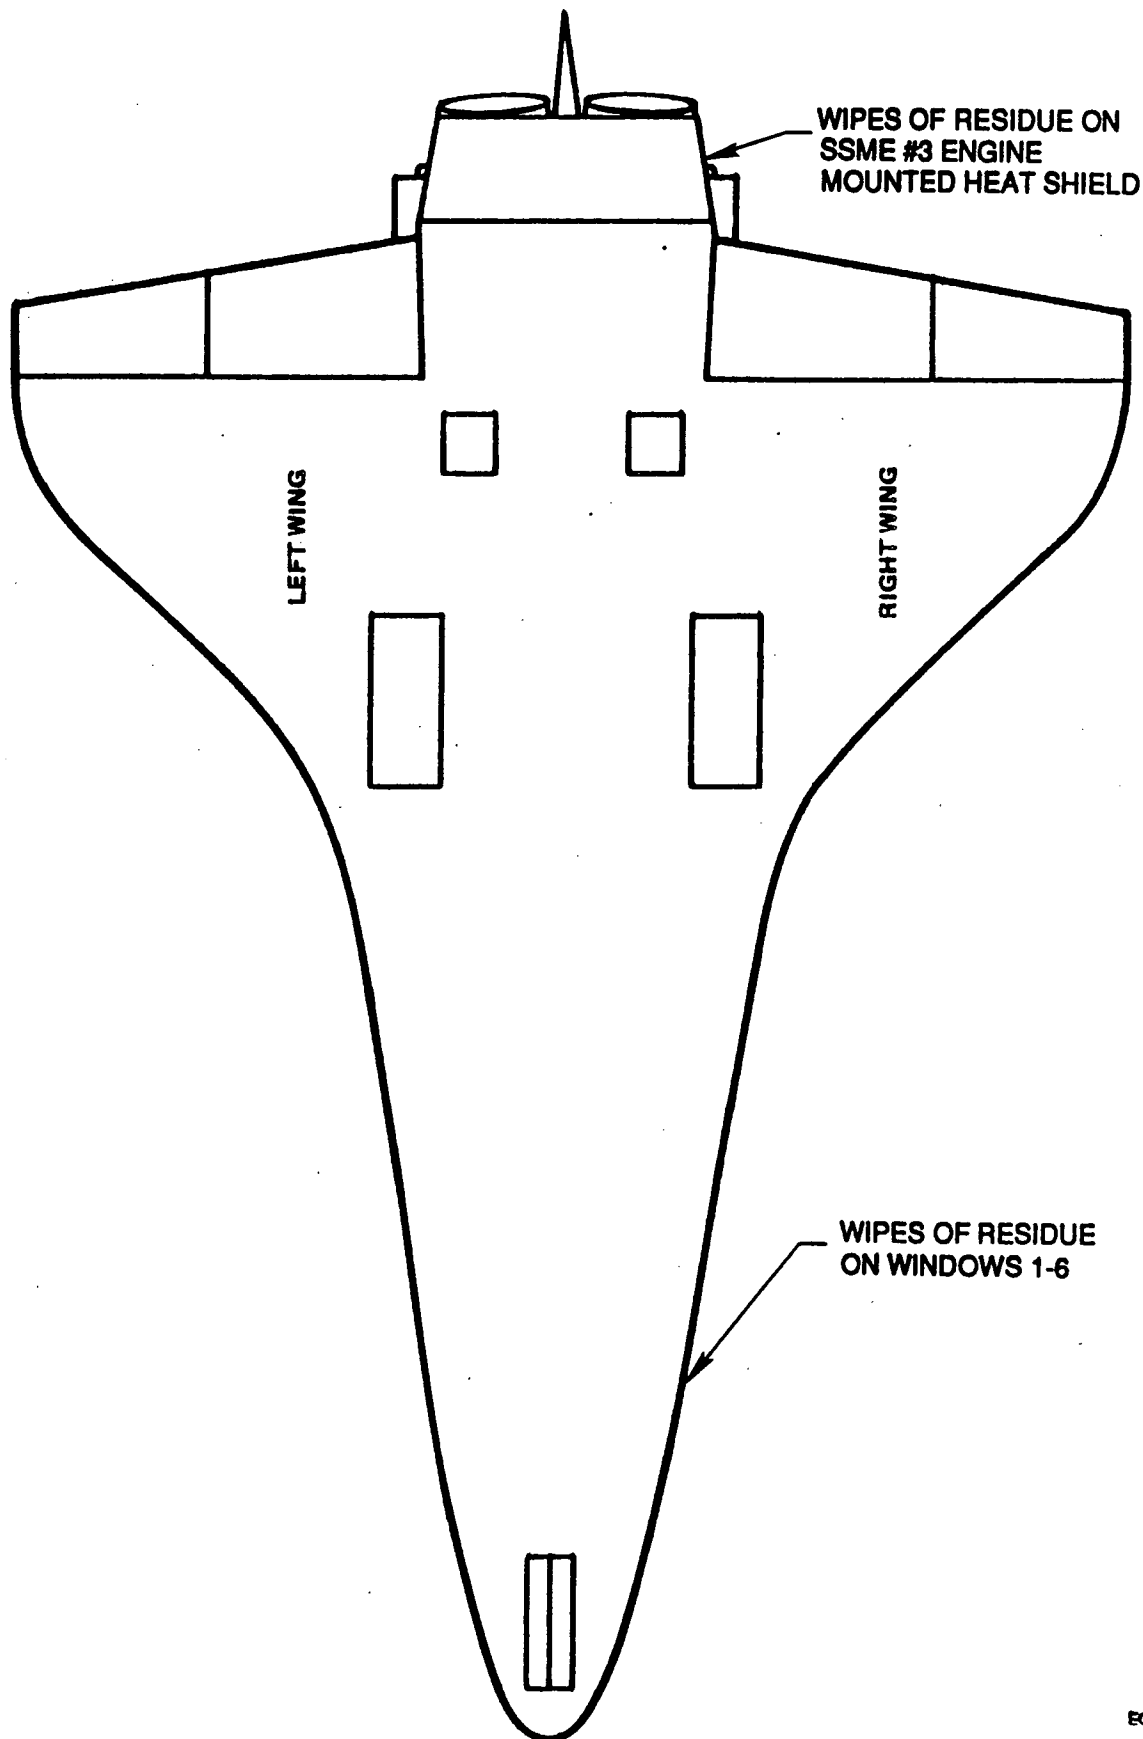
FIGURE 17. **CHEMICAL SAMPLE LOCATIONS**

All Orbiter windows exhibited typical hazing with the greatest amount present on windows #3 and #4. Surface wipes were taken from windows #1-8 for laboratory analysis (Figure 17).

Tile damage on the base heat shield was less than usual. The SSME Dome Mounted Heat Shield (DMHS) closeout blanket sacrificial panels were intact and undamaged. A one-foot square oval shaped area of residue was present on the SSME #3 engine mounted heat shield (EMHS) at the 4:00 o'clock position. The tan colored residue was sampled for laboratory analysis (Figure 17).

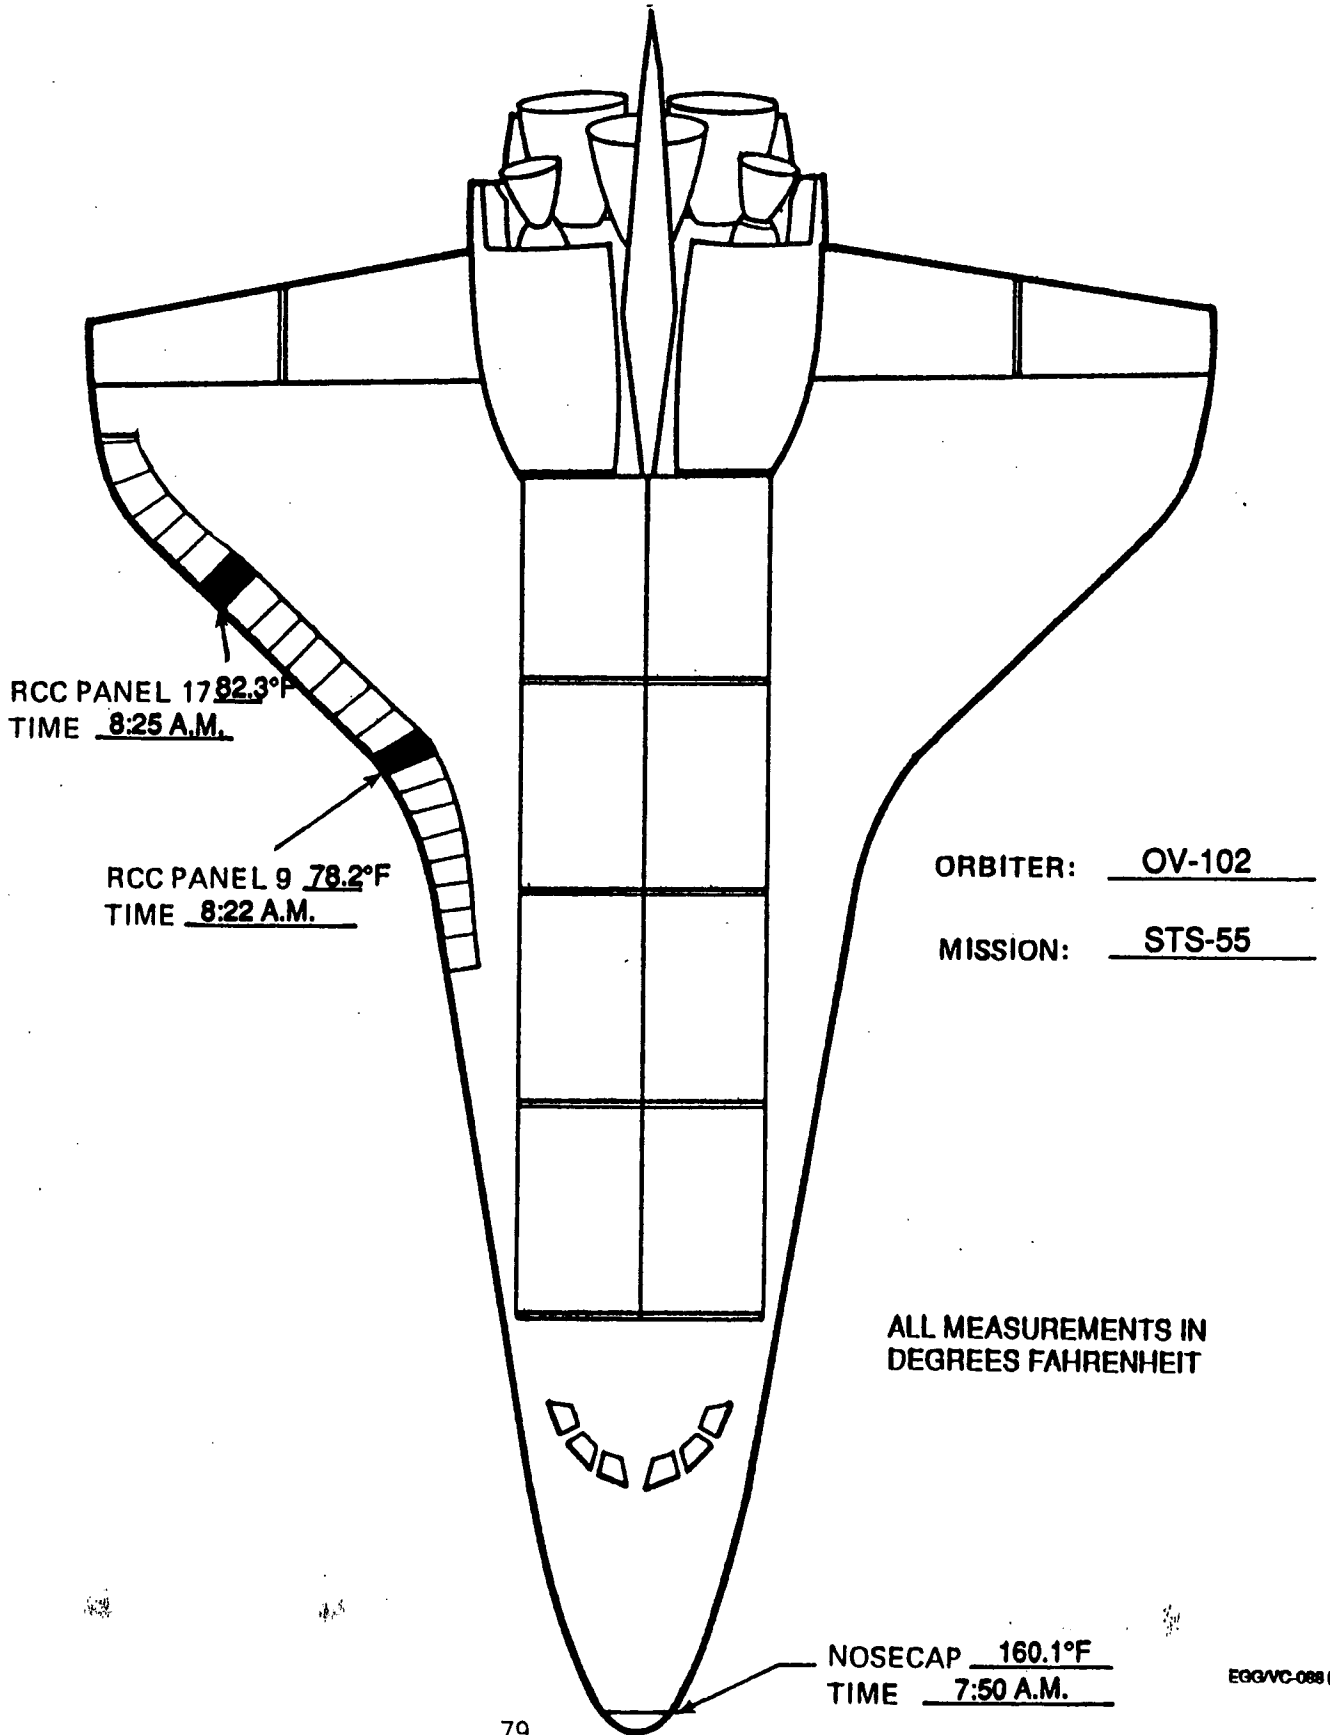
FIGURE 18. STS-55 RCC TEMPERATURE MEASUREMENTS AS RECORDED BY THE SHUTTLE THERMAL IMAGER TEMPERATURE MEASUREMENTS

A portable Minolta/Land Cyclops infrared spot radiometer was used to measure the surface temperatures of three areas on the Orbiter (per OMRSD V09AJ0.095). Twenty-two minutes after landing, the Orbiter nose cap RCC was 160 degrees Fahrenheit. Fifty-two minutes after landing, the RH wing leading edge RCC panel #9 was 78 degrees F and panel #17 was 82 degrees F. (Figure 18).

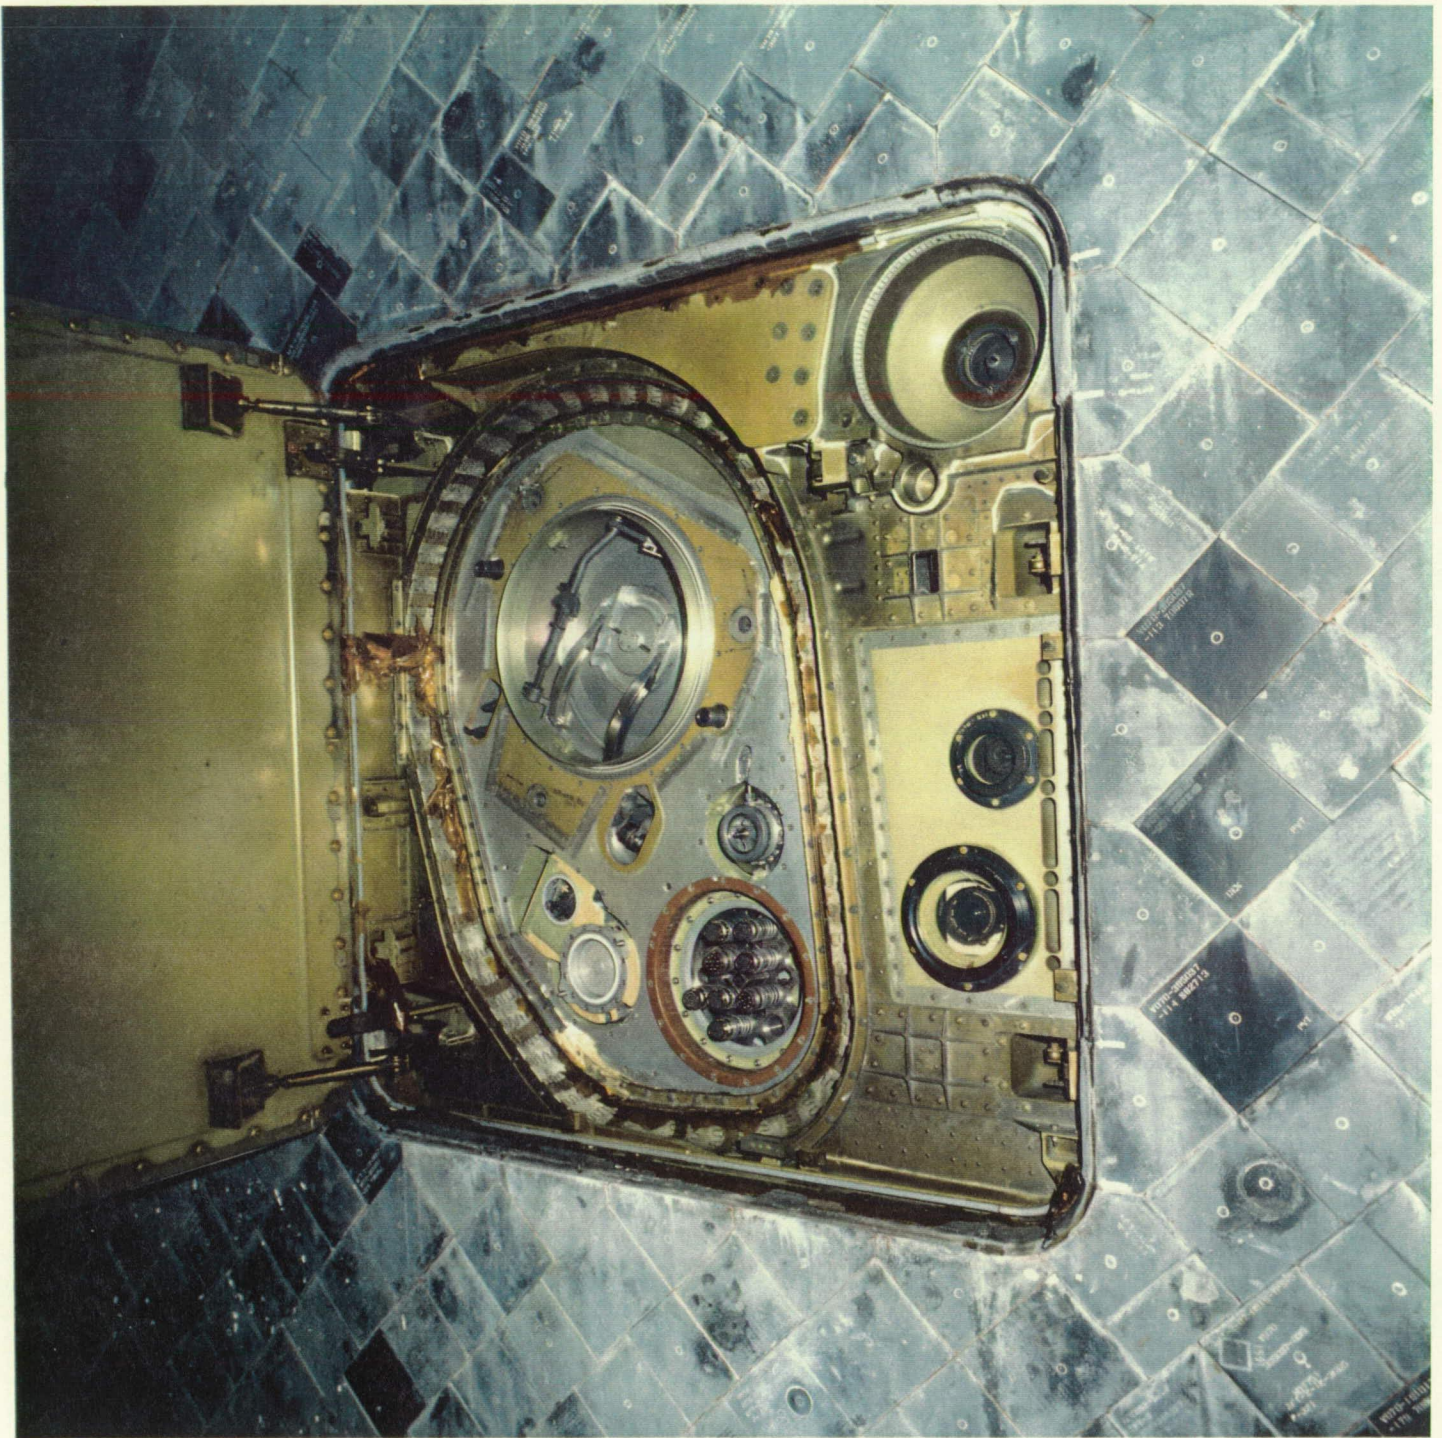
The Orbiter lower surface sustained a total of 128 hits. The majority of this damage occurred in a cluster near the ET/ORB LH2 umbilical. Similar clusters have been observed on previous flights and are attributed to impacts from the umbilical purge barrier and/or ice during ascent.

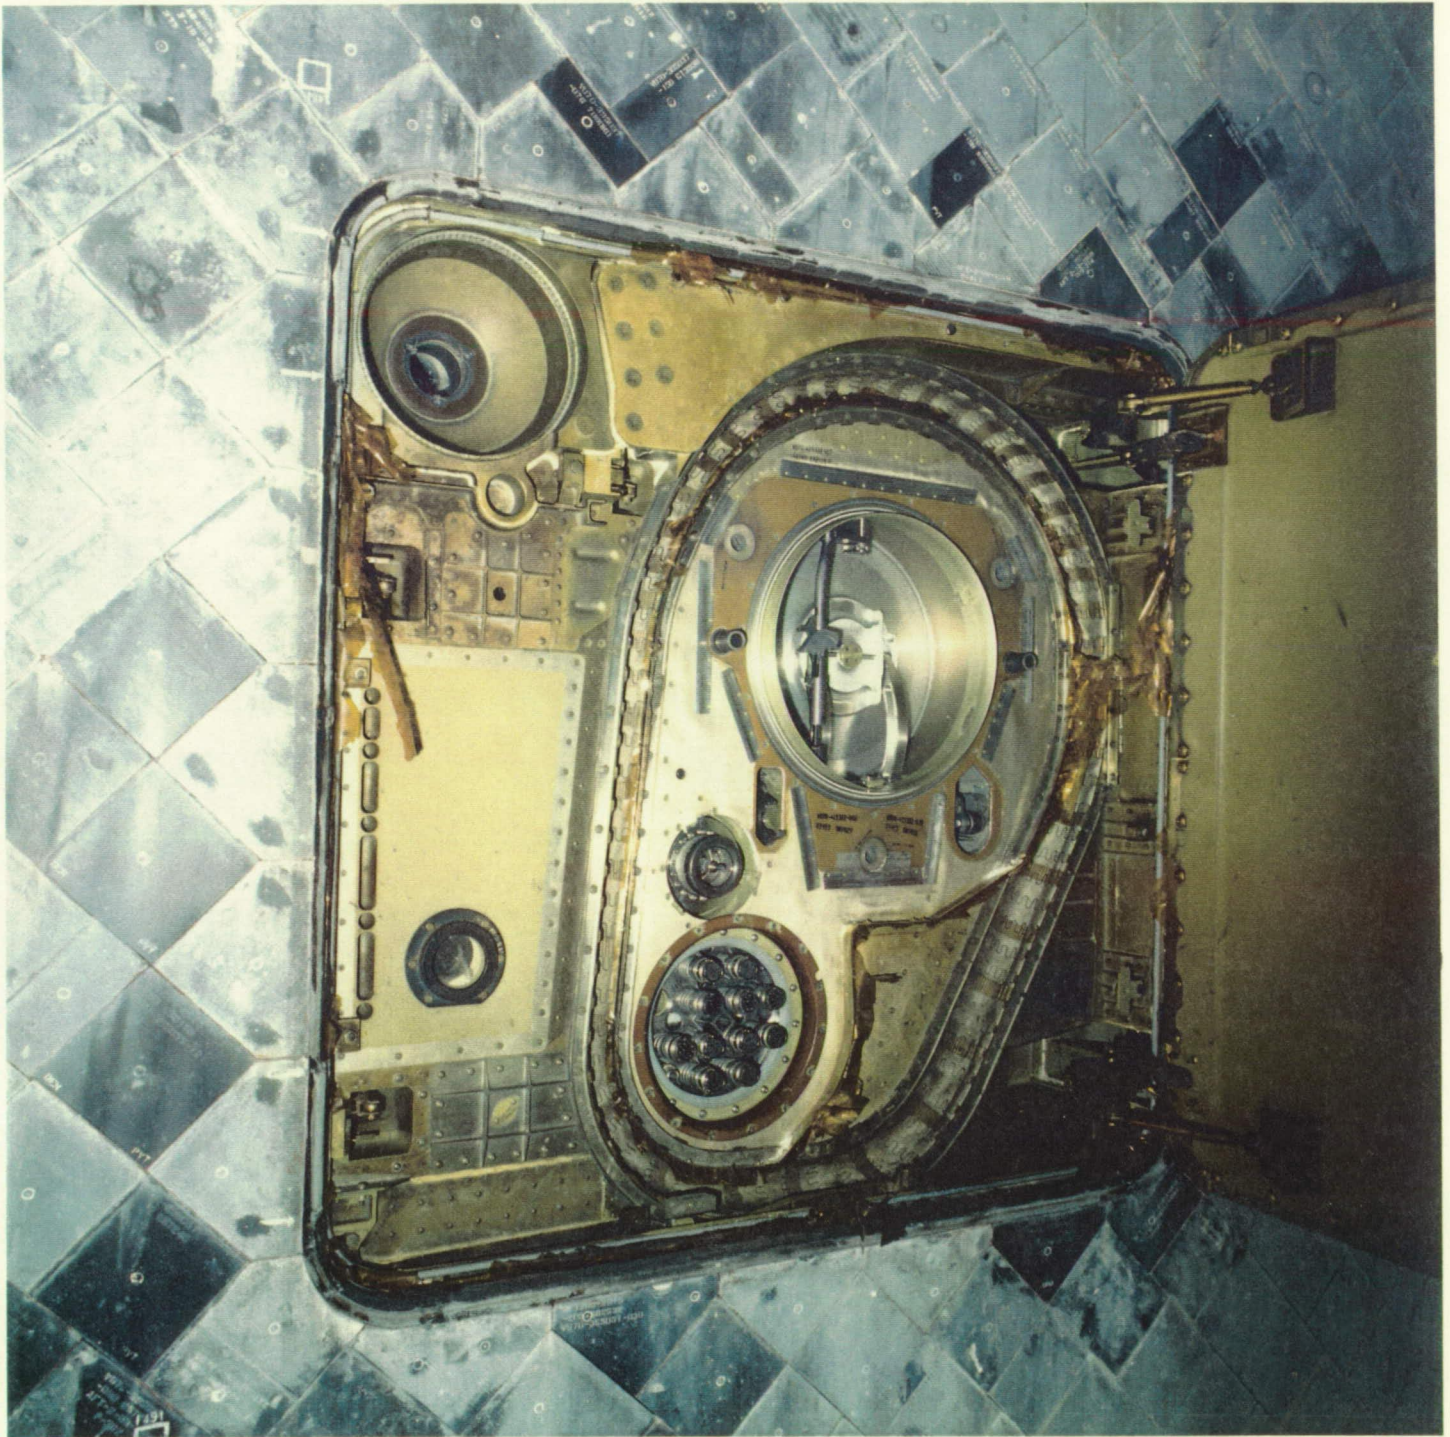
Visual inspection of the LH2 4-inch line interface revealed the rack (arrow) was extended and protruding beyond the nominal mold line. The seal plate behind the flapper exhibited some deformation.

During separation of the External Tank from the Orbiter, an MPS sensor indicated the LH2 recirculation line valve may not have closed properly. Photography from the umbilical camera showed no anomalies on the ET side of the LH2 disconnect. Visual inspection of the Orbiter LH2 recirculation line interface after landing revealed the disconnect actuator (PD3) was in the open position (should have been closed). The disconnect flapper was in the proper position since it is spring loaded closed and cannot cycle without the ET disconnect in place. The seal plate behind the flapper exhibited some deformation. The disconnect will be replaced.

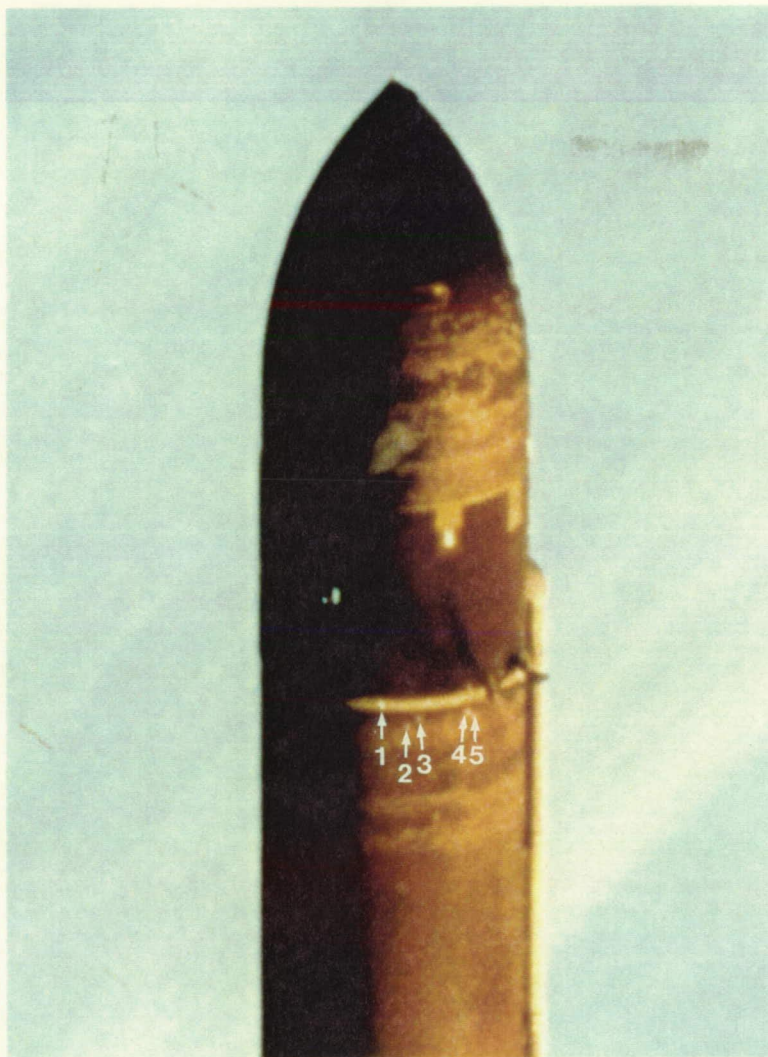
Figure 2.4.1 Divots on the External Tank

Thirty-four photographs of the ET after separation were taken by the crew between 15:03:39 UTC and 15:22:49 UTC with a Hasselblad 70 mm format camera configured with a 250 mm lens. Five divots were seen on the +Y+Z area near the LH2 intertank close-out. Divot 1 (see Figure 2.4.1) is on the close-out area and divots 2 through 5 are below it. A sixth divot, not shown in the figure above, was noted on the +Y-Z area on the LH2 intertank close-out. Based on scaling the divots by the diameter of the ET, the divots ranged in size from 4.7 inches (divot 4) to 19.9 inches (divot 6). At the time of the first photograph, the ET was 1130 meters from the orbiter. At the time the last photograph, the ET was 8677 meters away from the orbiter. Further details are given in Appendix D, Task #6.

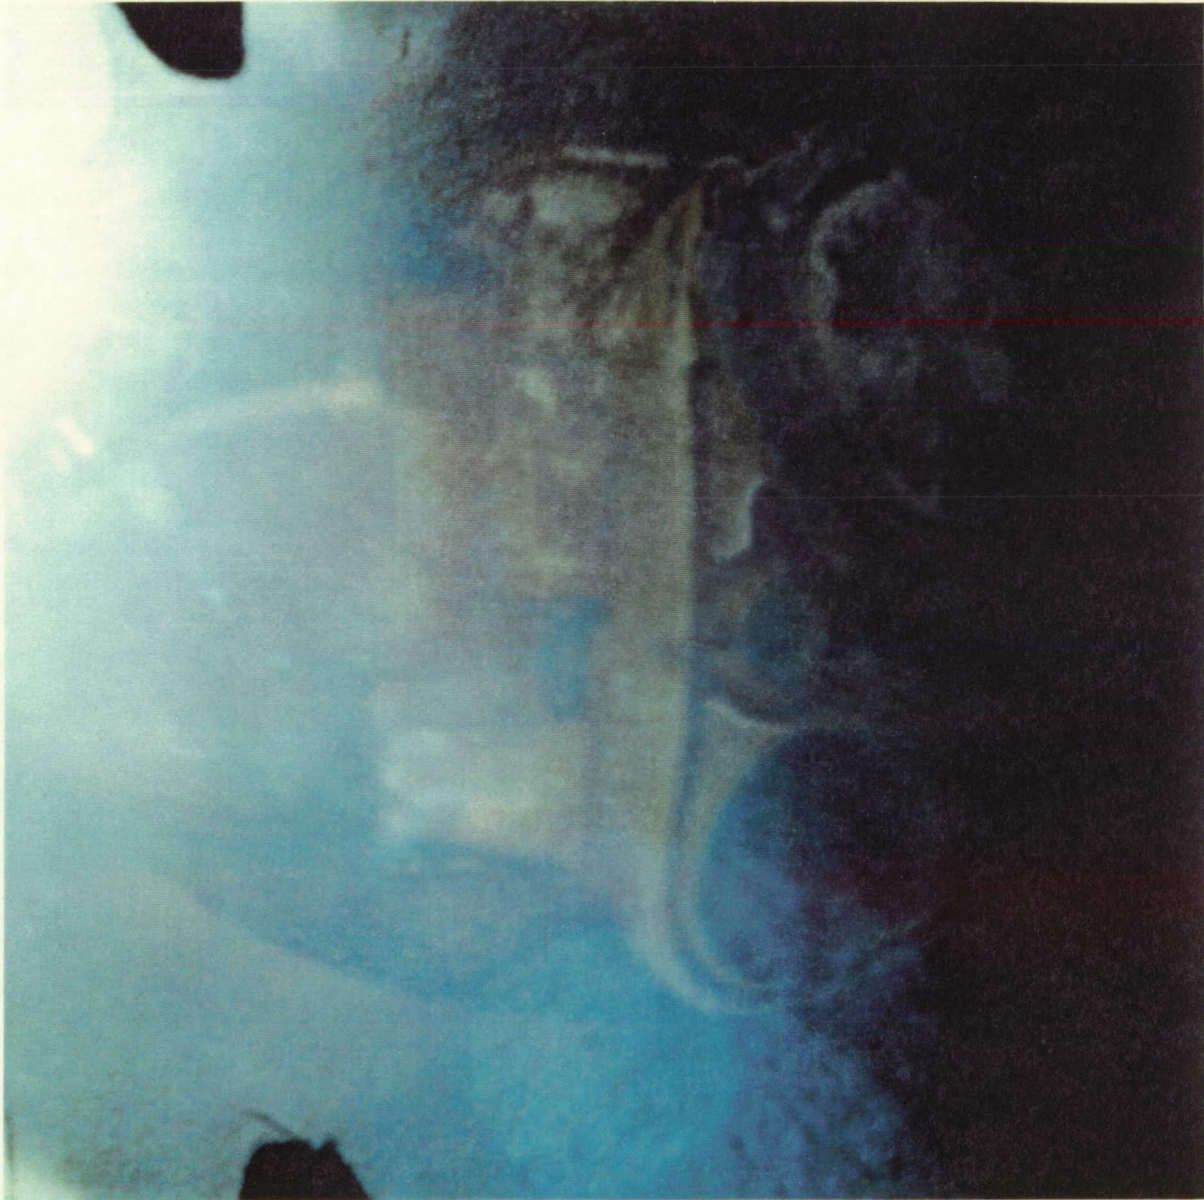
Figure 2.4.2.1 16 mm Camera View of the LH2 Umbilical

A 16 mm motion picture film was taken from the Orbiter umbilicals and reviewed. This motion picture film showed LSRB and ET separation along with the normal venting and debris associated with these events. Due to the large amount of debris seen by the crew after ET separation, it was thought that perhaps the LH2 4" purge valve may not have closed properly. The 4" purge line appeared normal and no venting was noted from the ET. Poor imagery due to sun glint significantly hindered analysis. Normal TPS erosion was noted. No anomalies were detected.

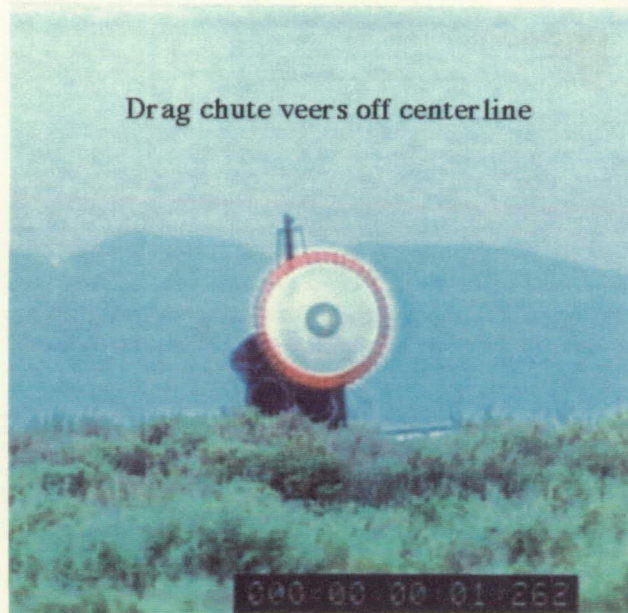
Figure 2.5.3 Drag Chute Veers From Center Line of the Orbiter

Video coverage of the drag chute deployment was obtained. The deployment of the drag chute appeared as expected. The drag chute was seen to veer to the right after deployment (See Figure 2.5.3). Analysis of the drag chute performance was not done this mission due to limited film coverage, the lack of timing, and the fact that the drag chute has been modified since STS-55 and this configuration will no longer be used.

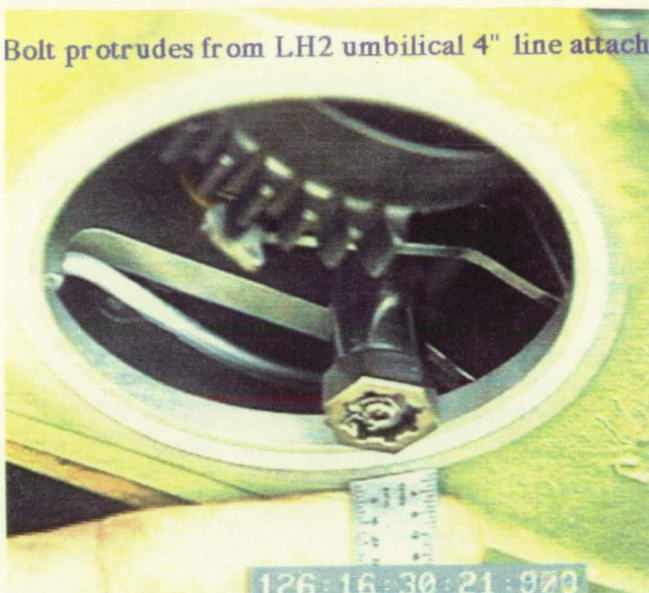
(A)

Bolt protrudes from LH2 umbilical 4" line attach

The following items were noted during the post-landing inspection of the Orbiter:
A bolt with a hexagonal nut was seen protruding approximately 5/16" from the LH2 umbilical in the attach associated with the 4" recirculation line (See Figure 2.5.4 A).
