Debris/Ice/TPS Assessment and Integrated Photographic Analysis for Shuttle Mission STS-55

(NASA-TM-107559) DEBRIS/ICE/TPS
ASSESSMENT AND INTEGRATED
PHOTOGRAPHIC ANALYSIS FOR SHUTTLE
MISSION STS-55 Final Report, 22
Mar. - 7 May 1993 (NASA) 136 p

Gregory N. Katnik
NASA/Kennedy Space Center

DEBRIS/ICE/TPS ASSESSMENT
AND
PHOTOGRAPHIC ANALYSIS
OF
SHUTTLE MISSION STS-55

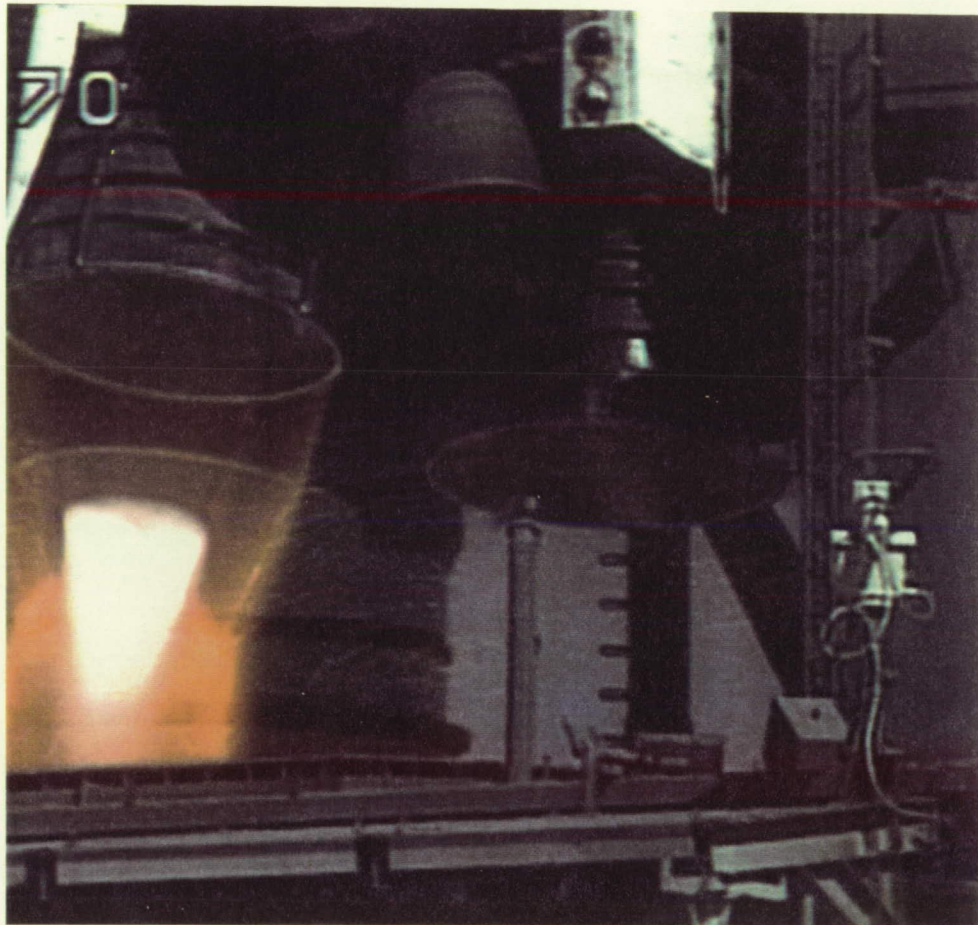
Figure 2.7.1.2.1 Shut Down of SSME #3

During the launch attempt of STS-55, SSME #3 was shut down by its main engine controller when a higher than allowable pressure reading showed up in a purge line (See Figure 2.7.1.2.1). The general purpose computers, responding to SSME #3 controller's report of a shutdown, began shutting down SSME #2 and then SSME #1. After all three engines were shut down, safing procedures that include a series of valve closures, leak checks and fire detection checks began. Thousands of gallons of water were then sprayed on the engines to extinguish any fires that may have been present.

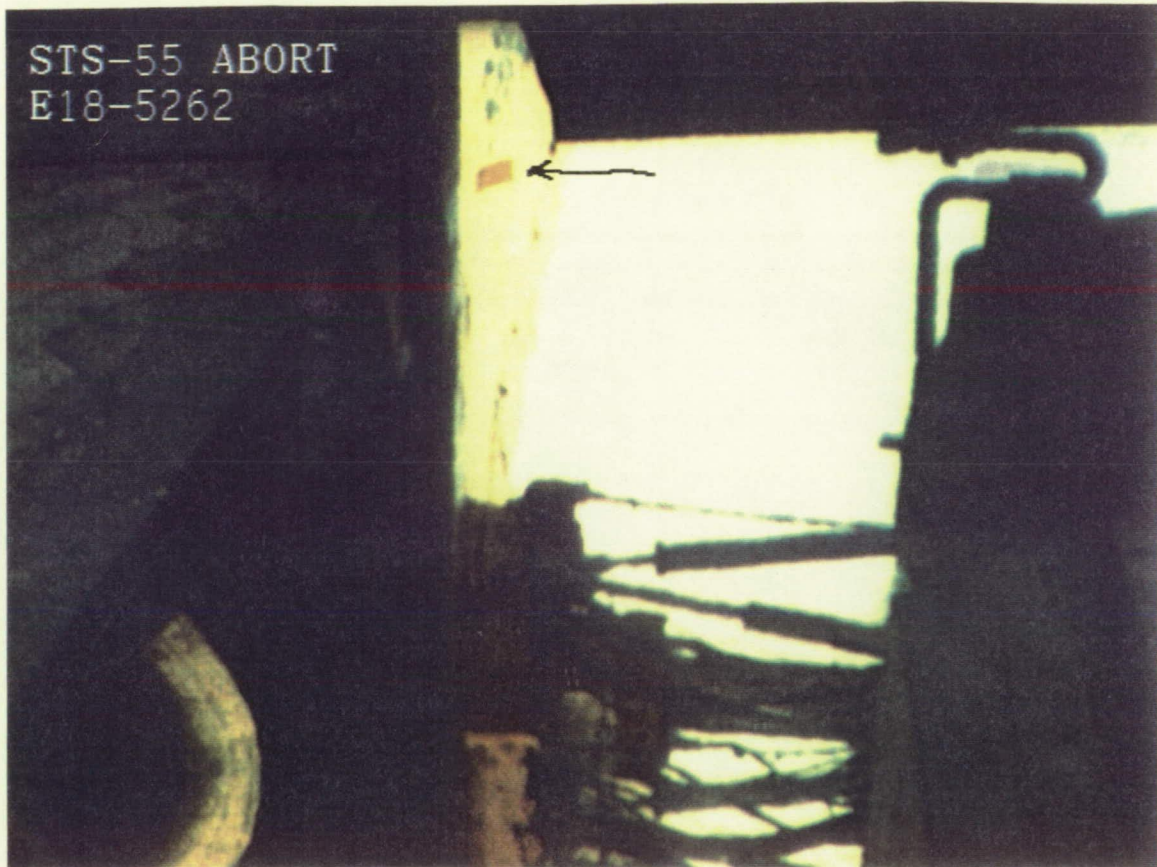
Figure 2.7.1.2.2 Rectangular Shaped Debris

A yellow, flexible, rectangular appearing piece of debris moved from left to right across the field of view. The origin was possibly the LH2 TSM T-0 umbilical area.

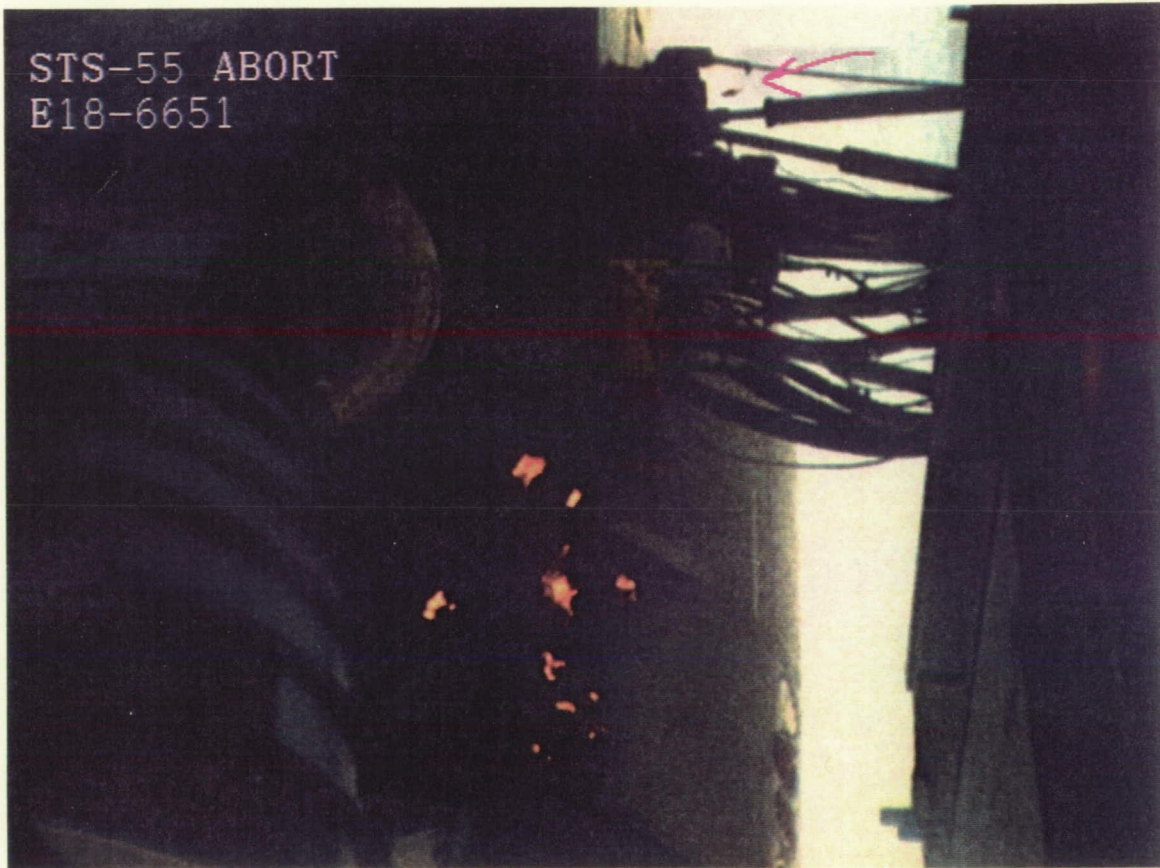
Figure 2.7.1.2.4 (B)

Burning RCS Paper

RCS paper from the left RCS stinger ignited and burned after engine shutdown. Pieces of the burning RCS paper were noted to drift across the field of view throughout the sequence.

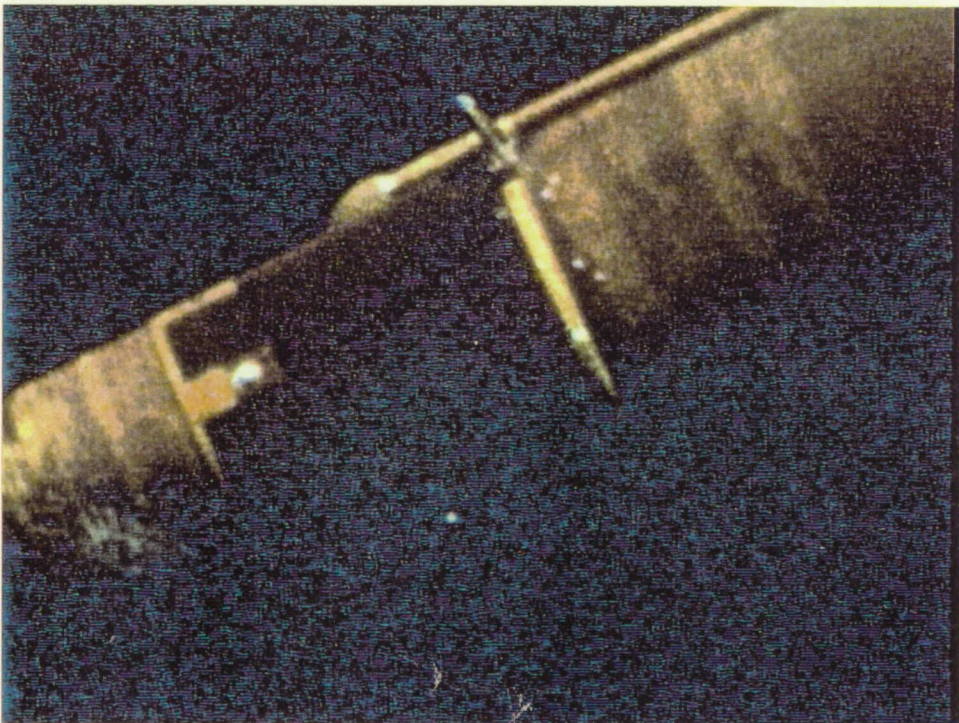
Figure 2.

Thirty-one frames of 70mm film of the ET after separation were received and reviewed. Four divots were noted on the LH2 tank to the left of the forward bipod and two divots noted at the LH2/intertank scarf joint. Figure 2 is a frame of film taken from the 70mm on board camera showing these divots.

ET TPS Divots
