NEW RESULTS FROM FRECOPA ANALYSIS

Christian Durin  
CNES RA-DP EQ/QM  
18, av E. Belin Toulouse FRANCE  
Phone (33) 61 28 14 39, Fax (33) 61 27 47 32

This paper discusses new results from the ongoing analysis of the FRECOPA's (FREnch COoperative PAssive payload) system hardware. FRECOPA (AO138) was one of the 57 experiments flown on the LDEF satellite. The experiment was located on the trailing edge (Tray B3) and was exposed to UV radiation (11,100 equivalent sun hours), ≈ 34,000 thermal cycles, higher vacuum levels than the leading edge, a low atomic oxygen flux and minor doses of protons and electrons. Due to LDEF's extended mission (5.8 years), CNES decided to set up a team to analyse the FRECOPA system. Initial results were presented at the First Post-Retrieval Conference, June, 1991. This paper summarizes the results obtained since then.

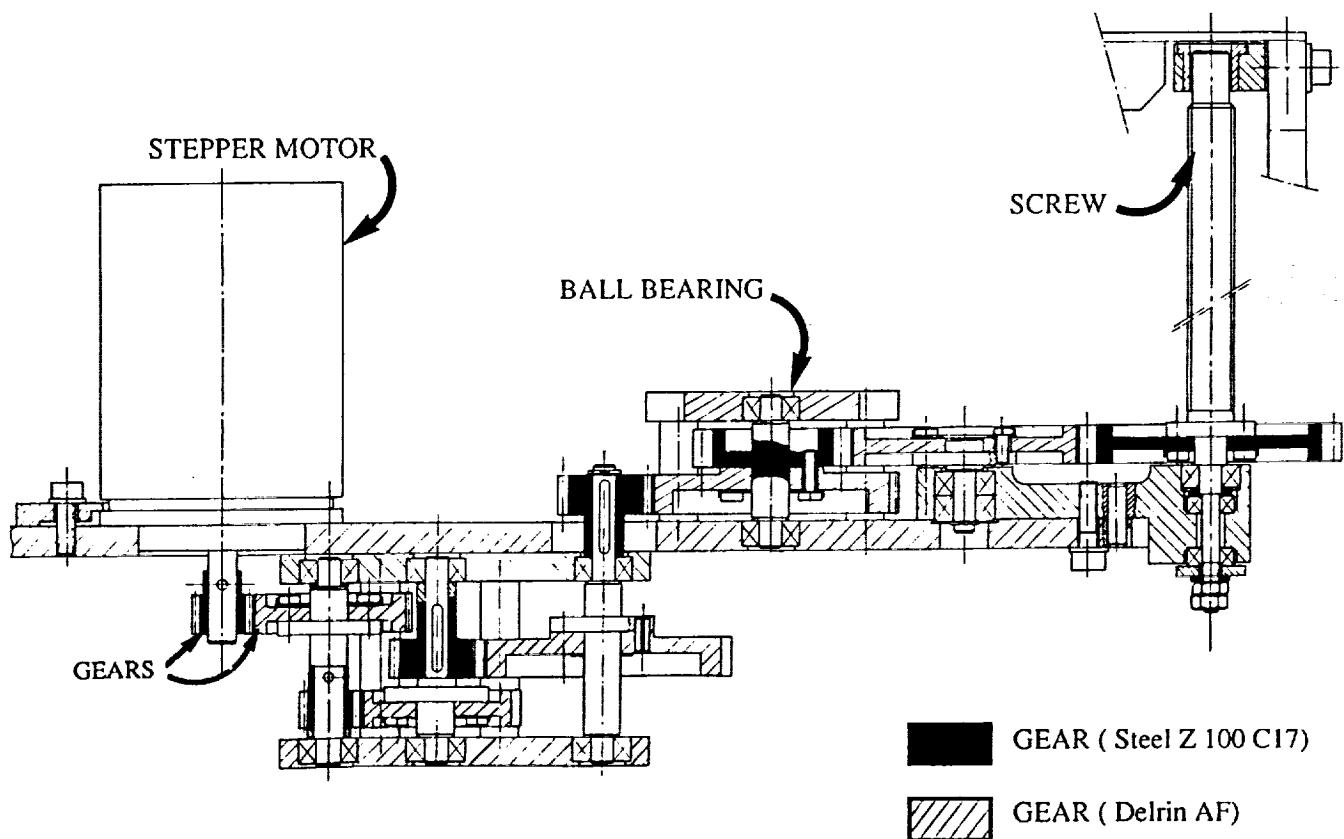
Figure 1. Kinematic reduction mechanism

It is composed of a stepping motor driving two screw nuts via a double 6-stage reduction set-up. The raising or lowering of the nuts, fixed to the canister, allows the canister to be opened or closed. The figure 1. illustrates a reduction set-up. Note that we alternated gears made of DELRIN and gears made of steel to avoid the risk of micro-welding and to ensure lubrication. Between metal parts (nut, screw), powdered MoS<sub>2</sub> was used as a lubricant. The whole opening mechanism operated correctly before and after the flight. The resistance couple was found to have increased by 50 % but there was still a safety margin of 22.

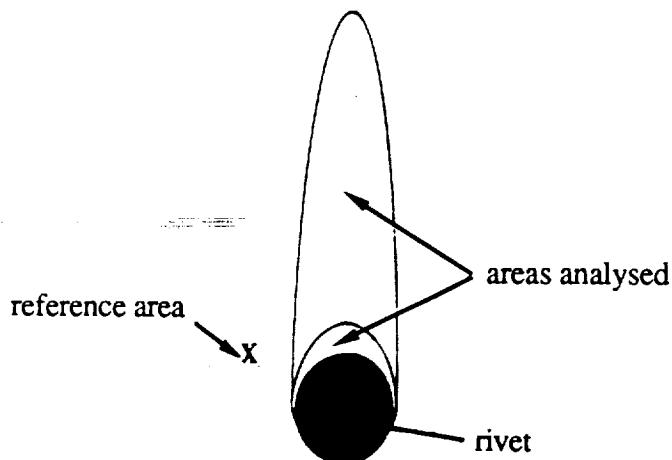
- our third task was to analyse the multiple shadows around the rivets on the outer surface of the support (as seen in fig 5.). The reference zone was out of the shadows, the contaminated zone was inside the shadow or shadows (see figure below).
