# NATIONAL ADVISORY COMMITTEE FOR AERONAUTICS

No. 1637

EFFECT OF PREIGNITION ON CYLINDER TEMPERATURES  
PRESSURES, POWER OUTPUT, AND PISTON FAILURES

By Lester C. Corrington and William F. Fisher

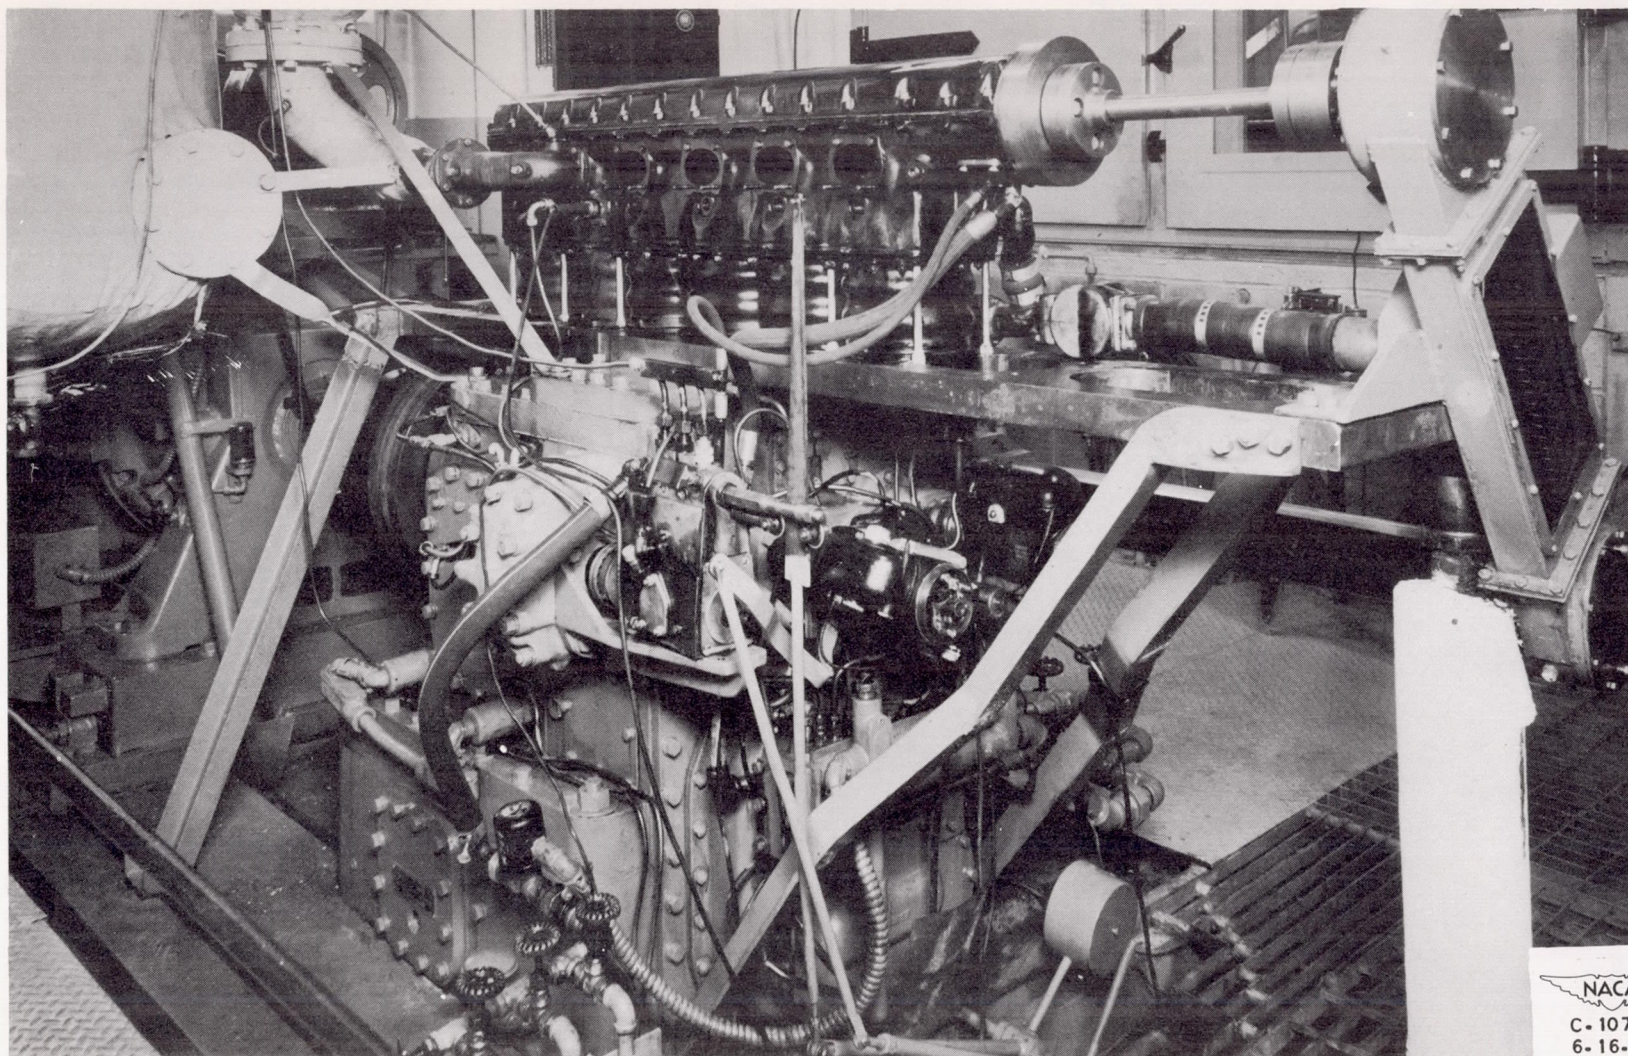
Figure 1. - Single-cylinder test engine showing intake side of multicylinder engine block mounted on CUE crankcase.

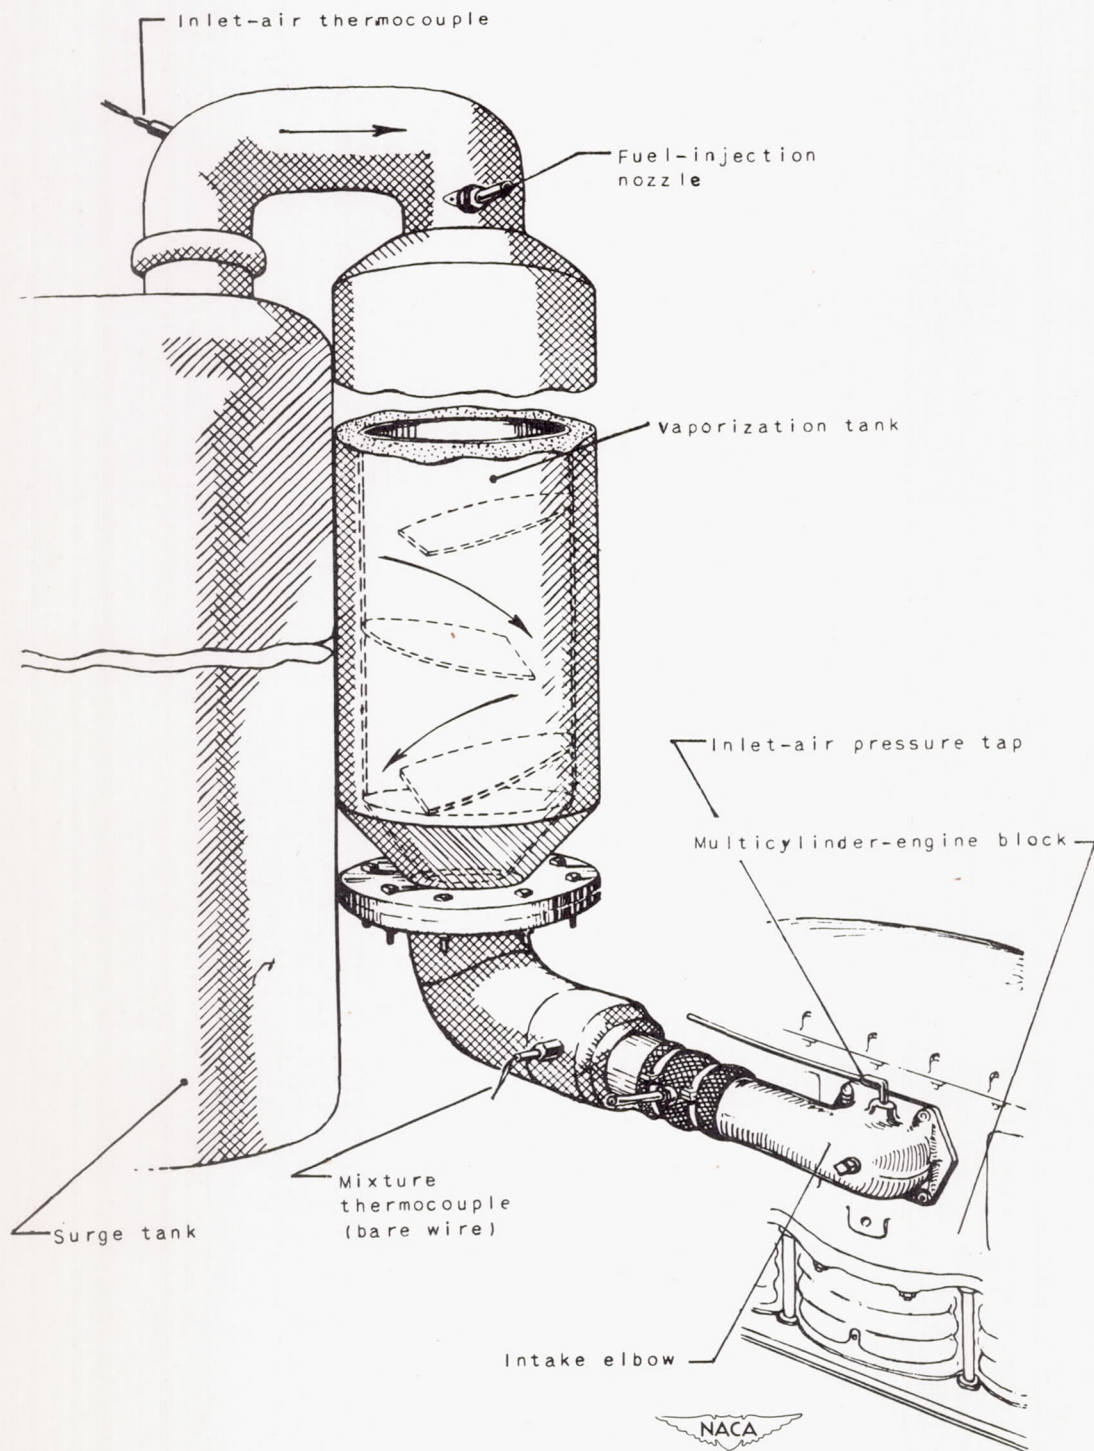
Figure 2. - Induction system used with single-cylinder test engine.

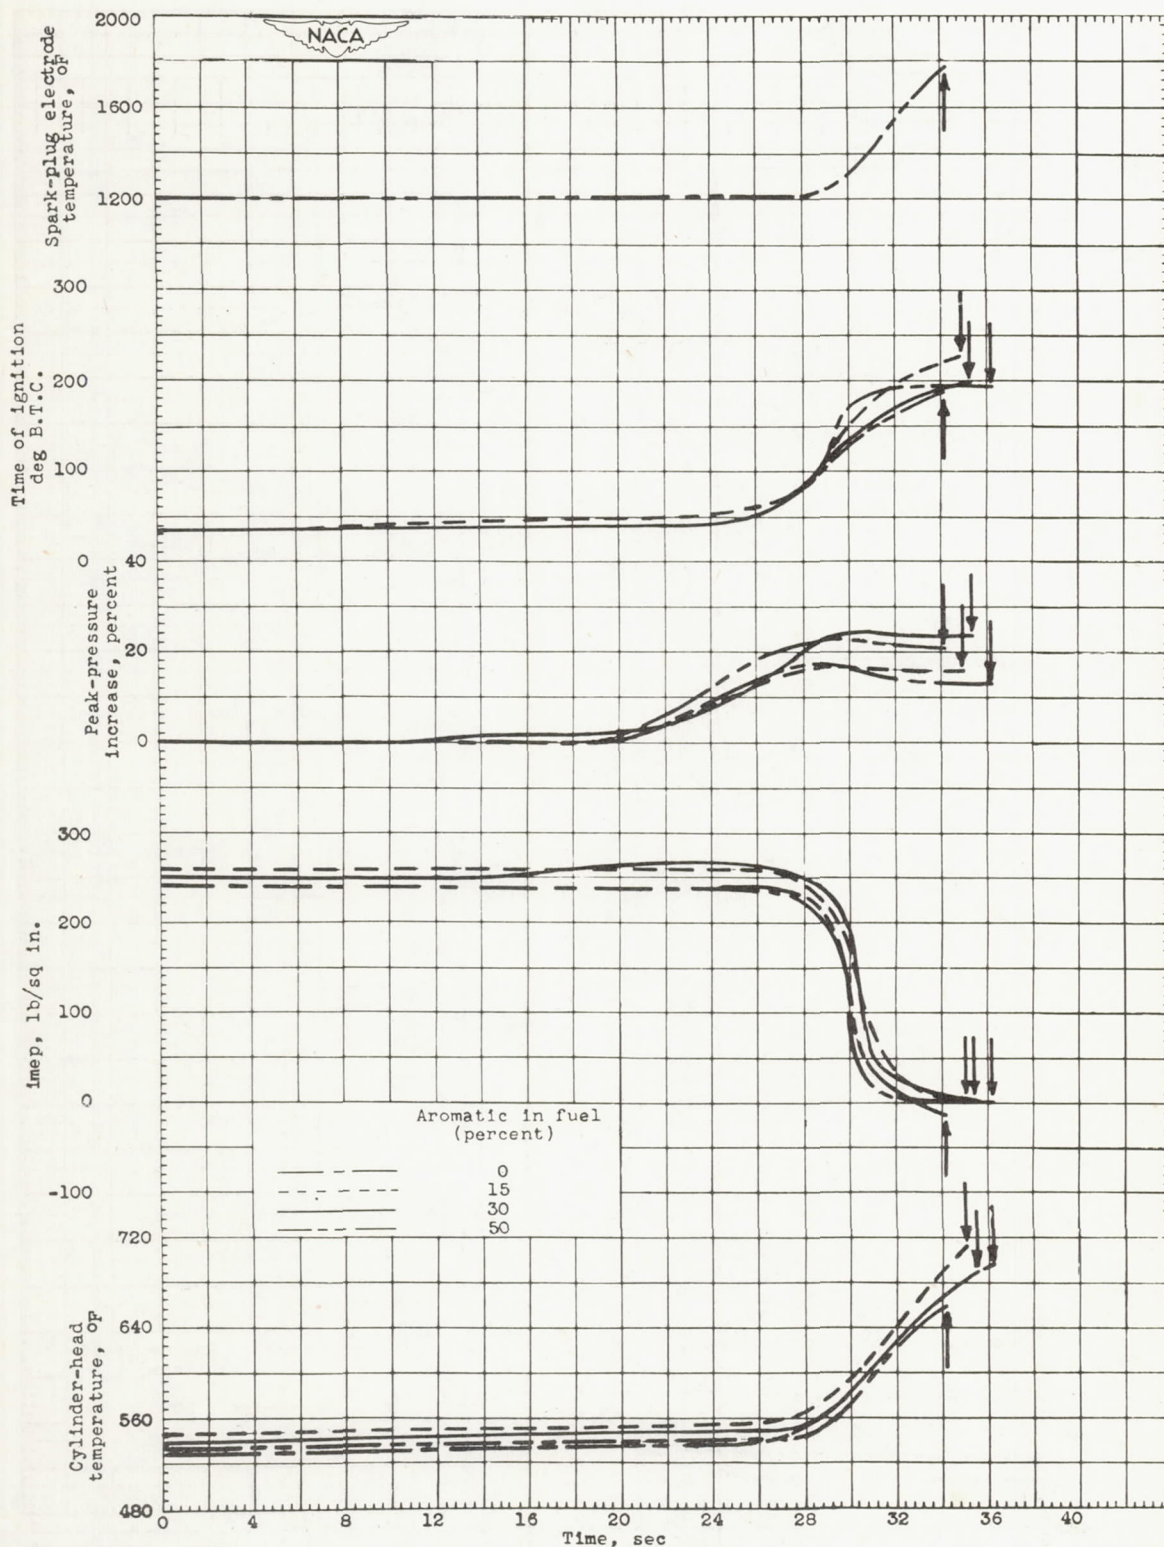
Effect of aromatic content of fuel. - The preignition rating of a fuel depends to a large extent on its aromatic content. At the conditions investigated, however, the percentage of aromatics in the fuel had only a small effect on the behavior of the engine after preignition was excited (fig. 7). The peak-pressure-increase curves show the greatest effect with a trend toward a direct relation between aromatic content and peak-pressure increase.

A curve is also included in figure 7 that shows the changes in the temperature of the center electrode of the intake spark plug during a preignition run. This spark plug was of a colder-operating type than that used in the exhaust side as the preignition source. The temperature of this intake plug increased approximately  $550^{\circ}\text{F}$  before backfiring was encountered. Because of difficulties involved in obtaining measurements of this temperature, the data shown are the only data available.

Figure 7. - Effect of aromatic content of fuels on behavior of engine after preignition is encountered. Engine speed, 3000 rpm; spark advance: inlet, 28° B.T.C.; exhaust, 34° B.T.C.; compression ratio, 6.65; outlet-coolant temperature, 250° F; mixture temperature, 175° F; inlet-oil temperature, 185° F; fuel-air ratio, 0.070; source of preignition, spark plug in exhaust side. (Arrows indicate time of backfire.)

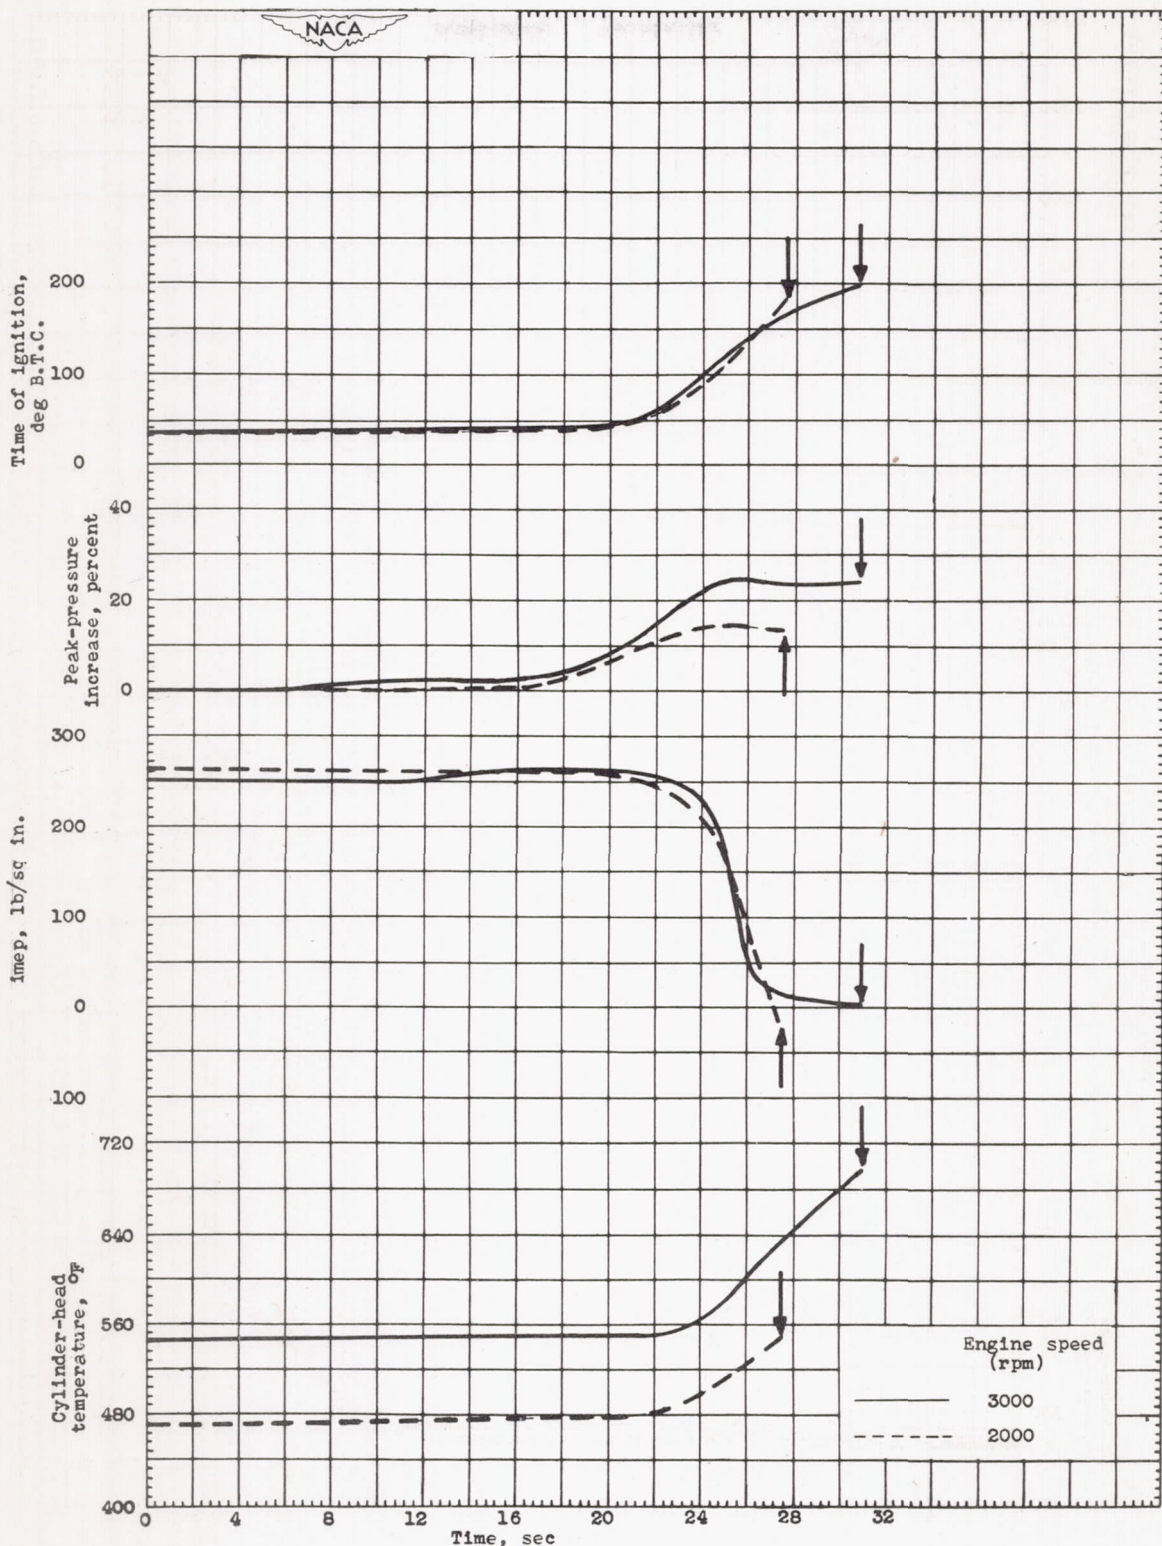
Effect of engine speed. - Data from runs at two engine speeds, 3000 and 2000 rpm, are shown in figure 8. Both runs were at approximately the same indicated mean effective pressure with spark plugs of the same type but of slightly different thermal ratings. The ignition advance required to cause backfiring was almost the same at both engine speeds.

Figure 8. - Effect of engine speed on behavior of engine when preignition is encountered. Spark advance: inlet, 28° B.T.C.; exhaust, 34° B.T.C.; compression ratio, 6.65; outlet-coolant temperature, 250° F; mixture temperature, 175° F; inlet-oil temperature, 185° F; fuel-air ratio, 0.070; fuel, 30-percent cumene blend; source of preignition, spark plug in exhaust side. (Arrows indicate time of backfire.)

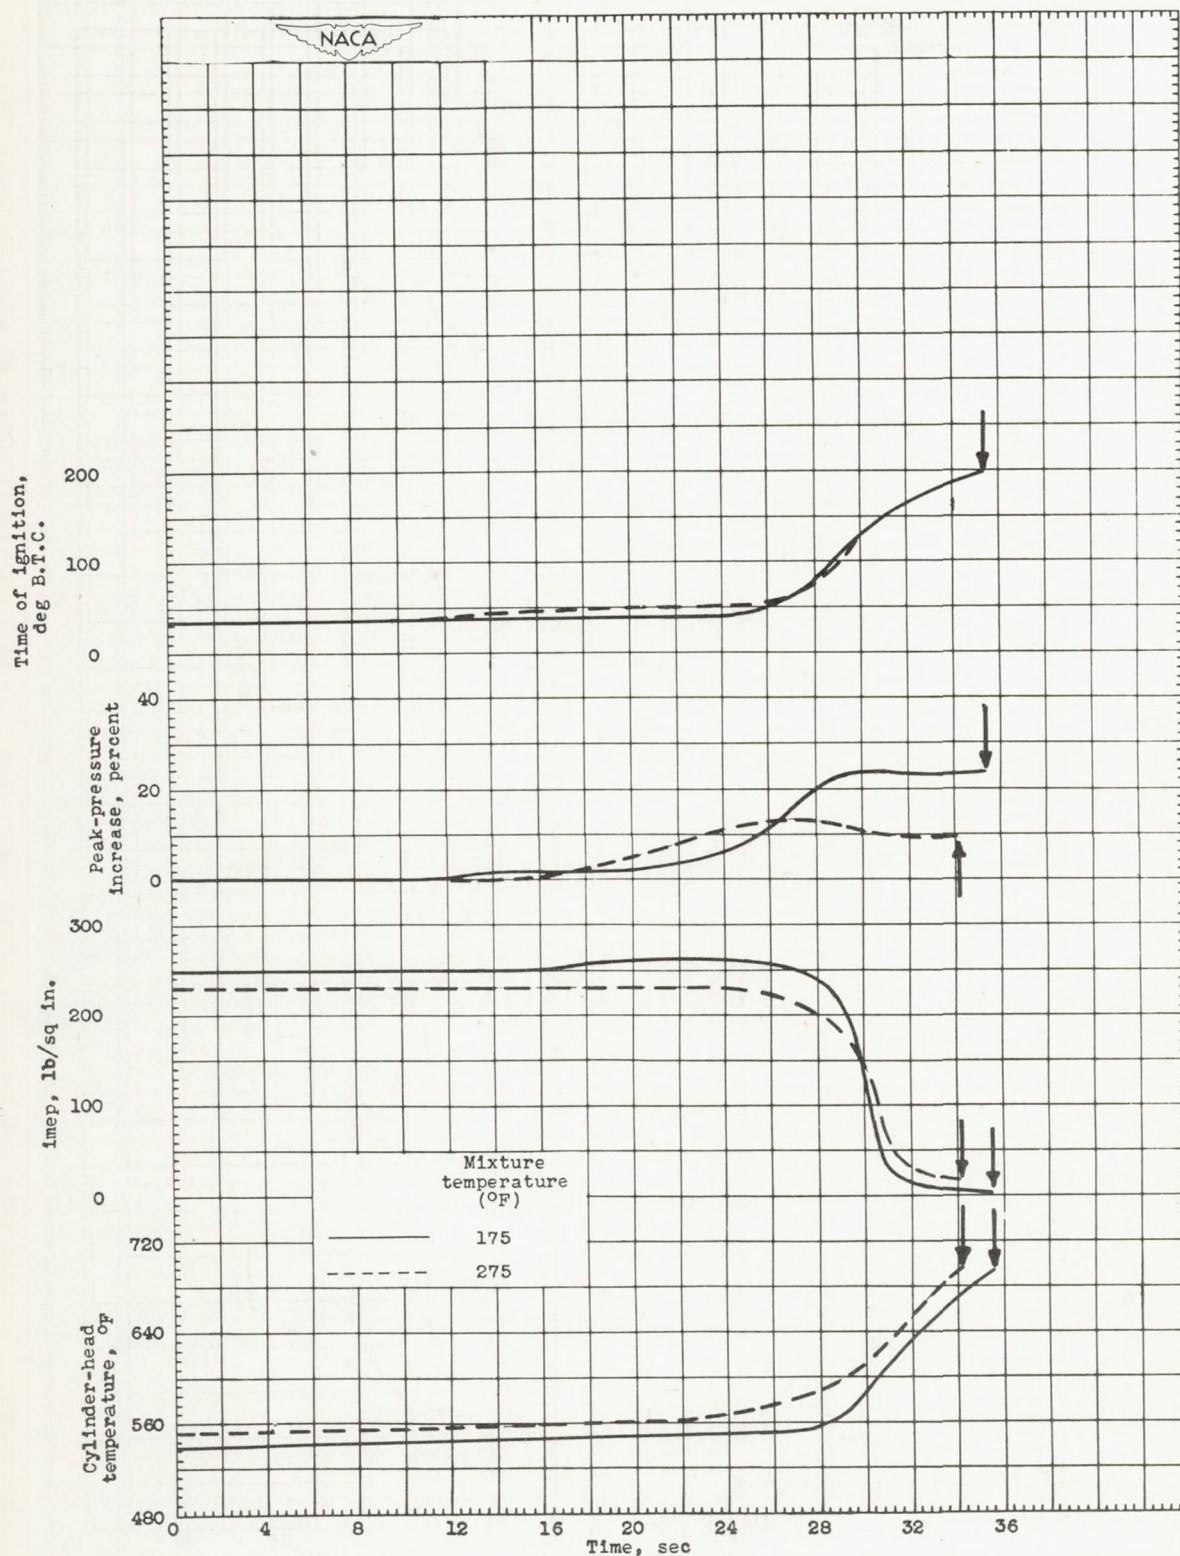
Effect of mixture temperature. - At approximately constant power output, mixture temperature had little effect on the behavior of the engine during preignition operation (fig. 9). At the higher mixture temperature of 275° F, the engine appeared to backfire a little more readily, probably because of better vaporization. The peak-pressure increase was greater at the lower mixture temperature of 175° F. Trouble was experienced with the ionization-gap trace (ignition indicator) during the runs at a mixture temperature of 275° F and therefore the time-of-ignition curve for these runs (fig. 9) is incomplete.

Figure 9. - Effect of mixture temperature on behavior of engine when preignition is encountered. Engine speed, 3000 rpm; spark advance: inlet, 28° B.T.C.; exhaust, 34° B.T.C.; compression ratio, 6.65; outlet-coolant temperature, 250° F; inlet-oil temperature, 185° F; fuel-air ratio, 0.070; fuel, 30-percent cumene blend; source of preignition, spark plug in exhaust side. (Arrows indicate time of backfire.)

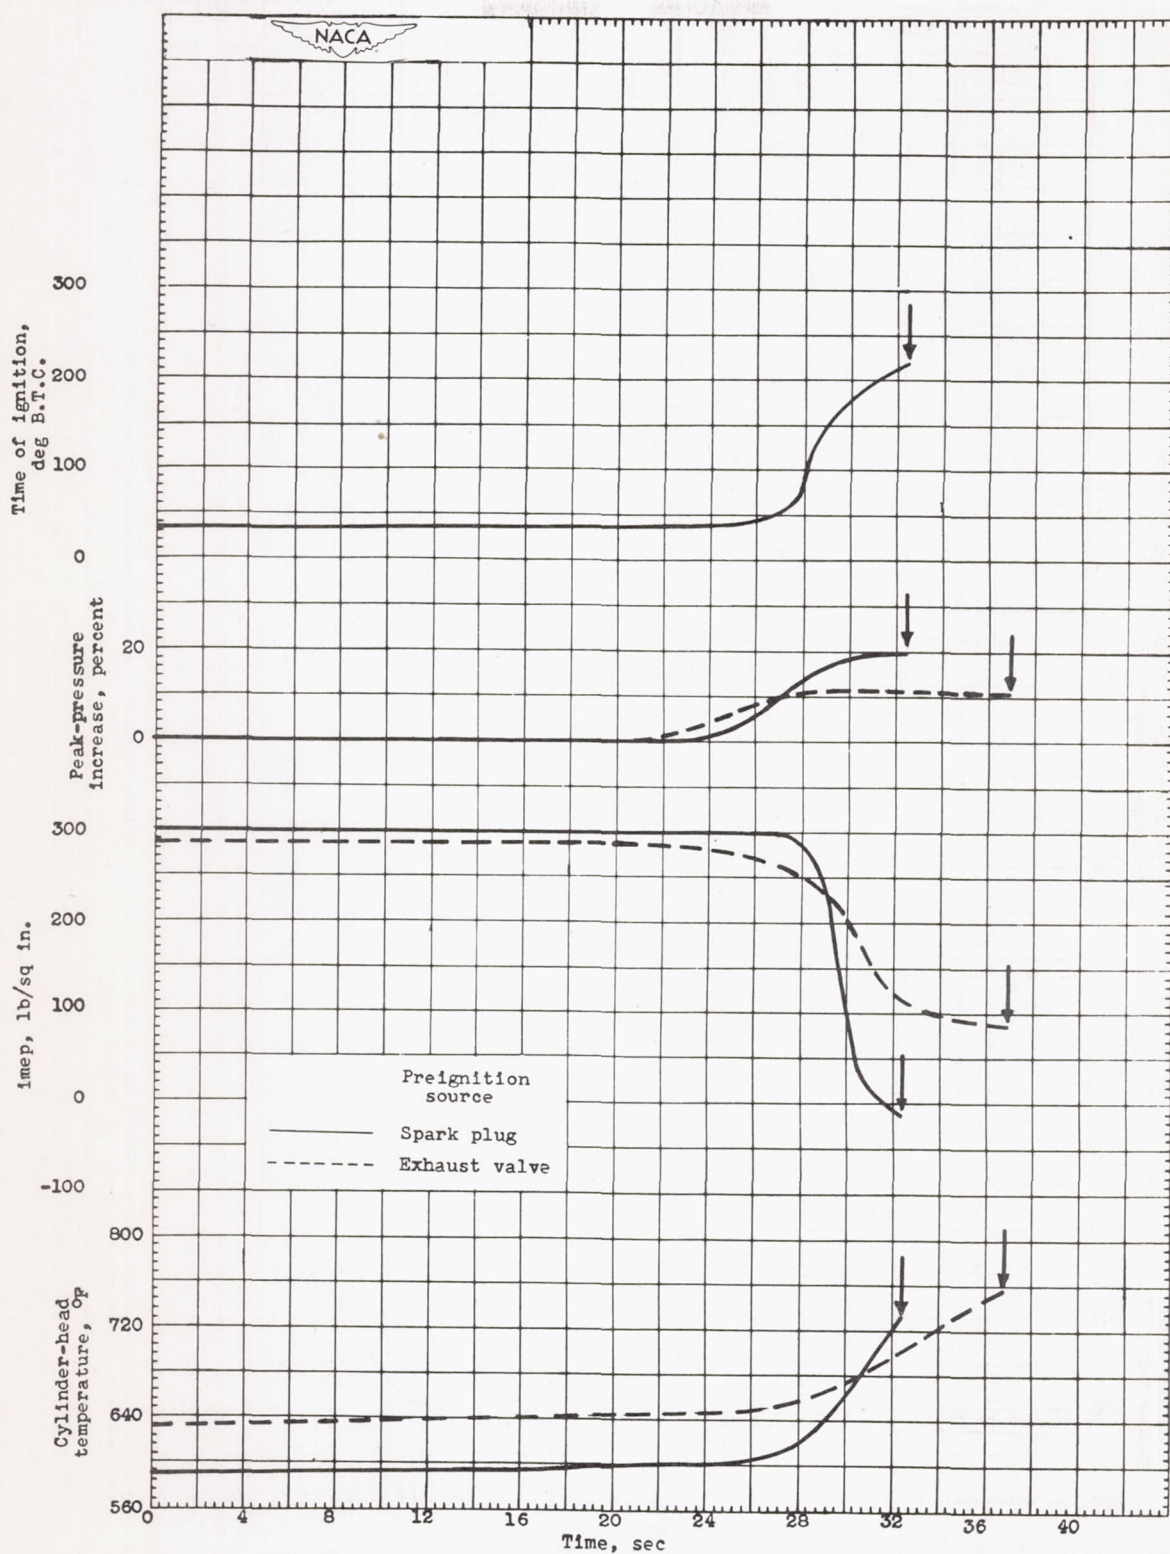
Effect of preignition source. - A comparison of preignition resulting from a hot spark plug and from a hot exhaust valve is shown in figure 10. When the hot exhaust valve was used, preignition advanced much more slowly than when the hot spark plug was used. Several minutes were required before preignition from the exhaust valve reached the point where it became rapidly accelerating. At the plotted zero point on the time scale, preignition was already in progress with the hot exhaust valve and had caused the cylinder-head temperature to rise approximately 50° F, whereas preignition had not yet begun with the hot spark plug. No satisfactory method of determining the time of ignition when the exhaust valve was the source was available, therefore the curve showing time of ignition is omitted from figure 10. From inspection of the power-output curves, however, it is apparent that backfiring took place with a less advanced time of ignition when the exhaust valve was the preignition source. This less-advanced time of ignition may explain the reason that the peak-pressure increase is lower for the exhaust-valve preignition than for the spark-plug preignition. These occurrences can be accounted for by the fact that the exhaust valves are much closer to the intake valves than is the exhaust spark plug.

Figure 10. - Effect of preignition source on behavior of engine when preignition is encountered. Engine speed, 3000 rpm; spark advance: inlet,  $28^{\circ}$  B.T.C.; exhaust,  $34^{\circ}$  B.T.C.; compression ratio, 6.65; outlet-coolant temperature,  $250^{\circ}$  F; mixture temperature,  $175^{\circ}$  F; inlet-oil temperature,  $185^{\circ}$  F; fuel-air ratio, 0.070; fuel, 30-percent cumene blend. (Arrows indicate time of backfire.)

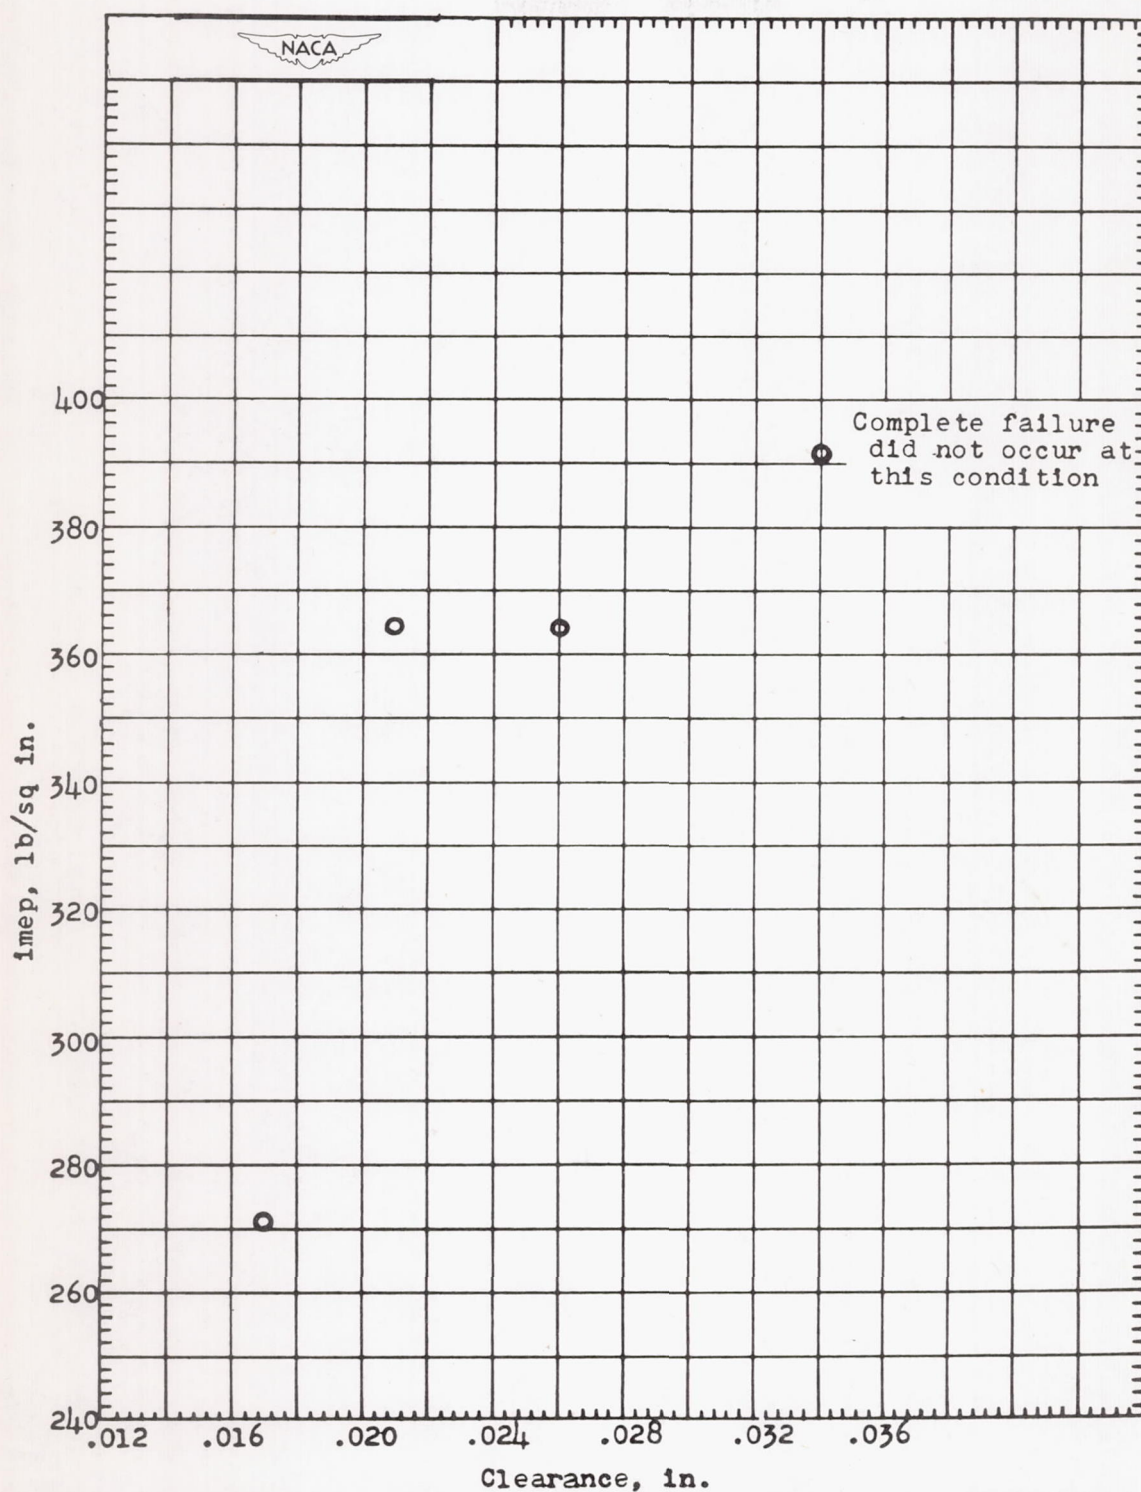
The indicated mean effective pressure required to cause piston destruction due to preignition as a function of clearance between the piston and the cylinder is shown in figure 13. Although the fuel-air ratios for the four runs were slightly different, the differences were small enough to be of no great importance. The points show that piston clearance is an important factor in preventing piston failures due to preignition. Determination of how near the piston cooling used for these destruction runs was to that used in the multicylinder engine is impossible; however, such a curve for other cooling conditions would undoubtedly show a similar trend.

Figure 13.- Effect of piston clearance (measured between top of piston skirt and cylinder barrel) on indicated mean effective pressure necessary to cause piston seizure when preignition is encountered.
