# NATIONAL ADVISORY COMMITTEE FOR AERONAUTICS

TECHNICAL NOTE 3973

ORIGIN AND PREVENTION OF CRASH FIRES IN TURBOJET AIRCRAFT

By I. Irving Pinkel, Solomon Weiss, G. Merritt Preston,  
and Gerard J. Pesman

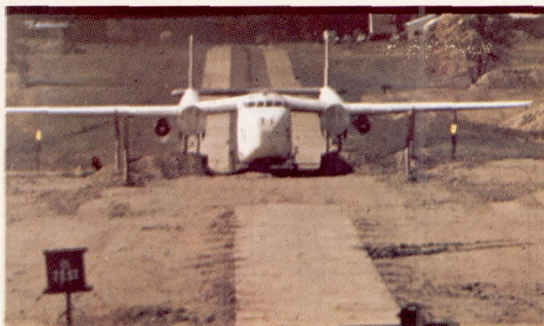
(a) Wing tank fuel spillage, 0.35 second after initial impact.

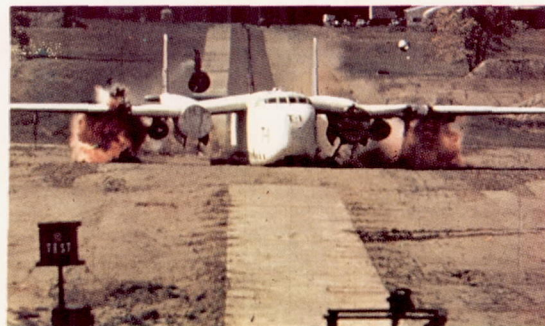
(b) Flames at engine tailpipe, 0.75 second after initial impact.

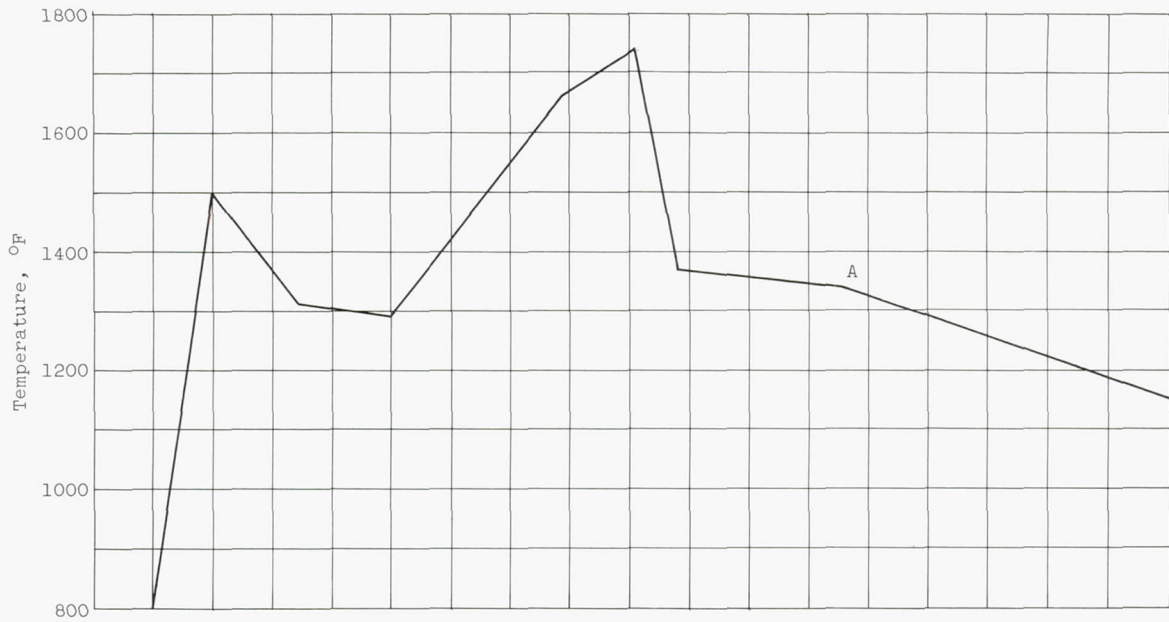
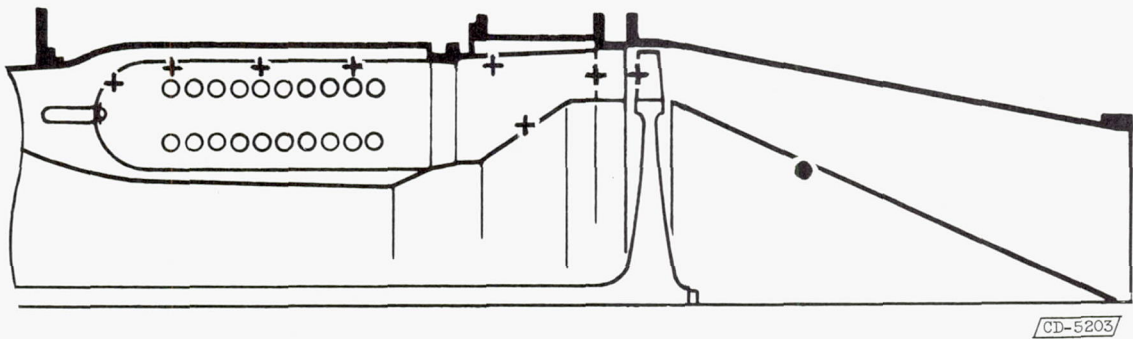
Figure 7. - Maximum temperatures of metal components in main gas streams of J47 and J35 engines.

Maximum temperatures obtained with the J47 and J35 engines running on the test stand were comparable (fig. 7). Temperatures of similar locations in the J30 engine, which are not given here, were also comparable to those recorded on the J47 and J35 engines.

The hottest parts of the engine, when operated at rated conditions, were those which lay in the main gas stream downstream of the compressor. The highest temperatures (fig. 7) were measured on the primary zone of the combustion liner, on the bend in the transition liner where the hot gases leaving the combustor impinge, and on the turbine nozzle vanes. Temperatures as high as  $1660^{\circ}$  and  $1740^{\circ}$  F were found on the transition liner and the adjacent turbine nozzle vanes, respectively. The stagnation gas temperature at the moving turbine blades was less than the stagnation temperature at stationary engine members in the same gas stream. The temperature of the blades was correspondingly lower, being about  $1370^{\circ}$  F for the hottest parts of the blade. The gases leaving the turbine were reduced in temperature because of the turbine work that had been done. Therefore, the temperature of the inner tailcone at location A on figure 7 was about  $400^{\circ}$  cooler than the turbine nozzle vanes. The temperature was about  $1350^{\circ}$  F at the hottest point of the inner cone and about  $1150^{\circ}$  F at its coolest point.

The largest temperature gradients occurred within the combustor (fig. 7) where some metal was in contact with the relatively cool combustor-inlet air and other metal was heated by the combustor flame. The maximum temperatures recorded were about  $800^{\circ}$  F on the dome, about  $1500^{\circ}$  F on the primary section of the combustor liner, and about  $1300^{\circ}$  F at the outlet. The lower temperatures at the combustor liner outlet were produced by the cooler secondary combustor air.

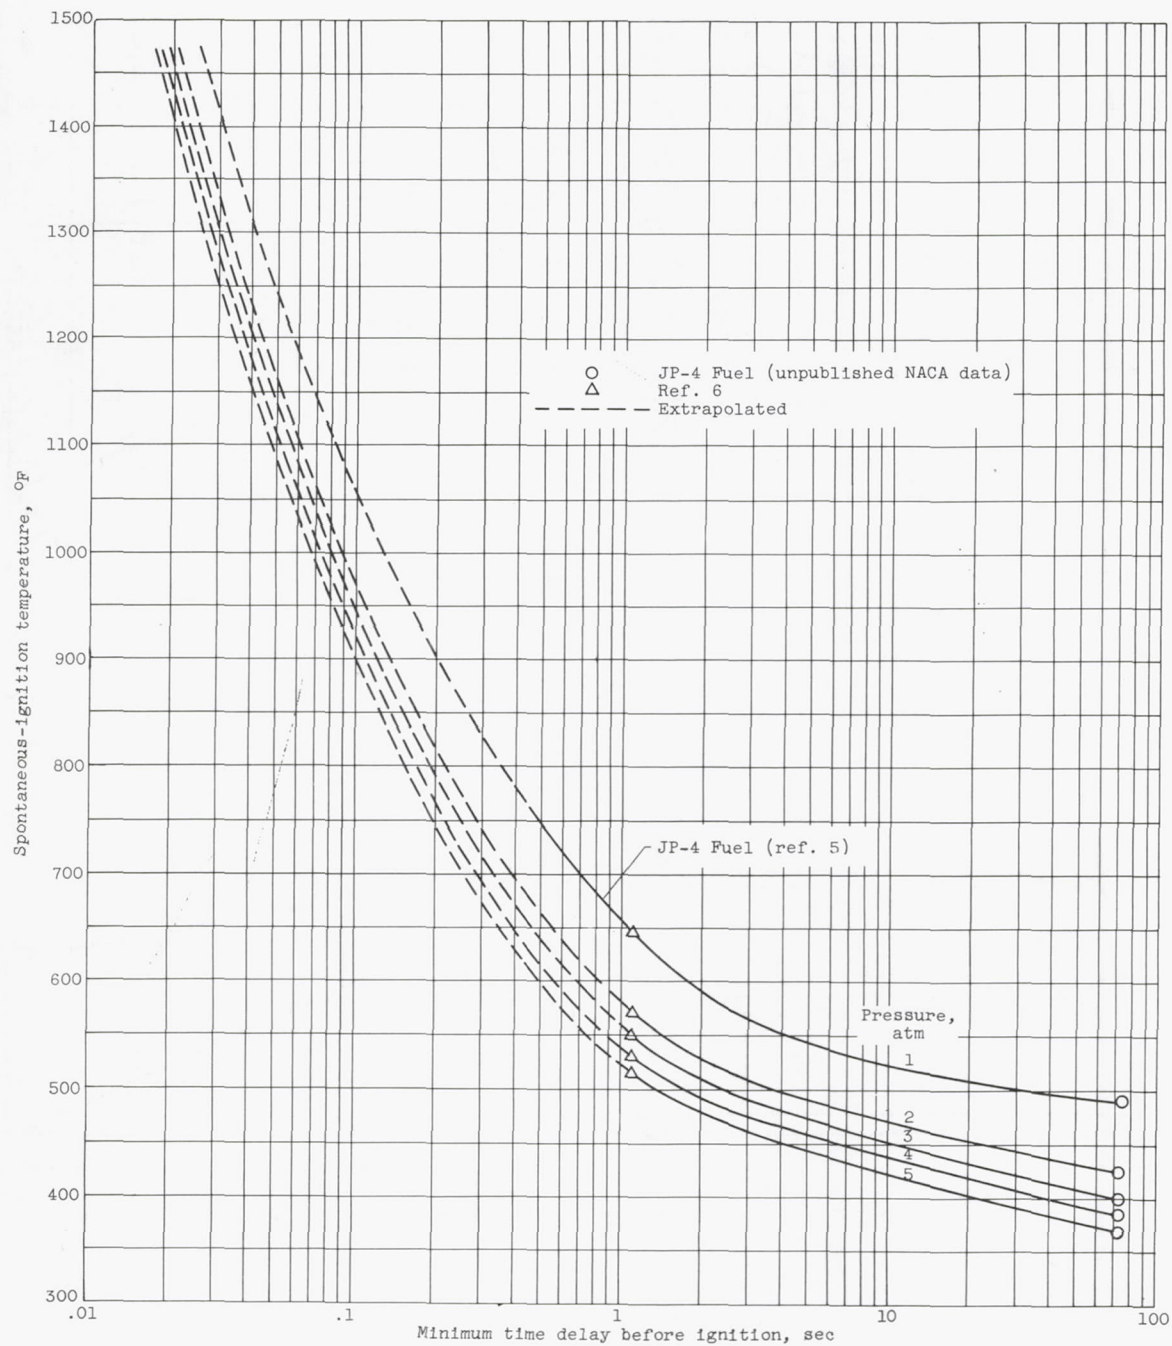
Figure 8. - Ignition characteristics of aviation fuels.

5017 The data on contact time required for ignition (fig. 8) can be used to obtain an approximation of the probability of hot-metal ignition of combustibles sucked into the engine inlet. The engine metal temperatures are known from the measurements given in figures 29 and 30. The contact time can be computed from the known mass airflow through the engine (fig. 33). From the airflow data for the J35 engine and the engine geometry, the local air velocity through the engine downstream of the turbine inlet was plotted and appears in figure 9. Velocities were calculated only at the engine stations marked on the sketch. Each line connecting the symbols provides the velocity distribution through the engine at the time indicated. It is interesting to note that at 3 seconds after fuel shut-off the velocity at the compressor exit was slightly higher than at the compressor inlet. This was due to the fact that the turbine-inlet total temperature had fallen to the point where it caused a large drop in compressor-exit static pressure. The lower static pressure was the dominant influence on the speedup in airflow.

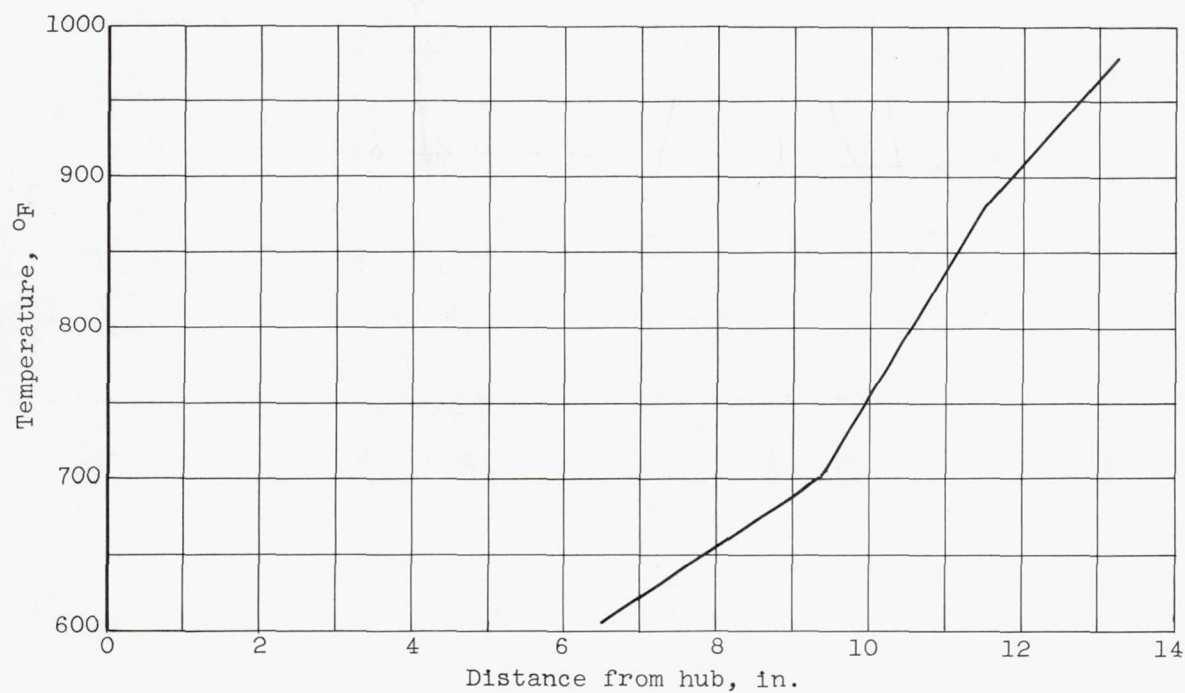
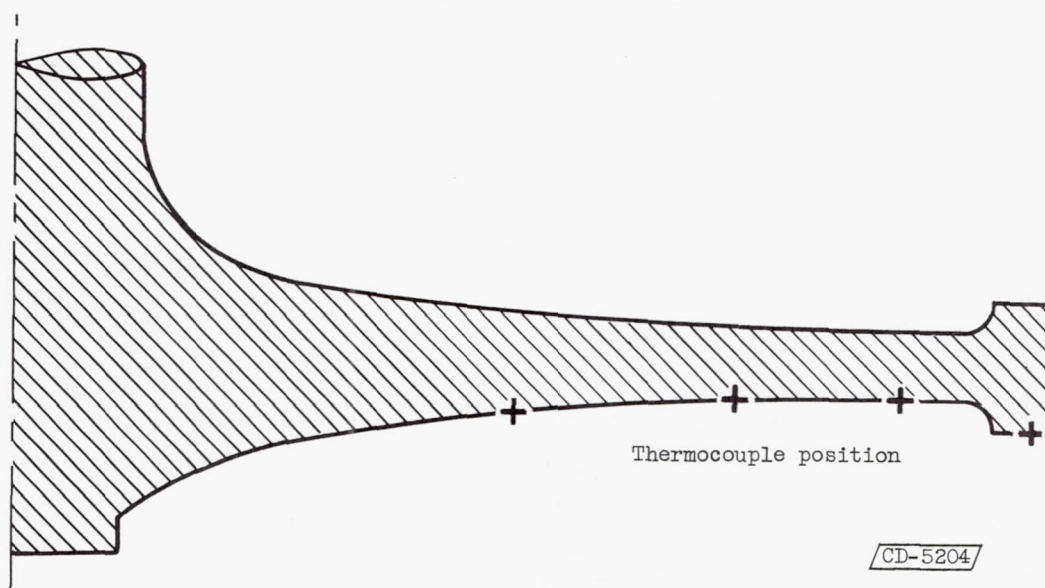
Figure 28. - Maximum temperatures recorded on J47-engine turbine wheel.

Engine parts not in the main gas stream were heated mostly by conduction. The turbine wheel was the most massive engine part heated this way. The radial variation in temperature on the surface of the turbine wheel, shown in figure 28, resulted from the fact that the heat conduction was from the wheel rim to the relatively cool hub. The data shown were obtained with the engine operating at rated sea-level conditions. The turbine-wheel surface temperature varied from approximately  $980^{\circ}$  F at the rim to about  $605^{\circ}$  F at a point midway between the rim and hub. Cooling air from the compressor applied to the hub to protect the engine bearings maintained this temperature pattern.

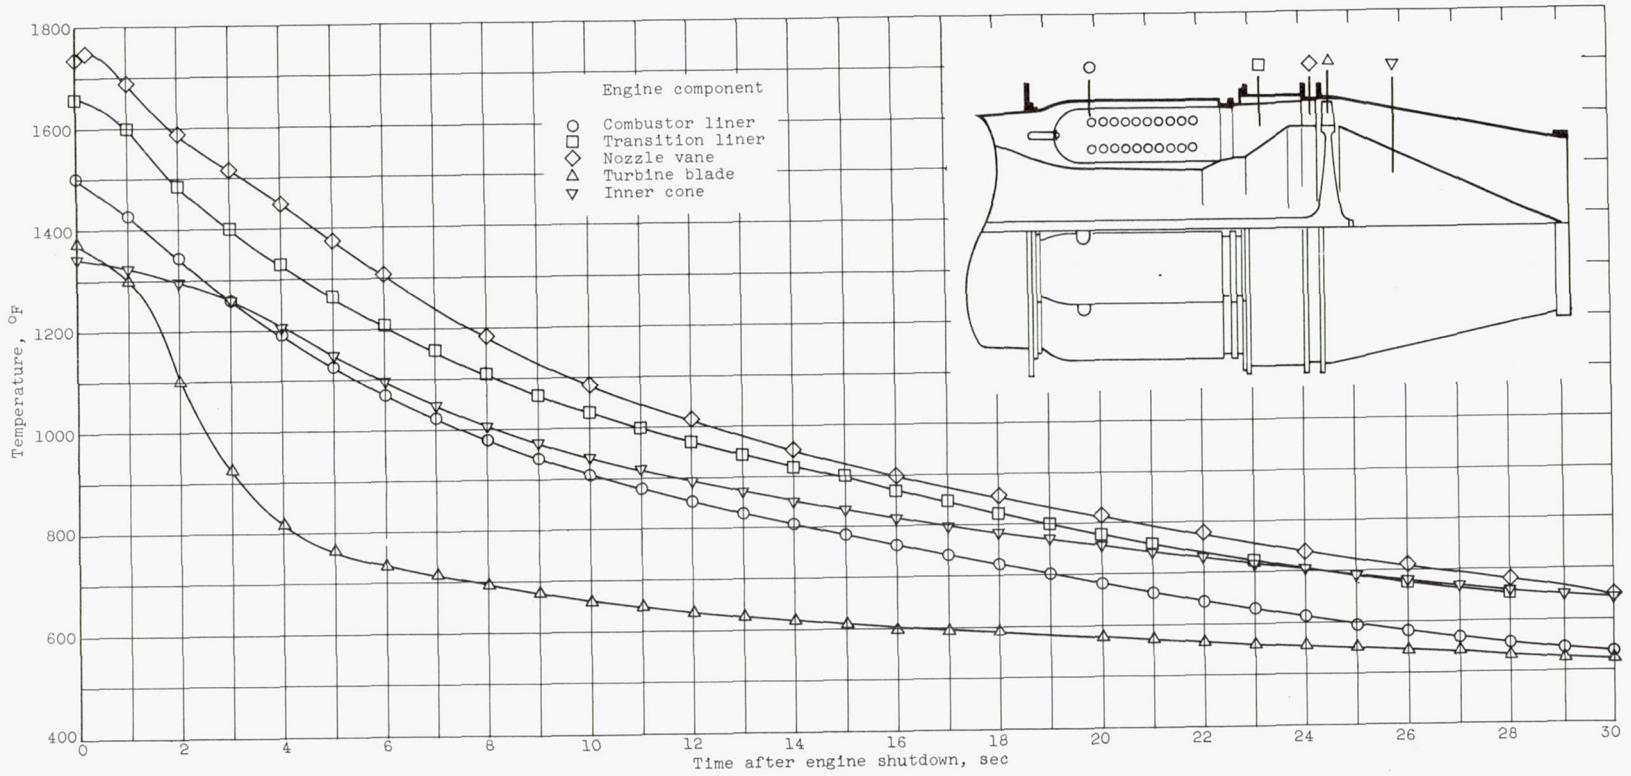
Figure 29. - History of maximum temperatures on engine components in main gas stream.

A history of the temperature of engine parts lying in the main gas stream is shown in figure 29. Fuel shutoff occurred at zero second, and the temperatures indicated were the maximum recorded anywhere on the component at the time noted. The hottest section of the combustion-chamber liner cooled from  $1500^{\circ}$  to  $600^{\circ}$  F in  $24\frac{1}{2}$  seconds. It took over 30 seconds for the transition-liner temperature to decline from  $1660^{\circ}$  to  $600^{\circ}$  F. In 30 seconds the turbine nozzle-vane temperature dropped from a maximum temperature of  $1750^{\circ}$  to  $645^{\circ}$  F. The rotating turbine blade temperature fell from  $1370^{\circ}$  to  $600^{\circ}$  F in 16 seconds. Inner-cone skin temperatures declined from  $1340^{\circ}$  to  $640^{\circ}$  F in 30 seconds.

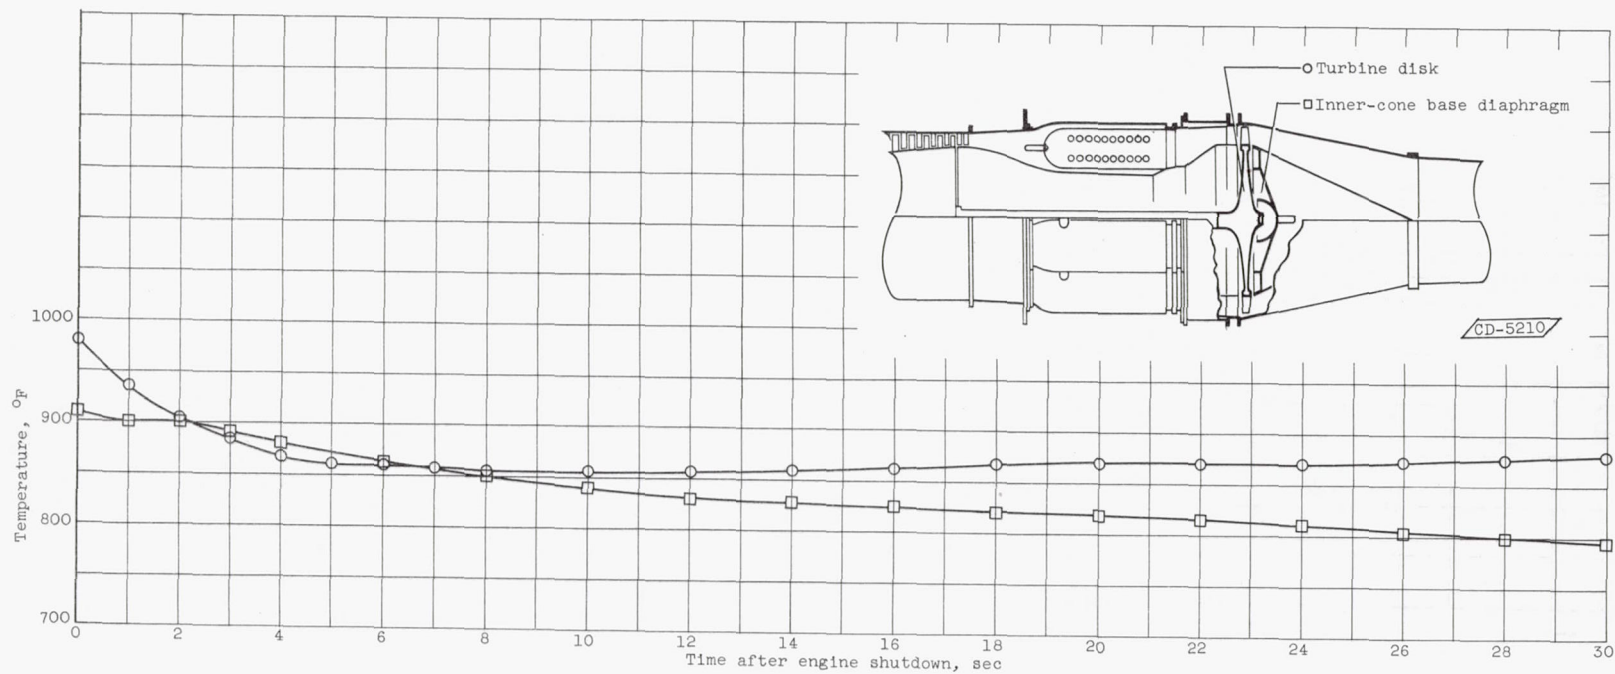
Figure 30. - History of maximum temperatures on turbine disk and inner-cone base diaphragm.

Engine parts not located in the main gas stream declined in temperature at much slower rates (fig. 30). The hottest part of the turbine wheel was initially at  $980^{\circ}$  F and dropped only  $100^{\circ}$  F in 30 seconds after fuel flow to the engine had stopped. The turbine wheel remained above the ignition temperature of JP-4 fuel for 30 minutes after the engine was shut down. The large mass of the turbine disk contributed to its slow cooling rate. The inner-cone base diaphragm exhibited the same slow rate of cooling. Its maximum temperature was  $910^{\circ}$  F and cooled only approximately  $115^{\circ}$  F in 30 seconds.

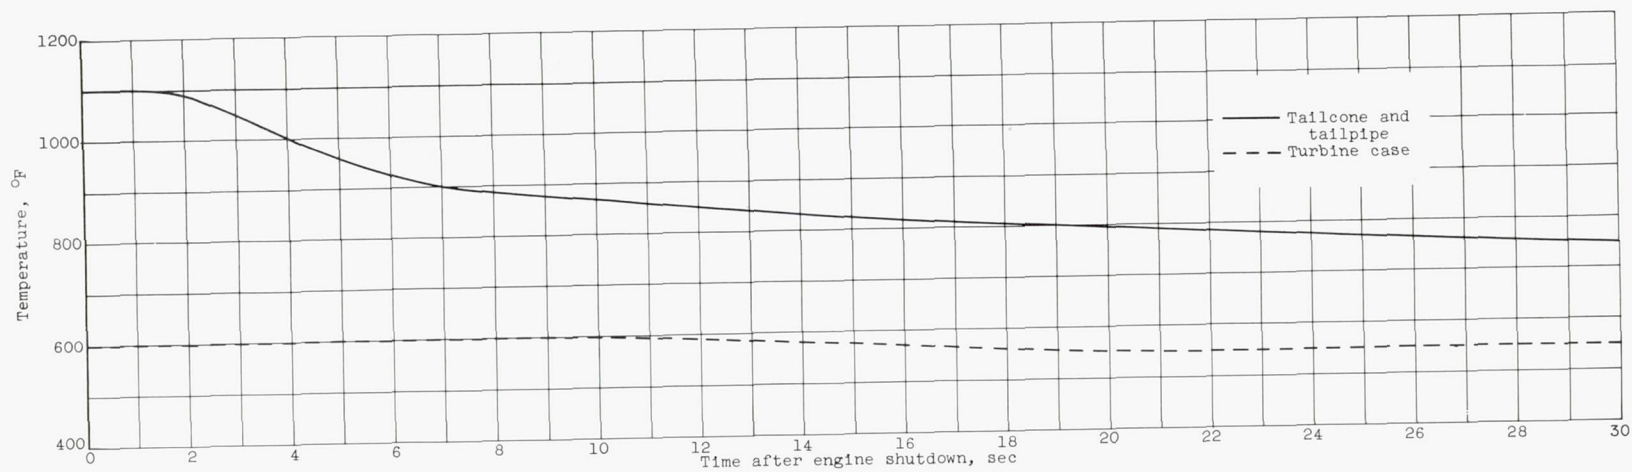
Figure 31. - History of maximum external skin temperatures on J47 turbine case and tailcone and tailpipe.

Temperature measurements made on the external skin of the J47 engine (fig. 31) indicated that the tailcone and tailpipe temperatures remained above  $600^{\circ}$  F for more than 30 seconds after the fuel to the combustor was shut off. Temperatures of the engine case upstream of the tailcone and tailpipe were usually below  $600^{\circ}$  F (fig. 32). Although the turbine case reached a maximum temperature of  $600^{\circ}$  F and remained so for 10 seconds after the fuel was shut off (fig. 31), no ignitions were experienced here.

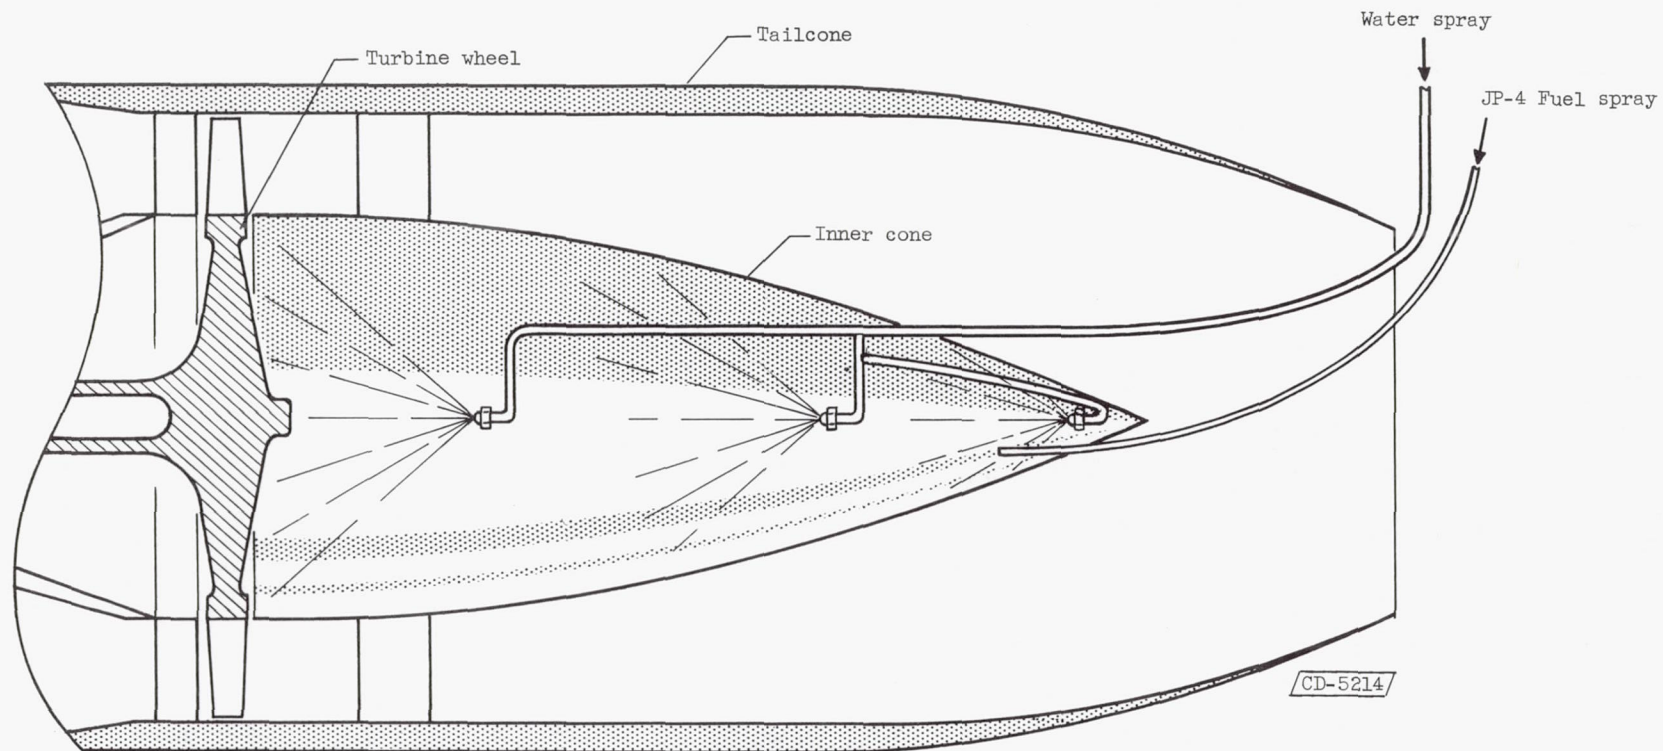
Figure 34. - Sketch of typical equipment used to study ignition hazard (J30 inner tailcone).

The engine cavity farthest downstream, the inner tailcone, was studied first. The arrangements used for the J30 tailcone are shown schematically in figure 34. A fuel system, consisting of a single tube and nozzle, was arranged to spray fuel in measured quantities into the cavity of the tailcone to produce a combustible atmosphere. In addition, three water spray nozzles were installed facing the upstream direction. Since the J30 engine has no base diaphragm, the downstream face of the turbine wheel must be taken as a bounding surface of this cavity. The upstream water nozzle was arranged to spray water on the turbine wheel to avoid ignition from this source.
