NATIONAL ADVISORY COMMITTEE FOR AERONAUTICS

TECHNICAL NOTE 4030

EXPERIMENTAL INVESTIGATION OF CERMET TURBINE BLADES
IN AN AXIAL-FLOW TURBOJET ENGINE

By William C. Morgan and George C. Deutsch

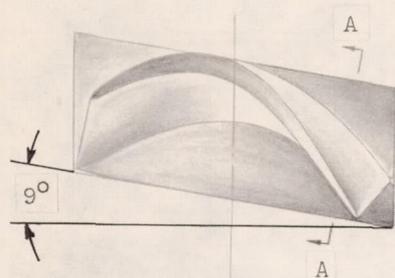
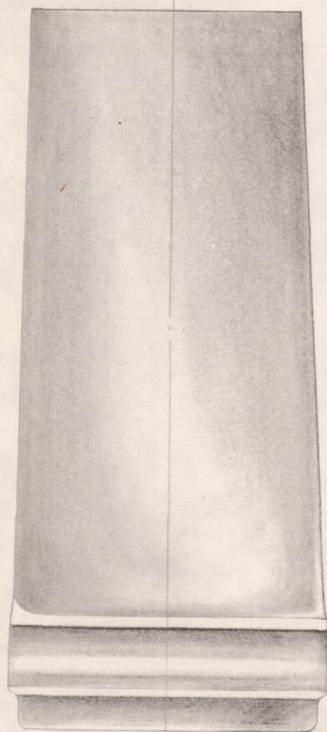
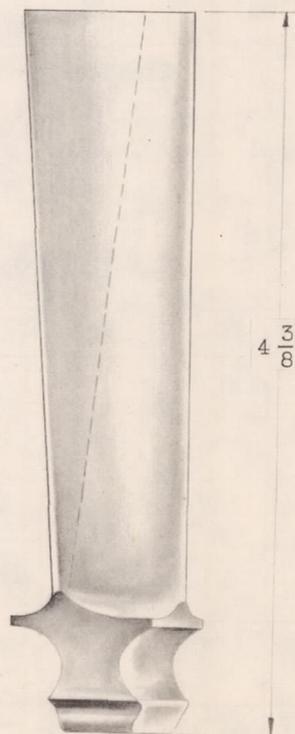
Modification used in some test
operations ($\frac{1}{4}$ " radii at blade tip)

Figure 1. - Cermet turbine blade.

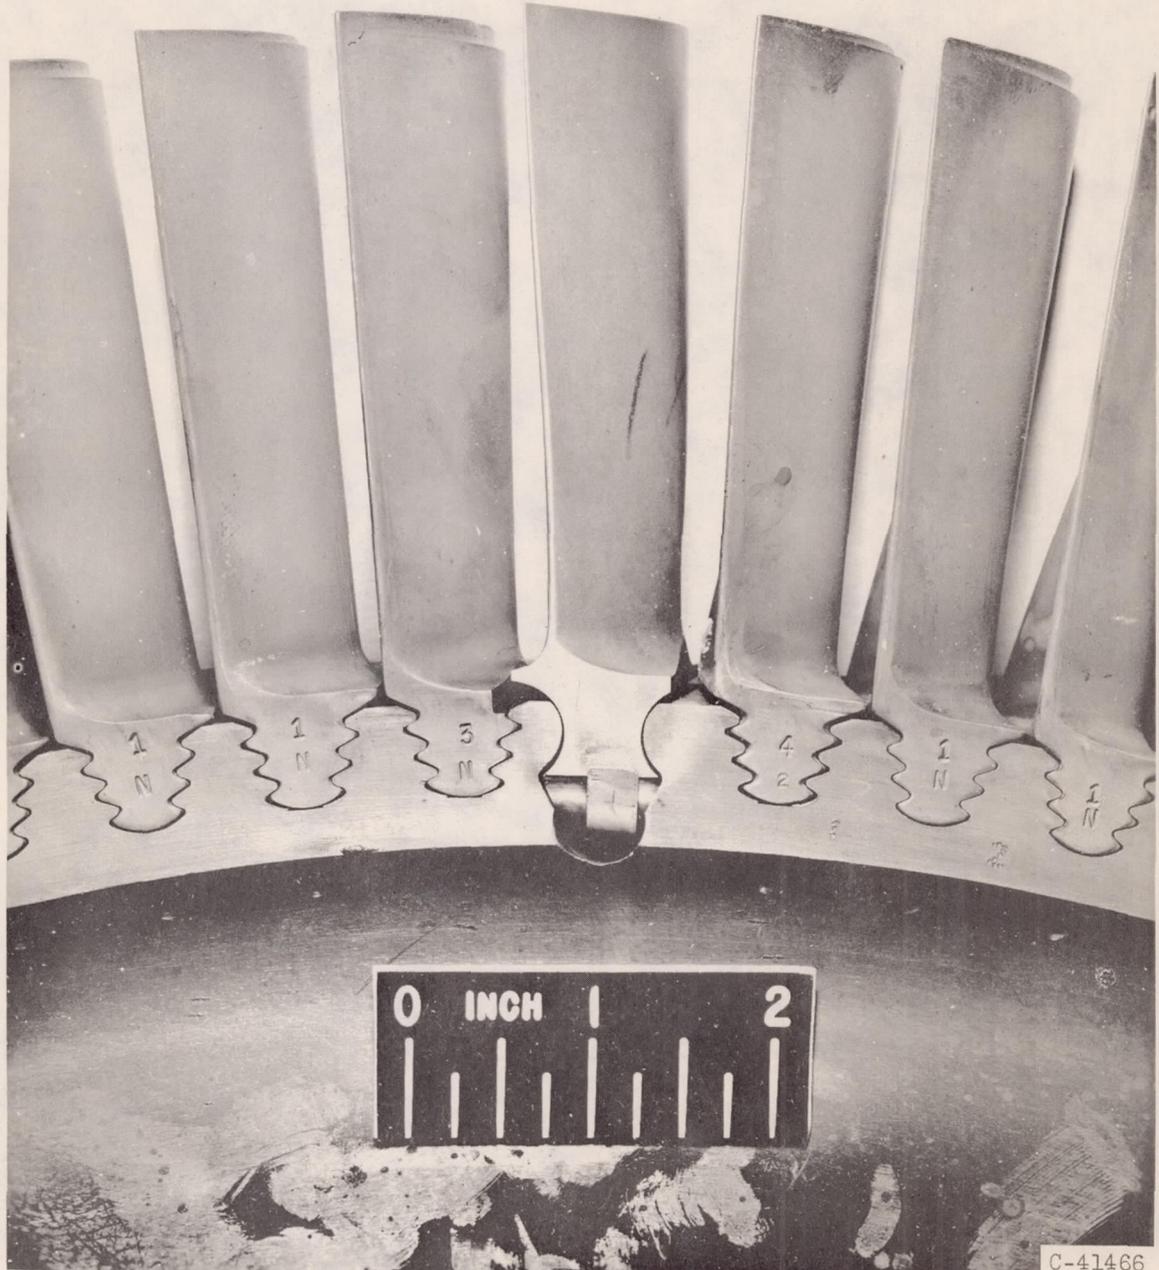
(c) Vibration may have been more serious in the six-blade tests. The spacing between the outer blades of a cluster of three and the adjacent metal blades was not a normal condition (fig. 2). In the course of a concurrent program on light-weight metal blades one test blade was placed in the space normally occupied by two blades. This metal test blade failed because of fatigue in the tip after a short time; blade life was less than 2 percent of the time for similar test blades in standard spacing.

Figure 3. - Cermet turbine blade installed in standard spacing.

- (a) Elimination of excessive space between cermet and adjacent standard blade; installation in tests 15 and 16 of a single cermet blade in same relative position as standard metal blades, as shown in figure 3
- (b) Use of phased nozzle assembly to damp out excitation from the 64th order of turbine speed
- (c) Use of 57-vane nozzle assembly to bring excitation forces below the resonant frequency of a majority of blade complex vibration modes

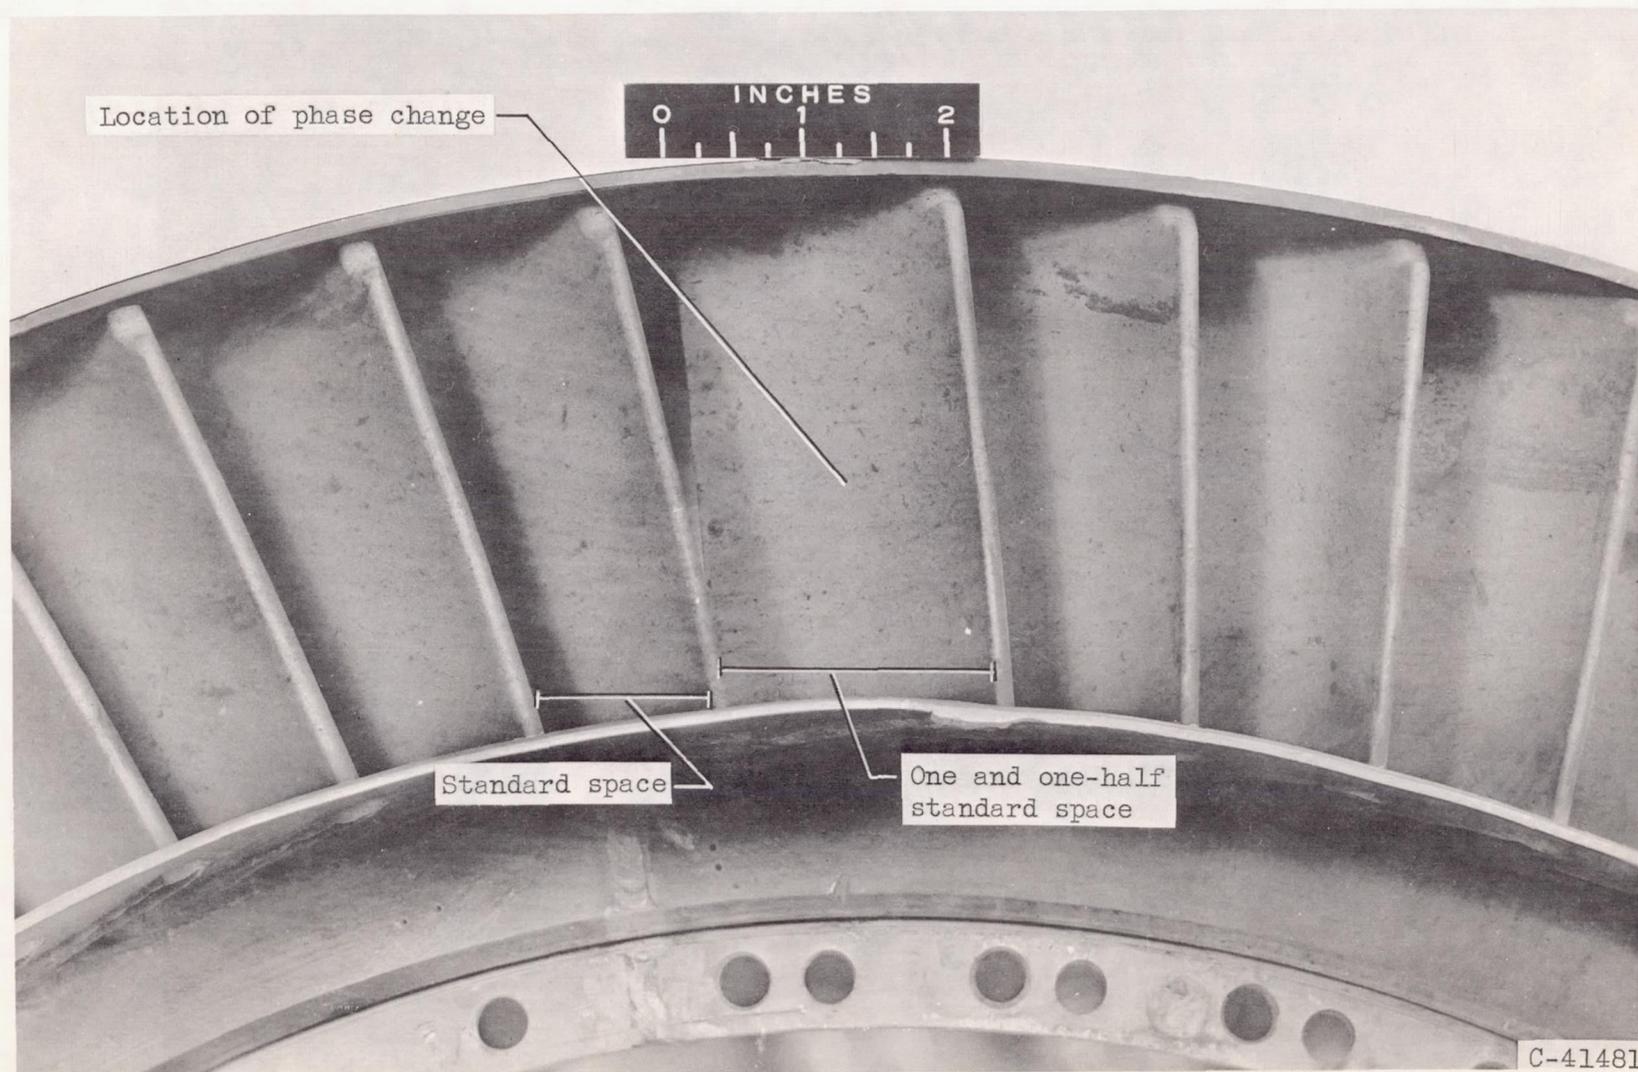
One special assembly had 57 vanes equally spaced (tests 8, 8a, and 8b). In the fabrication of the second modified assembly ("phased" assembly for tests 10, 11, and 12) a standard unit was cut apart on a diameter. An arc segment containing one vane adjacent to a cut face was removed, and the remainder of that half of the assembly was revolved through an arc equal to one-half standard vane space. With the two parts fixed in this relation, material was added to the inner and outer rings where required to complete the reassembly. Figure 4 shows the resulting vane spacing at the location of phase change. There was a similar discontinuity nearly diametrically opposite.

Figure 4. - Phased nozzle diaphragm, showing location of phase change; 61 standard spaces; 2 phase-change spaces.
