# RESEARCH MEMORANDUM

OBSERVATIONS ON AN AILERON-FLUTTER INSTABILITY ENCOUNTERED  
ON A 45° SWEPT-BACK WING IN TRANSONIC AND SUPERSONIC FLIGHT

Marvin Pitkin, William N. Gardner  
and Howard J. Curfman, Jr.

April 11, 1947

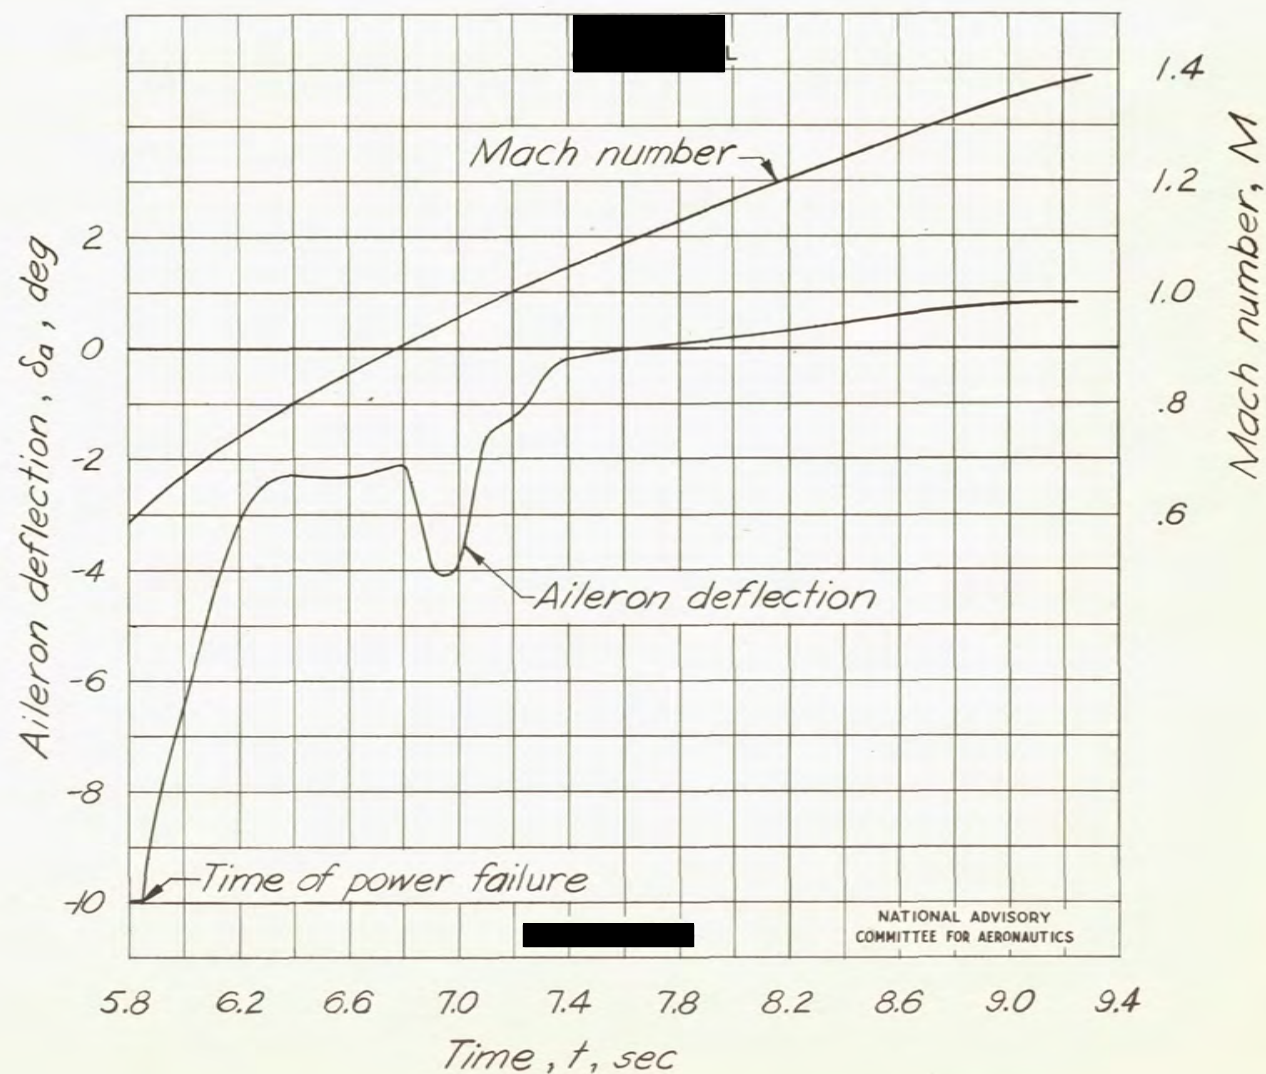
Telemeter records showed that normal operation of the ailerons and automatic pilot was experienced prior to the power failure. The model stabilized in roll during this period, and a rolling oscillation of  $\pm 3.5^\circ$  amplitude was obtained up to the time the sustaining rocket ignited (5.8 seconds). After this time, the control was free floating. Figure 8(a) shows the aileron behavior and Mach number variation for the time the sustaining rocket was firing. These data are cross-plotted in figure 8(b) to show the variation of control deflection with Mach number.

(a) Aileron deflection and Mach number against time.  
Figure 8.- Aileron characteristics in accelerated flight.
