NACA RM E50C15

EFFECTS OF INLET ICING ON PERFORMANCE OF AXIAL-FLOW
TURBOJET ENGINE IN NATURAL ICING CONDITIONS

By Loren W. Acker and Kenneth S. Kleinknecht

May 25, 1950

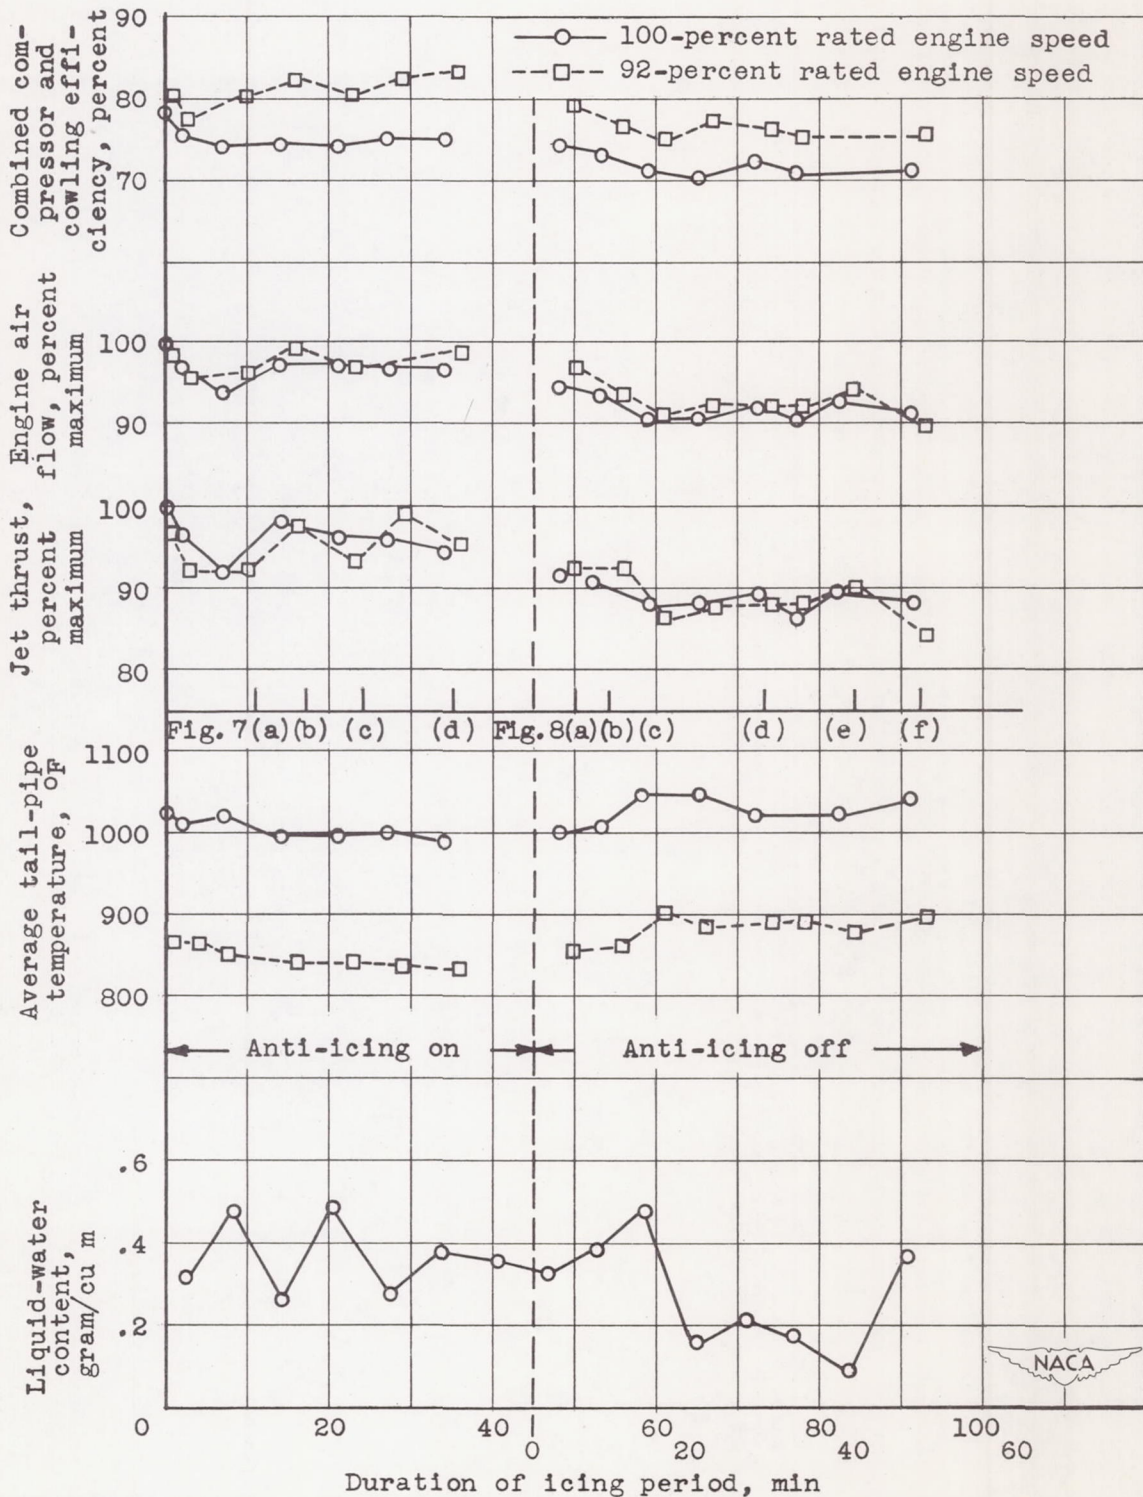
The data obtained from flight 2 are shown in figure 6. In the first part of the flight, during which icing protection was provided for all of the inlet components except the inlet guide vanes, maximum losses of 8 percent in jet thrust, 6 and 4 percent in air flow, and a 4- and 6-percent decrease in compressor efficiency occurred during 45 minutes of operation at 100- and 92-percent rated speed, respectively, because of the restriction imposed by ice on the guide vanes. Increase in engine tail-pipe temperature due to the ice formations was negligible during this period at both engine speeds.

Comparison of the results of the two phases of flight 2 (fig. 6) revealed that ice accretions on the compressor-inlet guide vanes accounted for about one-half the total reduction in engine performance caused by ice on the air inlet. The range of icing conditions remained sufficiently alike throughout the flight to validate this comparison.

Figure 6. - Time history of flight data obtained in icing condition during flight 2. Ambient-air temperature, 22° to 26° F; droplet size, 11 to 20 microns; indicated airspeed, 170 to 180 miles per hour; pressure altitude, 5000 to 6400 feet.

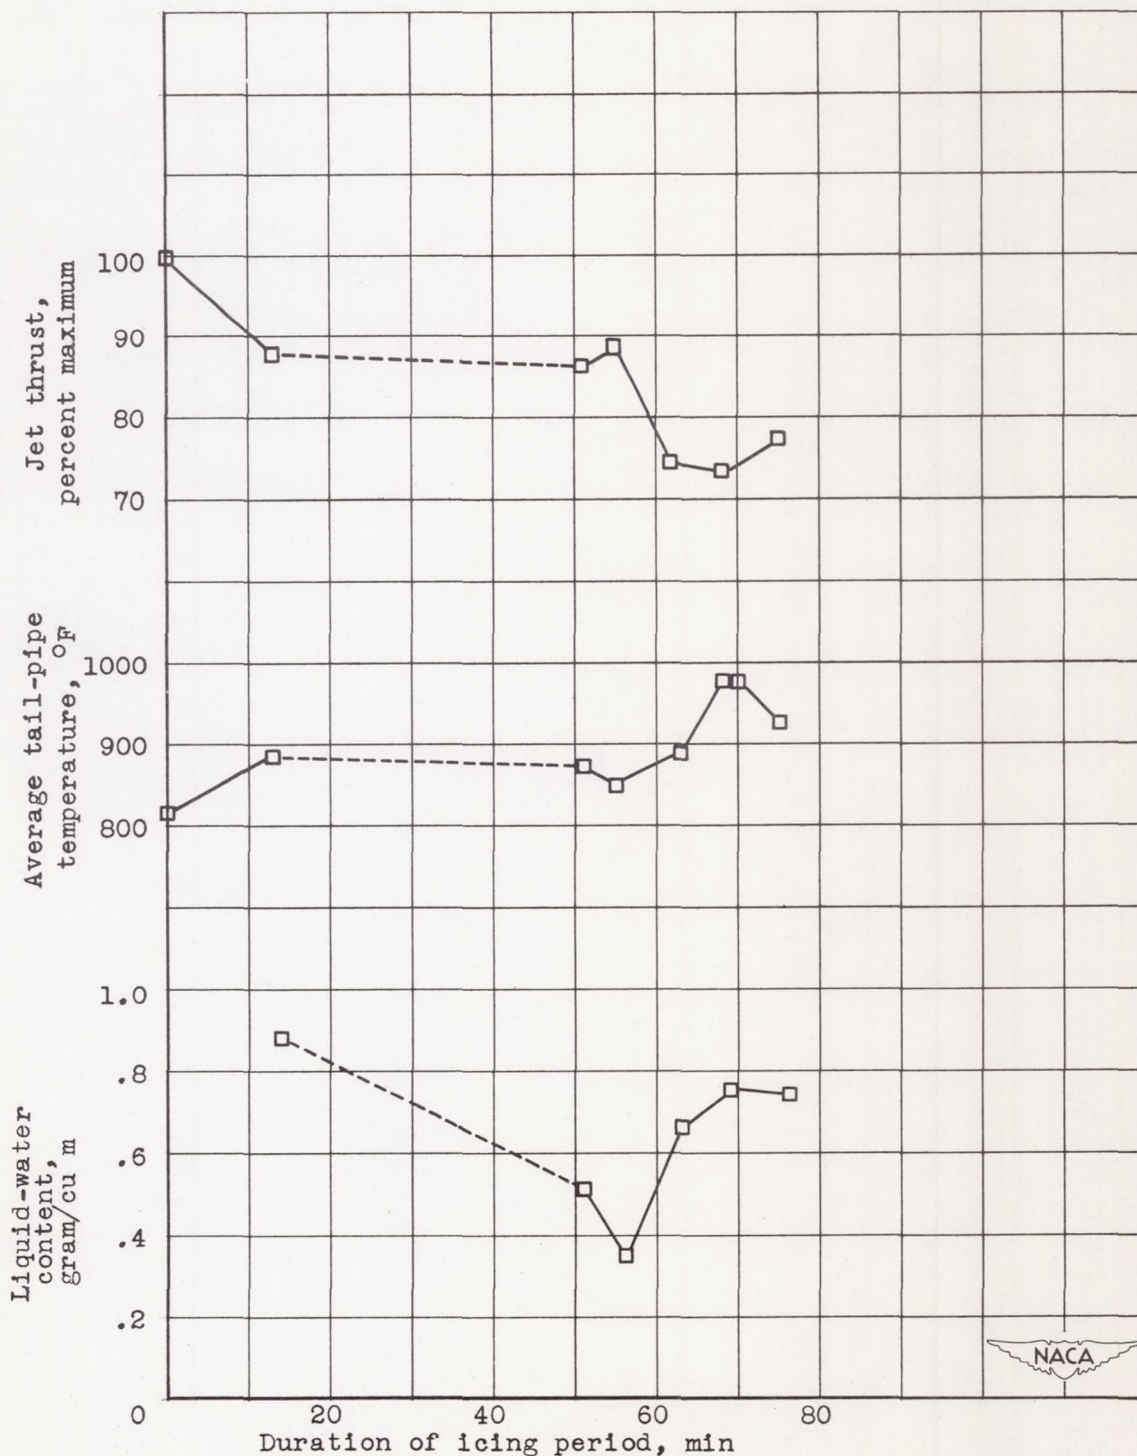
approximately 0.4 to 0.9 gram per cubic meter, which was the highest value of liquid-water content reached during the entire investigation. Water-droplet diameters ranged from 12 to 14 microns and the ambient-air temperature from 17° to 22° F. The resulting ice formations on the engine inlet caused a maximum reduction of 26 percent in thrust and a maximum increase of 160° F in tail-pipe temperature after 70 minutes of operation in the icing condition, as shown in figure 9. Photographs of these ice formations are shown in figure 10. During that part of the flight indicated by the dashed sections of the curves in figure 9, the icing was too intermittent and light to permit reliable measurements.

Figure 9. - Time history of flight data obtained in icing condition during flight 3 at 92-percent rated engine speed. Ambient-air temperature, 17° to 22° F; droplet size, 12 to 14 microns; indicated airspeed, 173 to 185 miles per hour; pressure altitude, 4600 to 5900 feet.
