# RESEARCH MEMORANDUM

INVESTIGATION OF MECHANISMS OF BLADE FAILURE OF  
FORGED HASTELLOY B AND CAST STELLITE 21  
TURBINE BLADES IN TURBOJET ENGINE

By C. Yaker, C. F. Robards, and F. B. Garrett

August 22, 1951  
Declassified September 10, 1954

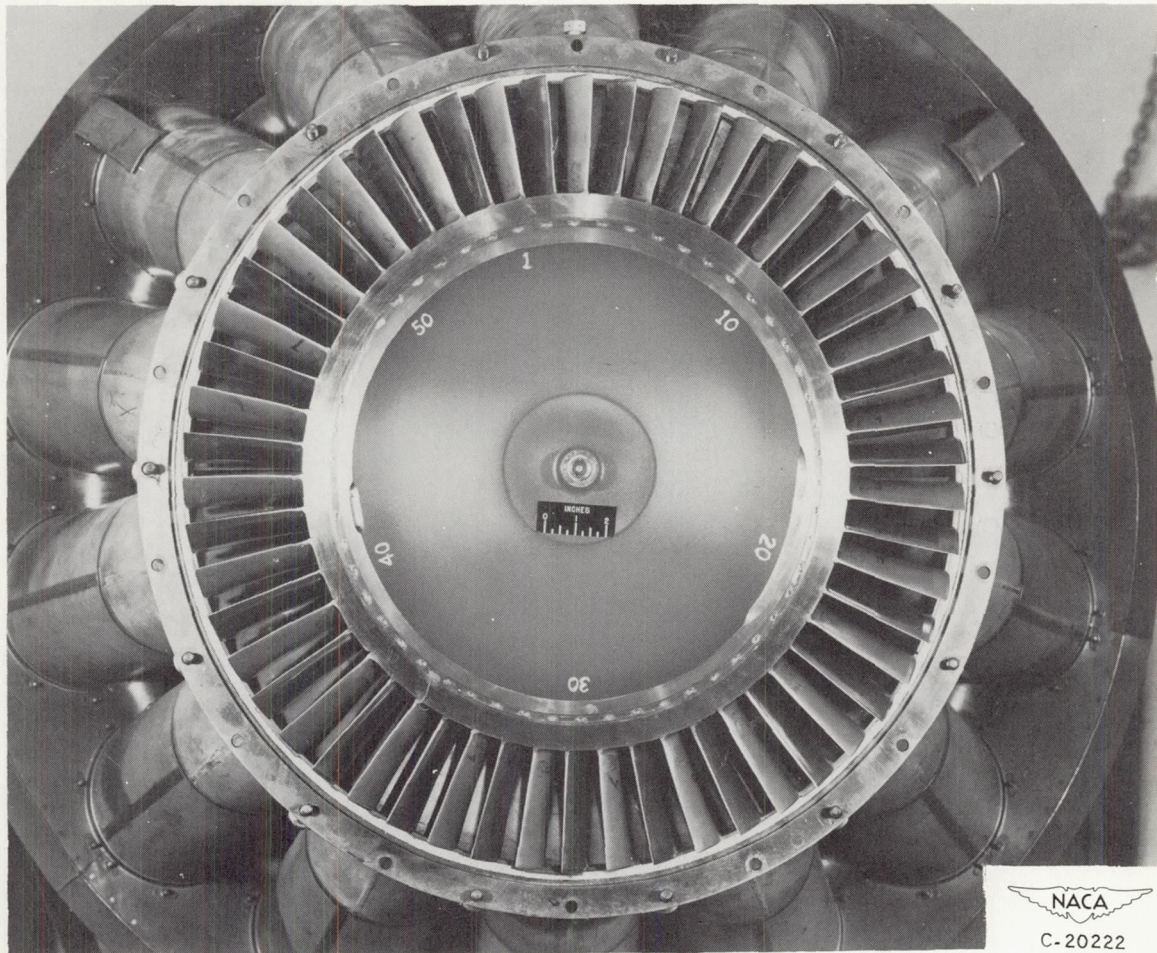
Figure 1. - Turbine rotor of Timken alloy before operation, alternately bladed with Hastelloy B and Stellite 21 turbine blades.

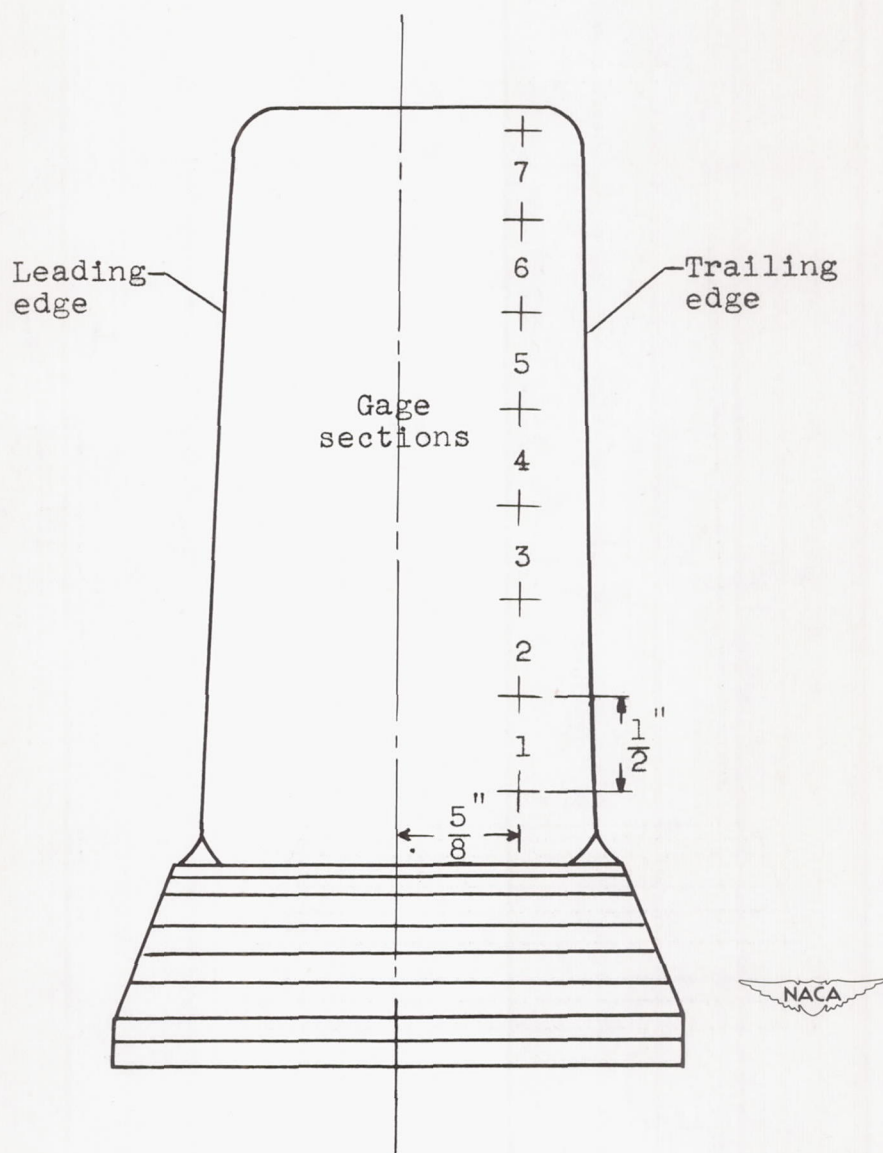
Figure 2. - Location of scribe marks on convex side of turbine blade for measurement of elongation.

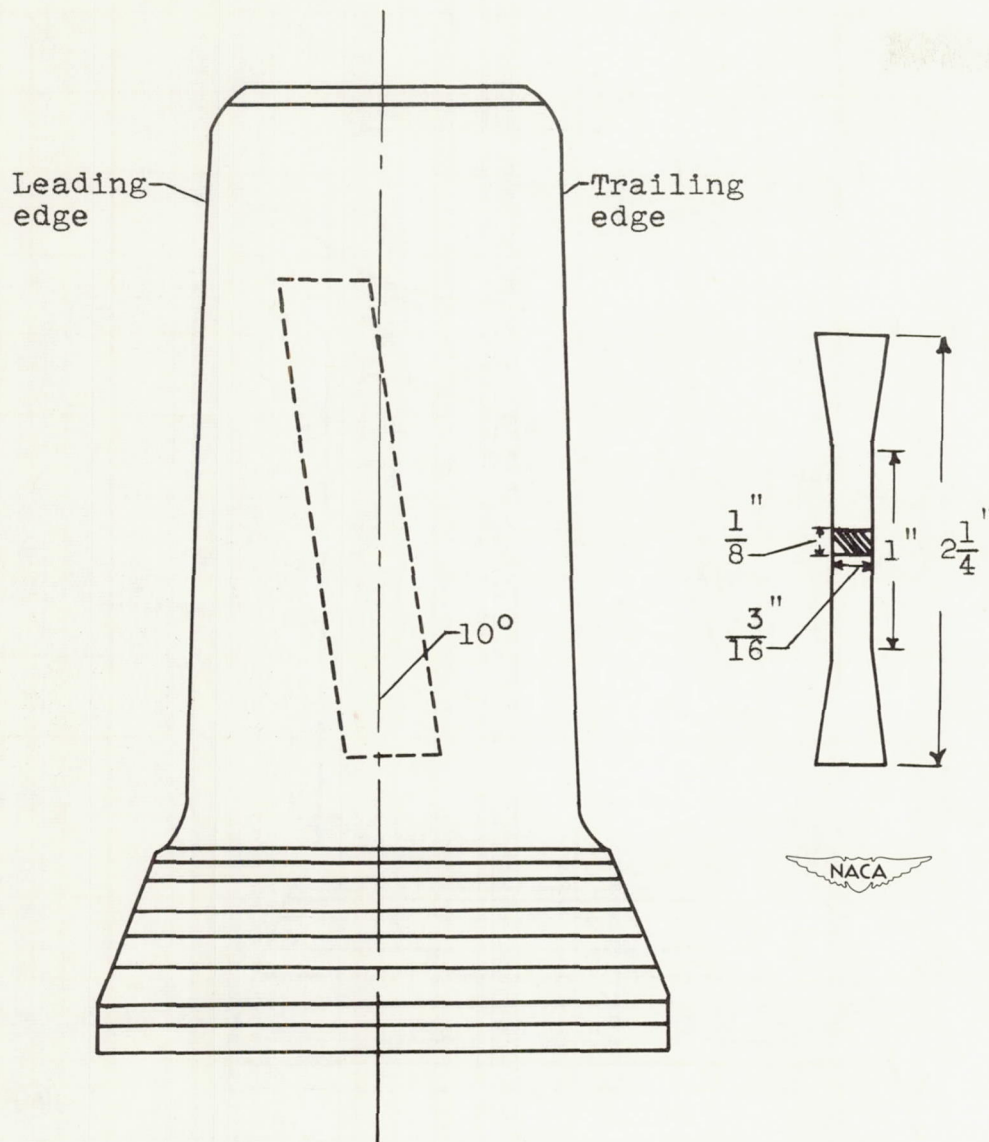
Figure 3. - Blade stress-rupture specimen and zone from which specimen is machined.

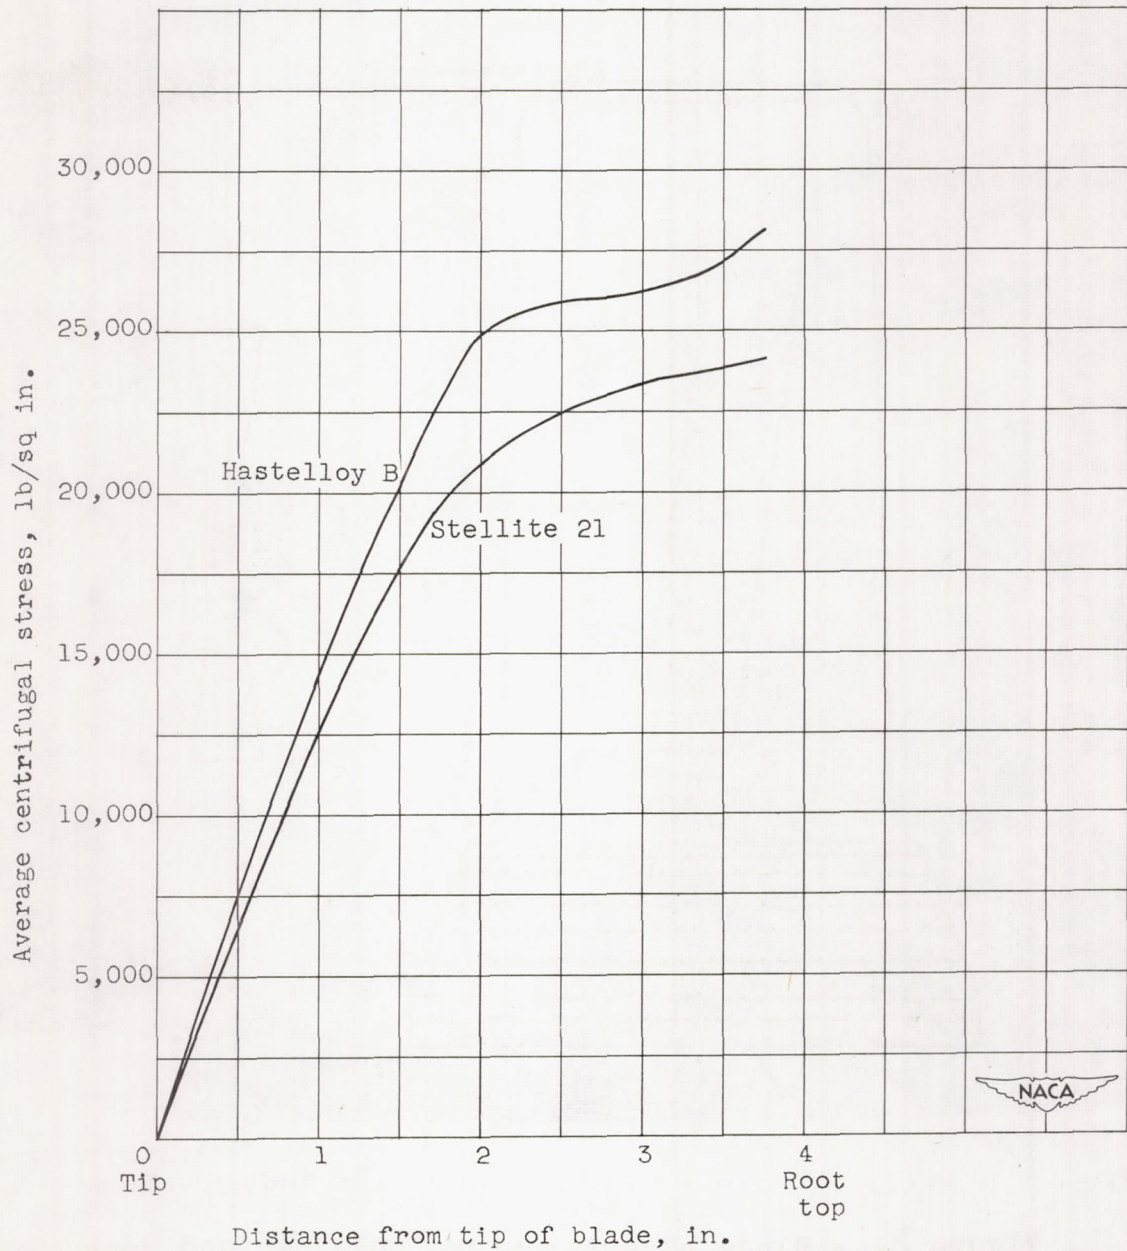
The results of the stress determinations based on the measured cross-sectional areas and 11,500 rpm for the two alloys Hastelloy B and Stellite 21 are plotted in figure 4. The stress curves are based on the average areas of six blades and an engine speed of 11,500 rpm.

Figure 4. - Average centrifugal stress distributions in Hastelloy B and Stellite 21 turbine blades at rotor speed of 11,500 rpm.

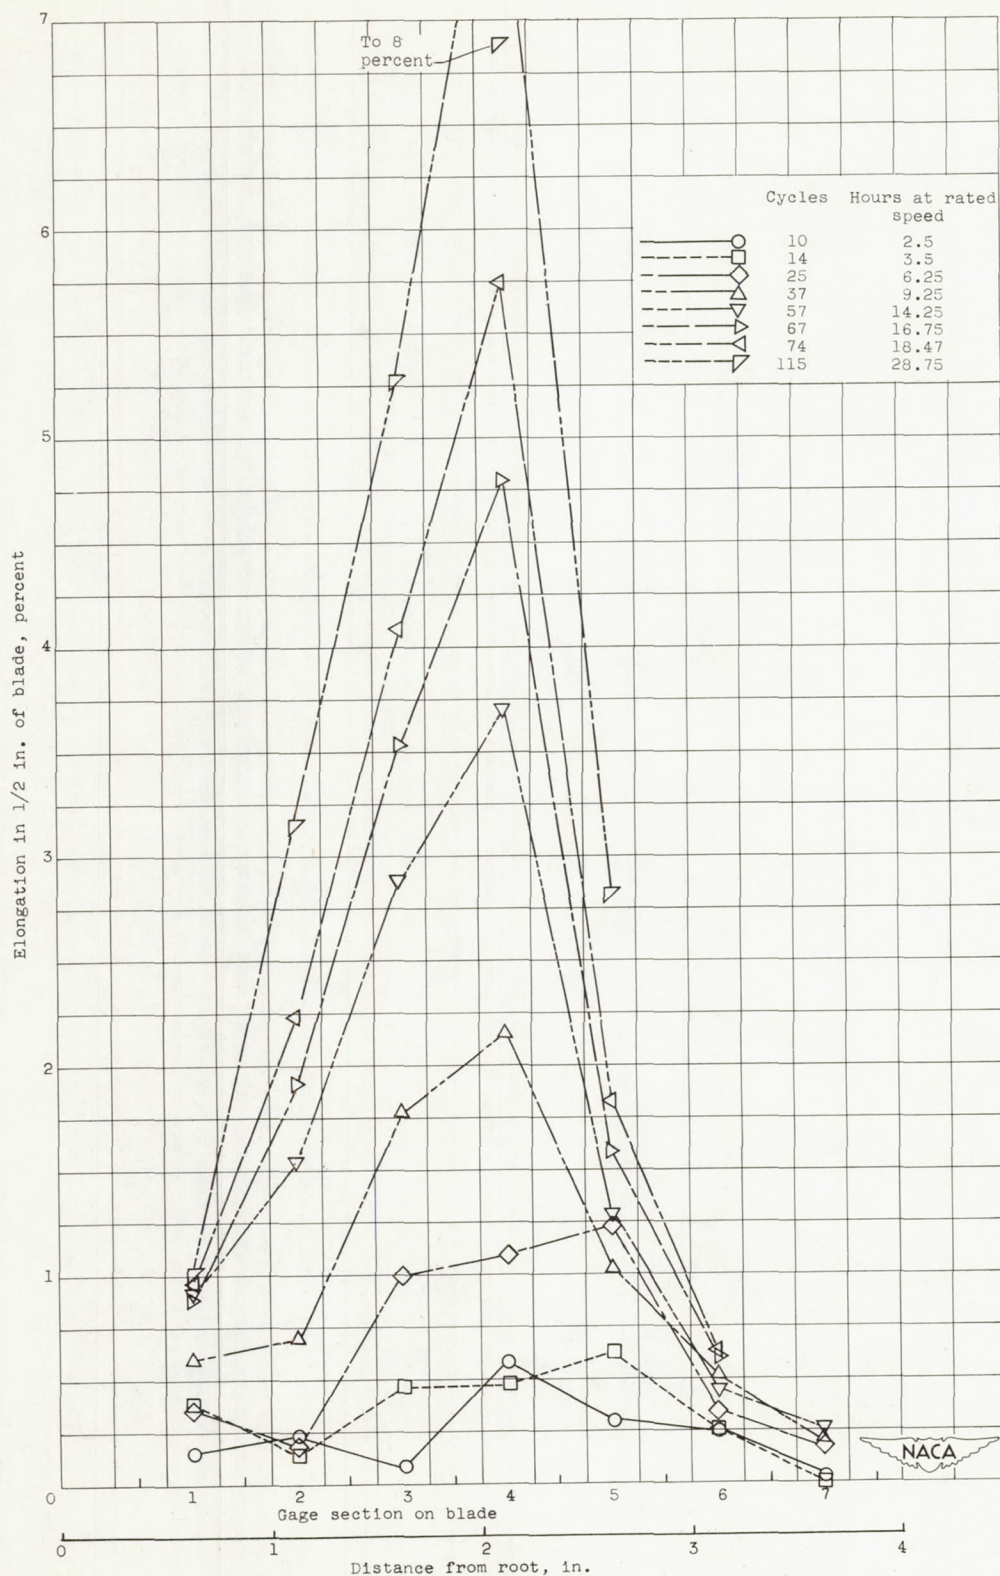
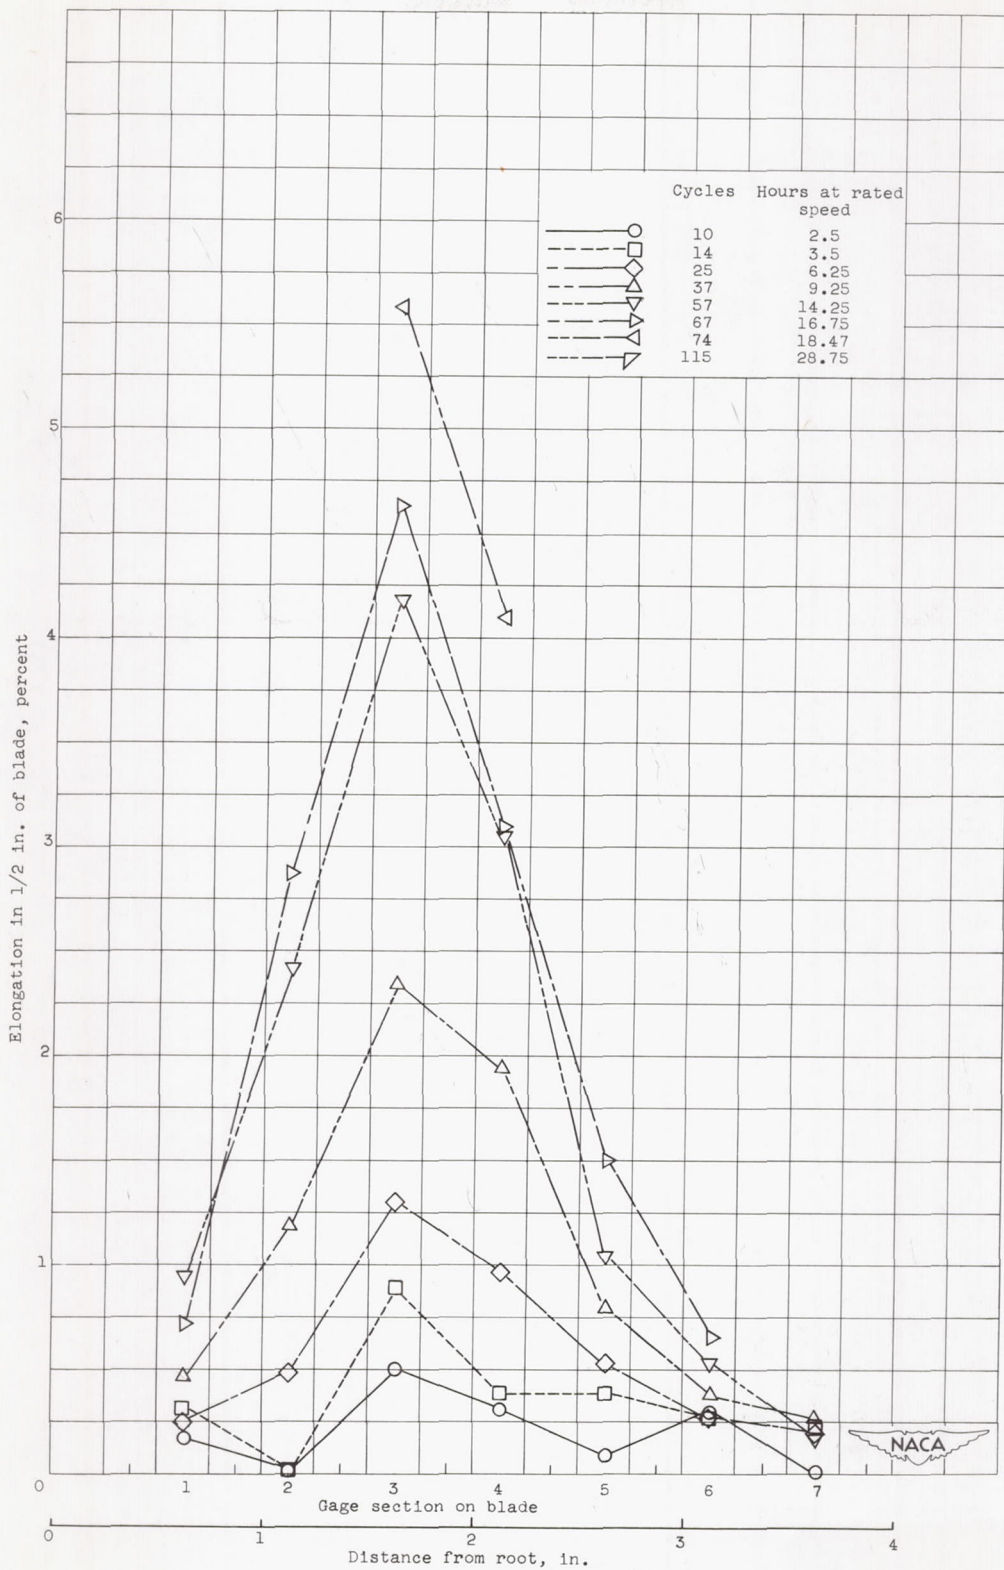
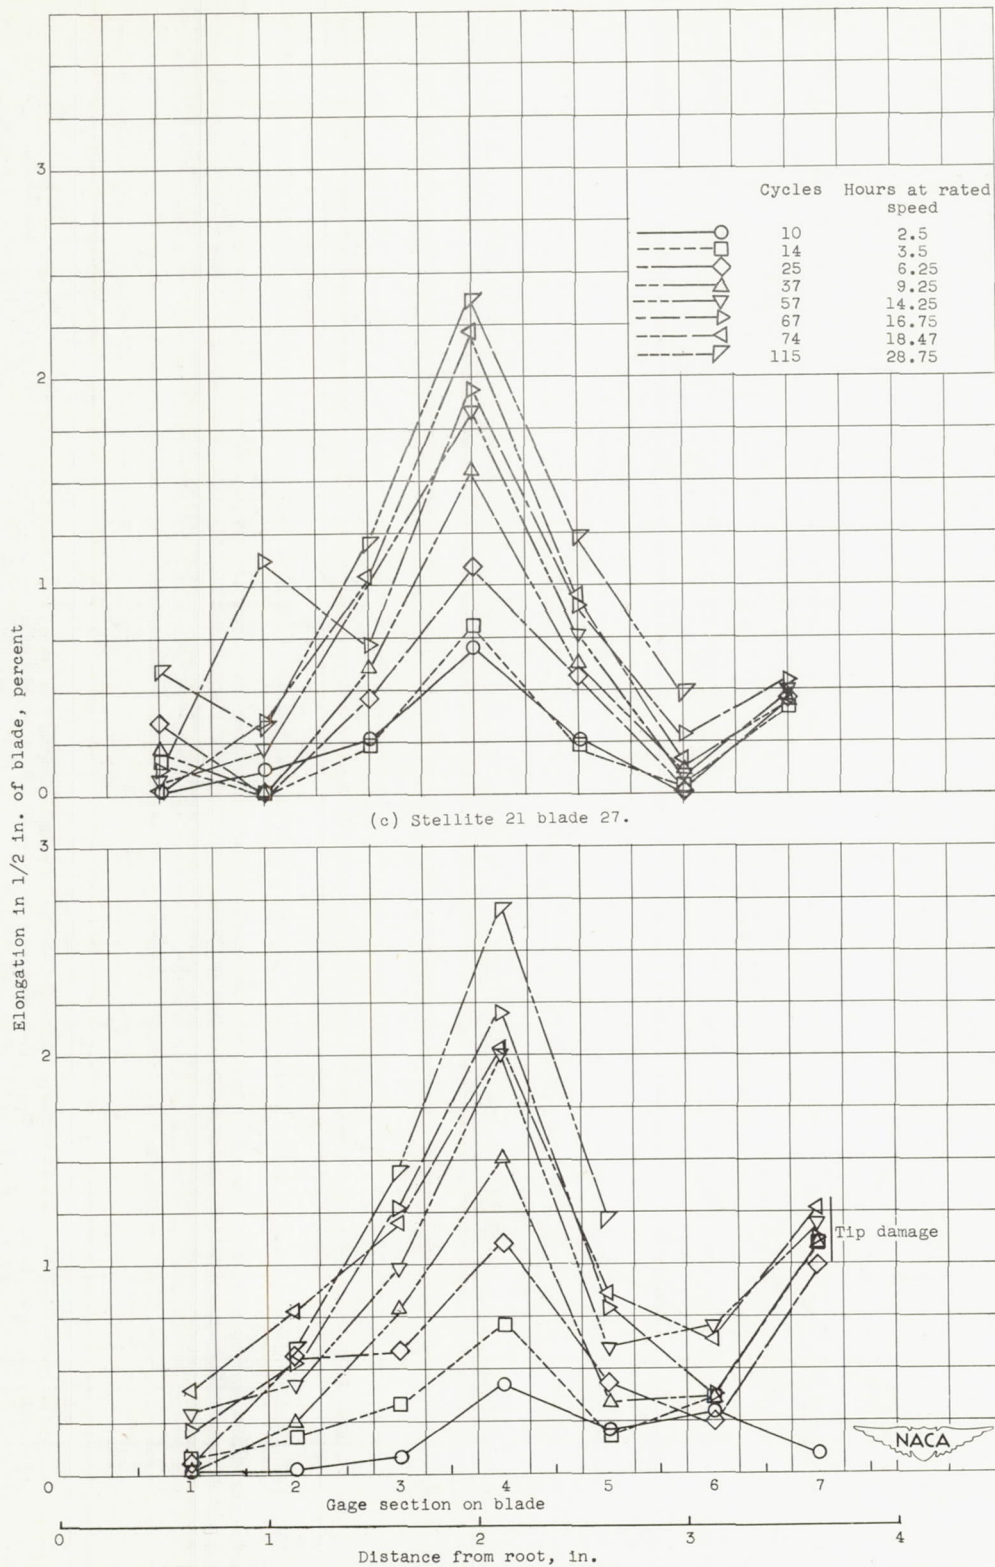
The results of the elongation measurements on the blades are presented in figure 15. Figure 16 shows the time-elongation curves for the entire blades and for the gage sections with a total elongation at the conclusion of test of greater than 1 percent. There was no measureable elongation in the 16-25-6 alloy turbine rotor.

(a) Hastelloy B blade 40.  
Figure 15. - Elongation distributions along turbine blades.

Figure 15. - Continued. Elongation distributions along turbine blades.

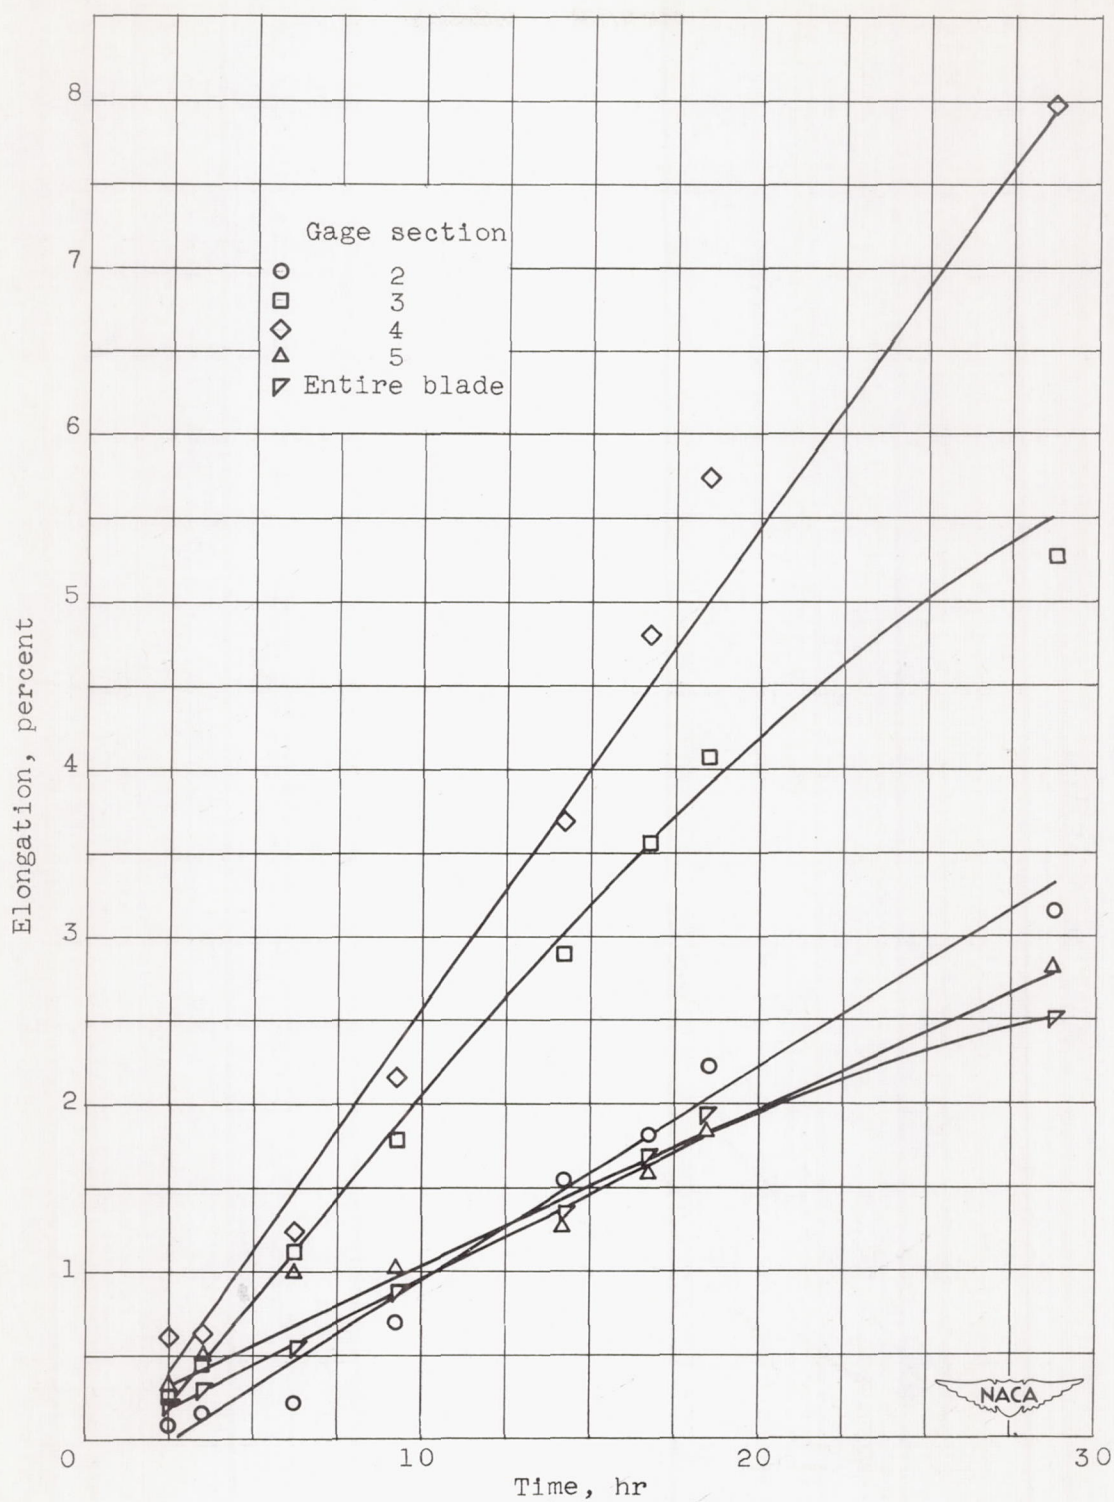
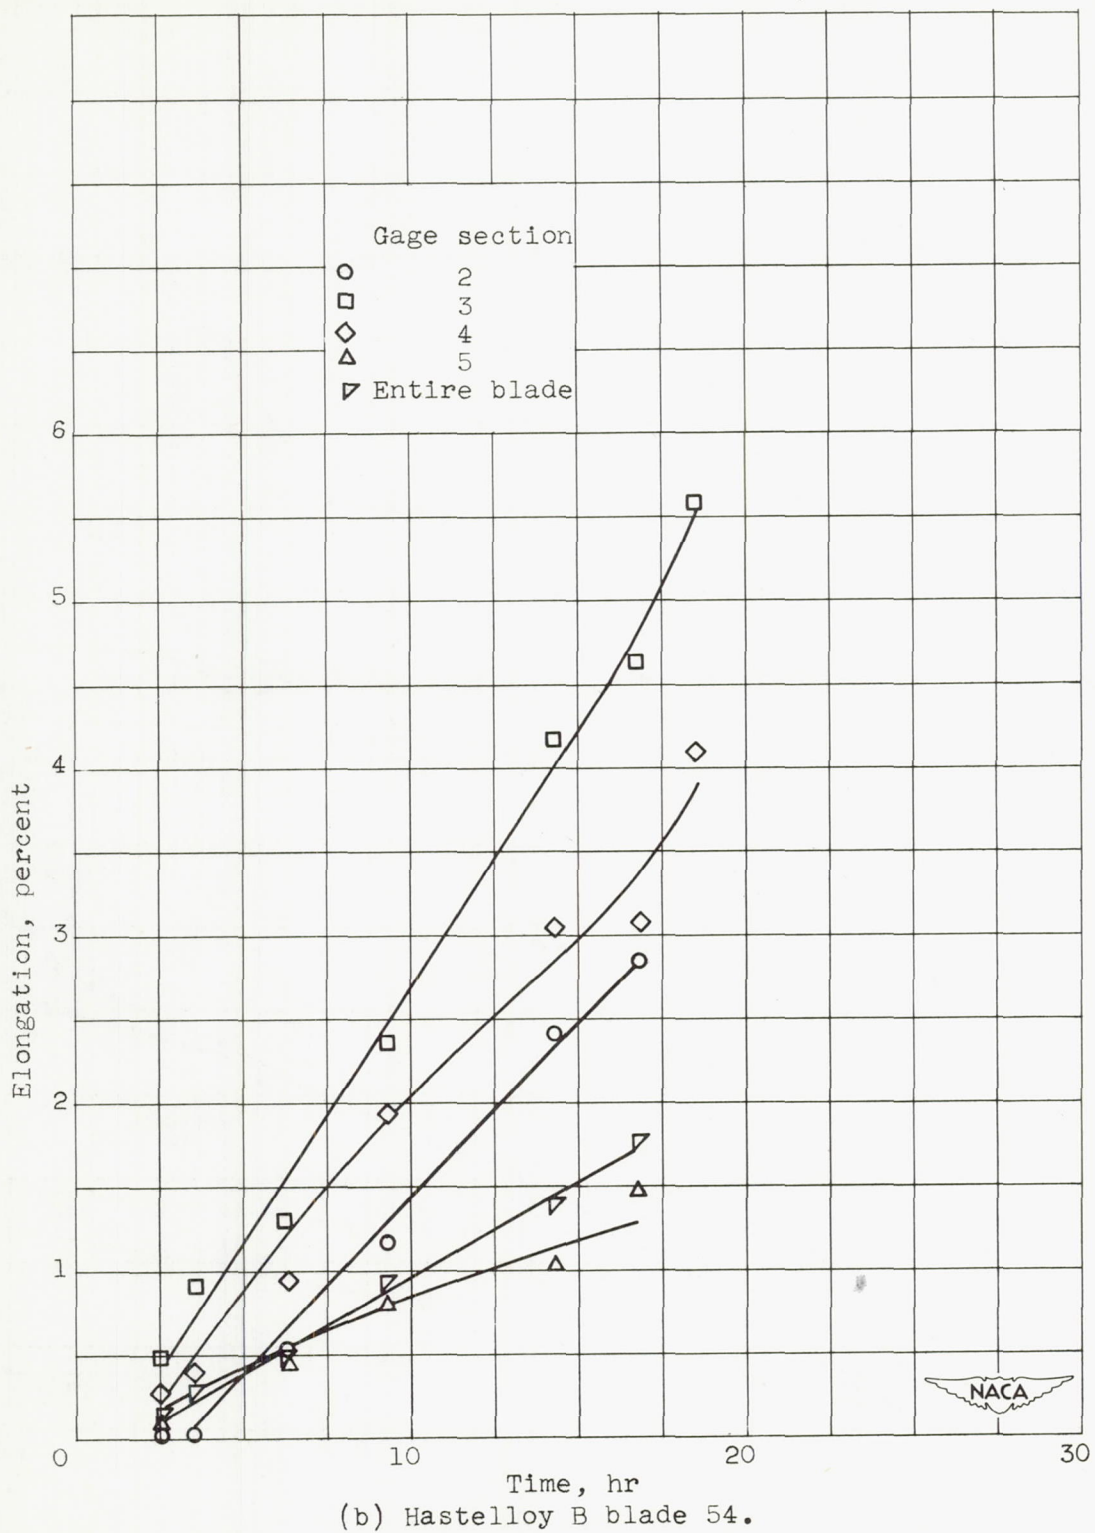
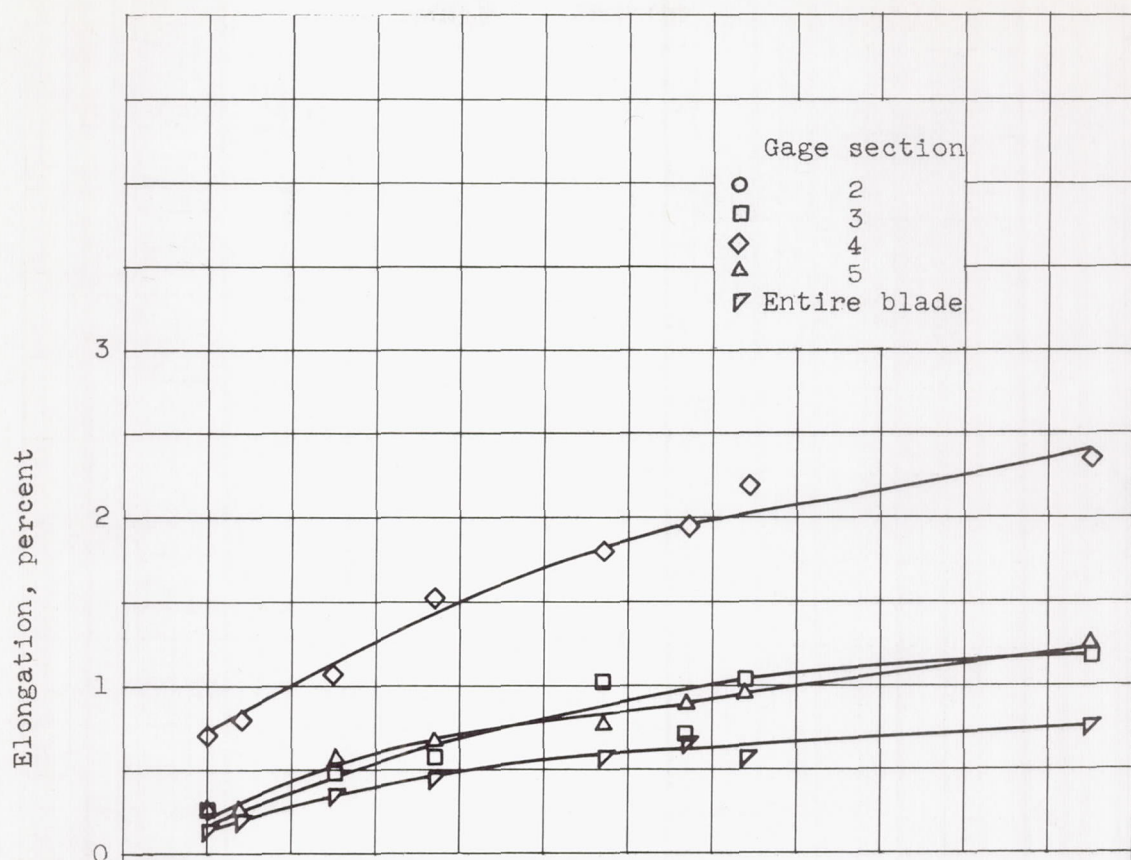
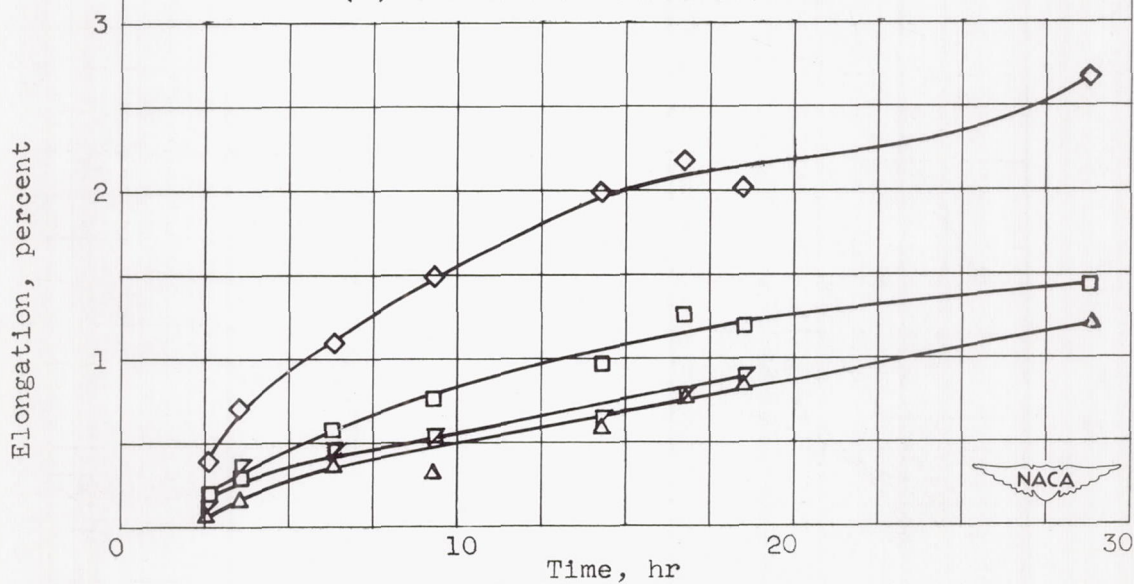
Figure 16. - Blade elongation during turbine operation for those sections having greater than 1 percent elongation.

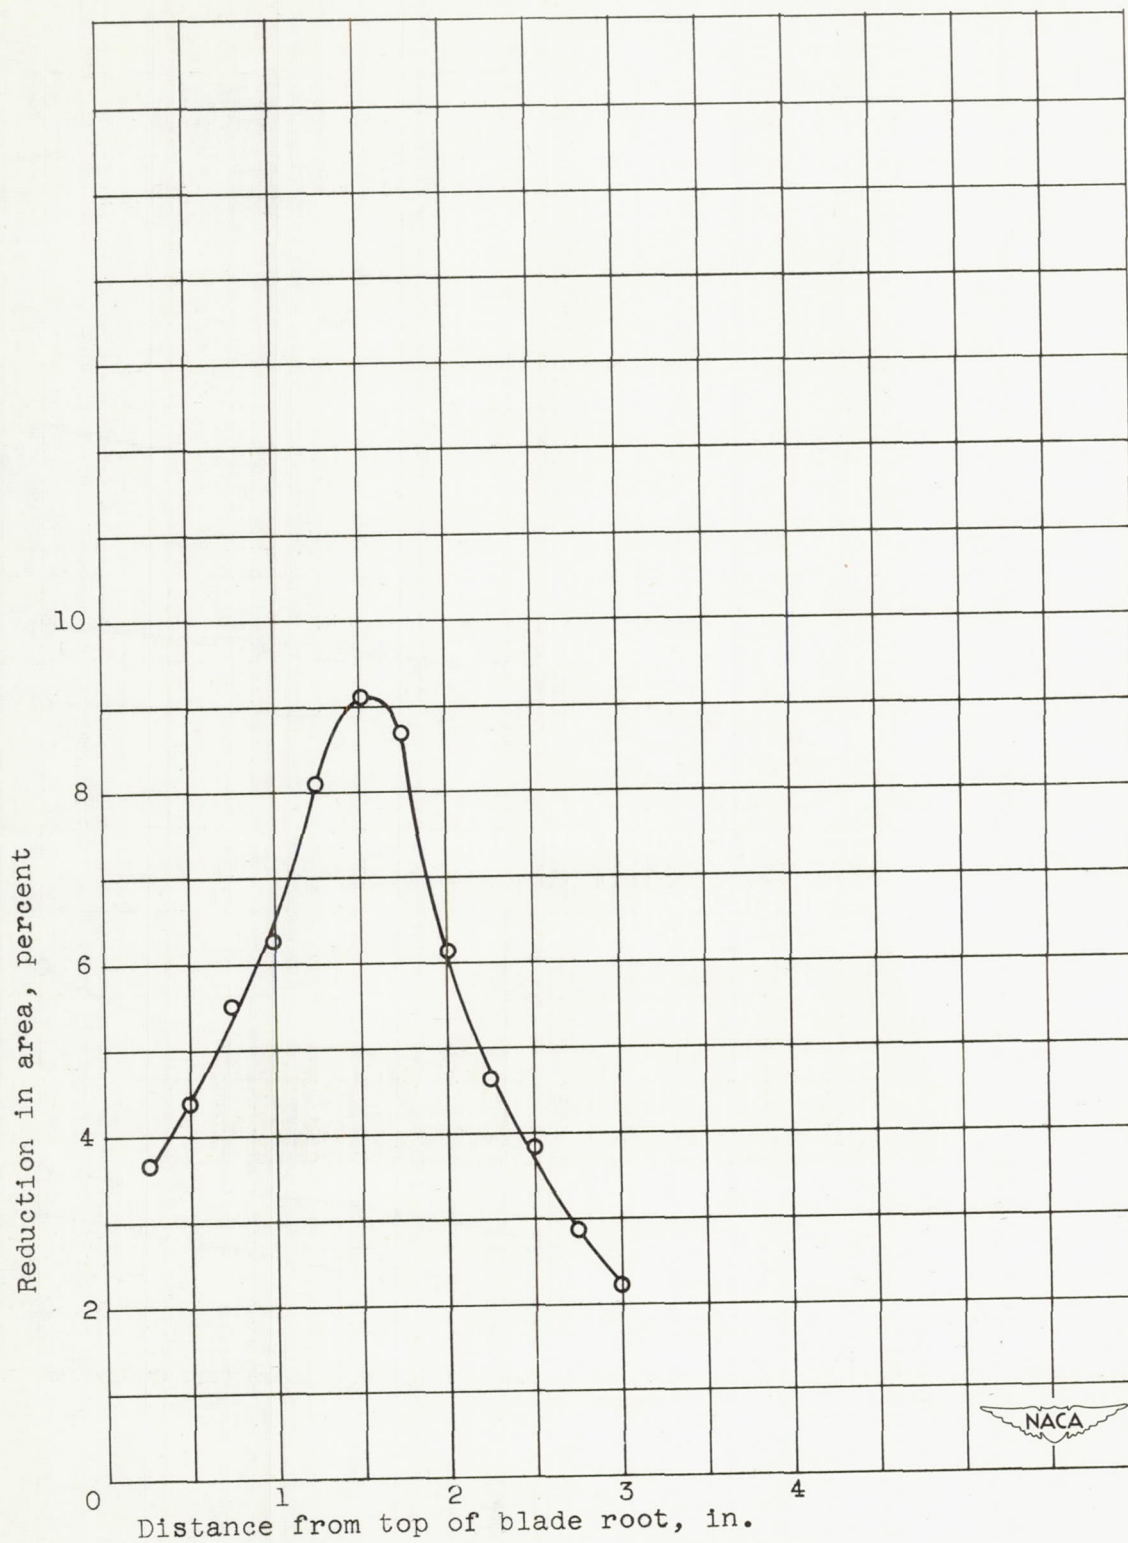
The results of the reduction in area measurements of a Hastelloy B blade after 28.75 hours (115 cycles) of operation are shown in figure 17. These results are only qualitative inasmuch as they represent the change in area of a single blade compared with the average area of the Hastelloy B blades prior to operation. The measurements of the area of a Stellite 21 blade after operation did not indicate any measureable reduction in area.

Figure 17. - Reduction in area in Hastelloy B blade after 28.75 hours (115 cycles) of operation.

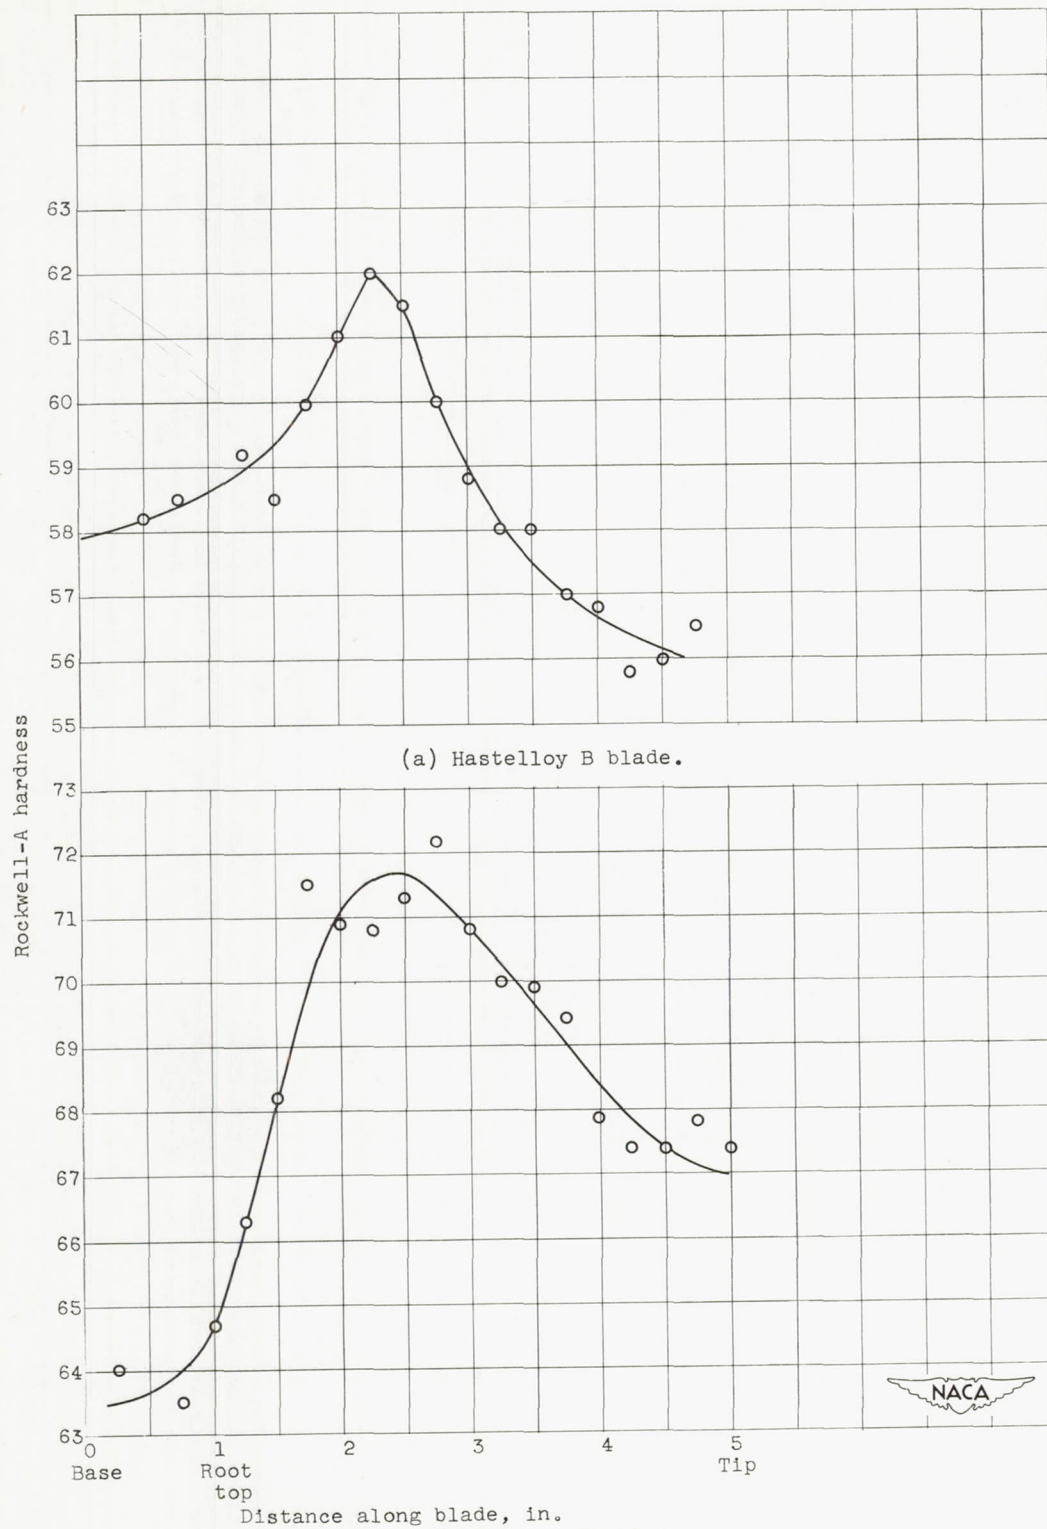
Typical hardness-distribution curves are shown in figures 19 and 20 for the Hastelloy B and Stellite 21 turbine blades, respectively, after 28.75 hours (115 cycles) of operation. Each point on these plots represents an average of three to five Rockwell-A hardness values. The hardness distributions in the blades that failed were generally the same as those in figure 19. These plots indicate that the maximum hardness occurs around the center of the airfoil section of the blades.

Figure 19. - Hardness distribution for blade after 28.75 hours (115 cycles) of operation.

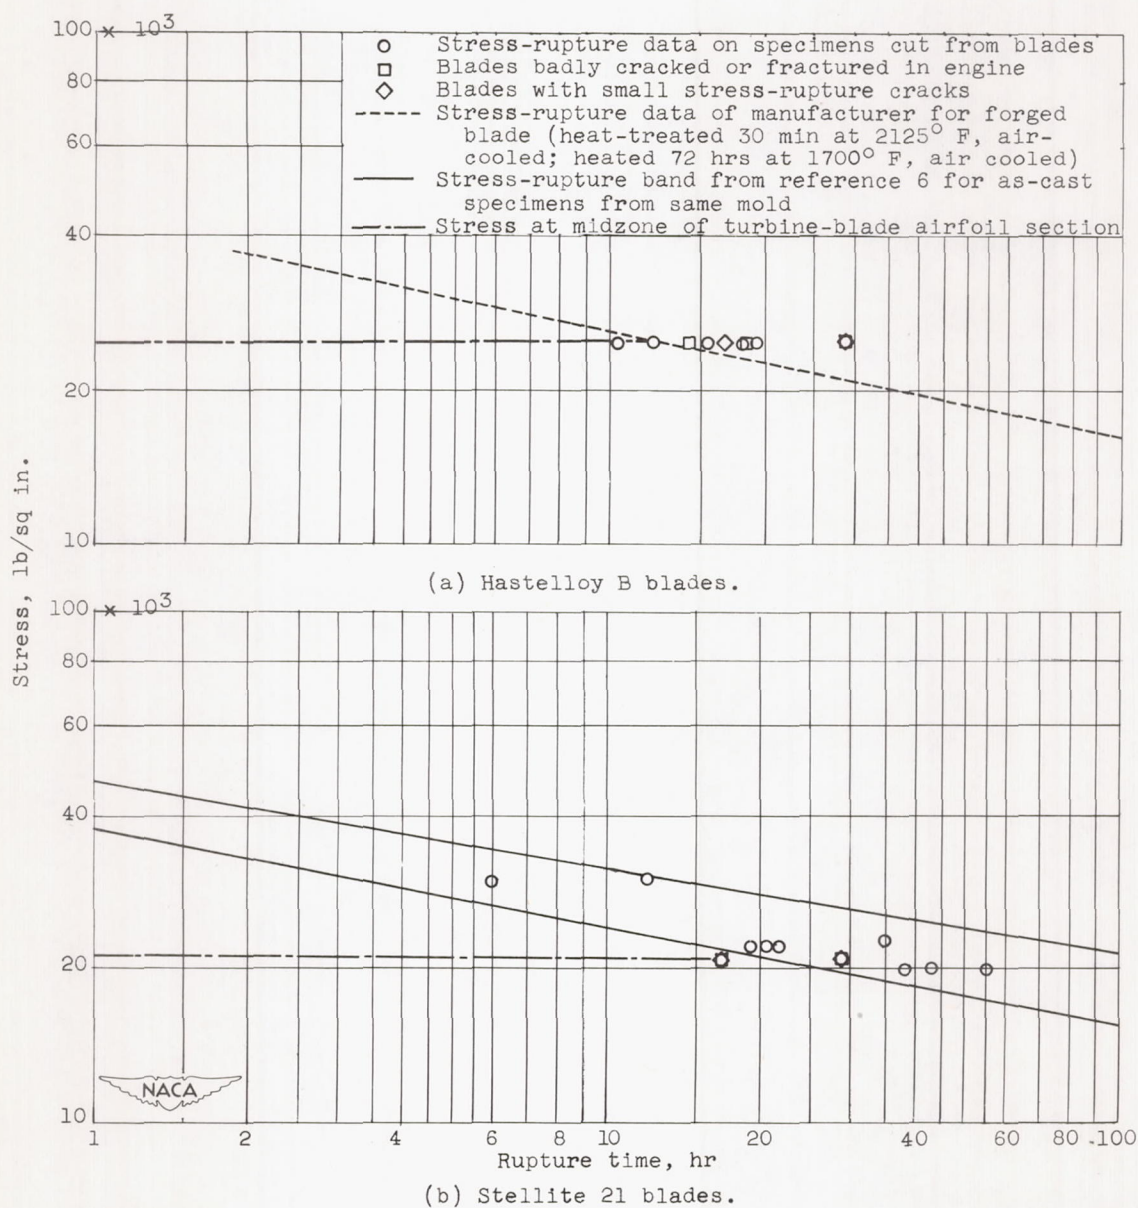
The results of the stress-rupture and engine tests of the Hastelloy B and Stellite 21 blades are compared with available strength data for these alloys in figure 20. All the blade failures are plotted on this curve, although some of the failures apparently were not of the stress-rupture type, to determine if stress rupture might have contributed to initiating failure even though metallurgical examination revealed no evidence of stress-rupture cracks. The design stress-rupture data of the manufacturer for Hastelloy B at  $1500^{\circ}\text{F}$ , although a heat treatment different from that of this investigation was used, compare favorably with the results of the rupture tests on specimens cut from blades. At a stress of 25,000 pounds per square inch, the manufacturer's data indicate a rupture life of 12 hours; the blade specimens had rupture lives ranging from 10.3 to 19.2 hours, or within the range that might be expected from the manufacturer's data. In the case of the alloy Stellite 21, the results of the blade-specimen rupture tests fall within the stress-rupture band for the alloy. For a maximum blade temperature of  $1500^{\circ}\text{F}$ , the minimum rupture life of the Hastelloy B blades at the average stress of 25,000 pounds per square inch would be 10.3 hours, the minimum rupture life of Stellite 21 blades at the average stress of 21,000 pounds per square inch would be 21 hours (minimum predicted by stress-rupture band).

rupture tests (fig. 20). This failure, however, could not be classed as a stress-rupture failure because unlike a rupture failure, it was transcrystalline in its propagation and had a smooth fracture surface. The failure started at a point on the blade above the zone of critical stress and maximum temperature (fig. 7). From the nature of the fracture, therefore, vibratory stresses were probably a principal cause of this first failure. After 16.75 hours of operation, the majority of the remaining Hastelloy B blades developed intercrystalline leading-edge cracks characteristic of the stress-rupture failures of the blade specimens. Inasmuch as this operating time was within the stress-rupture failure times expected from operating conditions, these cracks can be considered as evidence of the beginning of blade failure by stress rupture. The distribution of these cracks along the leading edge (fig. 11(a)) suggests that corrosion or localized hot zone along the leading edge may have been partly responsible for their formation. However, the correlation of the nature of the crack propagation and the time of the crack formation with the results of the stress-rupture tests on blade specimens indicates that other contributing causes such as corrosion are of less importance. As the engine operation continued, the remaining Hastelloy B blade fractures progressed from these leading-edge cracks. The failures progressed by two mechanisms, fatigue and stress rupture. Hastelloy B blades 4 and 34 (figs. 11(b) and 11(d)) fractured after 18.47 hours of (1.72 additional hr) operation as a result of a condition favorable for fatigue fracture having been set up by the leading-edge cracks. The vibratory stresses in the blades were therefore merely propagating a failure originated by stress rupture. In Hastelloy B blade 54 after 28.75 hours (12 additional hr) of operation, fracture occurred by the progression of the initial crack across the blade continued by a stress rupture following an intercrystalline path. Some of the original Hastelloy B blades were still in operation at times in excess of the predicted rupture life, which would be expected since a complete stress-rupture band for the alloy was unavailable, making the maximum blade life unknown. All but three of the original 27 Hastelloy B blades, however, had cracked or fractured at the conclusion of operation, indicating that failure had started in all but three blades.

Figure 20. - Comparison of stress-rupture properties and engine blade life at temperature of 1500°F for alloys Hastelloy B and Stellite 21.
