RESEARCH MEMORANDUM

PRELIMINARY INVESTIGATION OF SEVERAL ROOT DESIGNS FOR
CERMET TURBINE BLADES IN TURBOJET ENGINE

II - ROOT DESIGN ALTERATIONS

NATIONAL ADVISORY COMMITTEE
FOR AERONAUTICS

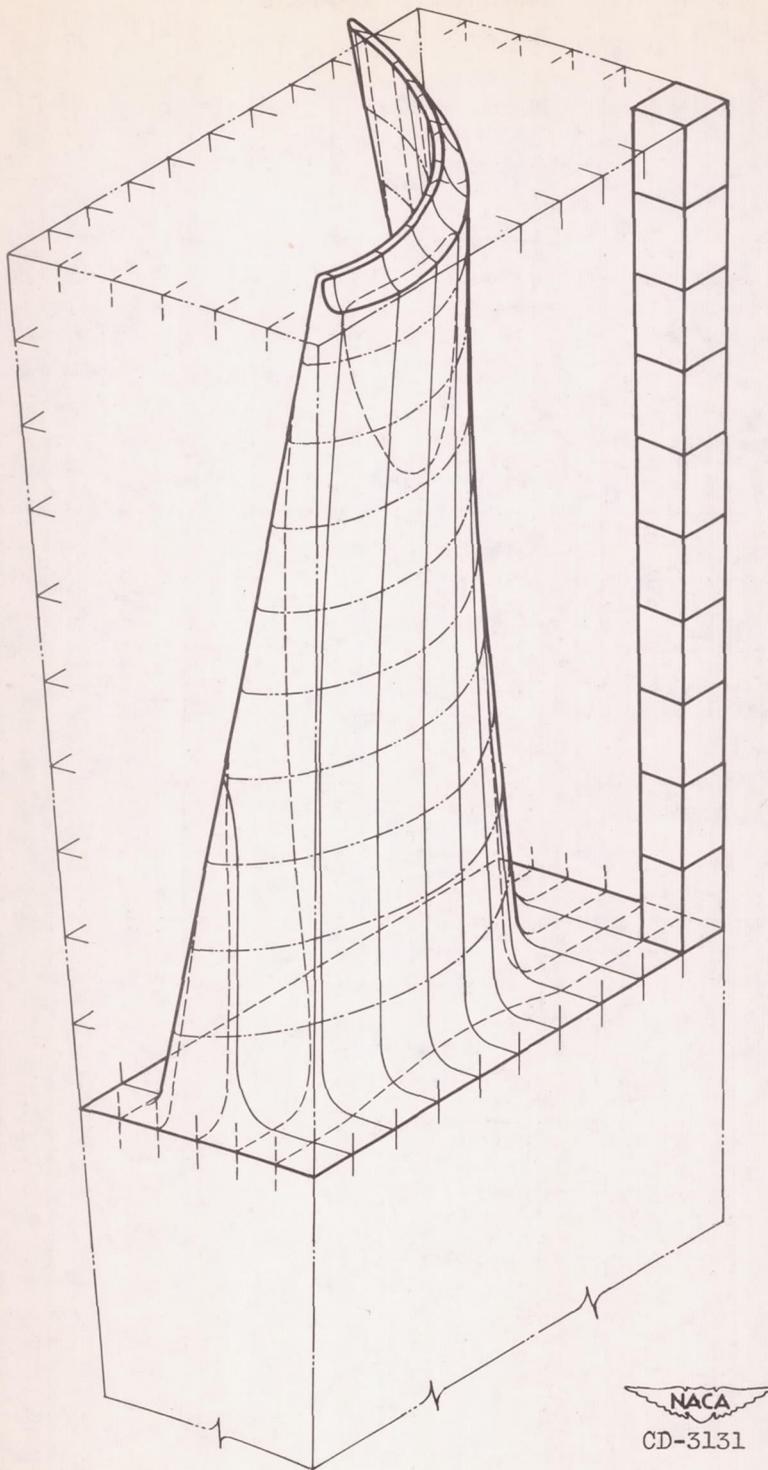
Figure 9. - Sketch showing airfoil divisions for computation.

Calculation procedure. - The airfoil span or length was divided into 10 sections. The profiles of the sections were drawn to five times the size. The base profile was subdivided into small squares $1/2$ inch on a side (0.1 inch on a side at actual blade size.) All other profiles were correspondingly subdivided into rectangles $1/2$ inch in the direction of the turbine wheel axis and slightly greater than $1/2$ inch in the tangential direction. The correction in tangential distance is due to the increase in chord length of a radial segment as the radial distance increases, as sketched diagrammatically in figure 9. The volumes of the small airfoil pieces between corresponding rectangles of each station were calculated and totalled. The centers of gravities and the radial distances of the resulting long thin radial columns were computed to permit calculation of the centrifugal force acting on each square of the base airfoil profile due to its respective column.
