FULL-SCALE PERFORMANCE STUDY OF A PROTOTYPE CRASH-  
FIRE PROTECTION SYSTEM FOR RECIPROCATING-  
ENGINE-POWERED AIRPLANES

By Dugald O. Black and Jacob C. Moser

NATIONAL ADVISORY COMMITTEE  
FOR AERONAUTICS

November 15, 1955

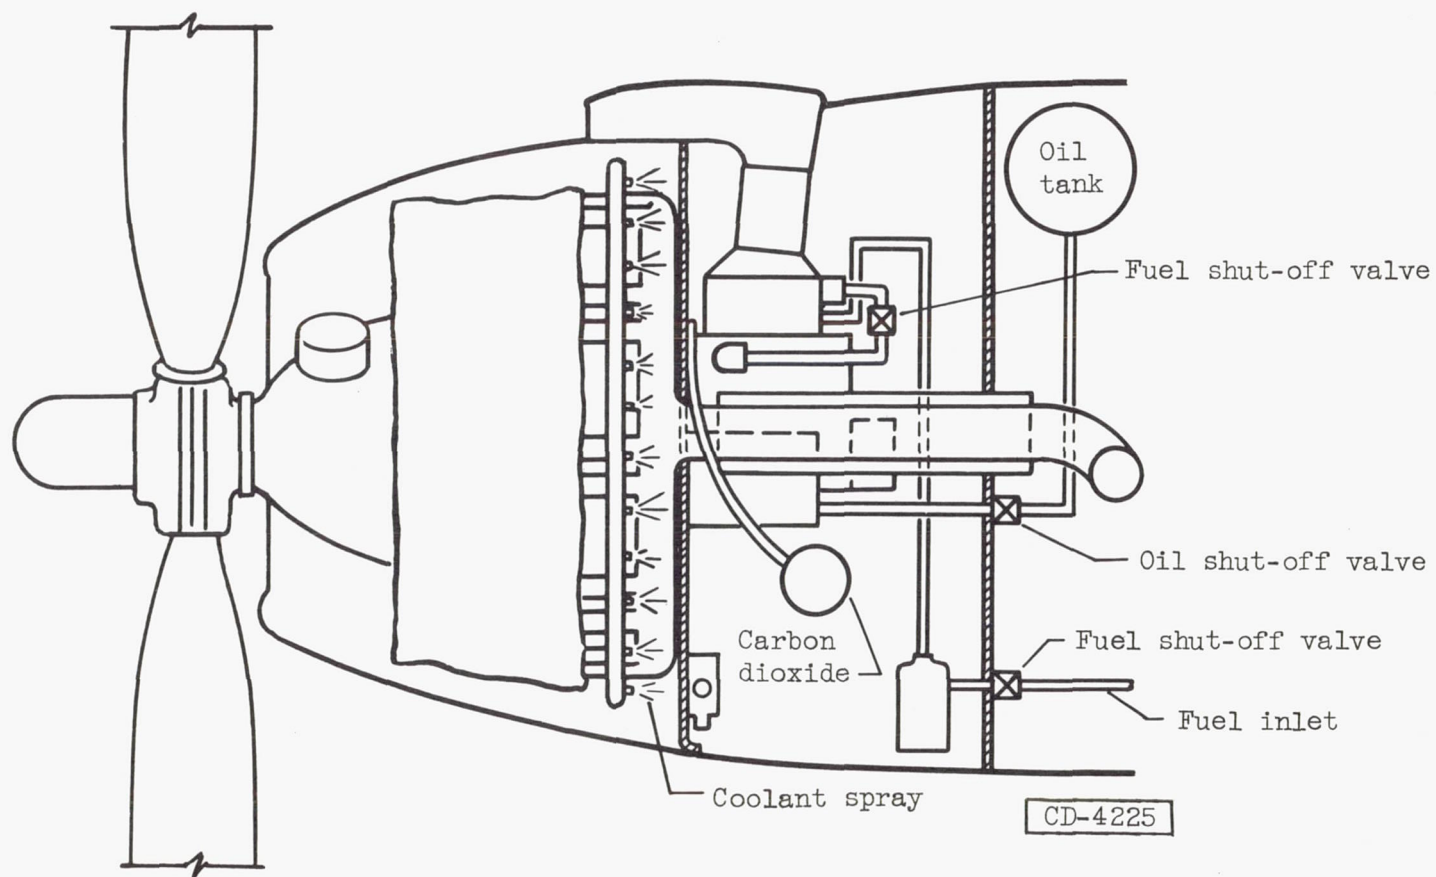
These components of the inerting system are installed in an engine nacelle at the locations shown by the schematic diagram in figure 1. This crash-fire ignition-source inerting system is completely automatic, since the inerting system is actuated at the time of impact with the crash barrier by the crash-actuated initiating system. All components of this crash-fire prevention system are described completely in reference 2.

Figure 1. - Schematic diagram of inerting-system components on engine.

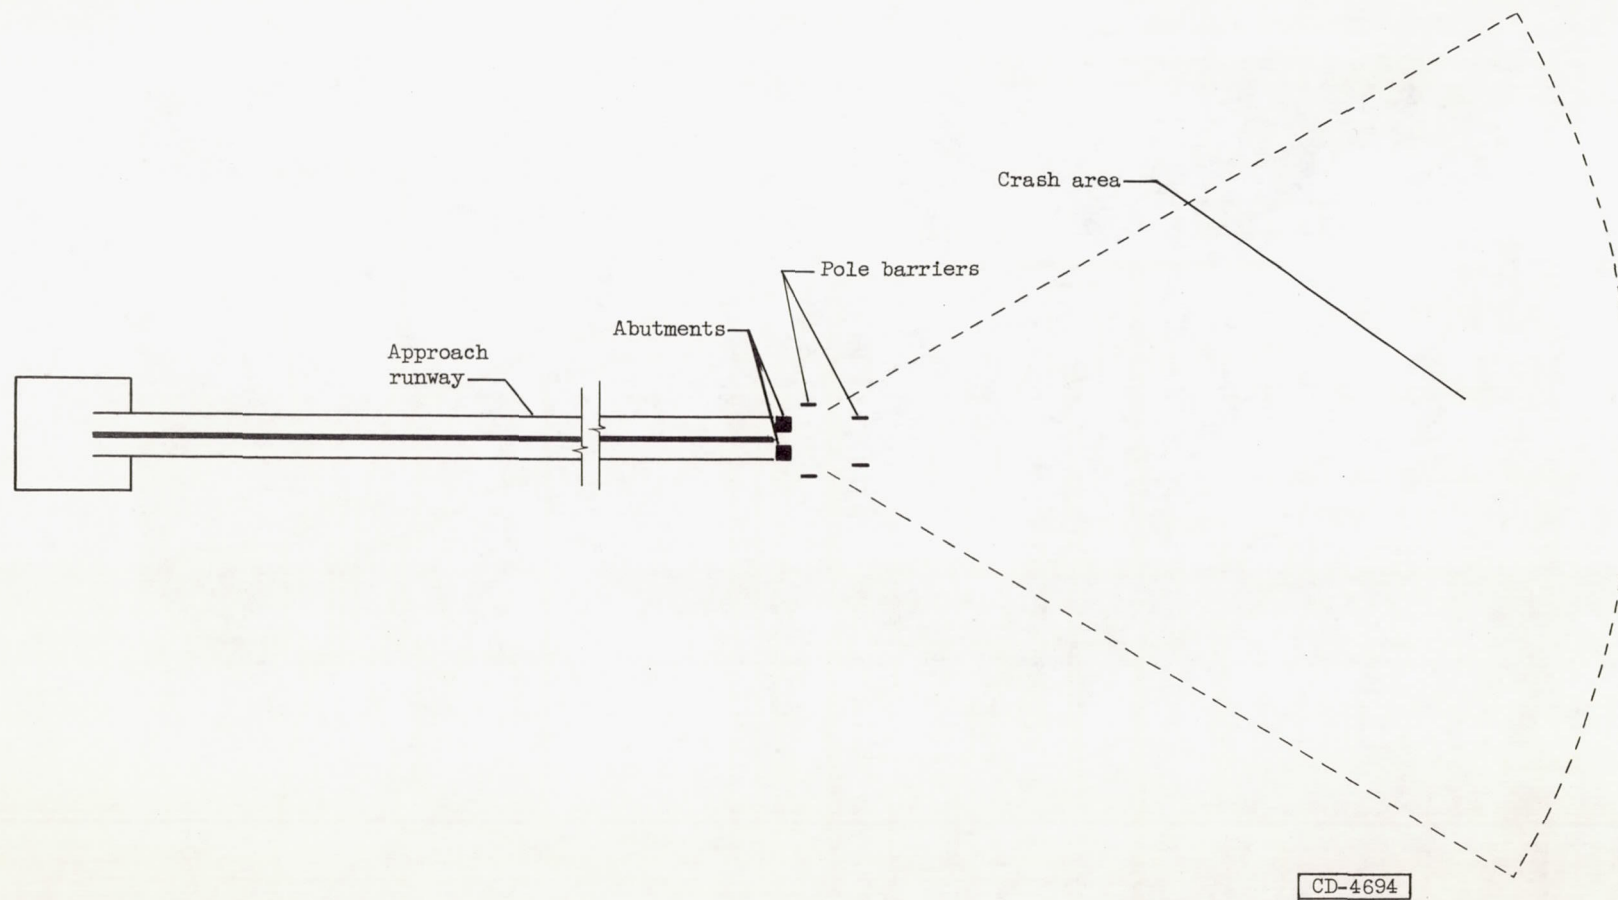
The procedure for such experimental crashes is fully described in reference 3. Briefly, however, the crash was conducted in the following manner. The unmanned airplane was guided by a rail along a 1700-foot paved runway at full power until it crashed into a series of obstacles at take-off speed (fig. 2). The first obstacles were two abutments, made of railroad ties and earth, placed in the path of the main landing wheels. These barriers removed the landing gear and damaged the propellers and engines. Four poles then ripped open the fuel tanks in the wings. After being damaged, the airplane slid across an open area on its belly. The sliding airplane was enveloped by a large volume of fuel mist formed by the fuel spilling from the wings while the airplane was in motion. Because the fuel in vapor, mist, and liquid form was extensively distributed, this crash was a severe test of the inerting system.

Figure 2. - Schematic drawing of crash site for conducting experimental crashes.

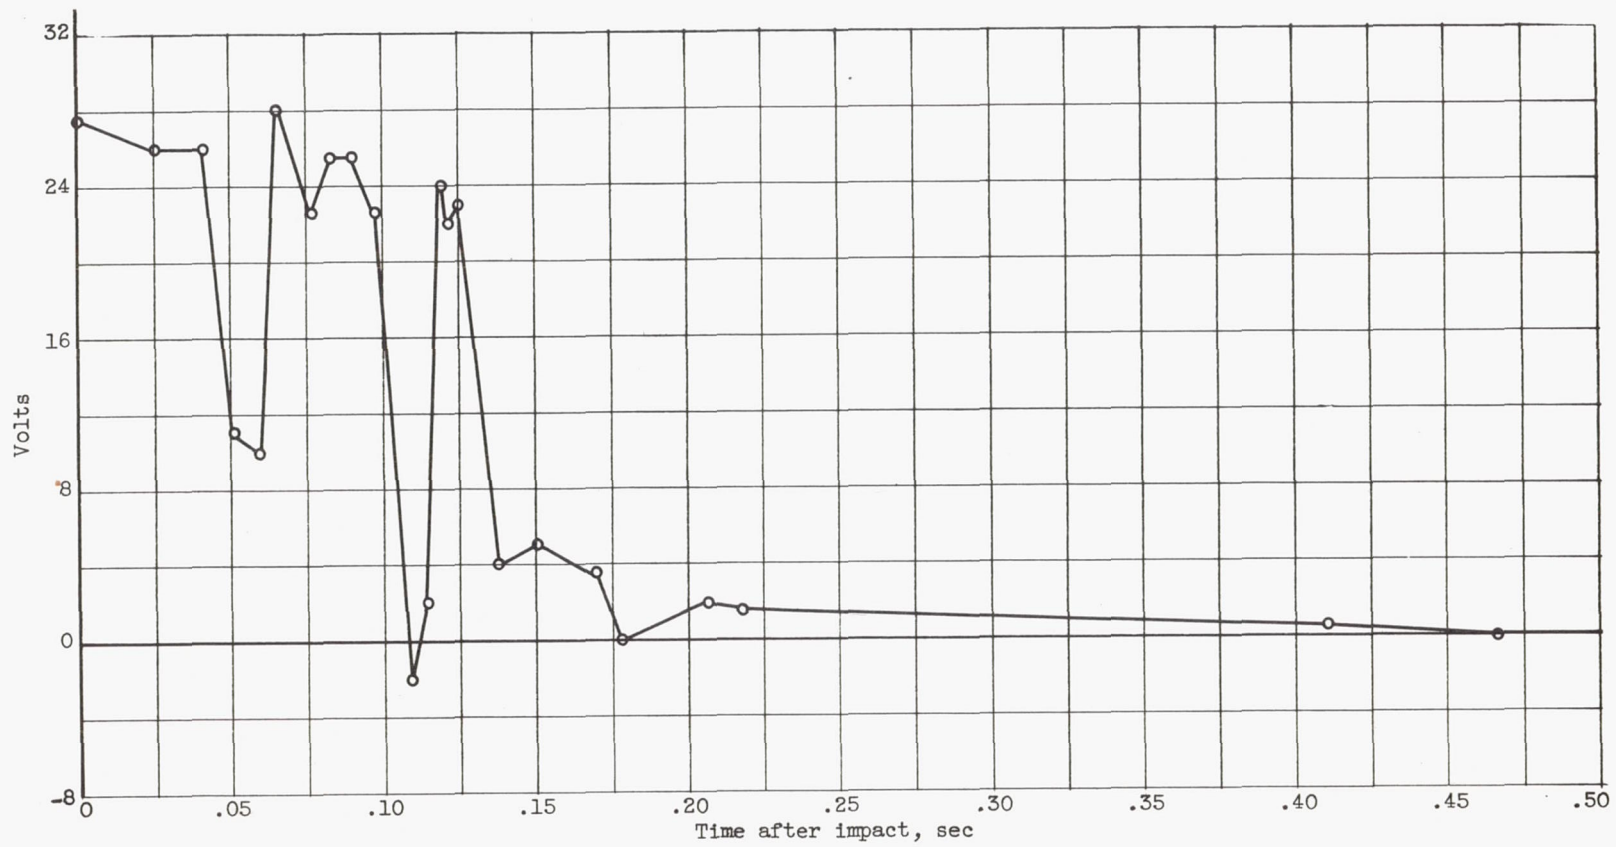
Electrical system de-energizing. - The variation of voltage in the airplane electrical system during the crash is presented in figure 12. Impact of the airplane with the first crash barriers occurred at time zero. Two sharp reductions in voltage occurred at approximately 0.05

The electrical de-energizing action was complete when the voltage (fig. 12) reached zero at 0.178 second after impact. The 2-volt rise in potential thereafter could have been caused by the generator effect of coasting motors. Although the energy represented by this resurgence of voltage may be marginal as an ignition source, it should be prevented by means of a better grounding system, as discussed in the following paragraph.

Figure 12. - Variation of voltage in airplane electrical system.

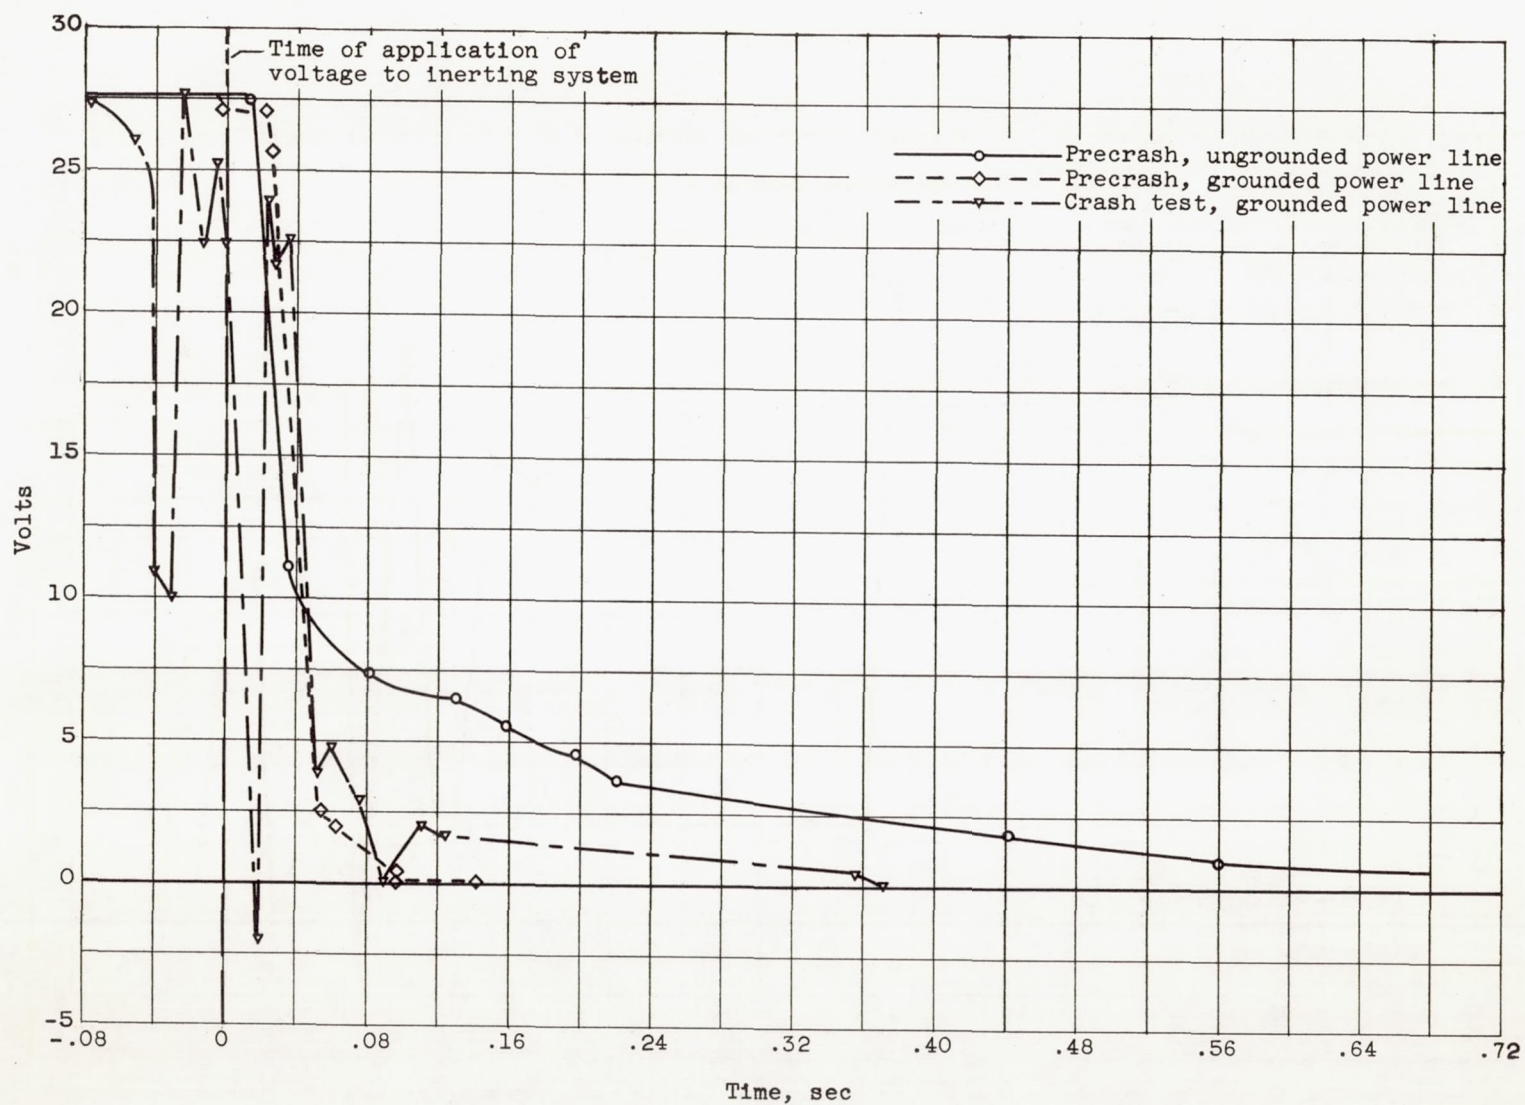
The effect of the grounding relay in the fire-prevention system on the airplane electrical system voltage is shown in figure 13. The voltage variations recorded during this crash are compared with those obtained in precrash trials of the electrical inerting system with and without a grounding relay. It can be seen from this figure that zero potential is obtained in a much shorter time with a grounding relay. The grounding relay used in the crash study had smaller contacts and lighter contact pressure than the relay used in the precrash studies. Because of these differences, the voltages in the precrash studies reached zero 0.25 second sooner than in the crash. In figure 13 "zero" on the time coordinate is defined as the moment at which voltage was applied to the inerting system.

Figure 13. - Effect of grounding on airplane electrical system voltage.

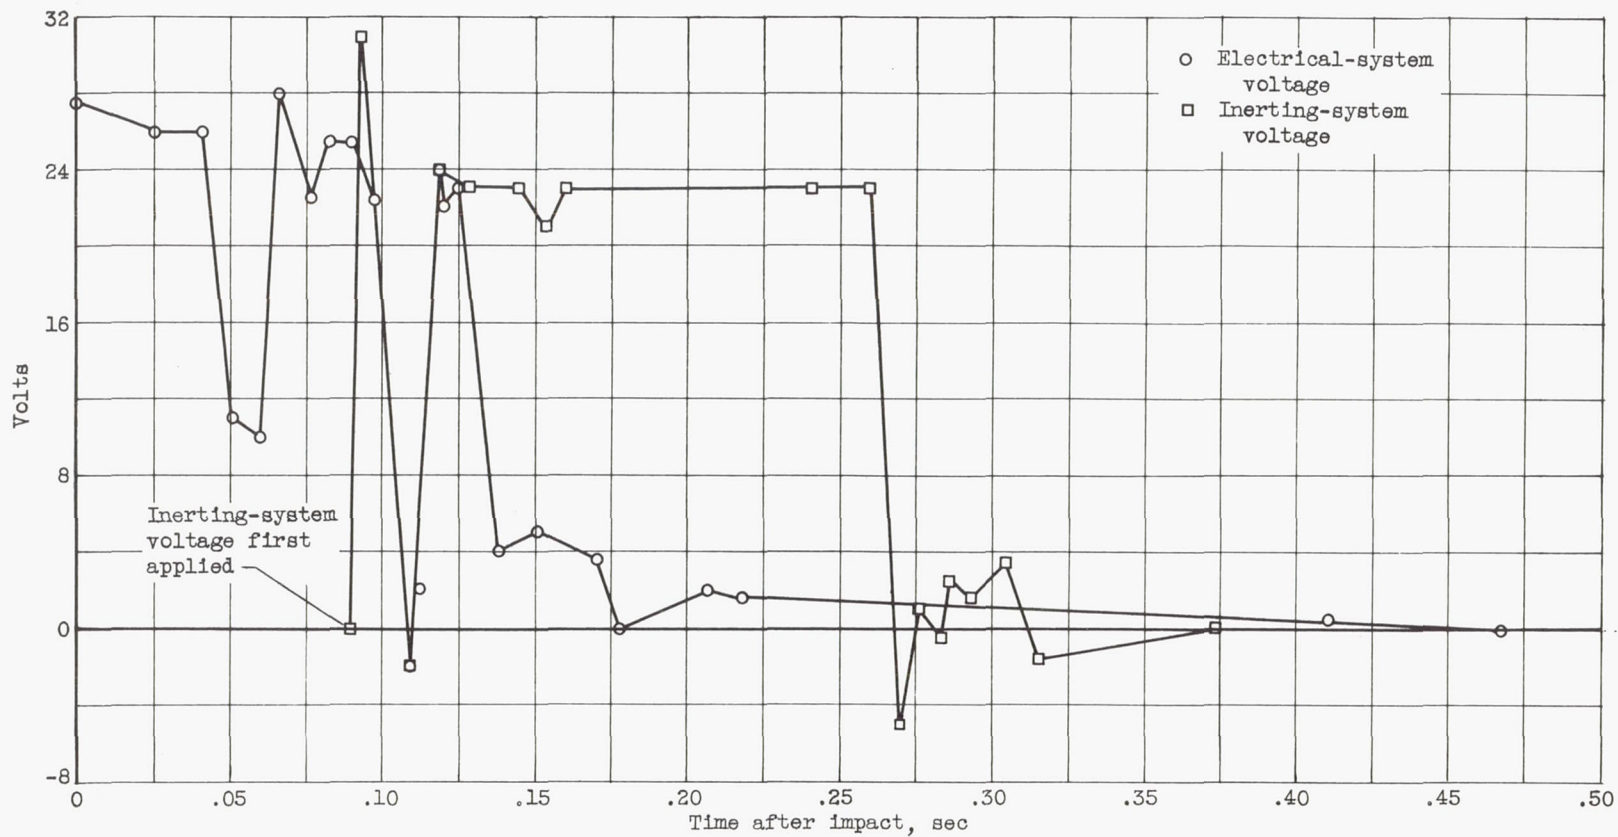
Inerting-system voltage. - The effect of the short circuits in the airplane electrical system on the voltage applied to the inerting-system components is presented in figure 14. The initiating system first applied voltage to the inerting-system components 0.09 second after impact. The second short circuit in the airplane electrical system occurred immediately thereafter and reduced the inerting voltage to zero, which delayed

Figure 14. - Effect of short circuits in airplane electrical system on voltage applied to inerting-system components.

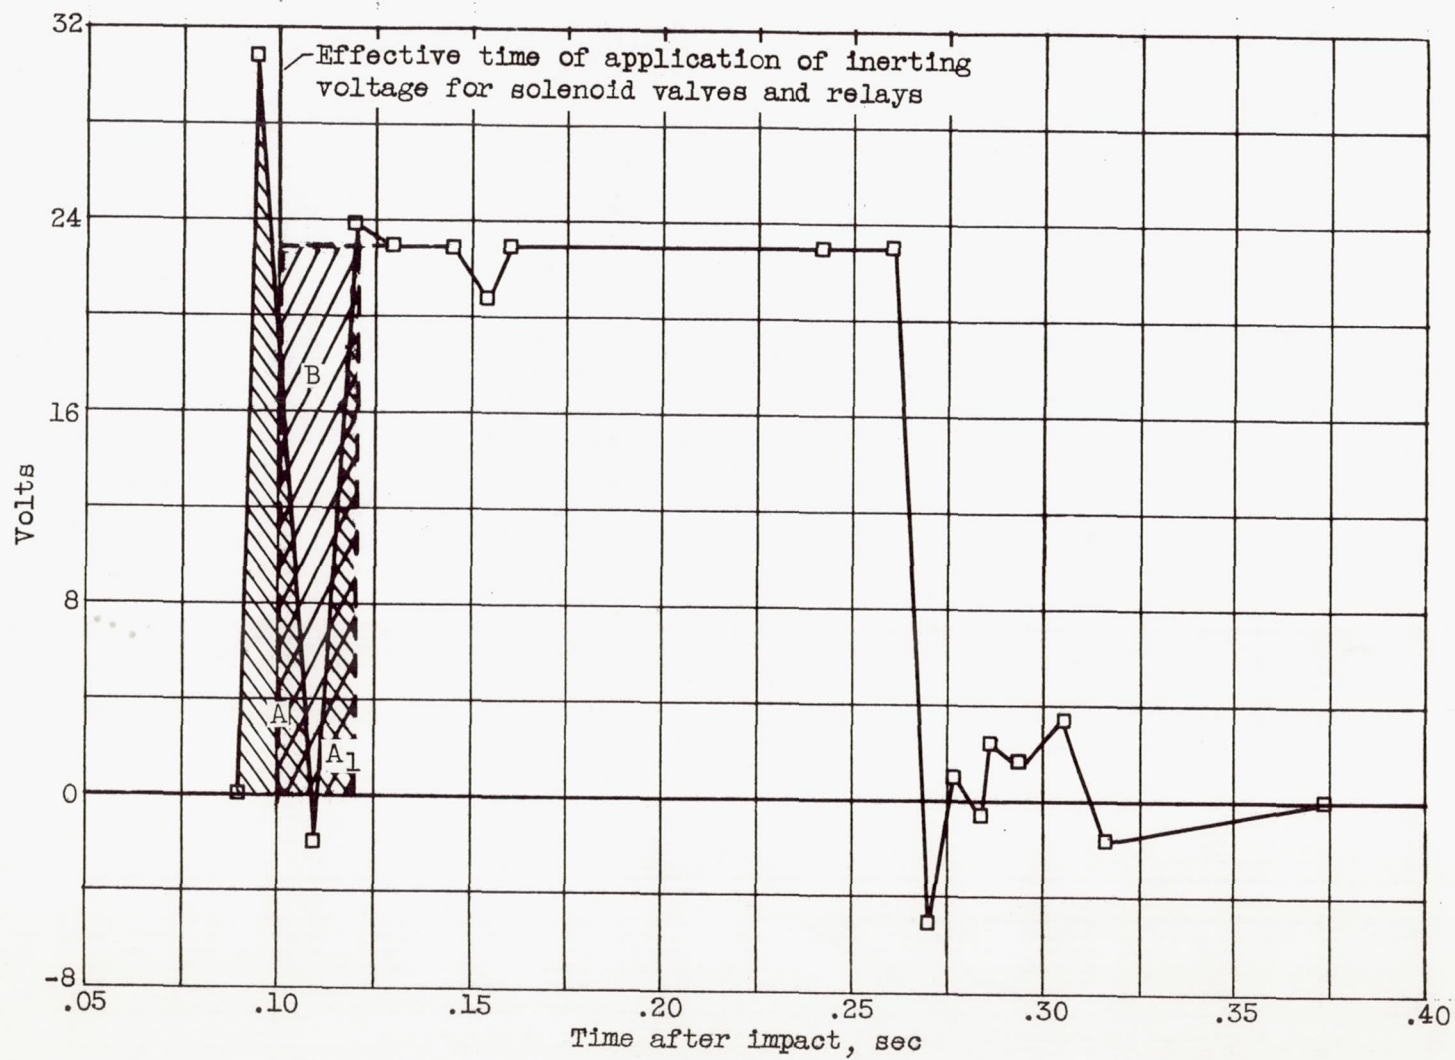
Figure 15. - Voltage applied to inerting system components.

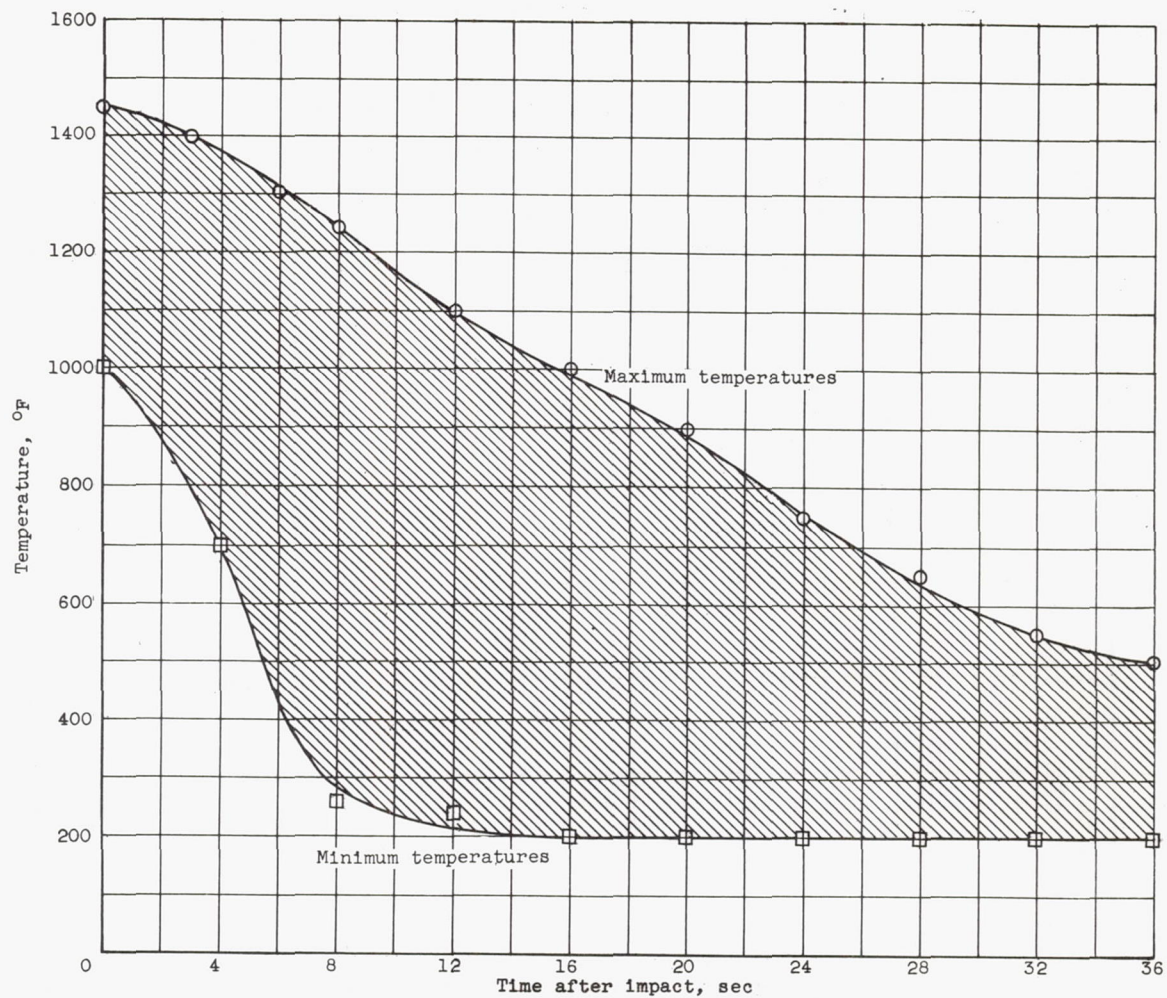
Figure 16. - Temperature history of right-engine exhaust collector ring.

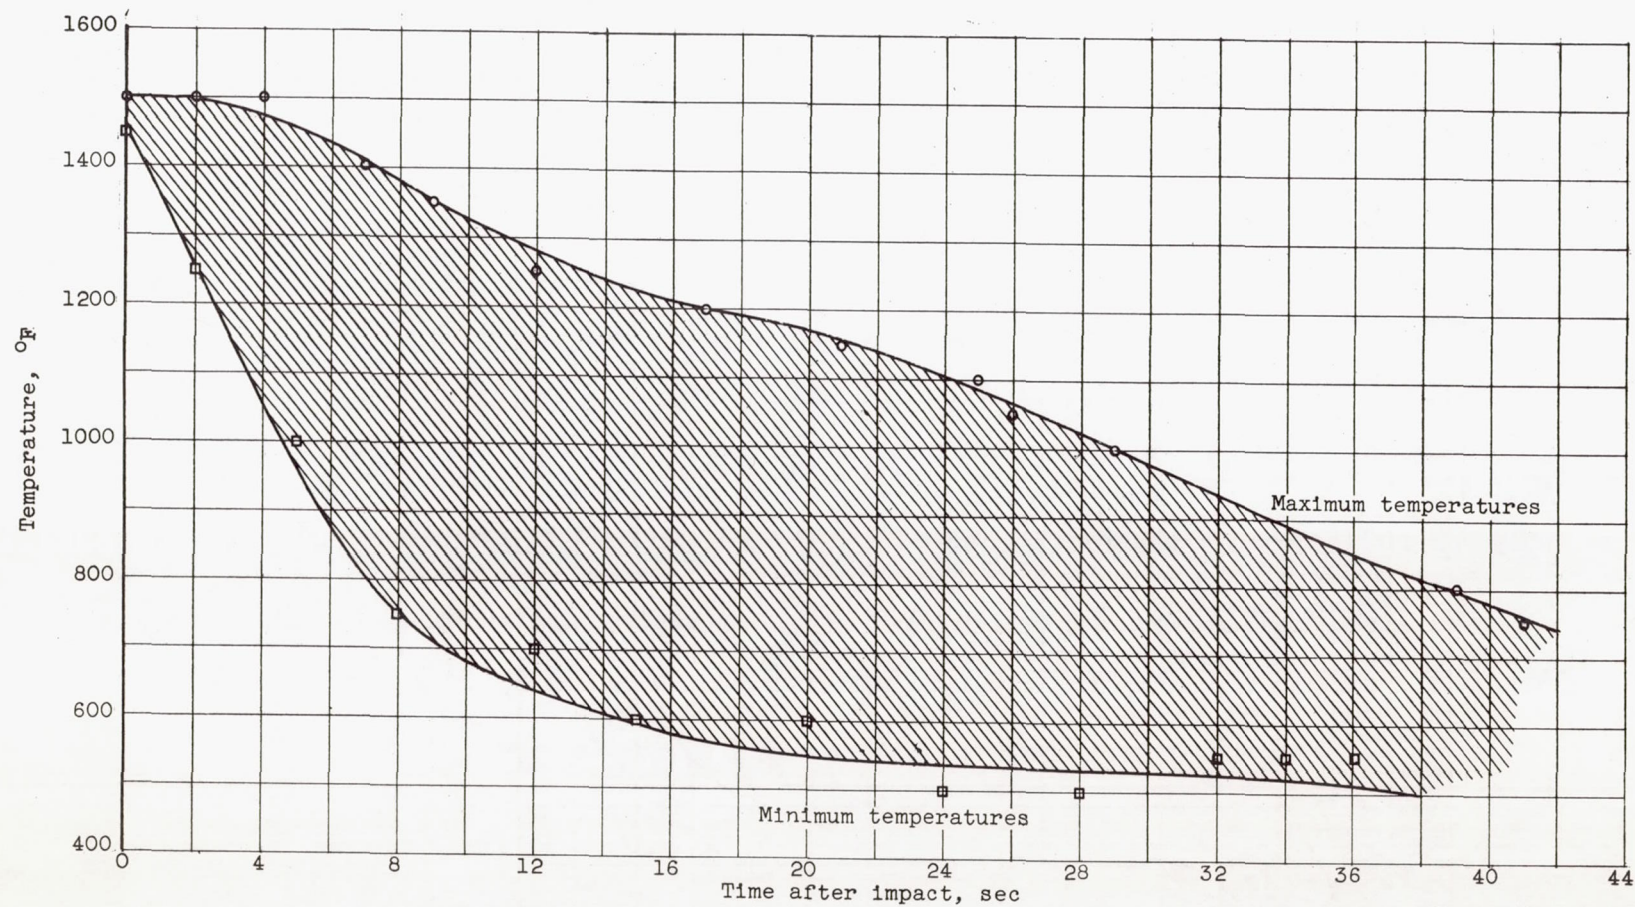
Figure 17. - Temperature history of right-engine exhaust heat exchanger.

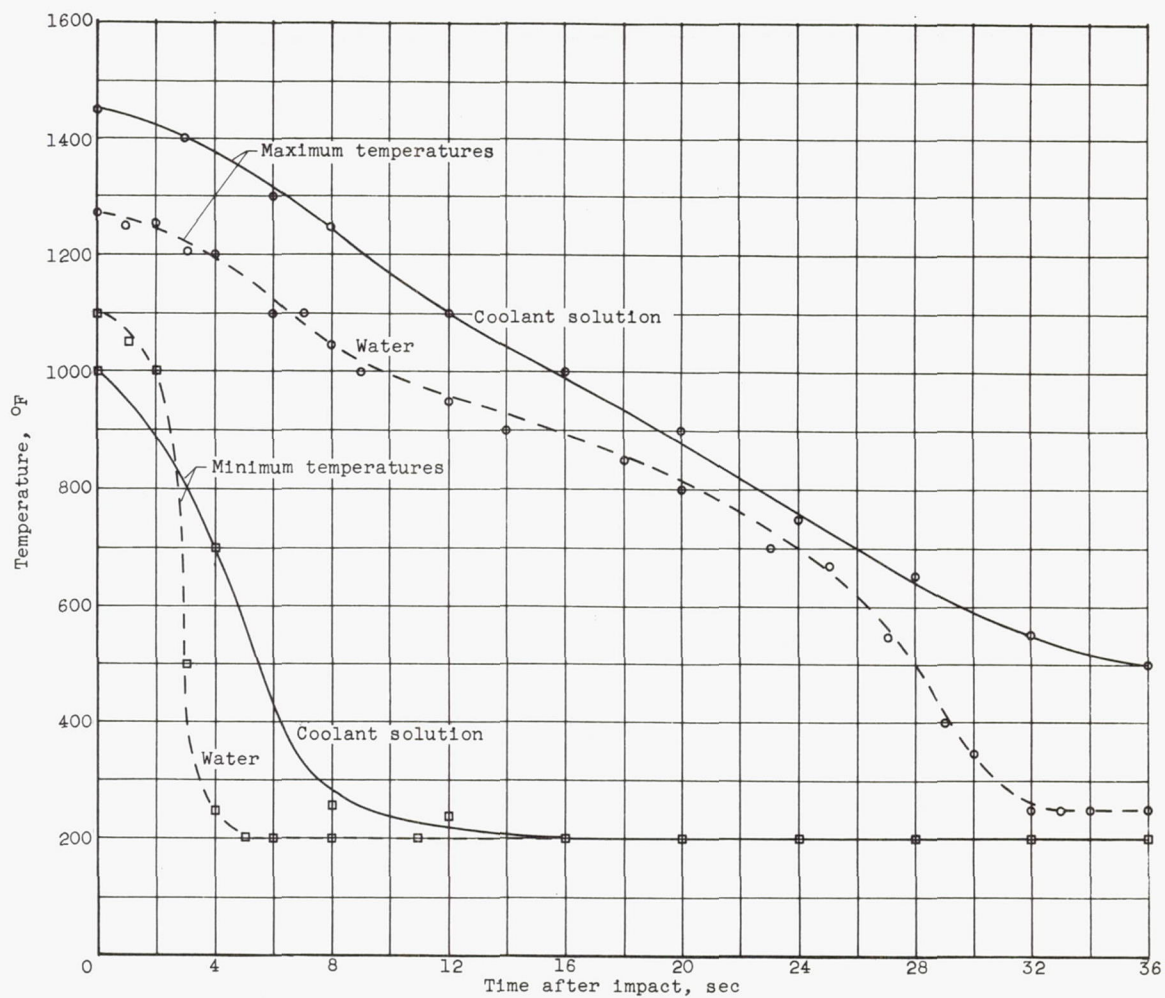
Figure 18. - Cooling effectiveness of water and coolant solution as indicated by temperature of exhaust collector ring.
