# RESEARCH MEMORANDUM

EFFECT OF FORGING TEMPERATURE AND HEAT TREATMENT  
ON THE PERFORMANCE OF INCONEL 700 BUCKETS AT  
1625° F IN A J33-9 TURBOJET ENGINE

Lewis Flight Propulsion Laboratory  
Cleveland, Ohio

February 18, 1958  
Declassified March 18, 1960

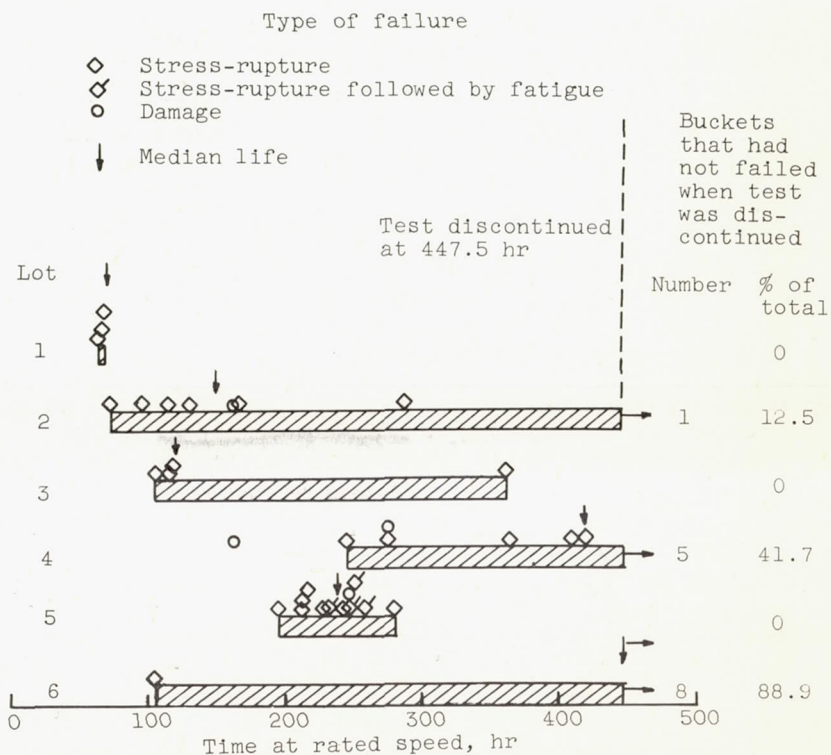
The results of the engine evaluation show that heat-treated Inconel 700 buckets can operate several hundred hours at a bucket temperature of 1625° F (in the critical zone). A comparison of engine performance of the six lots of Inconel 700 is presented in figure 6 and in table II.

Figure 6. - Effect of forging temperatures and solution treatments on performance of Inconel 700 turbine buckets in a J33-9 engine at material temperature of 1625° F.

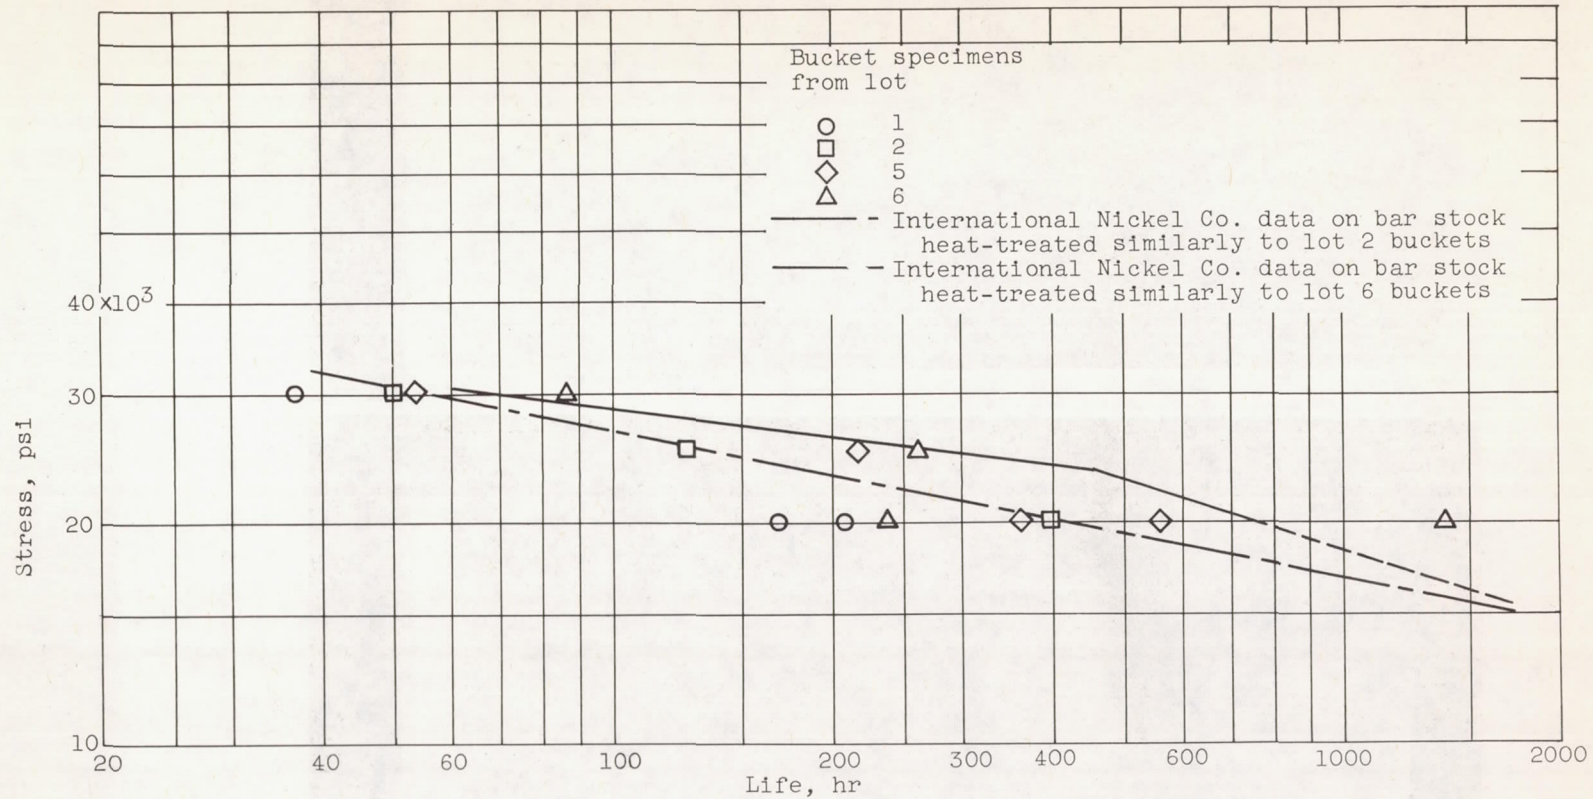
Although some of the stress-rupture data obtained from airfoil specimens were questionable, the remaining data compare favorably with the manufacturer's data, as shown in figure 7. It is interesting to note that one specimen from the lot 6 buckets had a stress-rupture life of nearly 1400 hours when stressed at 20,000 psi at  $1600^{\circ}\text{F}$ . This stress is comparable to that encountered in the critical zone of the buckets during rated-speed operation, and the temperature is within  $25^{\circ}\text{F}$  of the temperature in the critical zone of the bucket.

Figure 7. - 1600° F Stress-rupture life of Inconel 700 specimens taken from airfoils of buckets.

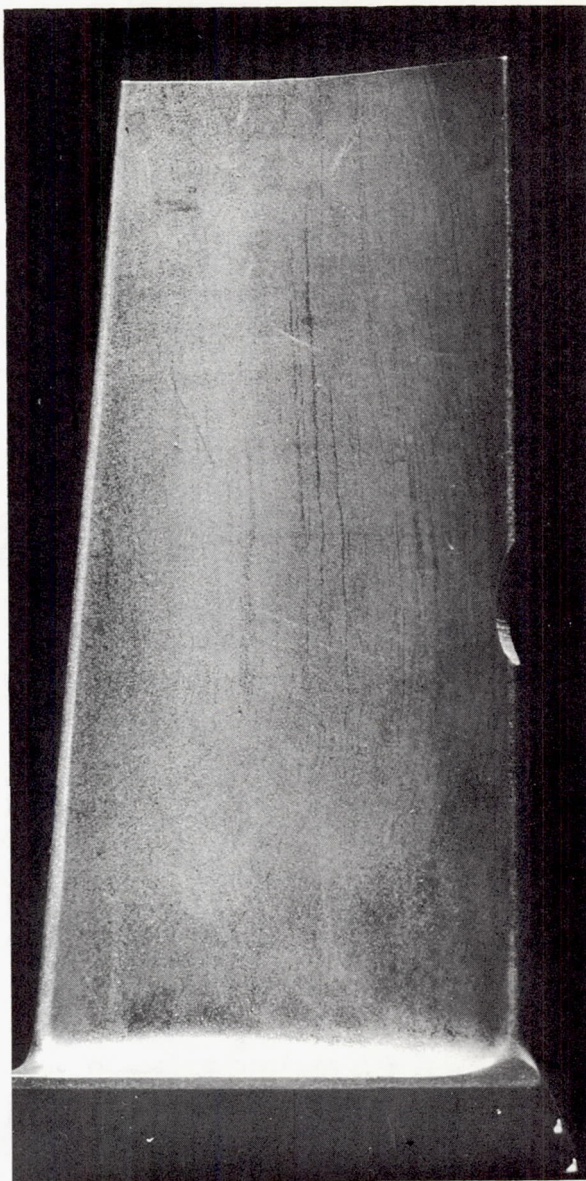
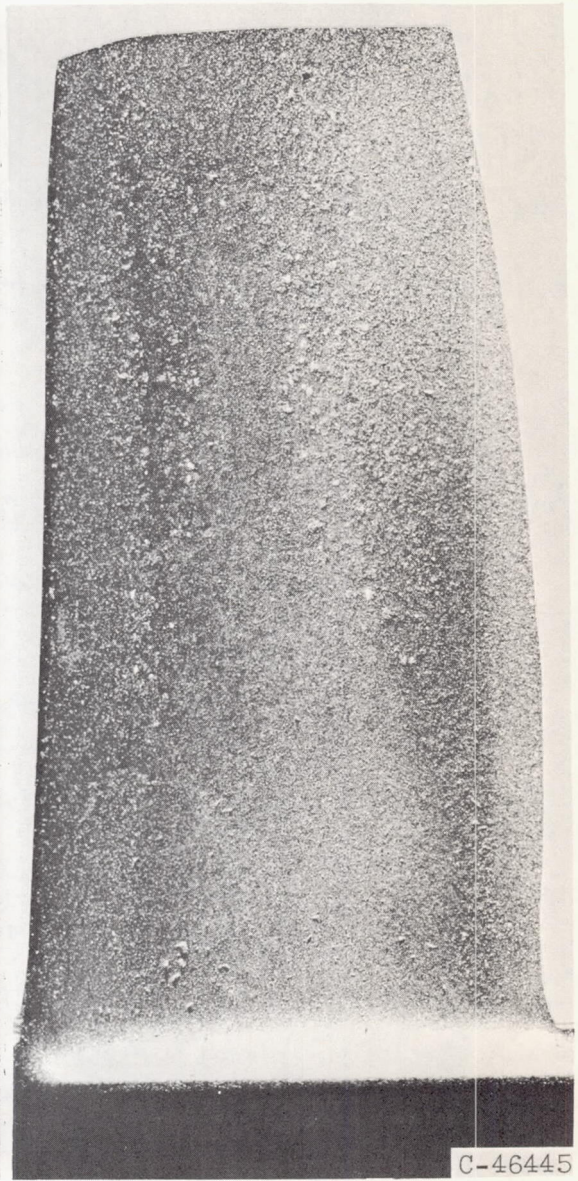
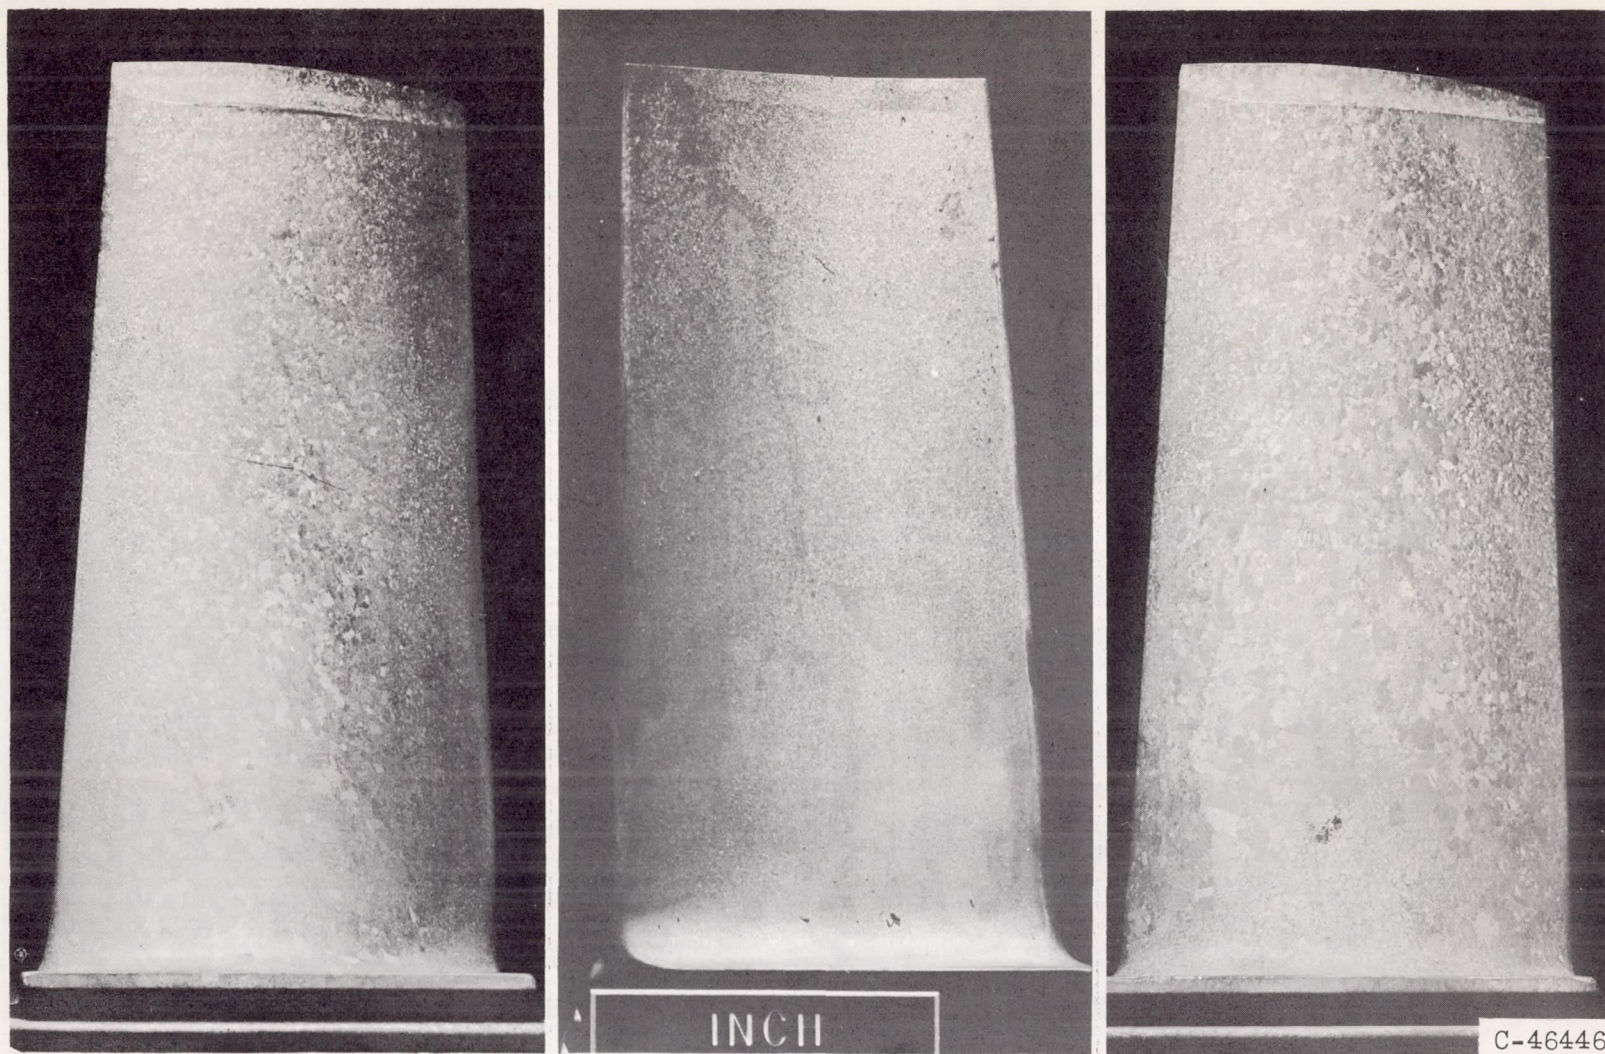
4217 The macrograin sizes of the various lots of buckets are shown in figure 8. The macrograin sizes were relatively uniform within each bucket. The grain sizes of lots of the solution-treated and aged buckets were slightly larger than those in the buckets that were not solution-treated. The grain measurements taken on microsections showed that the ASTM grain sizes ranged from 5 to 6 for the as-forged and aged (non-solution-treated) lot 1 buckets to -2 to 1 for the solution-treated lot 6 buckets, as shown in table VI and figure 9. Elongated grains, indicating the presence of cold-working, were detected in the two lots of buckets (1 and 5) that were not solution-treated.

Figure 8. - Comparison of grain sizes of macroetched buckets.

Figure 8. - Concluded. Comparison of grain sizes of macroetched buckets.

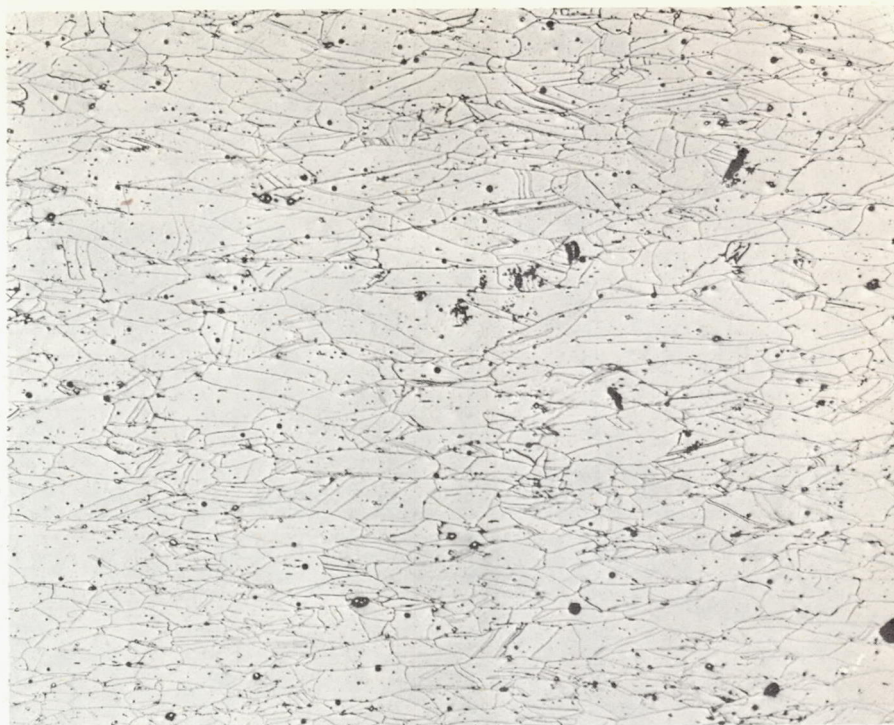
(a) Lot 1.

Figure 9. - Photomicrographs showing grain-size differences among various lots of Inconel 700 buckets. Original magnification, X100.

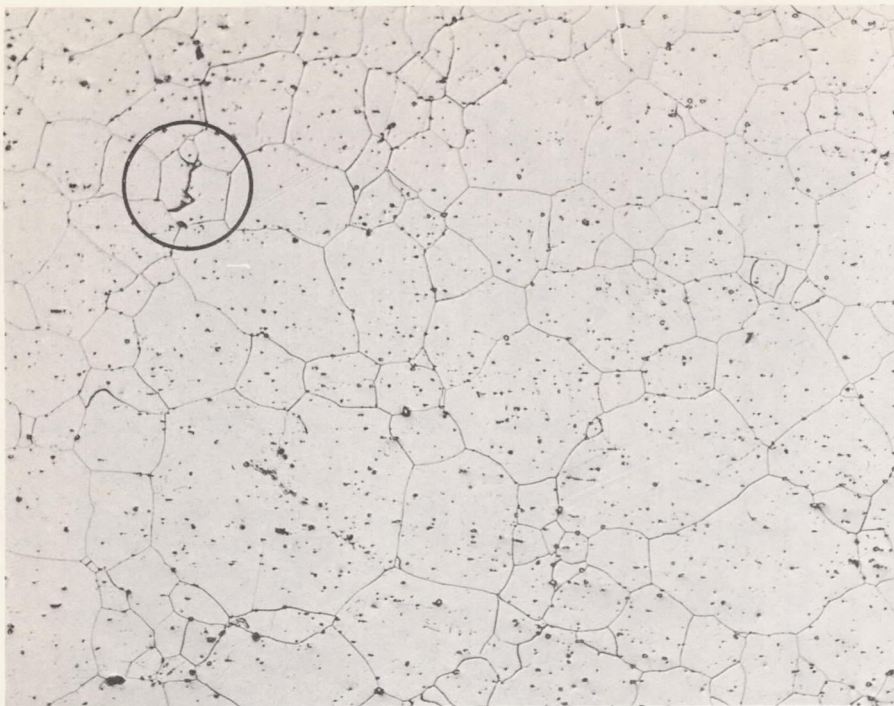
(c) Lot 3.

Figure 9. - Continued. Photomicrographs showing grain-size differences among various lots of Inconel 700 buckets. Original magnification, X100.

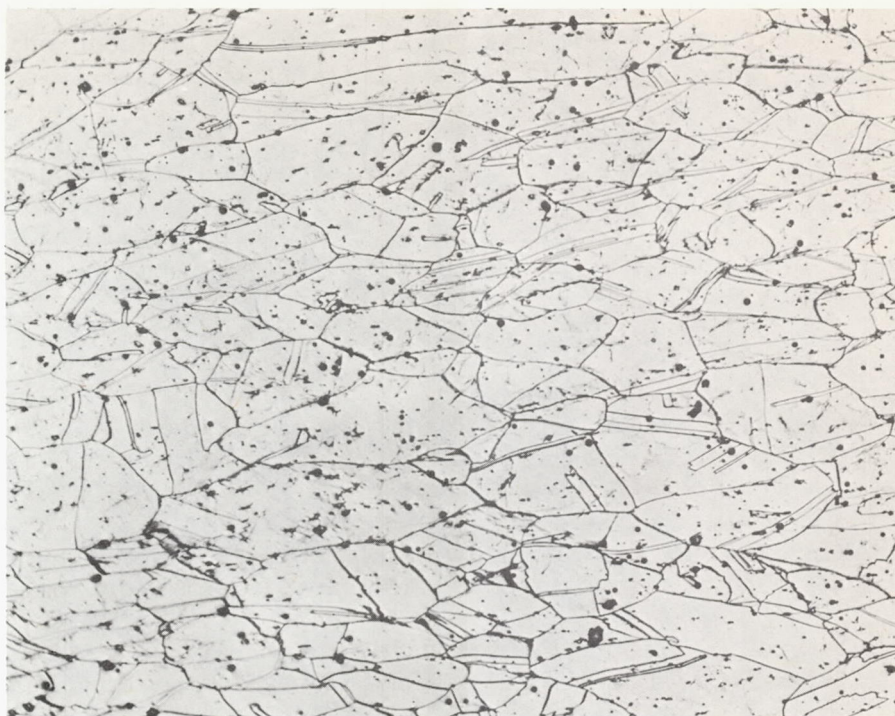
(e) Lot 5.

Figure 9. - Concluded. Photomicrographs showing grain-size differences among various lots of Inconel 700 buckets. Original magnification, X100.

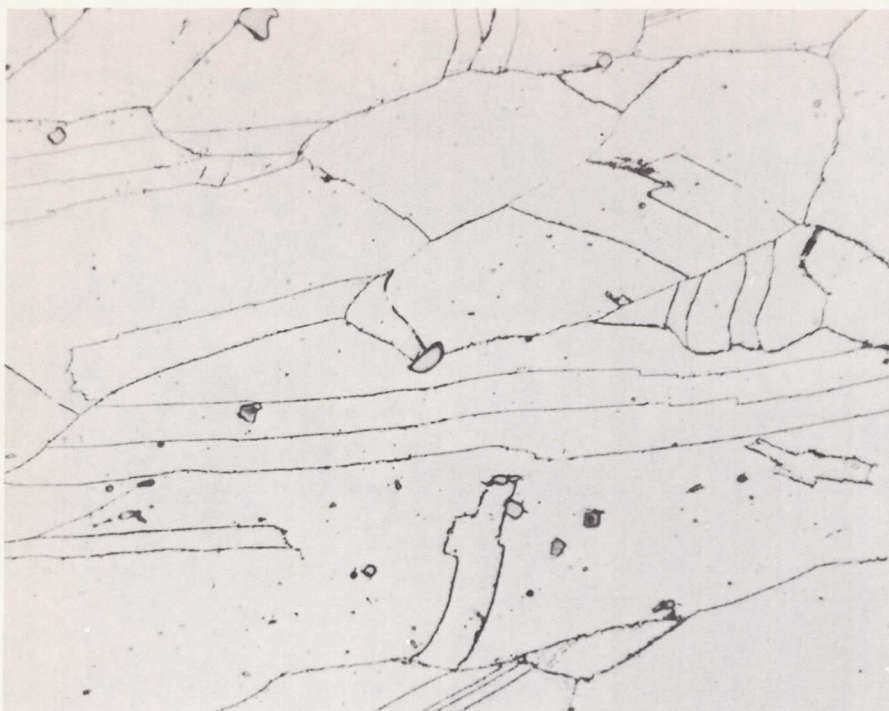
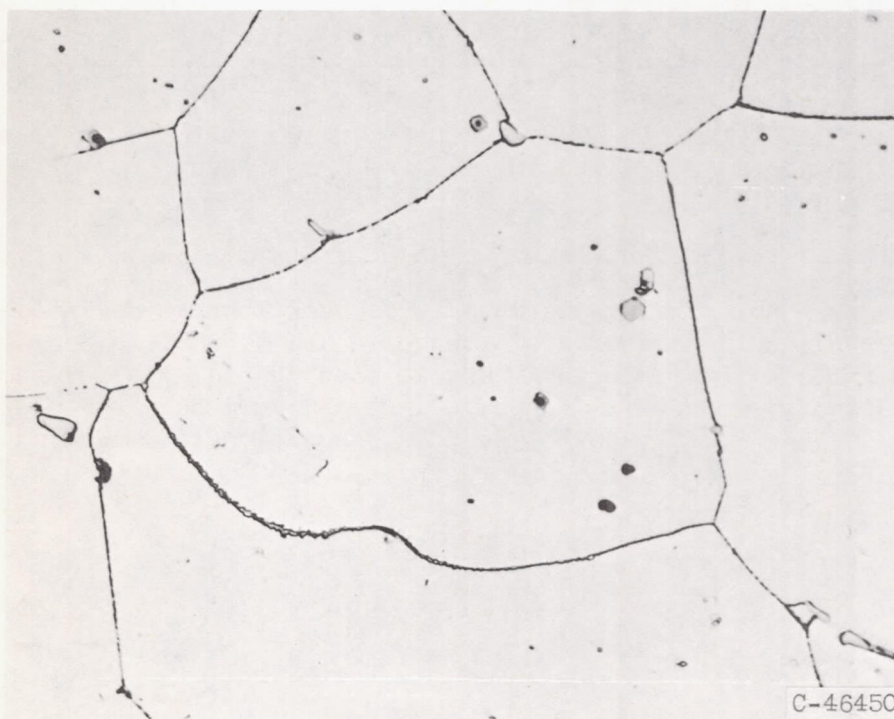
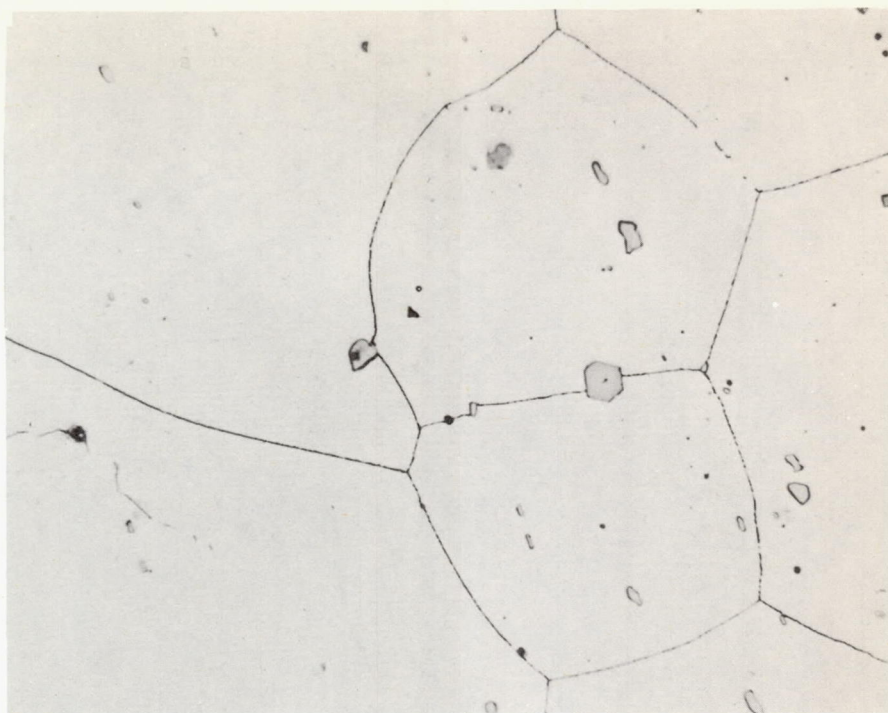
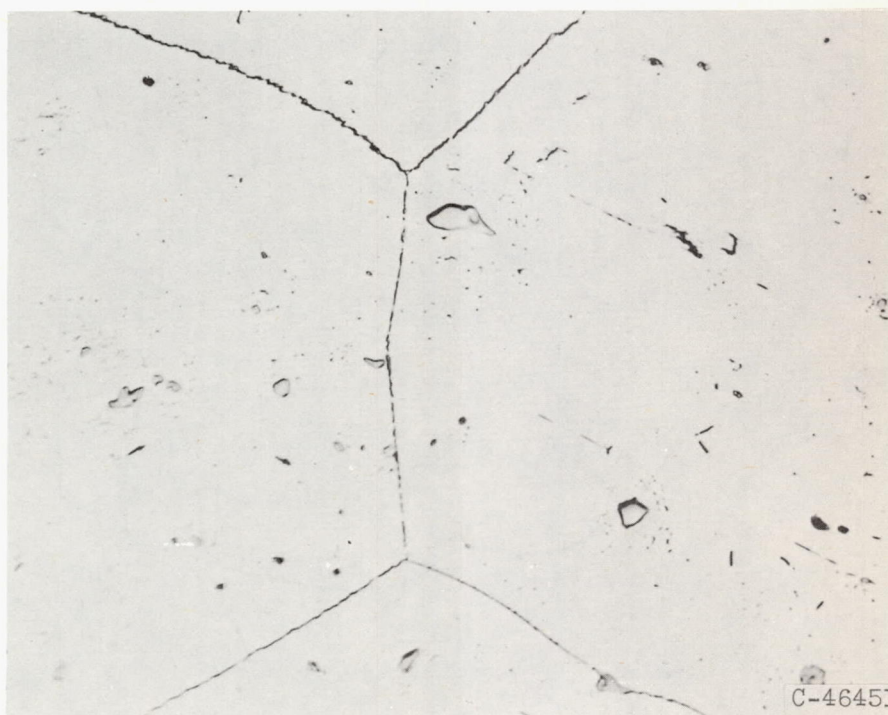
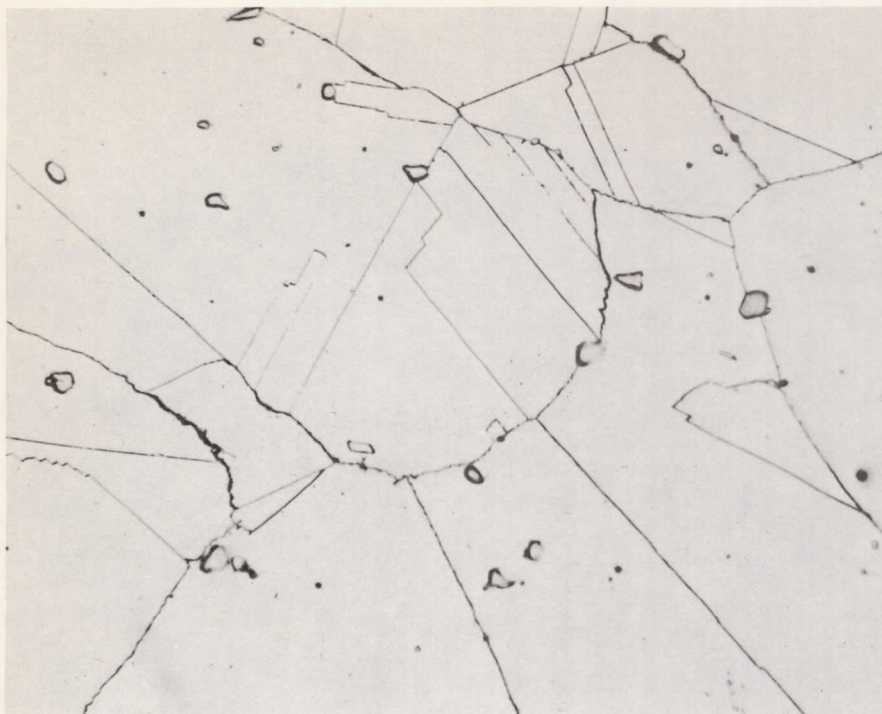
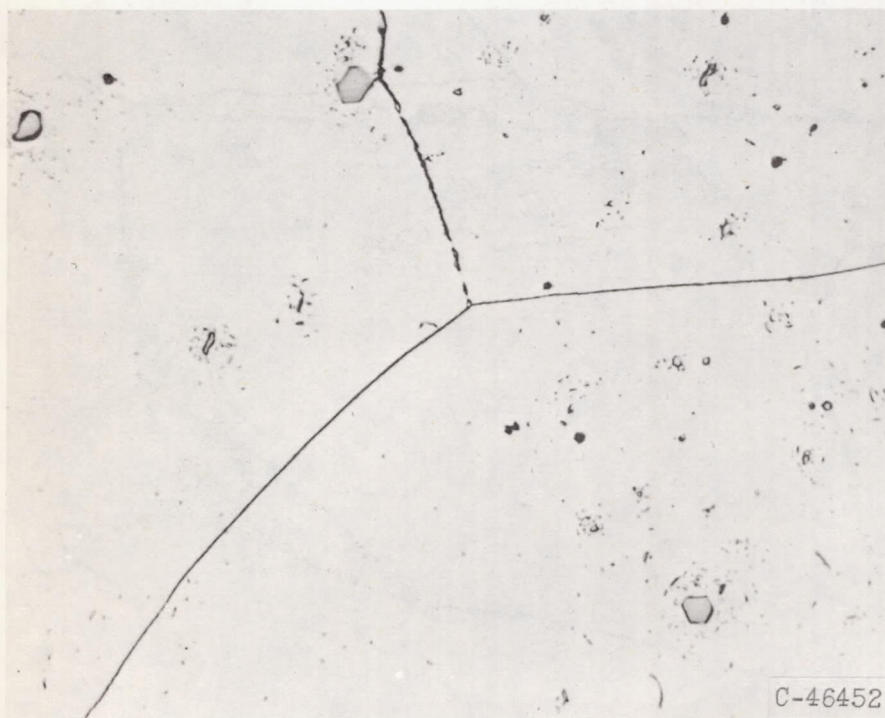
The typical microstructures of the six lots of buckets are shown in figure 10. The photomicrographs do not show the matrix precipitates that are often visible in an age-hardenable alloy. In all probability the precipitates are too fine (or coherent) to be resolved optically. (Long-time aging in a furnace or operating the buckets in an engine will cause the precipitates to grow and become readily visible, as will be shown later.) The larger minor-phase particles present in these microstructures have been identified as titanium carbonitride  $Ti(C,N)$  (ref. 3).

Figure 10. - Typical as-heat-treated microstructures.  
Original magnification, X750.

Figure 10. - Continued. Typical as-heat-treated microstructures. Original magnification, X750.

Figure 10. - Concluded. Typical as-heat-treated microstructures. Original magnification, X750.
