NATIONAL ADVISORY COMMITTEE FOR AERONAUTICS

FLUTTER TESTS OF B-34 FIN-RUDDER-TAB SYSTEM

By Theodore Theodorsen and N. H. Smith

MEMORANDUM REPORT

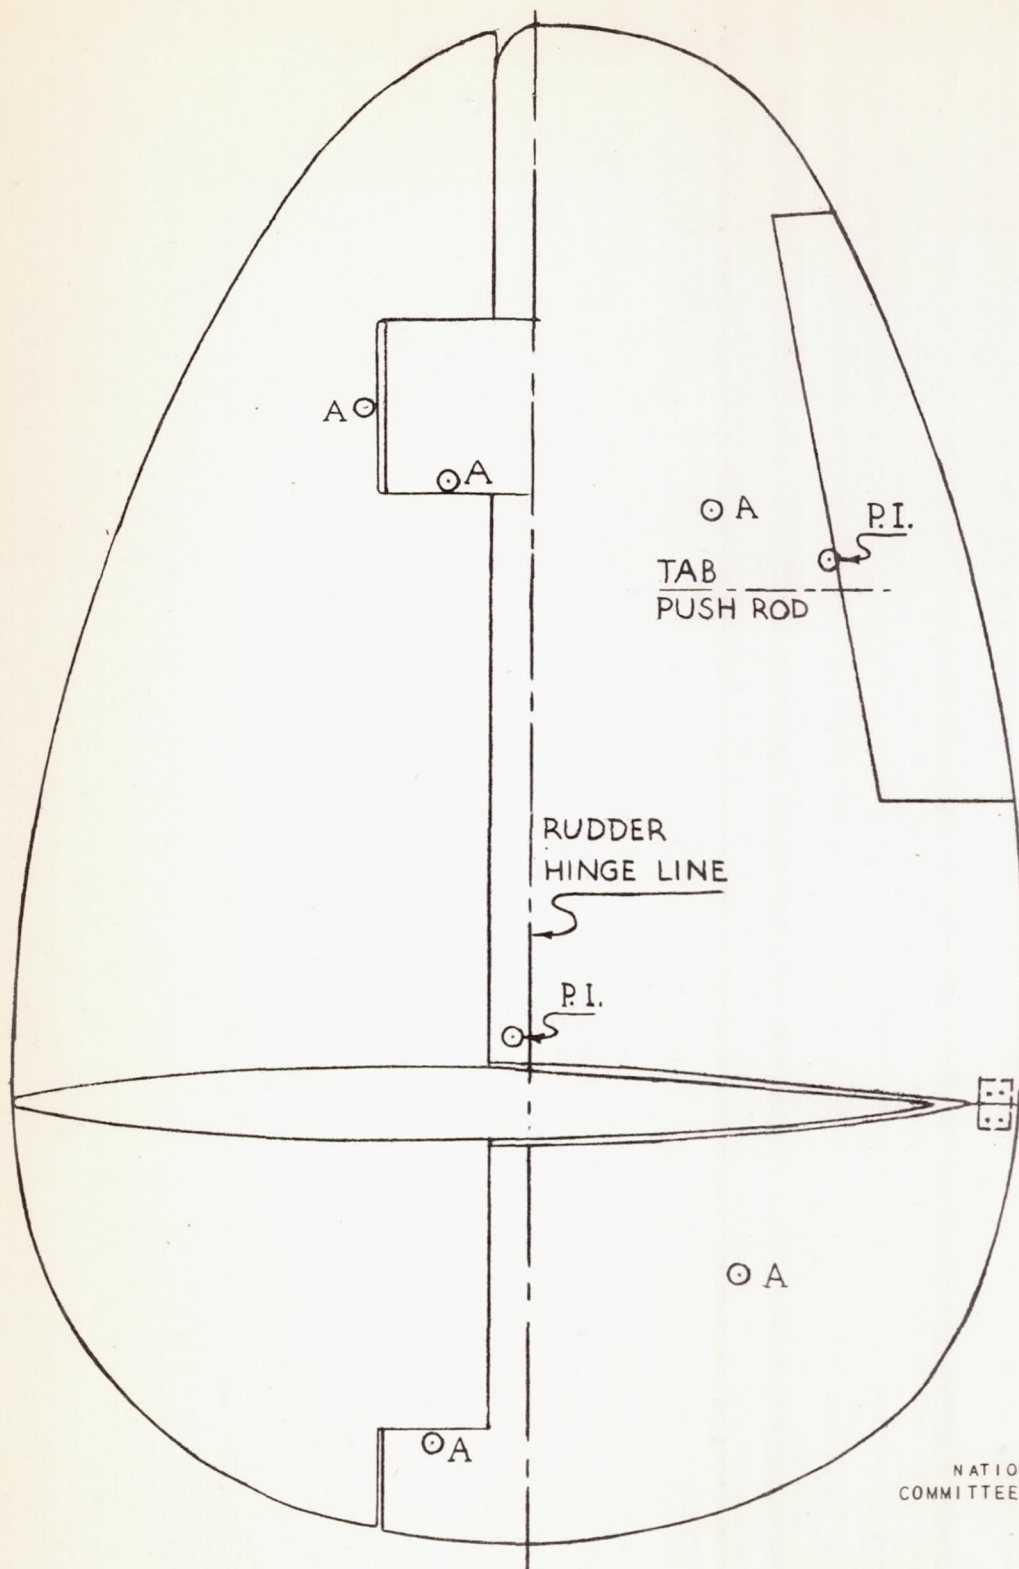
Table II and the oscillograph record in figure 7 show the rudder paddles and the upper-rudder trailing edge to be essentially in phase with one another in the case of the mild flutter. These parts of the rudder are in phase in the vibration mode pictured in figure 1. Also, the tab frequency is very near the frequency for this mode. It is therefore concluded that the flutter mode consisted of a coupling between the tab and the mode of figure 1.

Figure 1.- Mode of vibration at 31.5 cps.
