February 1944 as  
Advance Restricted Report 4B02

FLIGHT TESTS OF THE THERMAL ICE-PREVENTION  
EQUIPMENT ON THE B-17F AIRPLANE

By Bonne C. Look

Ames Aeronautical Laboratory  
Moffett Field, California

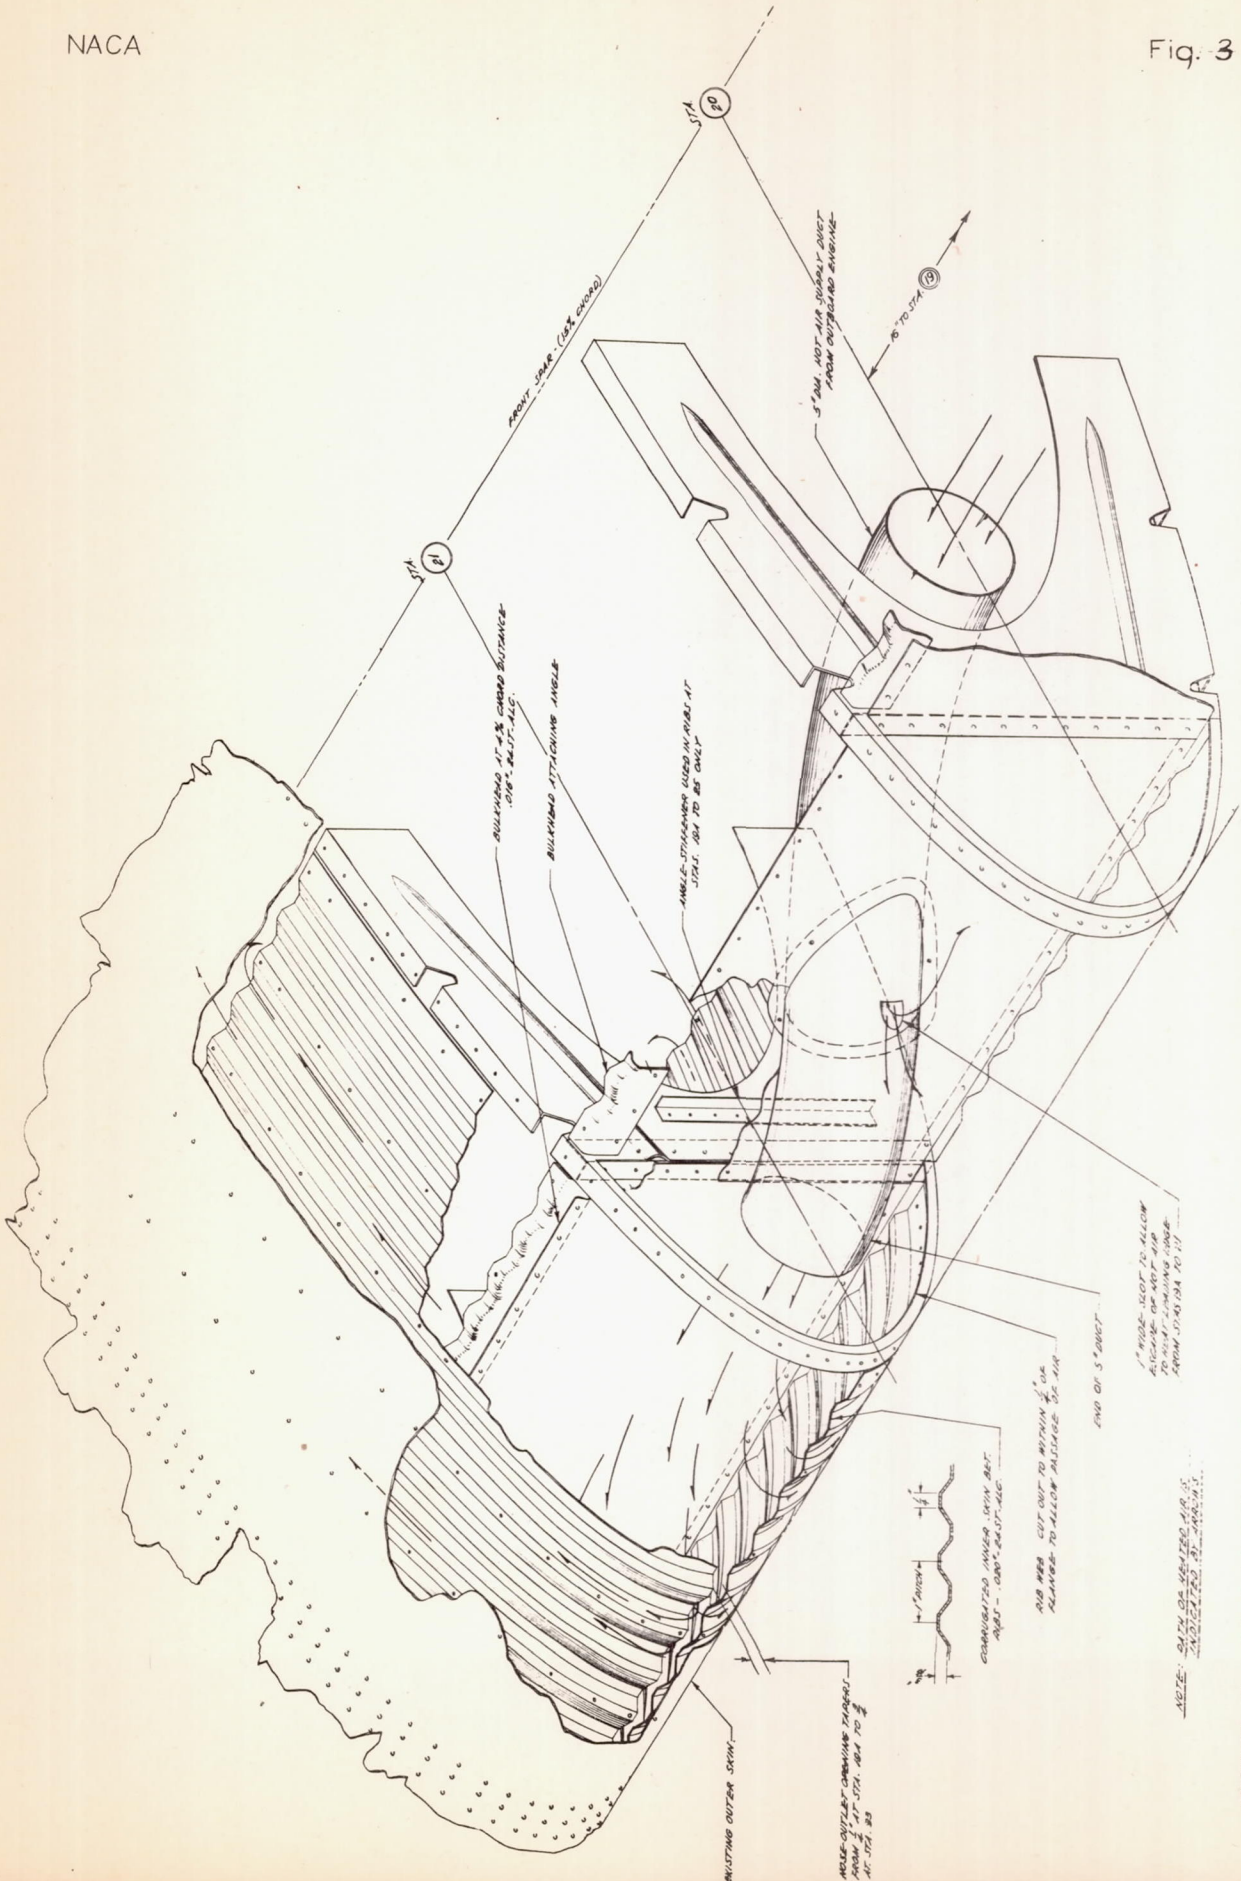
The design of the ice-prevention system was based upon a spanwise air temperature drop of  $40^{\circ}$  F. For the icing flights the average spanwise air temperature drop between stations  $22\frac{1}{2}$  and 33 was  $49^{\circ}$  F and for the dry-air flights was  $34^{\circ}$  F. The reversal of the spanwise gradient of the heated air and skin temperatures between stations  $22\frac{1}{2}$  and 20 was probably due to the method by which the heated region between stations 20 and 21 was supplied with heated air (fig. 3).

FIGURE 3 - DETAILS OF WING OUTER-PANEL LEADING-EDGE DESIGN FOR B-17F THERMAL ICE-PREVENTION SYSTEM.

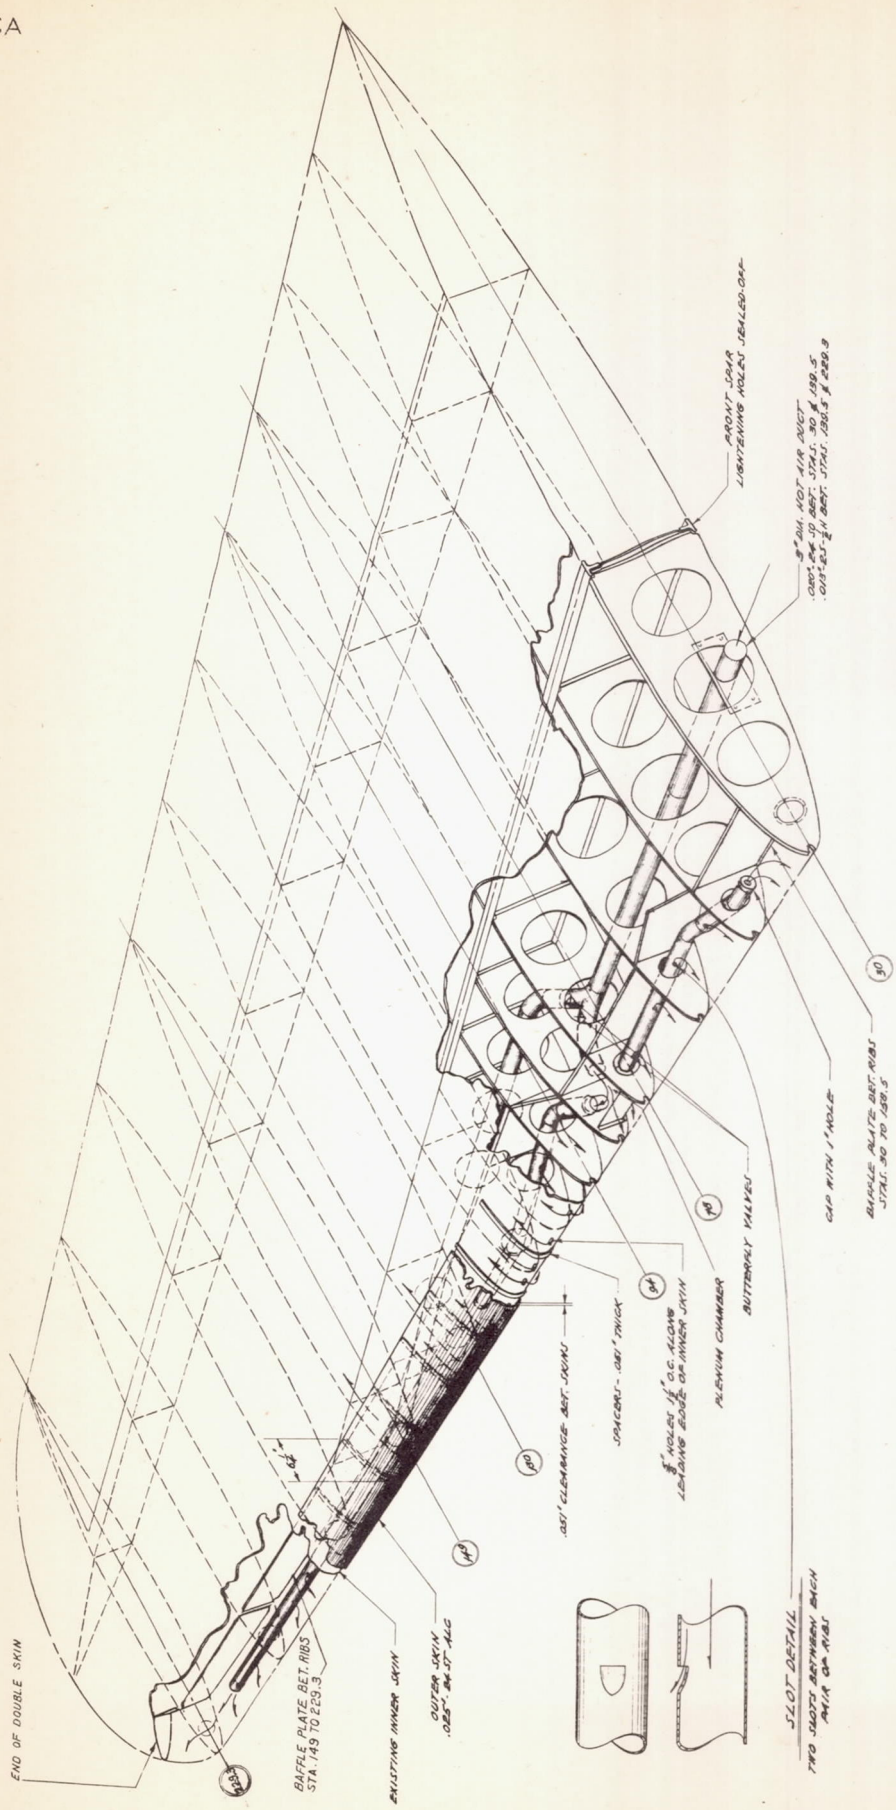
The ice formations which accumulated on the leading edge of the horizontal stabilizer were found to be at the inboard, midspan, and tip regions where the distribution duct had been discontinued and the heated air discharged into a chamber through a 1-inch-diameter hole in the end of the duct (fig. 6). The thermocouples which indicated the leading-edge skin temperatures were located in or near the regions where ice accumulated and, therefore, may not give a true indication of the temperature rise of the protected portion of the leading edge. The thermal data, given in table IV for the horizontal stabilizer, show an average skin temperature rise for the leading edge of approximately  $30^{\circ}$  F for tests 1, 3, 4, and 5, and  $65^{\circ}$  F for test 7. During the dry-air flights (tests 2 and 6) the average skin temperature rise was approximately  $40^{\circ}$  F. The increase in engine power conditions (test 5) did not materially affect the skin temperature rise or the degree of protection afforded by the ice-prevention system. The heated-air flow rate to the horizontal stabilizer was not obtained, but the total weight of air supplied to the empennage group was determined and the distribution of the air to the horizontal and vertical stabilizers was based upon the skin temperature rises.

FIGURE 6.- HORIZONTAL STABILIZER DESIGN FOR B-17F THERMAL ICE-PREVENTION SYSTEM.
