PRACTICAL EXPERIENCES WITH  
LIGHTNING DISCHARGES TO AIRPLANES

By Heinrich Koppe

Zeitschrift für Flugtechnik und Motorluftschiffahrt  
Vol. 24, No. 21, November 4, 1933

TECHNICAL MEMORANDUM NO. 730

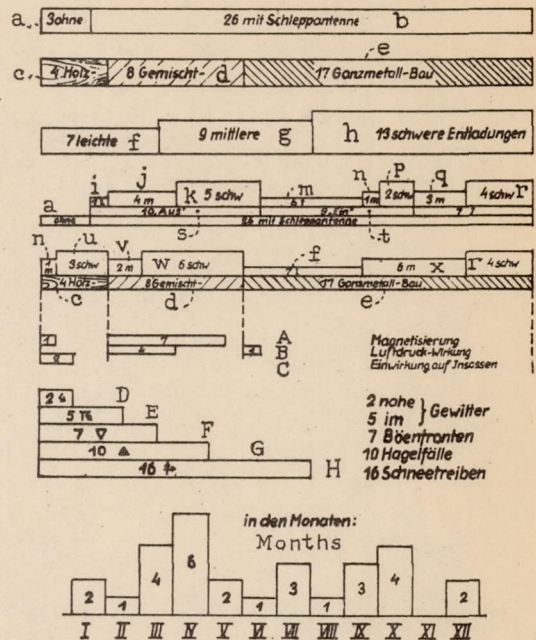
Figure 4.- Lightning discharges to airplane.

Of the 32 cases, 2 continuous discharges due to Saint Elmo's fire and 1 induced discharge on a glider are eliminated, which leaves 29 cases of lightning striking an airplane in flight (fig. 4).
