BRUSH SEAL BRISTLE FLEXURE AND HARD-RUB CHARACTERISTICS

Robert C. Hendricks, Julie A. Carlile, and Anita D. Liang
National Aeronautics and Space Administration
Lewis Research Center
Cleveland, OH 44135

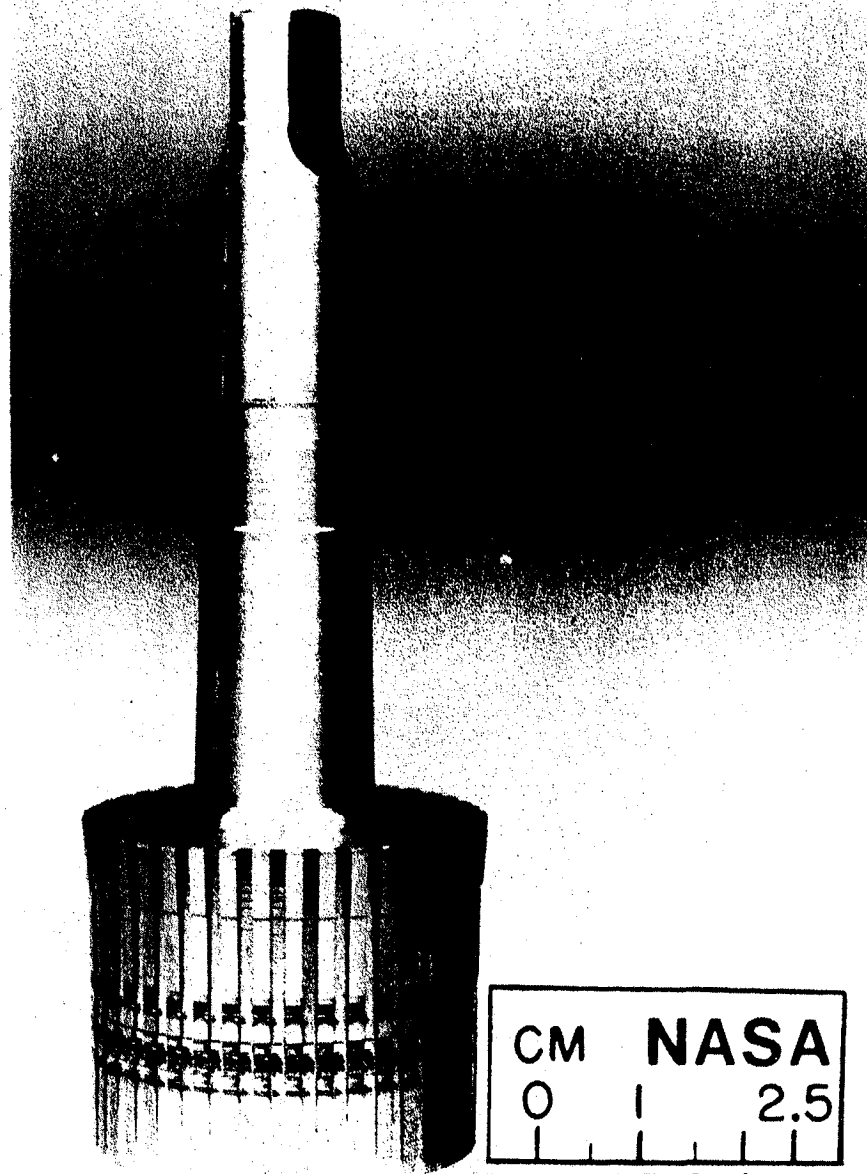
Figure 2.—Geometry of tapered, 40-tooth rotor.

In the tests described herein the 38.1-mm (1.5-in.) diameter brush seal was again mounted in the pressure vessel that simulated the static housing; but for these tests flutes were machined the length of the plug rotor, providing a set of 40 lands and 40 grooves, or a 40-tooth rotor (fig. 2). The lands were 1.638 ± 0.04 mm (0.0645 ± 0.0015 in.) just above the groove at test 3 and 1.582 ± 0.04 mm (0.0623 ± 0.0015 in.) just below the groove at test 1; see rotor sketch on table I. The groove width (fig. 3) averaged 1.397 to 1.422 mm (0.055 to 0.056 in.) with further dimensions provided in tables I and II. Prior to testing the machining tool marks were clear, being axial in the grooves and circumferential on the lands. This rotor provided 40 impacts of the brush bristles per revolution and was rotated at 2600 rpm.
