#### **INTEGRITY TESTING OF BRUSH SEAL IN A T-700 ENGINE**

# Robert C. Hendricks, Thomas A. Griffin, George A. Bobula, and Robert C. Bill National Aeronautics and Space Administration Lewis Research Center Cleveland, Ohio, 44135

### SUMMARY

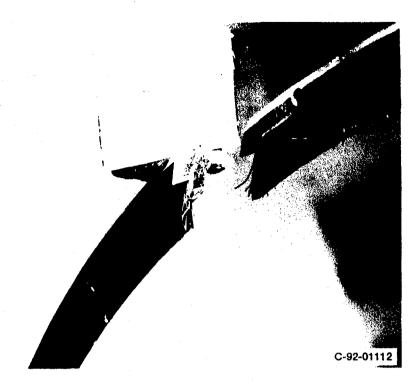
Figure 3.—Brush seal cross section crafted to fit turbine shroud between two labyrinthhoneycomb seals.

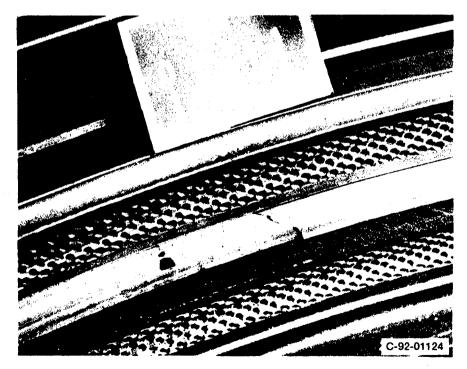
Before proceeding to discuss post-test results, we return to the installation of the brush into the power turbine shroud. Figures 4, 5, and 7 show views of the installed brush seal. The brush was designed for an interference of 0.51 mm (0.020 in.) diametral. The actual interference could not be determined, but estimates of the pretest brush clearance were -0.51 to -1.27 mm (-0.02 to -0.05 in.) diametral. Measurements of the shrouds differed as did those for the rotor. Although the differences were only a few thousands of an inch (mils), they represented a significant percentage of the clearance gap. It was also determined that individual blade sets could have a step change of 0.229 mm (0.009 in.) from one blade set to the next. These surface irregularities are shown in the post-test photograph (fig. 8).

Figure 4.---View of installed brush seal.

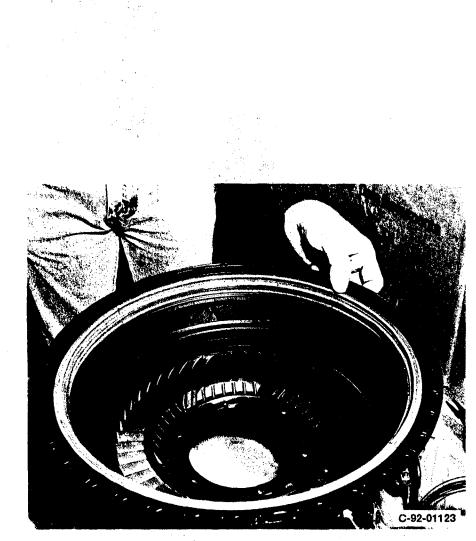
Figure 5.—Overview of installed brush seal and power turbine housing.

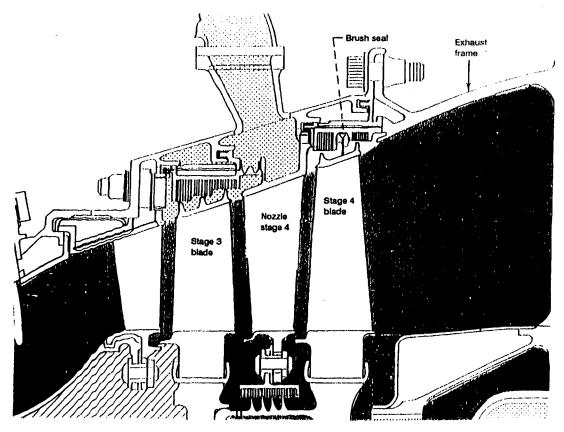
Assembly of the turbine with the shroud required forcing the brush past the upstream labyrinth tooth without any visual or instrumented guidelines; see figure 7 (power turbine). Forcing the brush over the labyrinth tooth spread the bristles axially into the upstream direction. This type of spreading alters the bristle packing configuration, but the extent of alteration and the degree of spreading are unknown. Post-test results indicated that perhaps two to three upstream bristle rows remained spread with possibly one downstream bristle row in disarray. Still the brush was resilient because the remaining rows appeared to be in position. The flexibility of a brush seal and the abuse it can withstand appear to be significant.

Figure 7.-Schematic of power turbine.

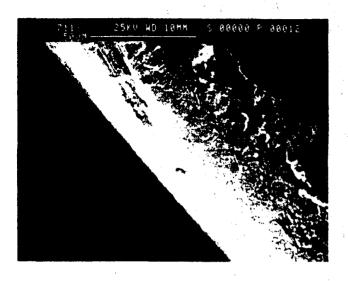
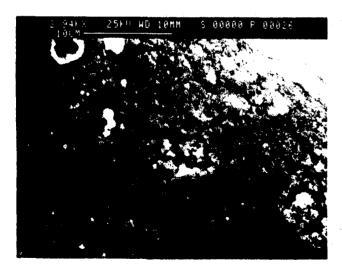
Upon initial engine startup, an orange burst was noted and was assumed to be expelled brush bristles (i.e., those that were inadequately attached, were pulled out by rotor irregularities, or were embedded within the blade row gaps during the blind installation and "snapped" or "yanked" or "bent" aside during engine break-in). Residual bristles from the exhaust were photographed (fig. 9). Although they appeared to be highly oxidized and stressed, they were curly and still wirey. The number of residual bristles decreased with operation until none were noted. It is assumed that at this time the bristles and the rotor were in nearly line-to-line contact (i.e., rubbed in). Precooling the bristles during the initial rub-in may mitigate bristle loss and the orange burst.

Figure 9.---Typical brush seal debris found in engine exhaust duct.

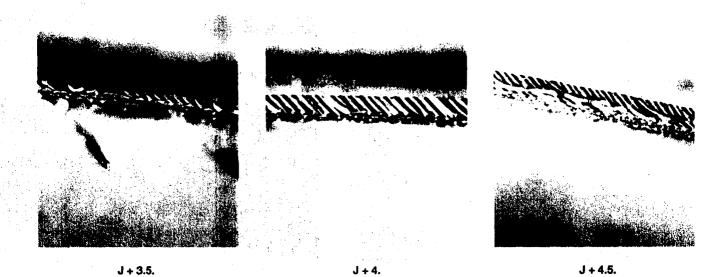
Figure 10 illustrates bristle spreading after testing, with a central core of bristles rubbed (probably clip cut and worn to shape). Although the environment was hostile, the brush did not disintegrate, but bristle pullout could be noted in a few places. Some upstream bristles (two or three rows) show spreading and perhaps one row downstream (toward the exhaust). The remainder of the bristles show wear (or cutting plus wear). Detailed estimates of the bristle stubble heights are given in figure 11(a) as taken from the set of photographs in figure 11(b) corresponding to positions (joint, J+1, J+1.5, J+2, J+2.5, J+3, J+3.5, J+4, and J+4.5) shown in figure 11(a). The last two photographs in figure 11(b) correspond to the minimum stubble height, where the rotor actually rubbed the fence (position J+3); the view is looking toward the bristle stubbles to show the rubbed fence. Figure 11(c) shows wear track and fence rub, and figure 11(d) shows the joint wear track.

Figure 11.---Post-test bristle stub height and backing washer rub. Bristle diameter, 0.0028 in.
