TWR-60695  
Revision B

## Final Postflight Hardware Evaluation Report 360T021(RSRM-21, STS-45)

**Final Postflight  
Hardware Evaluation Report  
360T021 (RSRM-21, STS-45)**

This document is the final report for the Clearfield disassembly evaluation and a continuation of KSC postflight assessment for the 360T021 (STS-45) RSRM flight set. All observed hardware conditions were documented on PFORs and are included in Appendices A through E. This report, along with the KSC Ten-Day Postflight Hardware Evaluation Report (TWR-61502), represents a summary of the 360T021 hardware evaluation. The configuration evaluated is documented in TWR-60467. Disassembly evaluation photograph numbers are logged in TWA-1982.

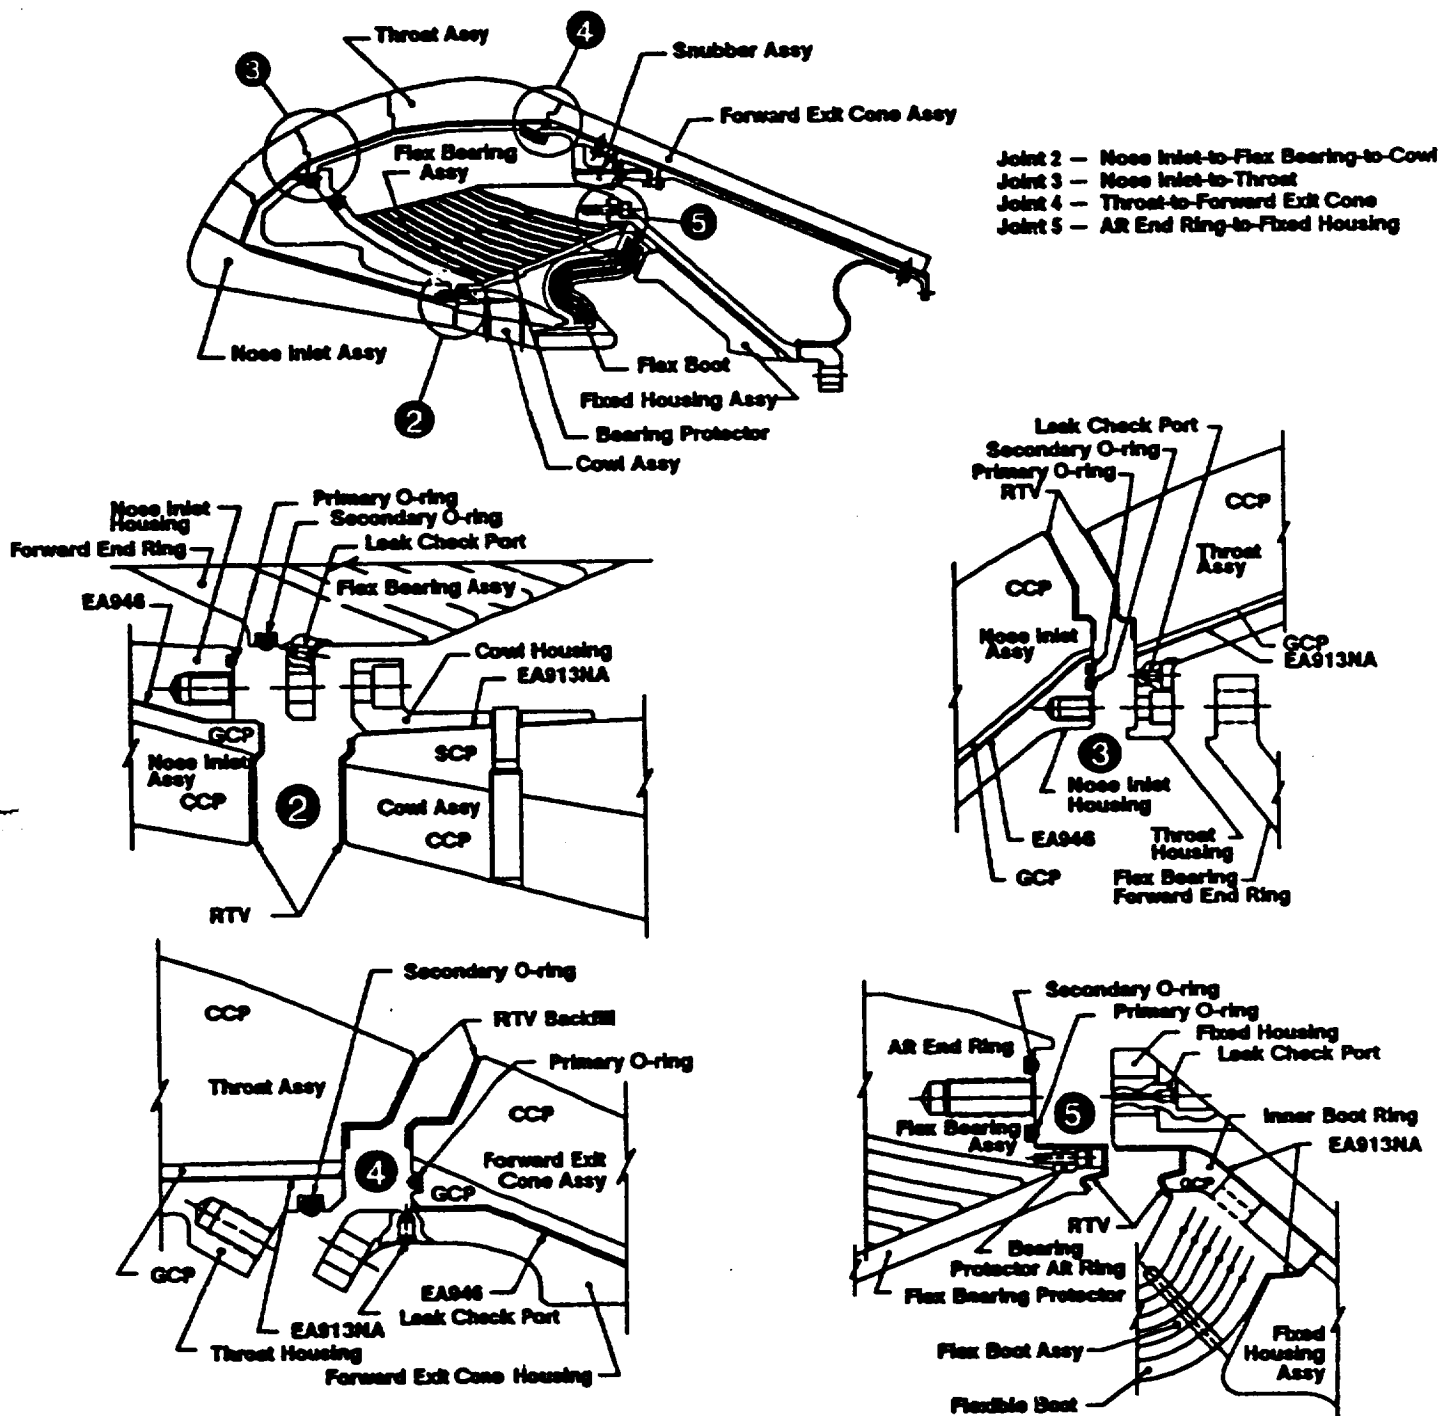
**Figure 3. RSRM Nozzle Internal Joints**

There was mixing of RTV and EA913NA adhesive, which is a normal condition for this joint. RTV was below the char line around the full circumference. Typical amounts of soot entered the joint between the layers of RTV and adhesive. Soot reached the primary O-ring intermittently around the circumference. The heaviest area of soot was from 336-0-96

degrees. No distinct gas paths were observed. There were no heat effects to the metal, phenolics, or O-rings.

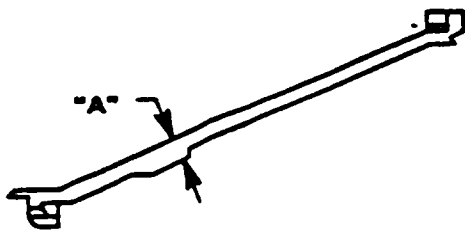
\* "A" is the minimum thickness of the bearing protector in-line with the cowl vent holes. It corresponds to the deepest gas impingement location.

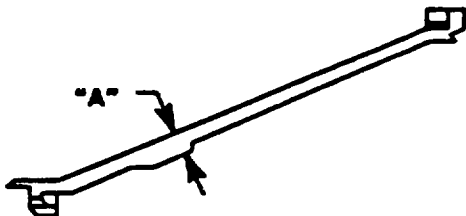
\* "A" is the minimum thickness of the bearing protector in-line with the cowl vent holes. It corresponds to the deepest gas impingement location.
