# The Characterization of WideSpread Fatigue Damage in Fuselage Structure

Robert S. Piascik  
*Langley Research Center, Hampton, Virginia*

September 1994

National Aeronautics and  
Space Administration  
Langley Research Center  
Hampton, Virginia 23681-0001

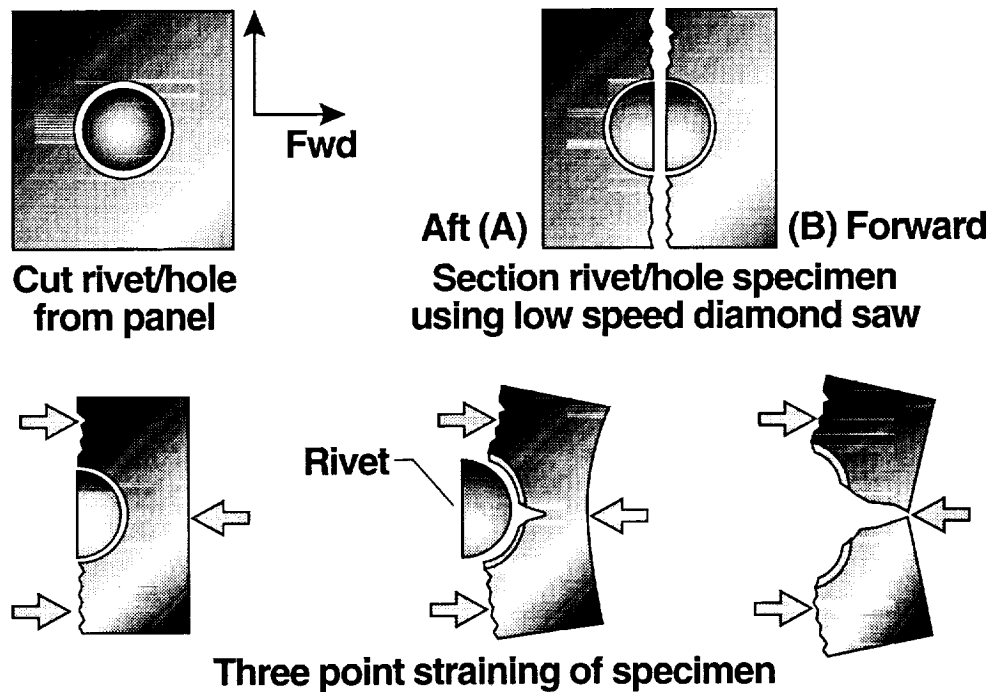
Figure 3. Schematic illustrating rivet hole destructive examination procedure.

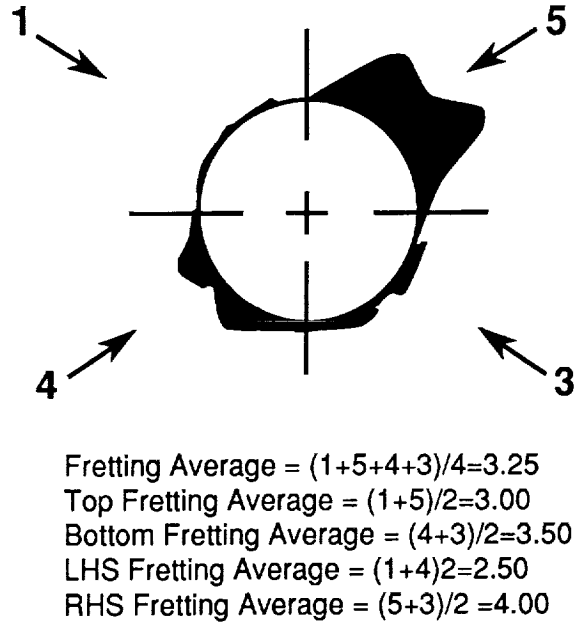
Upper rivet row fatigue cracking at the inner/outer skin interface shown in Figures 5c and 6 suggests that crack initiation is associated with localized damage due to fretting [8]. Evidence of fretting fatigue was noted by a black oxide deposit on the mating surface between the inner/outer skin around each rivet hole. Depicted in Figure 8 is the extent (area drawn to scale) of fretting debris (black oxide) observed on the inboard surface of bay #1 lap splice joint outer skin by estimating the area of fretting debris at each hole location. The amount of fretting was estimated by determining an arithmetic average of fretted surface area per the procedure shown in Figure 9. Here, a scaling factor was assigned to estimate the amount of fretting in each quadrant shown in Figure 9. The value 0 was assigned when no fretting was observed and 5 represented the highest degree of fretting. A "fretting Average" (FA) was calculated for each rivet position. A direct correlation of "fretting average" with rivet hole cracking was not conclusive, i.e., all fretting initiated cracks were observed in holes that exhibited a relatively high FA > 3.00, but, all holes that exhibited a FA > 3.00 did not contain fretting initiated cracks. Figure 10 is a plot of FA versus rivet hole location for the rows G, H, I and J. Here, a distinct correlation is observed for FA and rivet row, i.e., upper row J which contains the greatest number of fretting fatigue cracks, also exhibits the greatest evidence of fretting damage (highest FA level).

Figure 9. A schematic showing the procedure used for estimating the extent of fretting fatigue by averaging the amount (area) of visible black oxide observed on the inside surface of the lap splice outer skin.
