# Debris/Ice/TPS Assessment and Integrated Photographic Analysis of Shuttle Mission STS-73

Gregory N. Katnik, Barry C. Bowen, Jill D. Lin, Vehicle Engineering/Mechanical System Division/ET-SRB Branch, Kennedy Space Center, Florida

20 October 1995

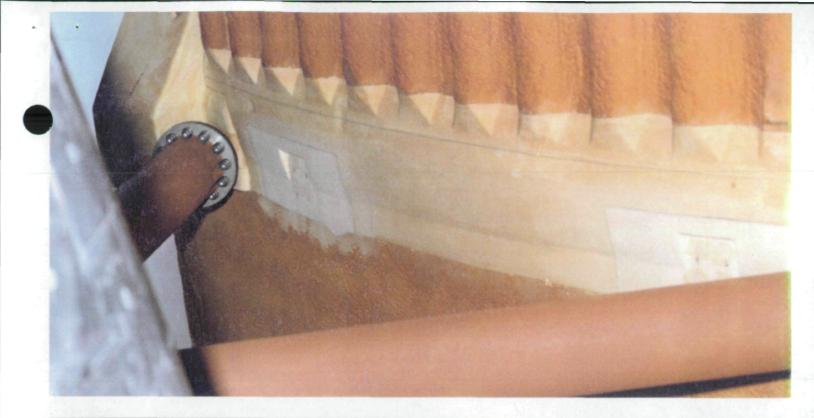
Photo 18: Intact Bipod Jack Pad Closeouts

Pre-Launch view shows the configuration of the new-method bipod jack pad closeouts. Note bright appearance of the BX-250 closeout foam before launch. The closeouts appeared to be unchanged and intact in a view from the ET/ORB umbilical separation cameras.

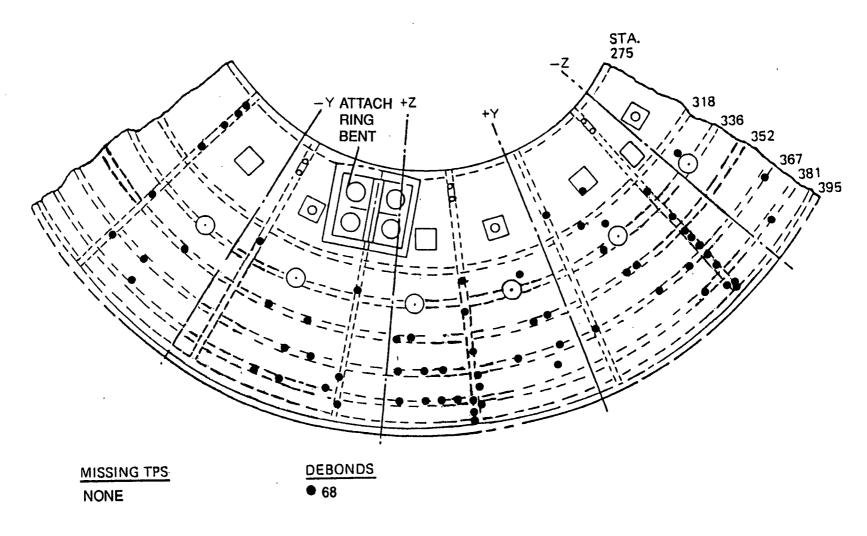
Figure 1: RH SRB Frustum

The RH frustum was missing no TPS. The number of debonds (67) over fasteners was greater than average (Figure 1). Hypalon paint was blistered/missing along the XB-395 ring frame where BTA closeouts had been applied. However, most of the exposed BTA substrate was not sooted. The BSM aero heat shield covers had locked in the fully opened position though the upper left cover attach ring had been bent by parachute riser entanglement.

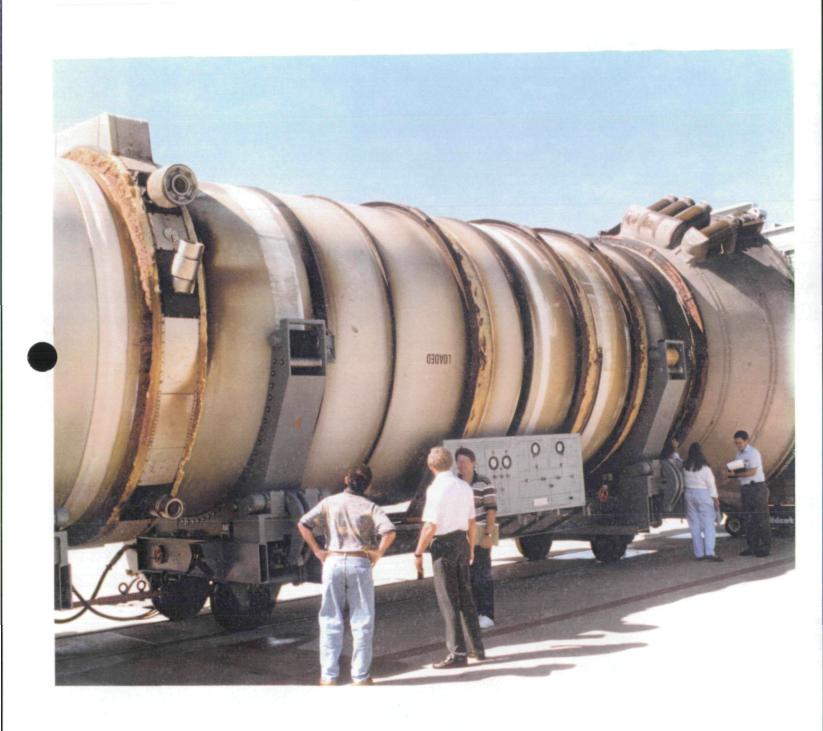
Photo 22: RH Aft Booster/ Aft Skirt

Aft skirt MSA-2 was intact. The HDP Debris Containment System (DCS) plungers appeared to have functioned properly though a piece of ordnance debris was wedged against the HDP #3 plunger and prevented full seating. The holddown post #2 stud hole was broached by a stud hangup at liftoff.

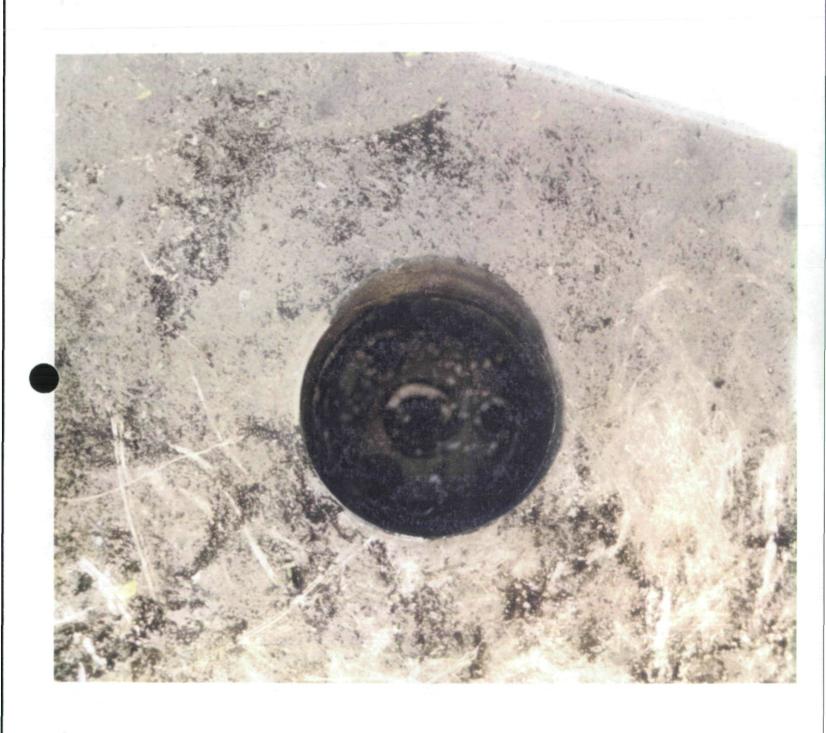
Photo 23: Broached Holddown Post #2 Stud Hole

A stud hang-up occurred on holddown post #2. As the vehicle gained altitude and the stud became visible above the HDP shoe, aluminum from the wall of the stud hole was observed in the stud threads. Two semi-circular pieces of aluminum fell from the top area of the stud to the HDP shoe. One ordnance fragment fell from the DCS after the stud cleared the stud hole. Drag from the stud hang-up and the rising vehicle lifted the holddown post shoe approximately 2 inches before the stud cleared the SRB aft skirt foot. No stud hang-ups occurred on any of the other holddown posts. No ordnance fragments or frangible nut pieces fell from any of the DCS/stud holes with the exception of the HDP #2 event.

The holddown post #2 stud hole was broached by a stud hang-up at liftoff

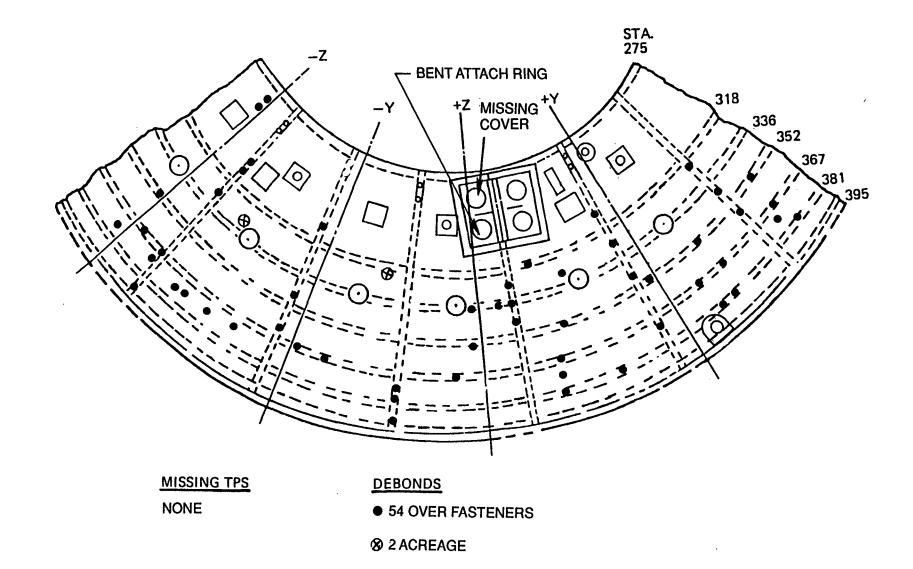
The LH frustum was missing no TPS. The number of MSA-2 debonds over fasteners (54) and over acreage (2) was greater than average (Figure 2). Hypalon paint was blistered/missing along the XB-395 ring frame where BTA closeouts had been applied. However, most of the exposed BTA substrate was not sooted. The BSM aero heat shield covers had locked in the fully opened position though the lower left cover attach ring had been bent. The upper left cover was missing. The damage to the BSM covers/attach rings was caused by parachute riser entanglement after splashdown.

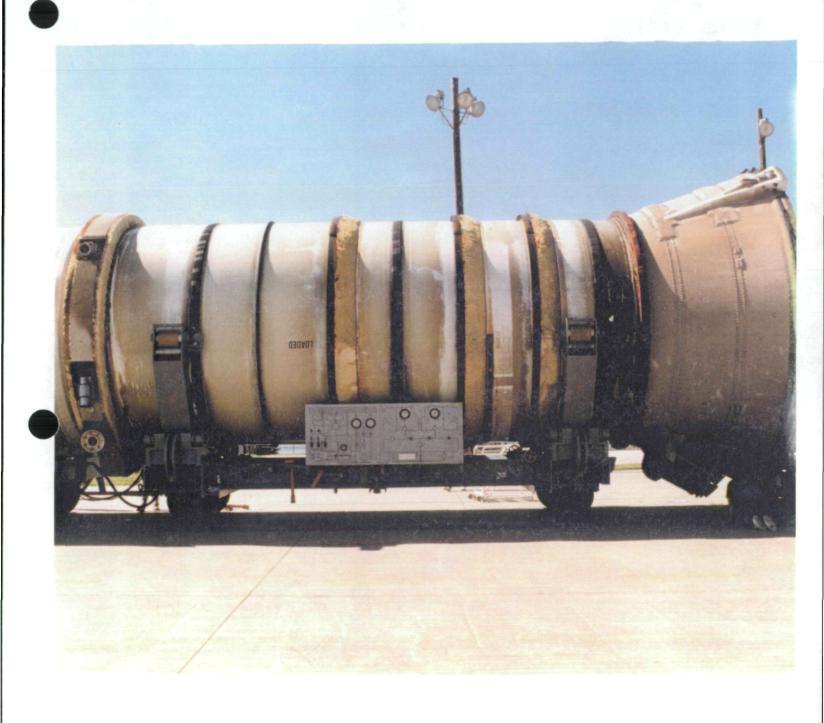
Photo 28: LH Aft Booster/ Aft Skirt

Separation of the aft ET/SRB struts appeared normal. No K5NA was missing from the separation plane of the upper strut fairing. The ETA ring, IEA, and IEA covers appeared undamaged. The stiffener ring splice plate closeouts were intact and no K5NA material was missing. Aft skirt MSA-2 was intact. The HDP Debris Containment System (DCS) plungers were seated and appeared to have functioned properly.

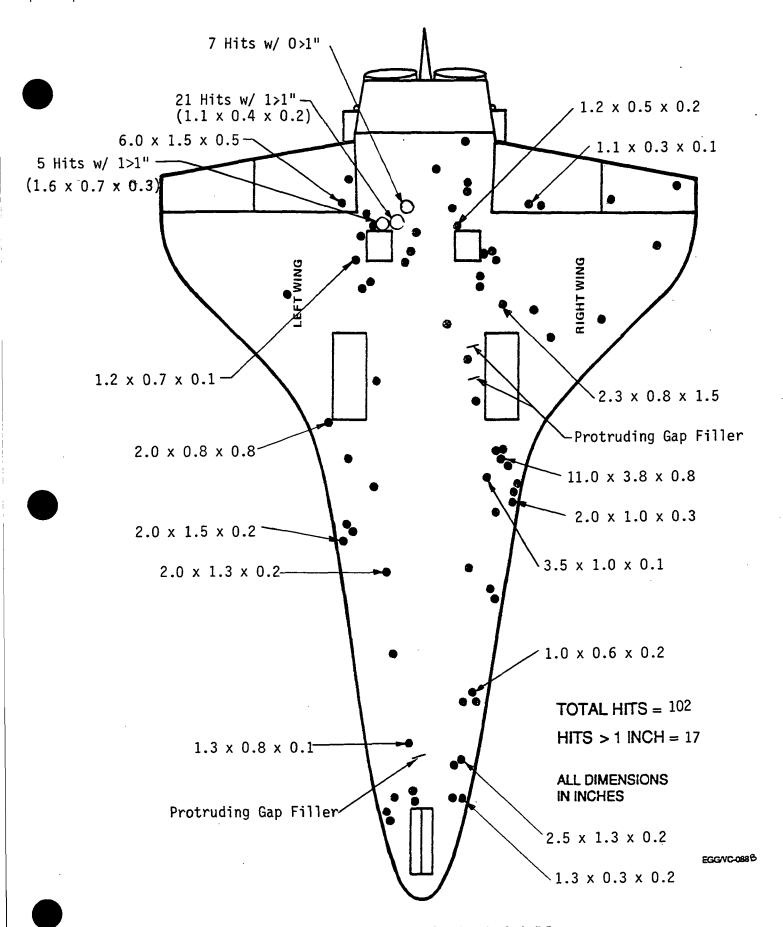
Figure 3: Orbiter Lower Surface Debris Map

The Orbiter lower surface sustained a total of 102 hits, of which 17 had a major dimension of 1-inch or larger. The largest lower surface tile damage site occurred approximately 10 feet forward of the RH MLG wheel well and measured 11.0 inches long by 3.8 inches wide by 0.8 inch maximum depth. The site showed significant signs of re-entry heating including interior glazing, slumping at the tile edge, and melting of the surface coating material.

Aerodynamic flow analyses performed at Rockwell-Downey showed debris sources/origins most likely to have caused this damage would have been located in the ET LO2 tank cable tray area. The LO2 feedline upper bellows, new-method bipod jack pad closeouts, and SRB nose cap ablator were much less likely debris source locations. However, review of ET/ORB umbilical camera films and on-orbit photography of the ET after separation from the Orbiter showed no anomalies that might have been the cause of the damage.

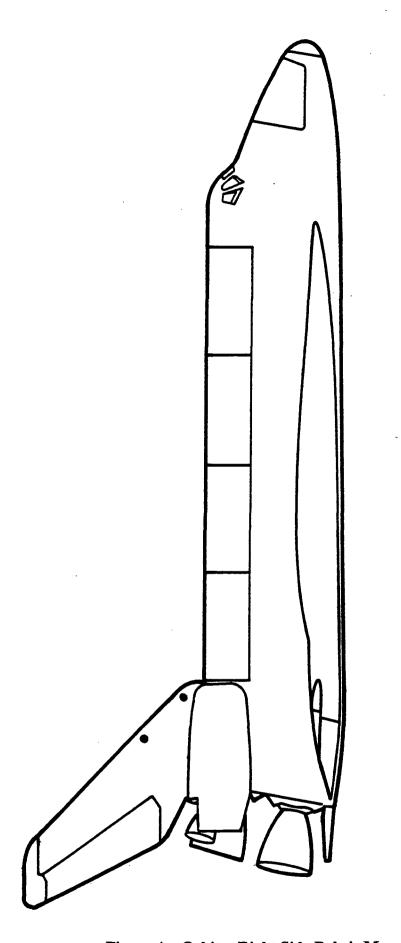
Figure 4: Orbiter Right Side Debris Map

TOTAL HITS = 2 HITS > 1 INCH = 0

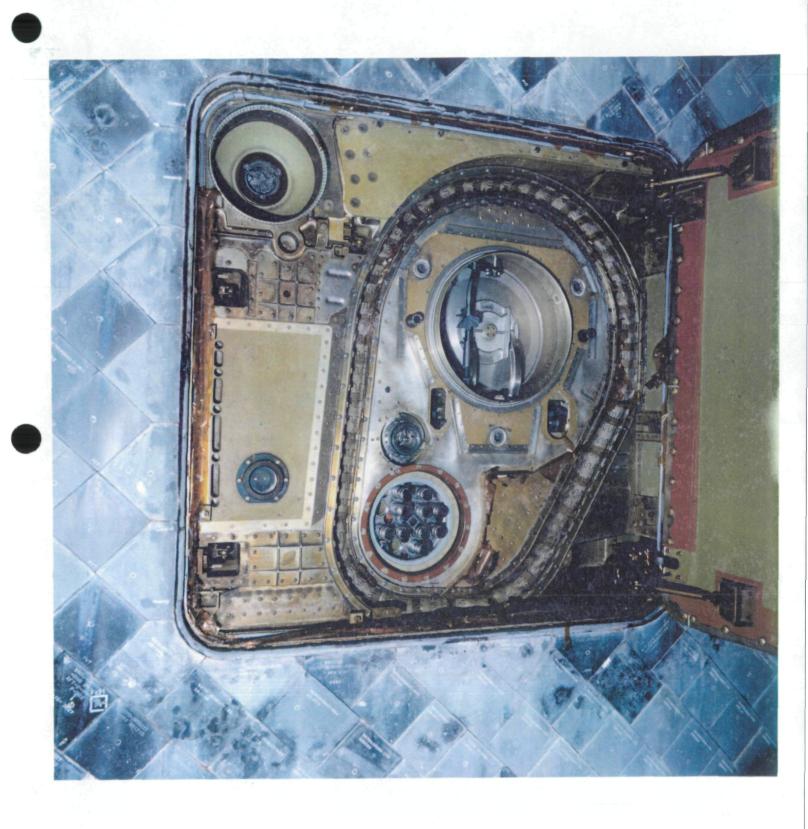
Photo 33: LO2 ET/ORB Umbilical

Orbiter umbilical camera films showed nominal separation of SRB's from the External Tank and normal separation of the ET from the Orbiter. The LO2 ET/ORB umbilical sustained TPS damage at the top and inboard forward corner. Pieces of loose foam from these damaged areas were wedged against the aft side of the crossbeam. Lightning contact strips across the forward part of the umbilical and at the 8 o'clock position were missing. Loss of lightning contact strips was the subject of a previous IFA.

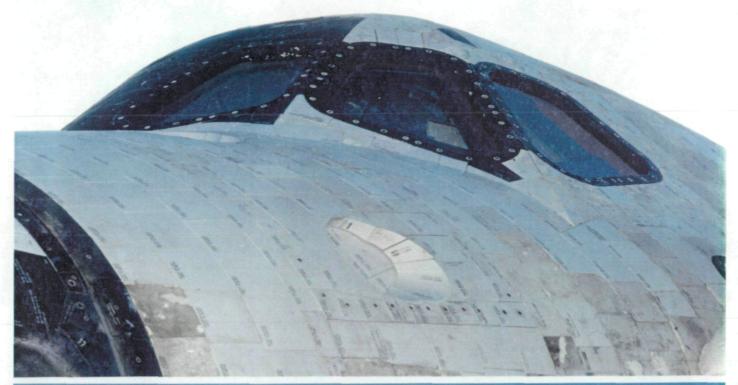
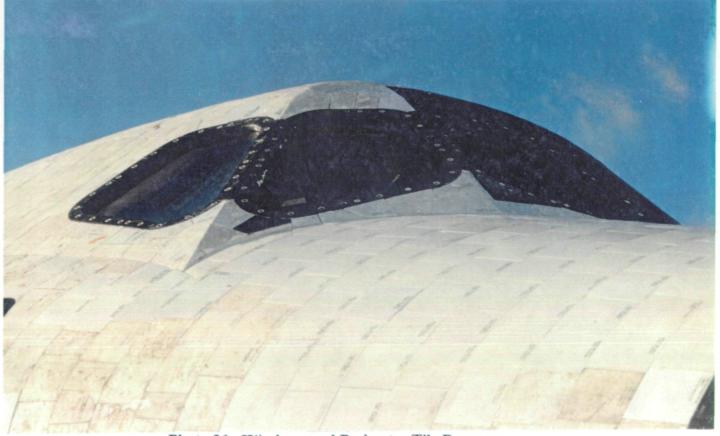
Photo 36: Windows and Perimeter Tile Damage

Orbiter windows #3 and #4 exhibited moderate hazing and streaking. A light haze was present on the other windows. Damage to the window perimeter tiles was concentrated on windows #2, #3, and #5. Several tile damage sites were caused by impacts from FRCS paper cover pieces and RTV. Some of the damage sites were previous tile repairs that had vibrated loose.

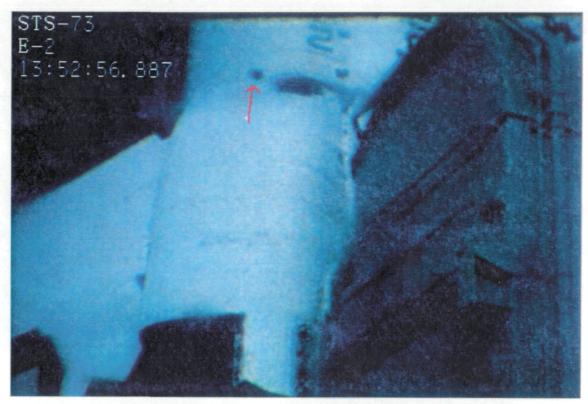
Figure 2.1.1.2 Dark Piece of Debris at SSME Ignition

A single dark piece of debris traveled through the field of view from left to right in front of the right OMS pod and the LO2 TSM at SSME ignition. The debris was not seen to strike the vehicle.

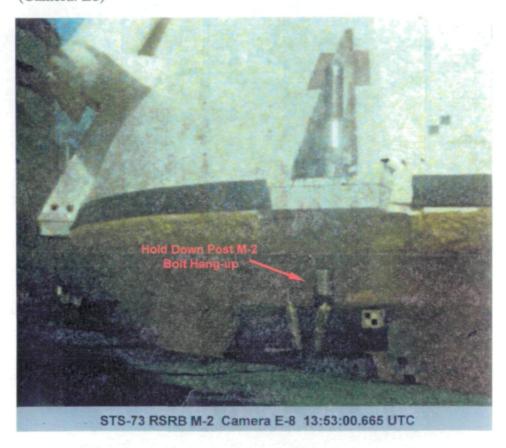
Figure 2.2.4 Bolt Hang-up on RSRB Holddown Post M-2

A bolt hang-up was seen on the RSRB holddown post M-2 at 13:53:00.665 UTC. The bolt released from the RSRB and retracted to its normal position after extending approximately nine inches above the shoe. At the same time, a single crescent shaped, light colored, shiny piece of debris appeared to originate from the DCS hole and fell into the flame duct. Rockwell Downey engineers had previously reported the possibility that one of the holddown bolts had hung-up based on the accelerometer data prior to the receipt of the films at JSC. The event was reported to the Mission Evaluation Room (MER) manager and the Shuttle Mission Management Team (MMT). No follow-up action was requested.

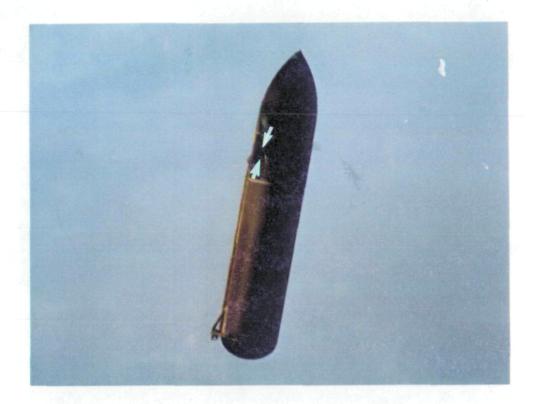
Figure 2.4.1 (B) Light Colored Marks on the +Y Axis of ET Intertank

Light colored marks were noted on the +Y axis of the Intertank in the BSM burn scar near the RSRB/ET forward attach point. Similar marks were seen near the LSRB/ET forward attach on the STS-57 handheld ET photography.

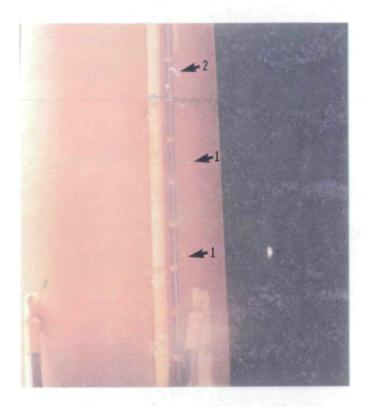
Figure 2.4.2 (B) Divots on ET LH2 Tank Acreage

Shallow divots on the ET LH2 tank acreage outboard of the LH2 cable tray were noted (1). The debris object (2) may be a missing lightning contact strip from the LO2 umbilical.

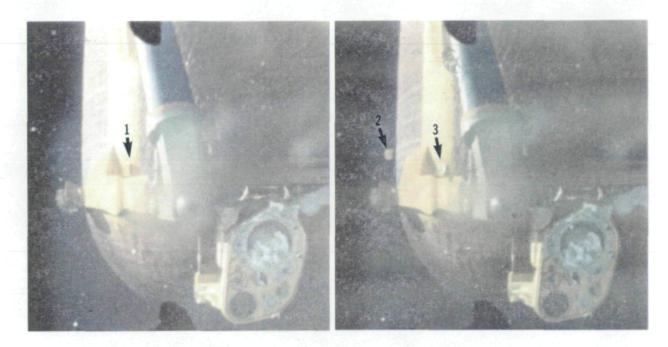
Figure 2.4.2 (D) Detached Closeout on the -Y Longeron-to-Vertical Strut Attach Point

A piece of closeout on the -Y longeron-to-vertical strut/cable tray attach point was seen to detach approximately five seconds after ET separation. The view on the left shows the closeout prior to detachment (1). The view on the right shows the detached TPS (2) and the resulting divot (3). No substrate was visible in the resulting divot.

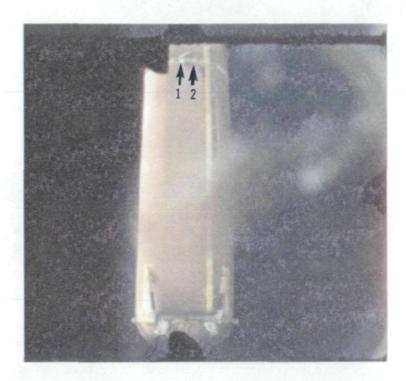
Figure 2.4.2 (E) Forward ET/Orbiter Attach Bipod Jack Pad Closeouts

A white mark is visible on the LH2 tank/intertank closeout flange under the left leg of the forward ET/Orbiter attach bipod (1). A second smaller white mark is visible near the right leg bipod on the same flange (2). These white marks were determined by KSC to be the pre-launch jack pad closeouts. Comparison of the umbilical well photography and pre-launch closeout photography of the jack-pads showed that the jack-pad closeouts were undamaged.

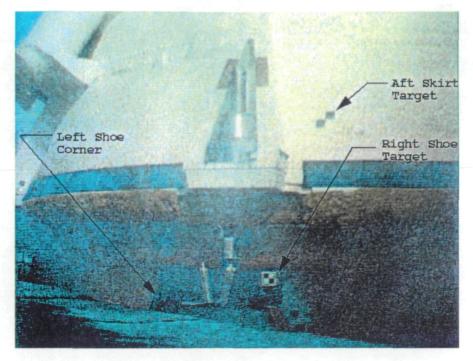
Figure 2. Post M-2 Stud Hang-up

The holddown post M-2 stud hung-up in the aft skirt at liftoff. Measured motion data of the post components are shown in figure 1. Figure 2 is a film frame from camera E-8 showing the stud hang up and the location of the measured components. The holddown post shoe was lifted up approximately 2 inches during liftoff. The stud appeared to remain fully extended until the aft skirt cleared the top of the stud.
