NASA Technical Memorandum 104627

Degradation of FEP Thermal Control Materials Returned from the Hubble Space Telescope

Thomas M. Zuby, Kim K. de Groh, and Daniela C. Smith

DECEMBER 1995

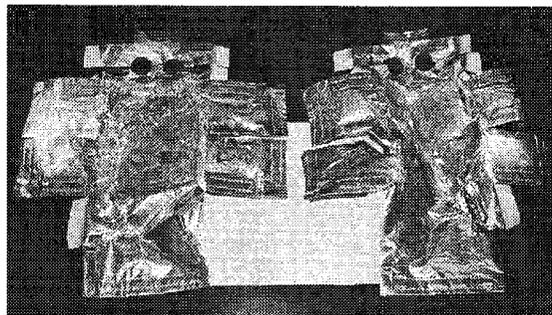
Figure 3: The returned magnetometer MLI assemblies. The thermal blankets are roughly 35 cm x 38 cm in size. The holes in the upper portion of the blankets are for cable access.

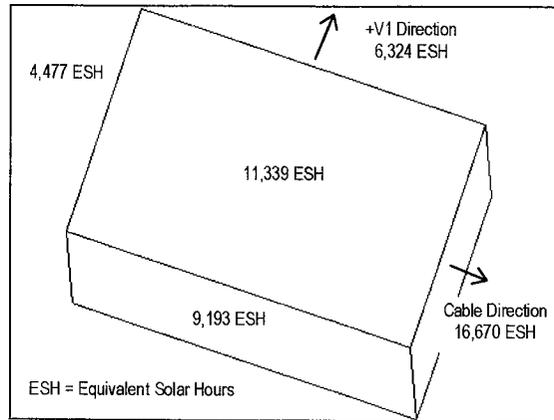
Figure 5 shows a model from Reference 3 that was used to calculate the solar fluence values of the exposed surfaces of the magnetometer MLI assemblies.

Figure 5: Calculated solar exposure values for the various sides of MSS 1 (see Fig. 2b). The cable direction is also referenced in Figure 2. The unit labeled MSS 2 would have similar ESH values, except the +V1 and -V1 directions (6,324 ESH and 9,193 ESH respectively) would be switched.

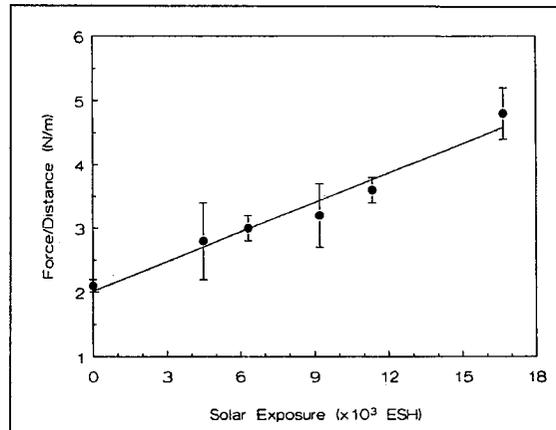
Figure 14 shows preliminary results of AFM microhardness results for magnetometer MLI samples with various solar exposures. In this graph the force per distance ratio was plotted versus solar exposure. Because it is not known from which MSS unit the MLI pieces were removed, the data for 6,324 ESH and 9,193 ESH may be switched in this graph. As can be seen, there is an increase in surface hardness of FEP with increasing solar exposure. This hardness increase is believed to be primarily due to UV induced cross-linking of the FEP, which causes polymer embrittlement.

Figure 14: AFM microhardness results of the magnetometer MLI samples.

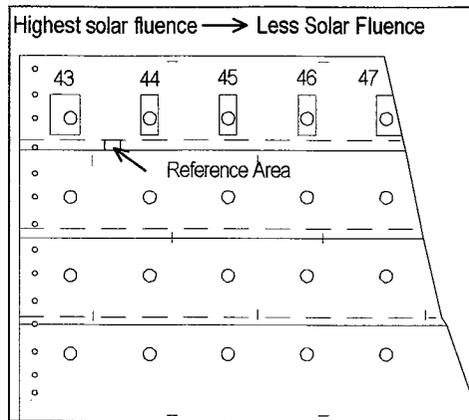
Thickness calculations were performed using standard metallographic cross sectional techniques for both the magnetometer and the SA-I drive arm MLI materials. The samples were cut, mounted in an epoxy material, polished, and then measured (up to 800x magnification). The FEP samples are thinner for the areas of higher solar exposure when compared to the areas with lower solar exposure. The cross sectioning technique also showed an abundance of cracks for the high solar fluence areas. Figures 16 and 17 show cross sectioned samples from the magnetometer and SA-I MLI respectively. Figure 18 describes the locations of the samples removed from the SA-I MLI for the cross sectional thickness measurement. Tables 2 and 3 list the measured thickness values.

Figure 18: SA-I MLI thickness sample sectioning diagram. Samples 43-47 were taken to examine the material thickness as a function of varying amount of solar exposure. The reference sample was taken from underneath an overlapping piece of FEP, and was not directly exposed to the space environment.
