# **Debris/Ice/TPS Assessment and Integrated Photographic Analysis of Shuttle Mission STS-74**

*Gregory N. Katnik, Barry C. Bowen, Jill D. Lin,  
Vehicle Engineering/Mechanical System Division/ET-SRB Branch,  
Kennedy Space Center, Florida*

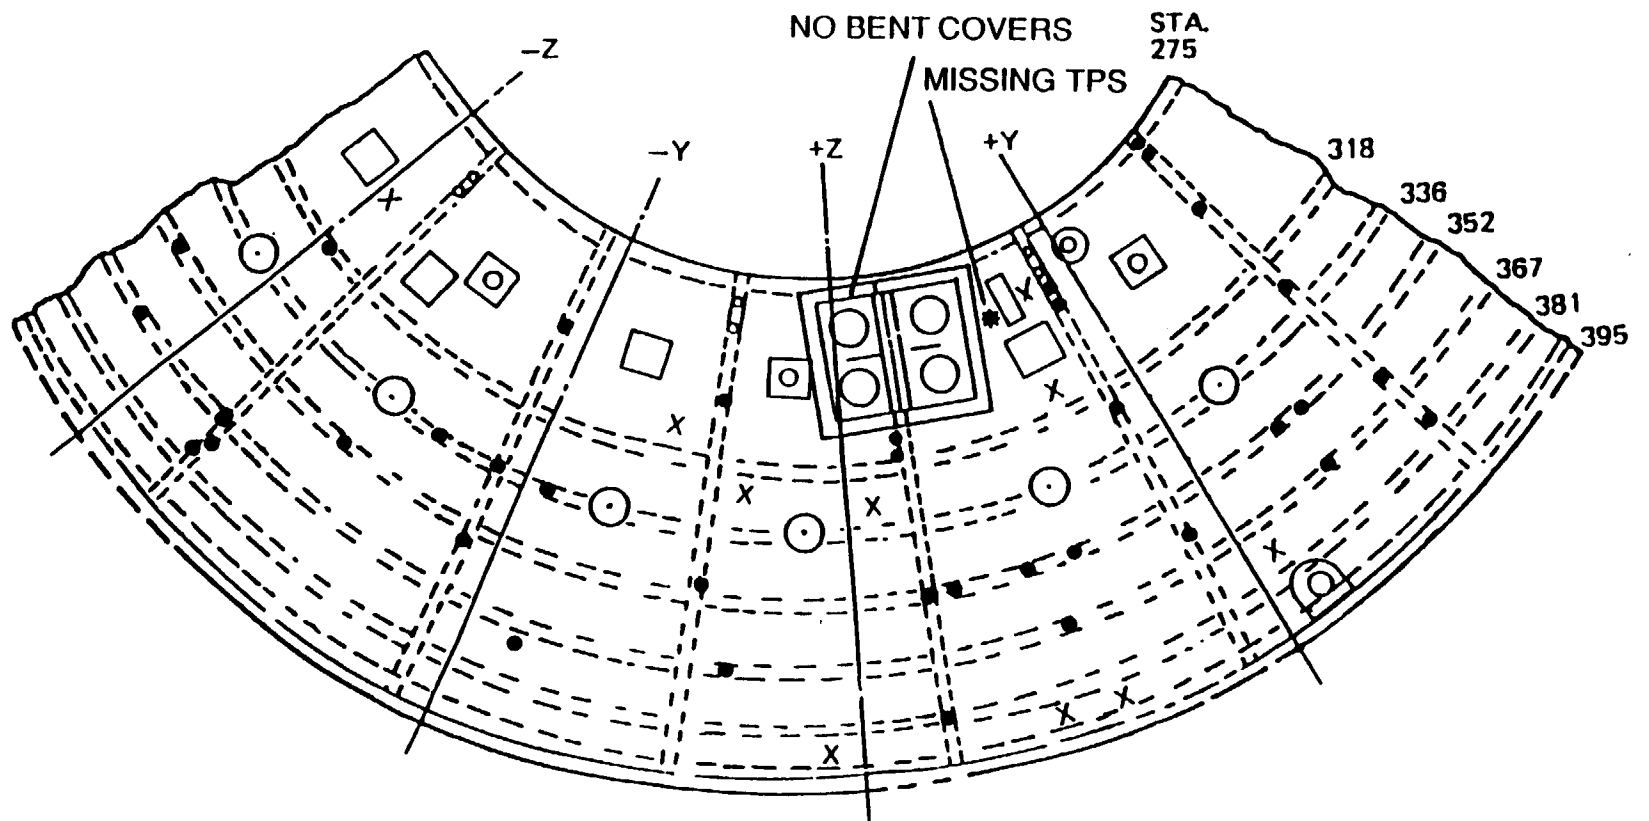
Figure 2 : LH Frustum

The LH frustum exhibited a 2-inch diameter divot with sooted substrate between the BSM cluster and the +Y axis near the XB-275 ring frame. The number of debonds (37) over fasteners was average (Figure 2). The ten MSA-2 acreage debonds was unusual. Surveillance for unfavorable trends will continue on the next vehicle. Hypalon paint was blistered/missing along the XB-395 ring frame where BTA closeouts had been applied. However, most of the exposed BTA substrate was not sooted. The BSM aero heat shield covers had locked in the fully opened position.

MISSING TPS

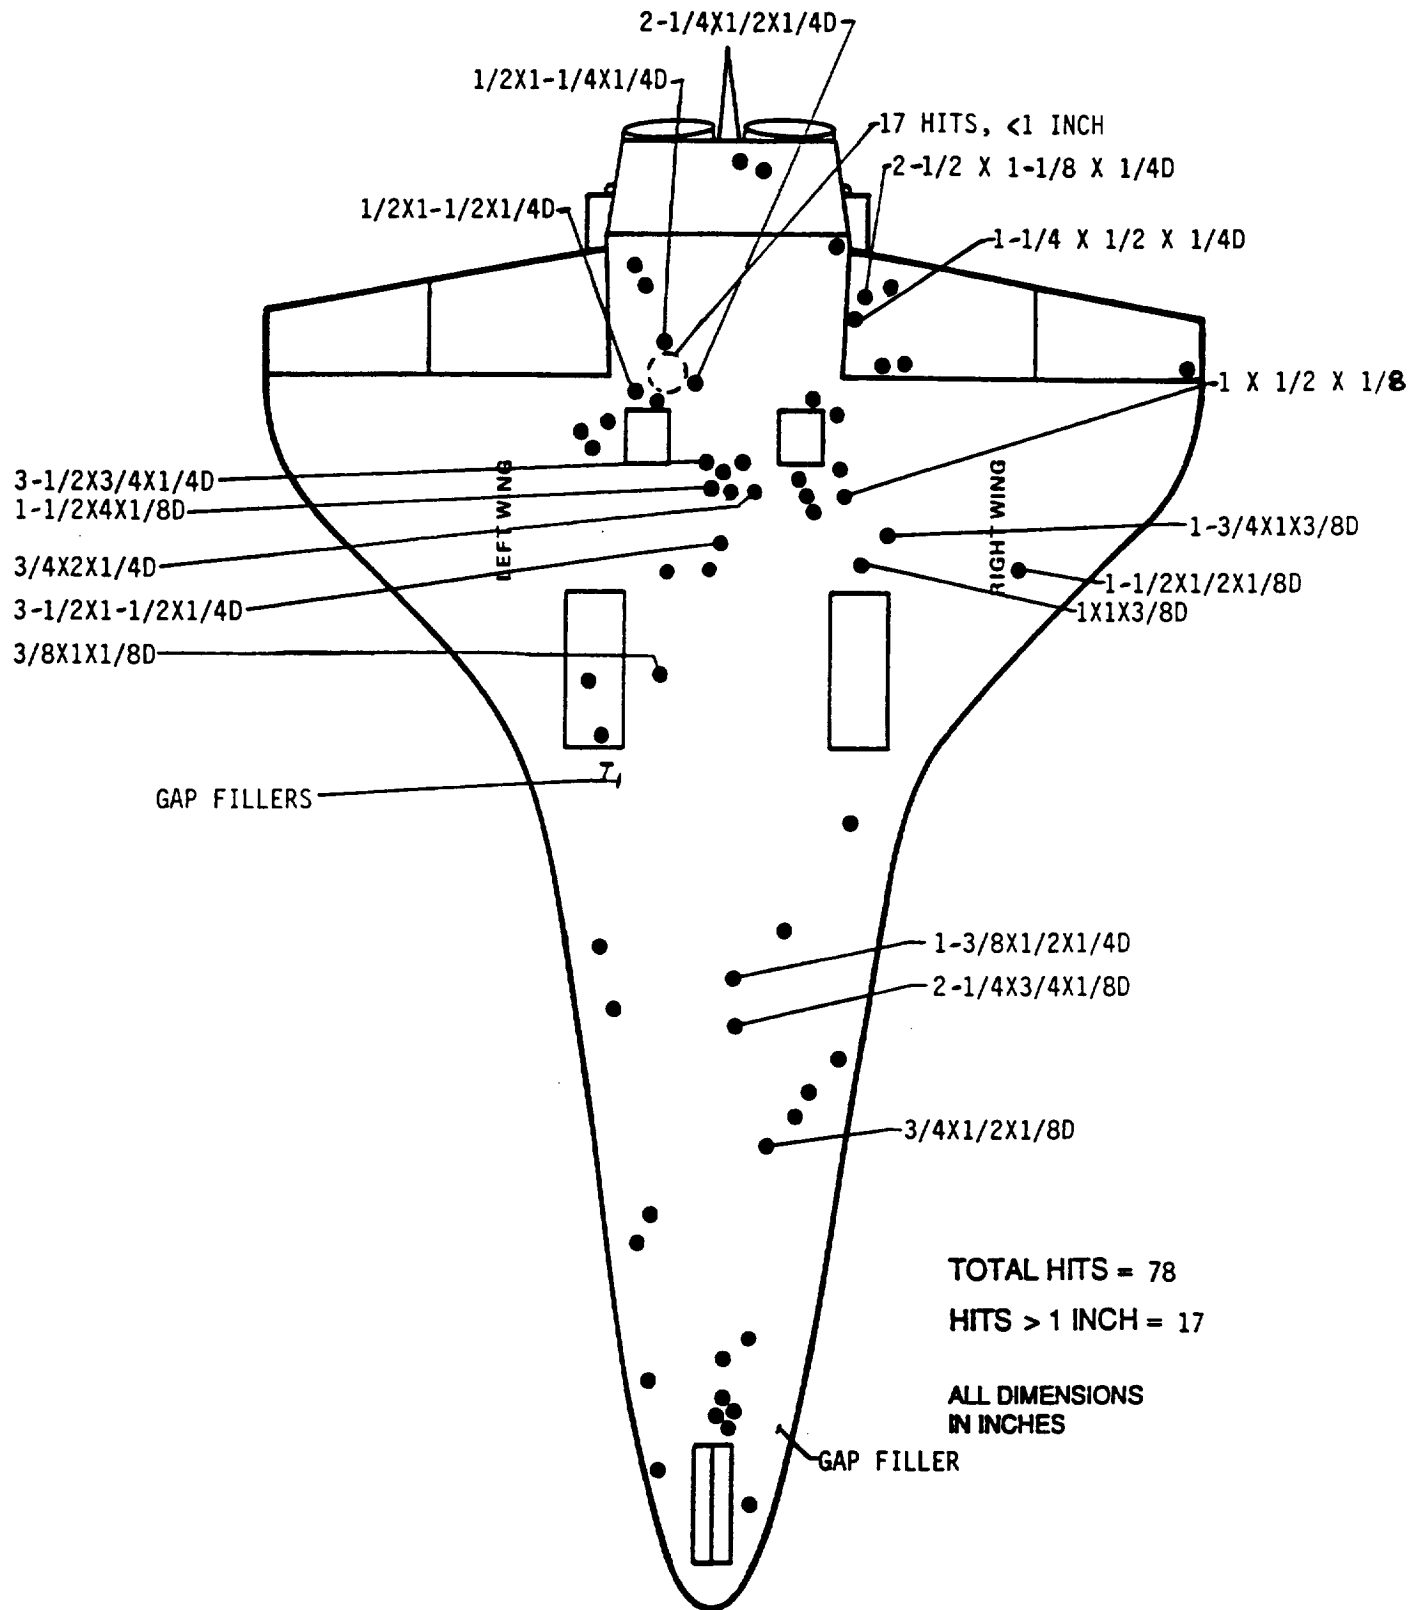
**Figure 3 : Orbiter Lower Surface Debris Map**

In summary, the number of hits 1-inch or larger was average while the total number of hits was less than average when compared to previous missions (Figure 5).

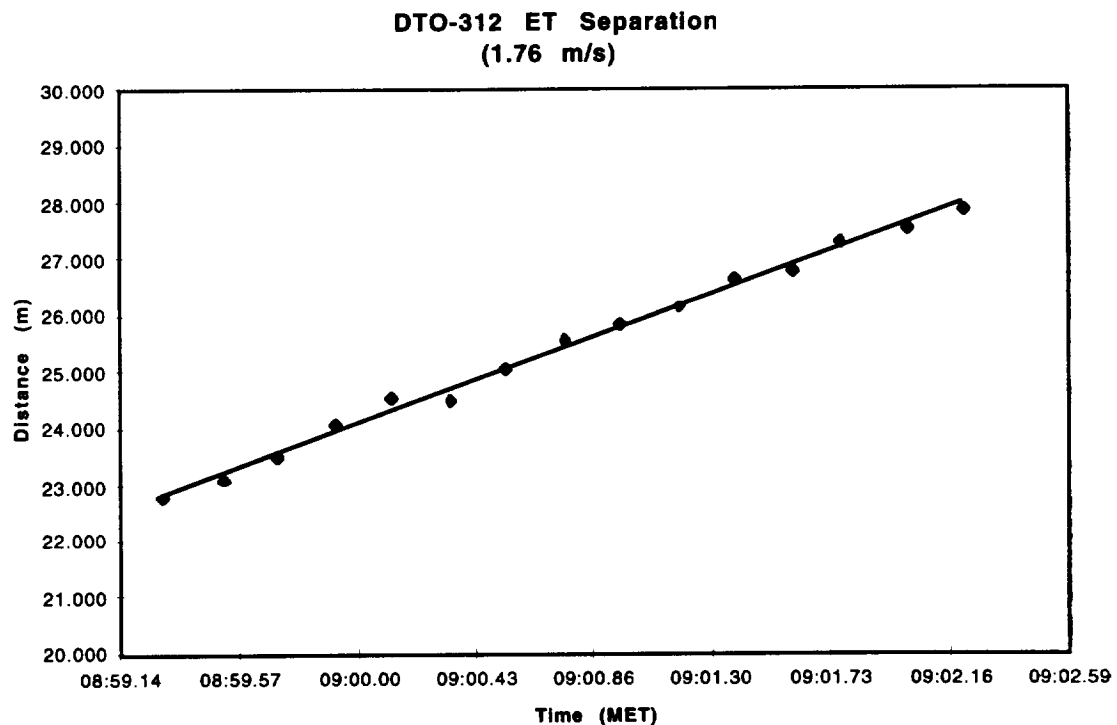
**Figure 2.4 ET Separation Velocity.**

Using the 16 mm LH2 umbilical well camera film (5 mm lens), the external tank distance was calculated over a 700 frame sequence. The external tank was calculated to be a distance of 22.8 meters away from the Orbiter at 8:59.29 MET; 2.92 seconds later at 9:02.21 MET the tank was calculated to be at 27.9 meters. The tank separation velocity was determined to be 1.8 meters per second.

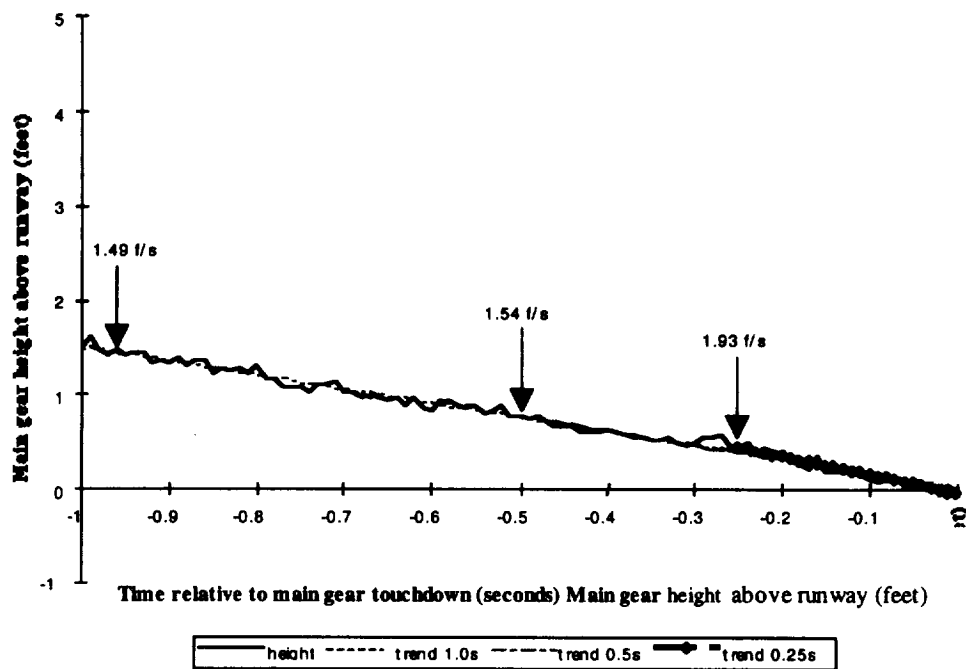
Figure 2.5.1 (A) Main Gear Height versus Time prior to Touchdown (Film)

The measured main gear and nose gear sink rate values were found to be below the maximum allowable values of 9.6 ft/sec for a 211,000 lb. vehicle and 6.0 ft/sec for a 240,000 lb. vehicle (the landing weight of the STS-74 Orbiter was reported to be 203,000 lb.). The sink rate measurements for STS-74 are given in Table 2.5.1. In Figures 2.5.1 (A) and 2.5.1 (B) the trend of the measured data points for film image data are illustrated.
