# **Debris/Ice/TPS Assessment and Integrated Photographic Analysis of Shuttle Mission STS-75**

*Vehicle Engineering/Mechanical System Division/ET-SRB Branch,  
Kennedy Space Center, Florida*

**22 February 1996**

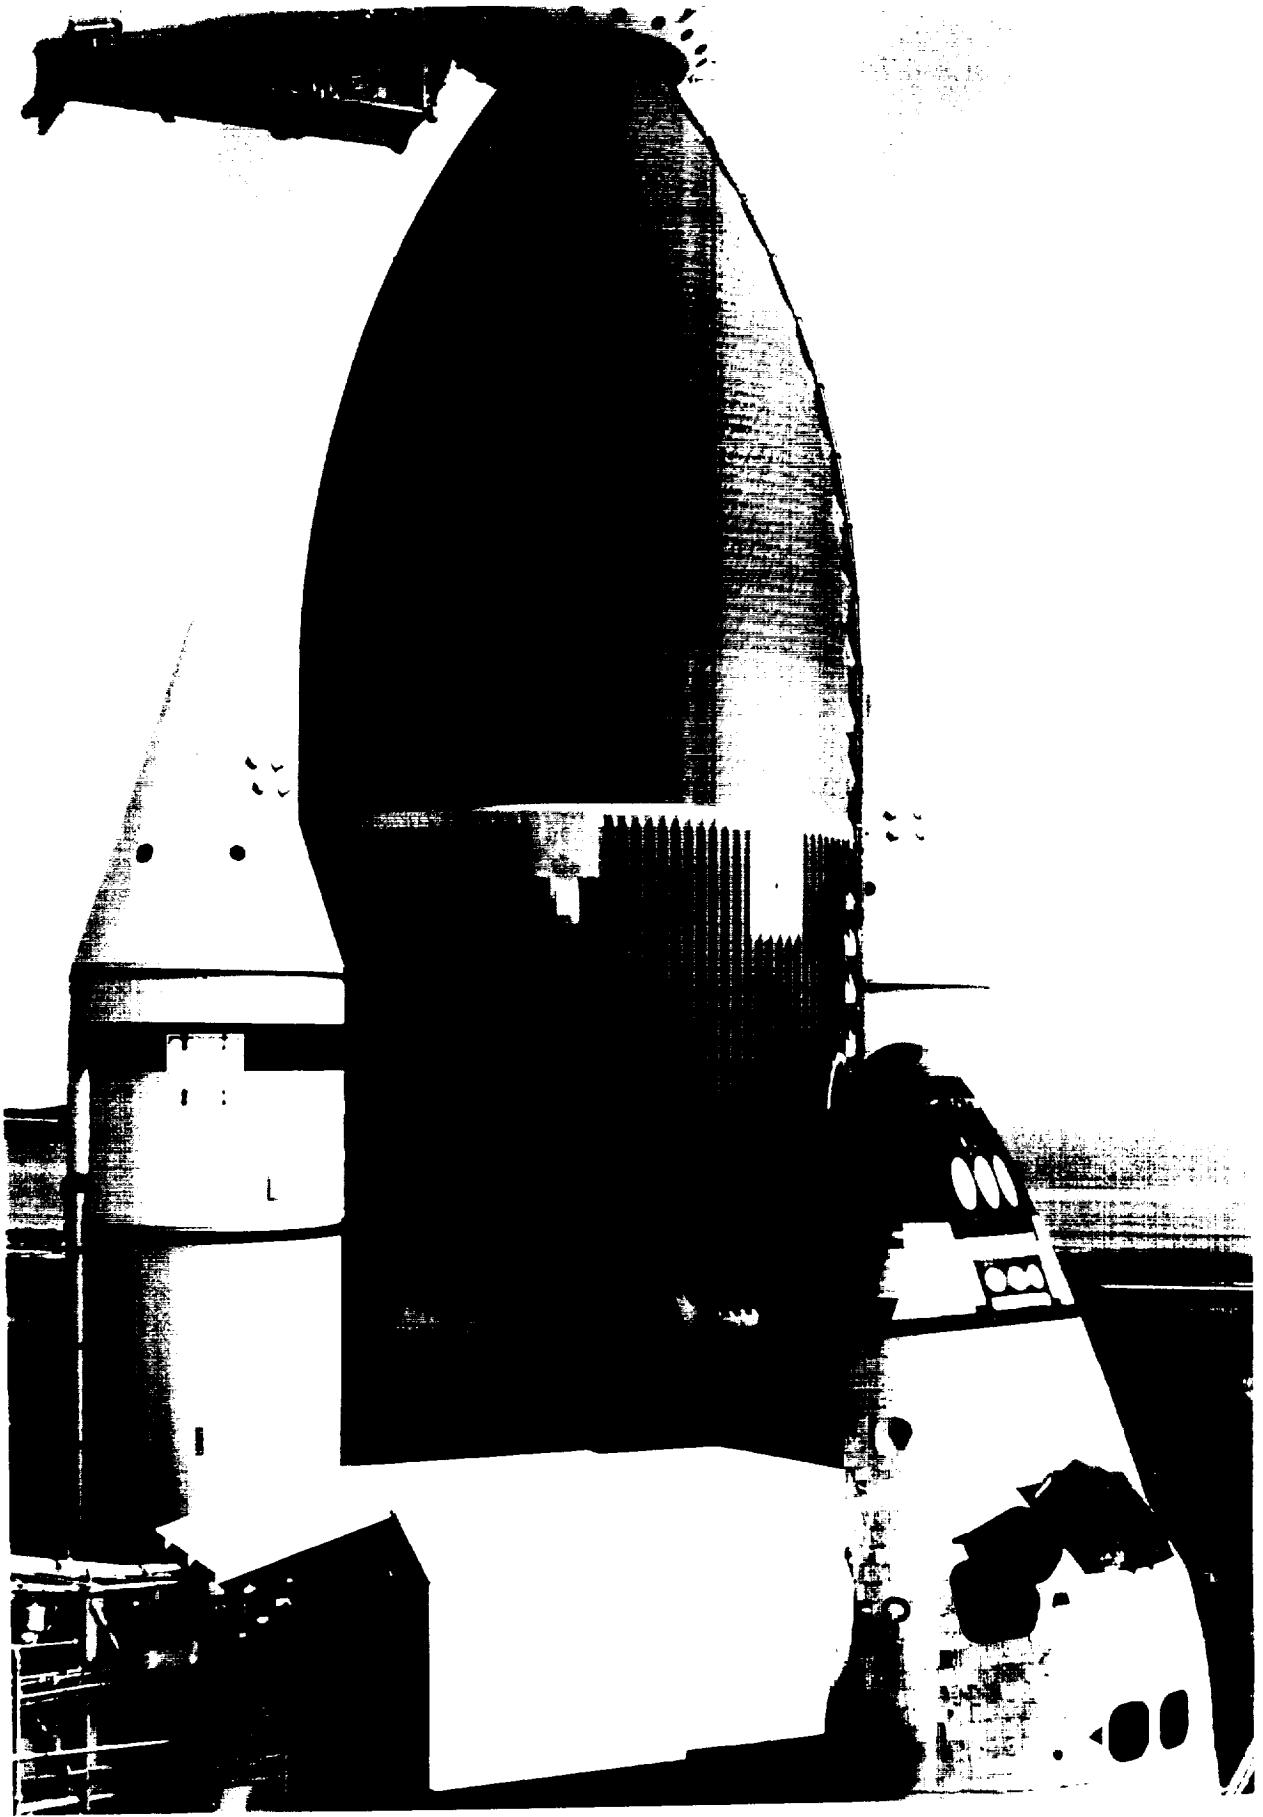
**Photo 3: ET-76 Cryoloaded for Launch**

The Final Inspection Team observed light condensate, but no ice or frost accumulations, on the LO2 tank. There were no TPS anomalies.

There were no LH2 tank TPS acreage anomalies. Light condensate, but no ice or frost accumulation, was present on the acreage. A crack, 10-inches long by 3/8-inch wide, was present in the -Y vertical strut attachment fitting fairing forward surface TPS. The presence of the crack was acceptable for flight per NSTS-08303 criteria. There were no anomalies on the new-method bipod jack pad closeouts.

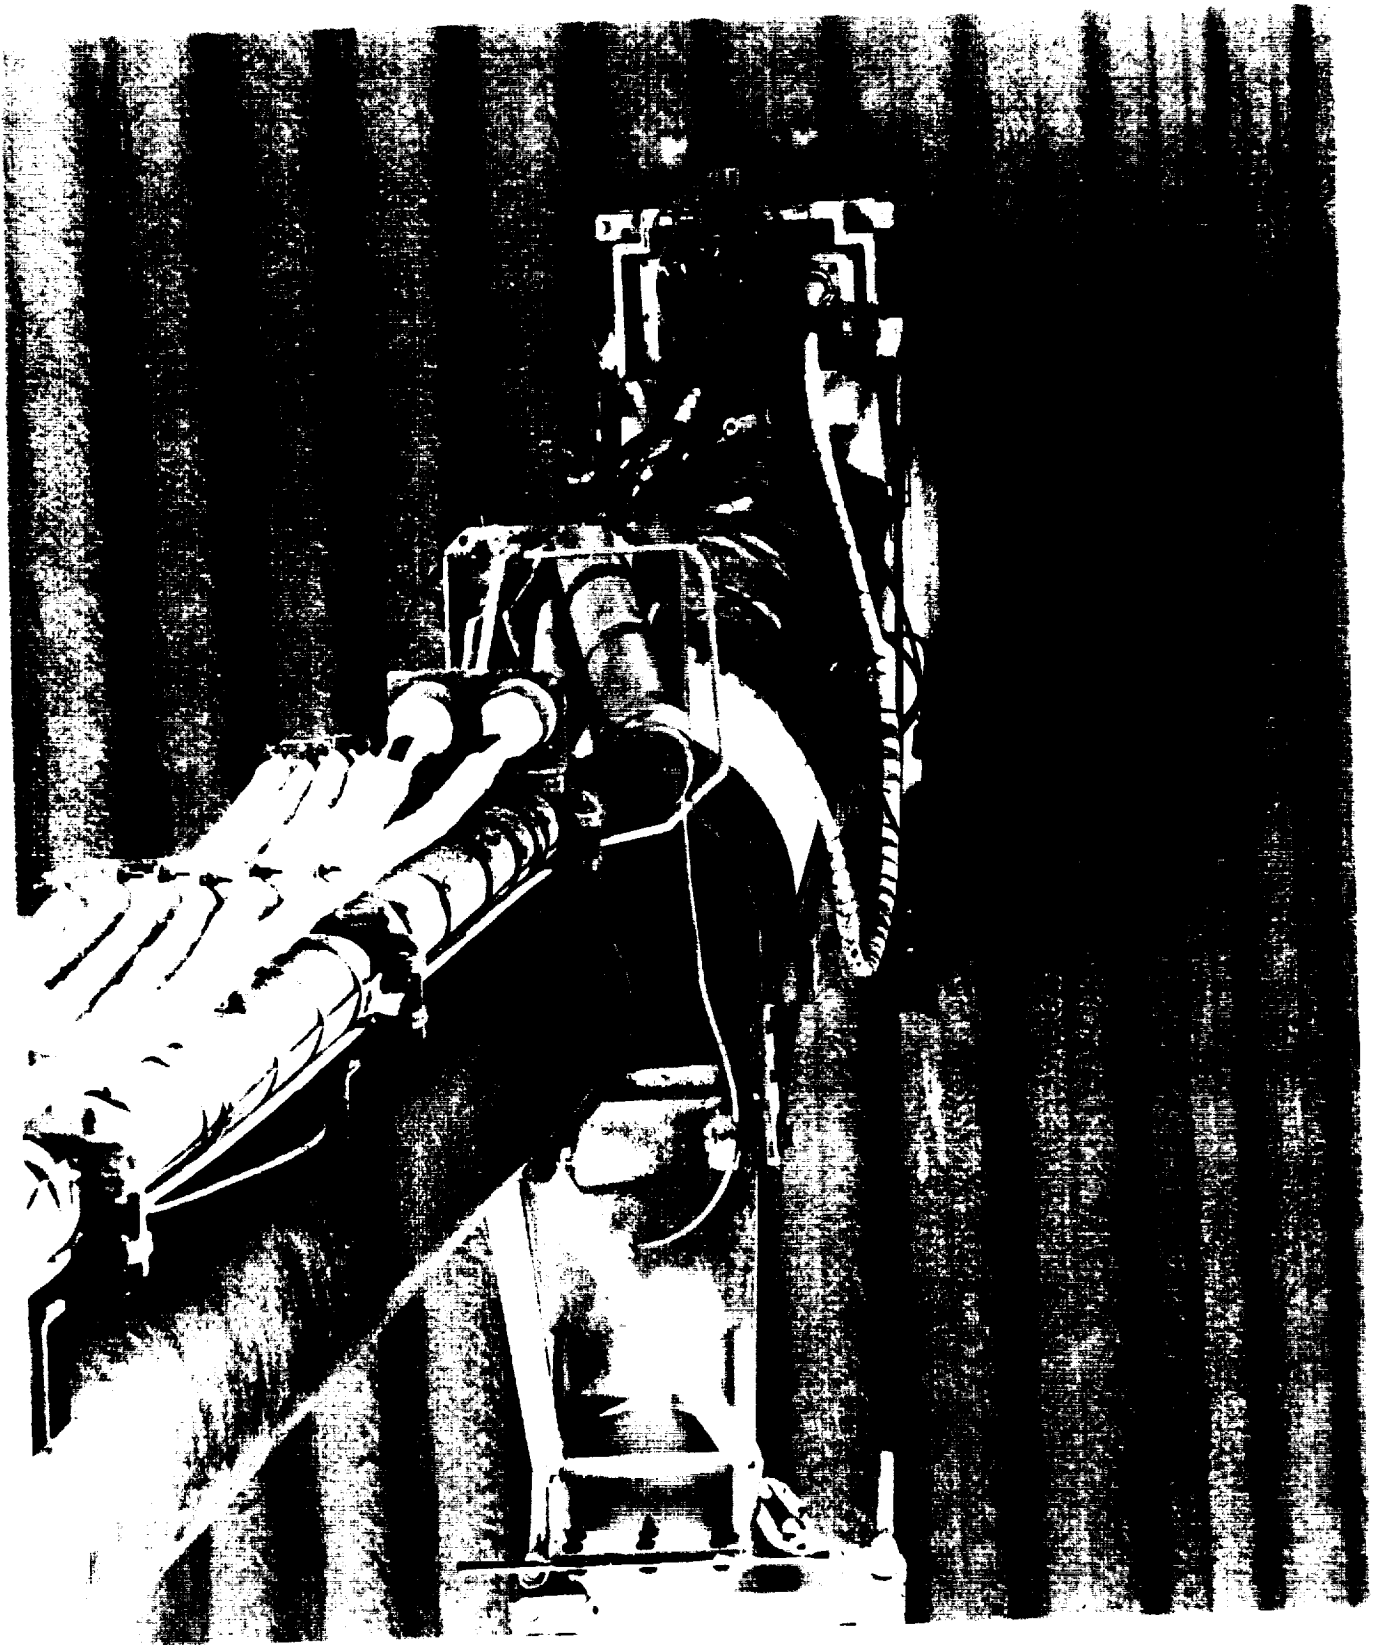
**Photo 5: Sodium Hydroxide Residue on GUCP**

The GH2 vent line had no loose cables, and appeared to have latched properly with no rebound. The GUCP legs and crossbeam showed no obvious signs of contact by the static retract lanyard. The vent line was latched on the eighth tooth of the latching mechanism. The RSS cable had disconnected properly. One latch back retainer spring was broken. The GUCP frame and legs were etched/discolored from the caustic sodium hydroxide leak of 21 February 1996.

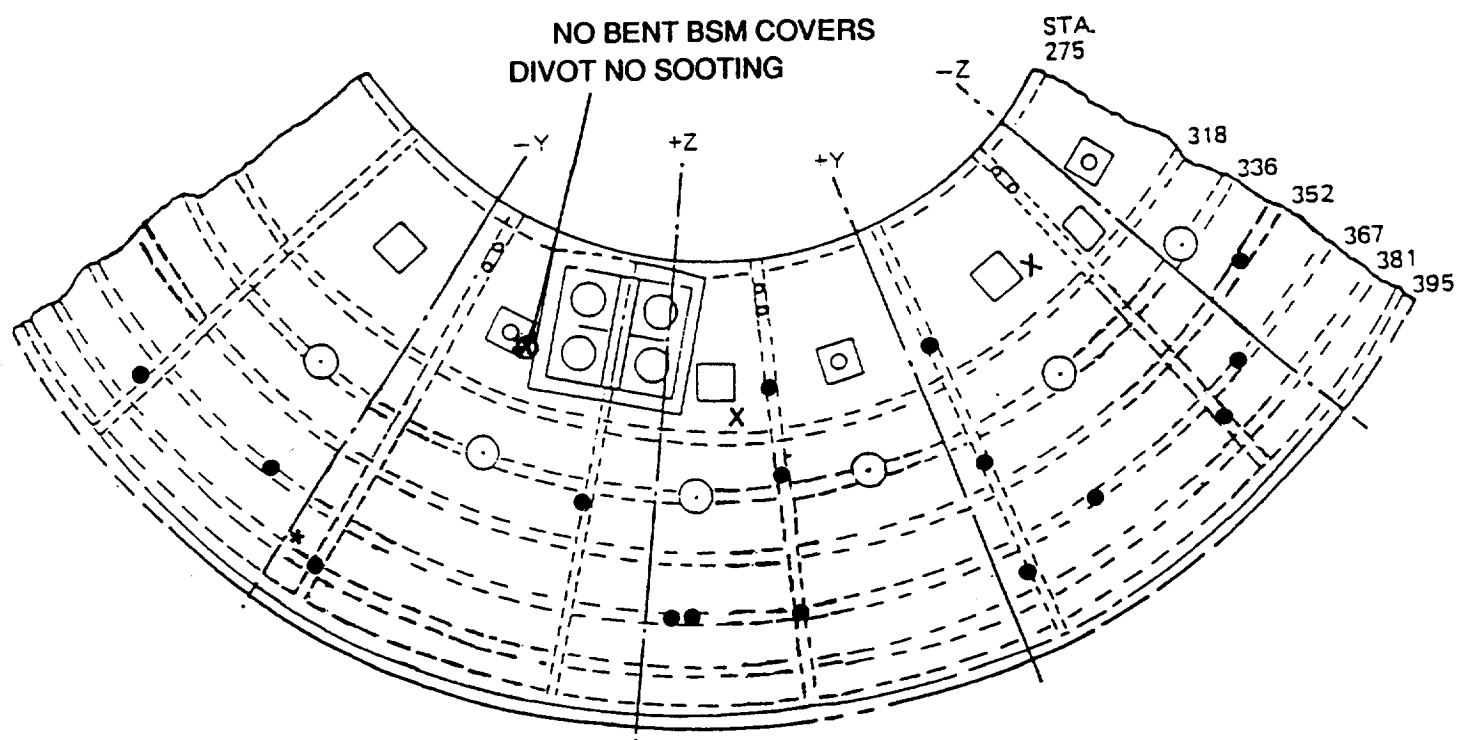
**Figure 1: RH SRB Frustum**

The RH frustum was missing no TPS. The number of debonds over fasteners (16) and over acreage (2) was less than average (Figure 1). Hypalon paint was blistered/missing along the XB-395 ring frame where BTA closeouts had been applied. However, most of the exposed BTA substrate was not sooted. The BSM aero heat shield covers had locked in the fully opened position.

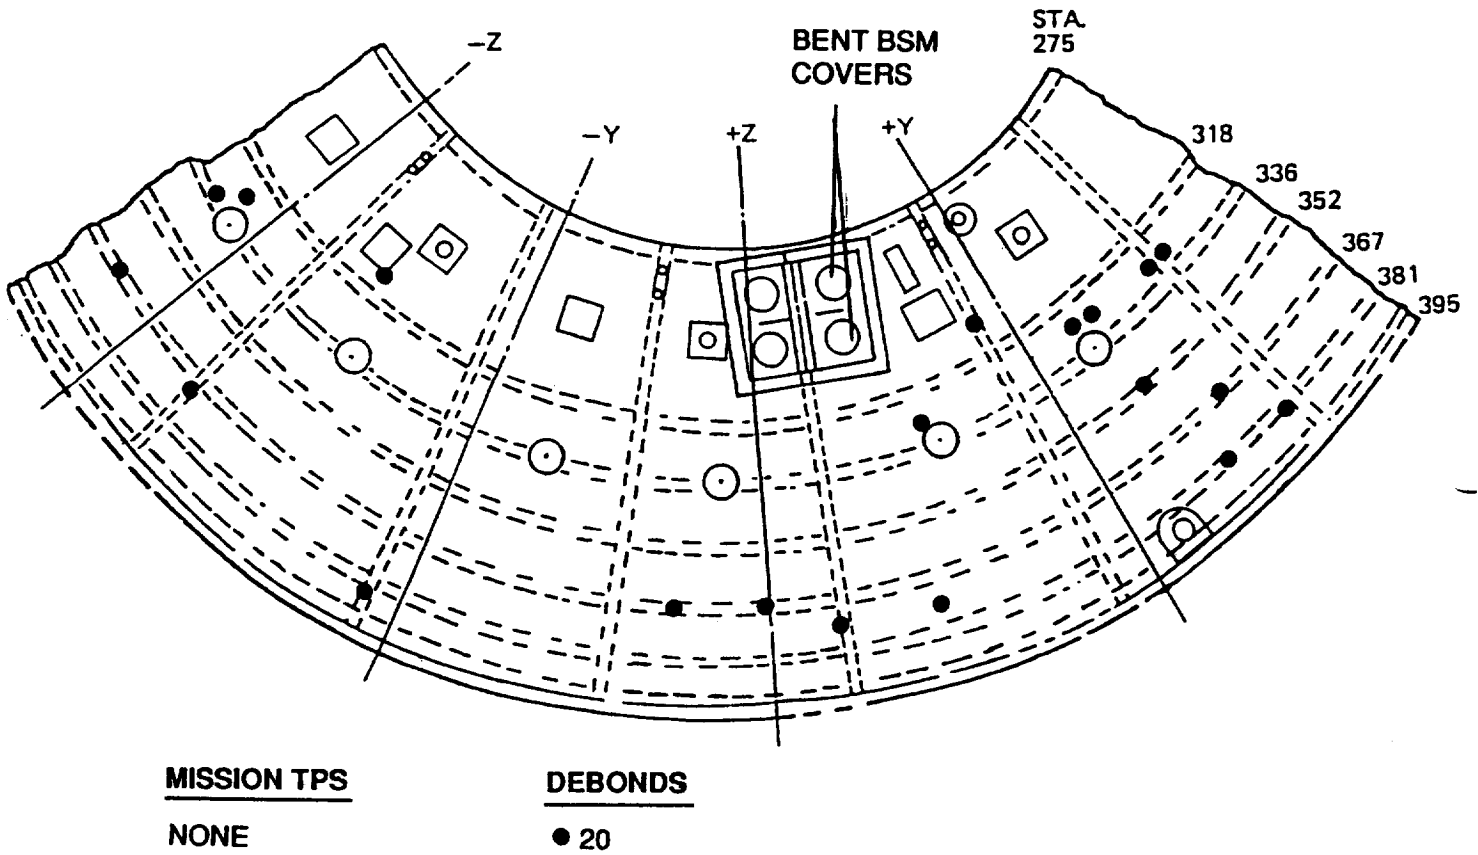
**Figure 2: LH SRB Frustum**

The LH frustum was missing no TPS. The number of MSA-2 debonds over fasteners (20) was less than average (figure 2). Hypalon paint was blistered/missing along the XB-395 ring frame where BTA closeouts had been applied. However, most of the exposed BTA substrate was not sooted. The BSM aero heat shield covers had locked in the fully opened position though the two right cover attach rings had been bent by parachute riser entanglement after splashdown.

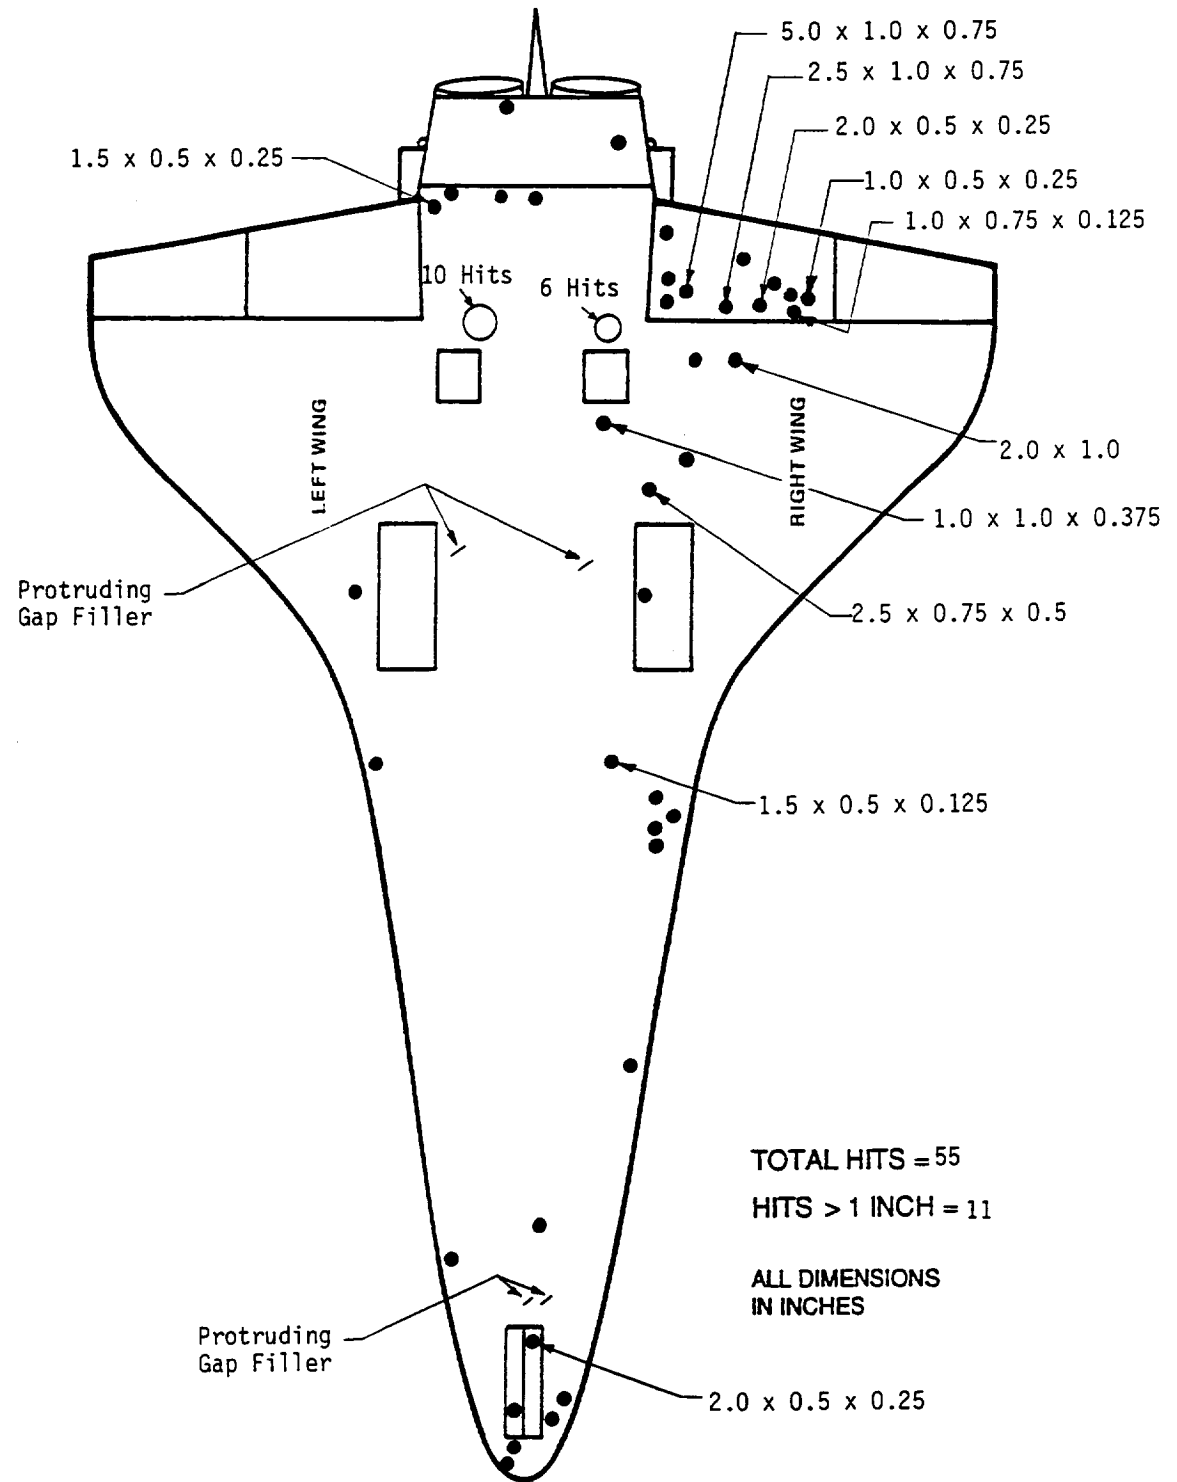
Figure 3: Orbiter Lower Surface Debris Map

The Orbiter lower surface sustained a total of 55 hits, of which 11 had a major dimension of 1-inch or larger. The largest lower surface tile damage site occurred on the right inboard elevon and measured 5.0-inches long by 1.0-inch wide by 0.75-inch maximum depth. Hits on the right side along a line from nose to tail are generally attributed to ice impacts from the ET LO2 feedline bellows and support brackets.

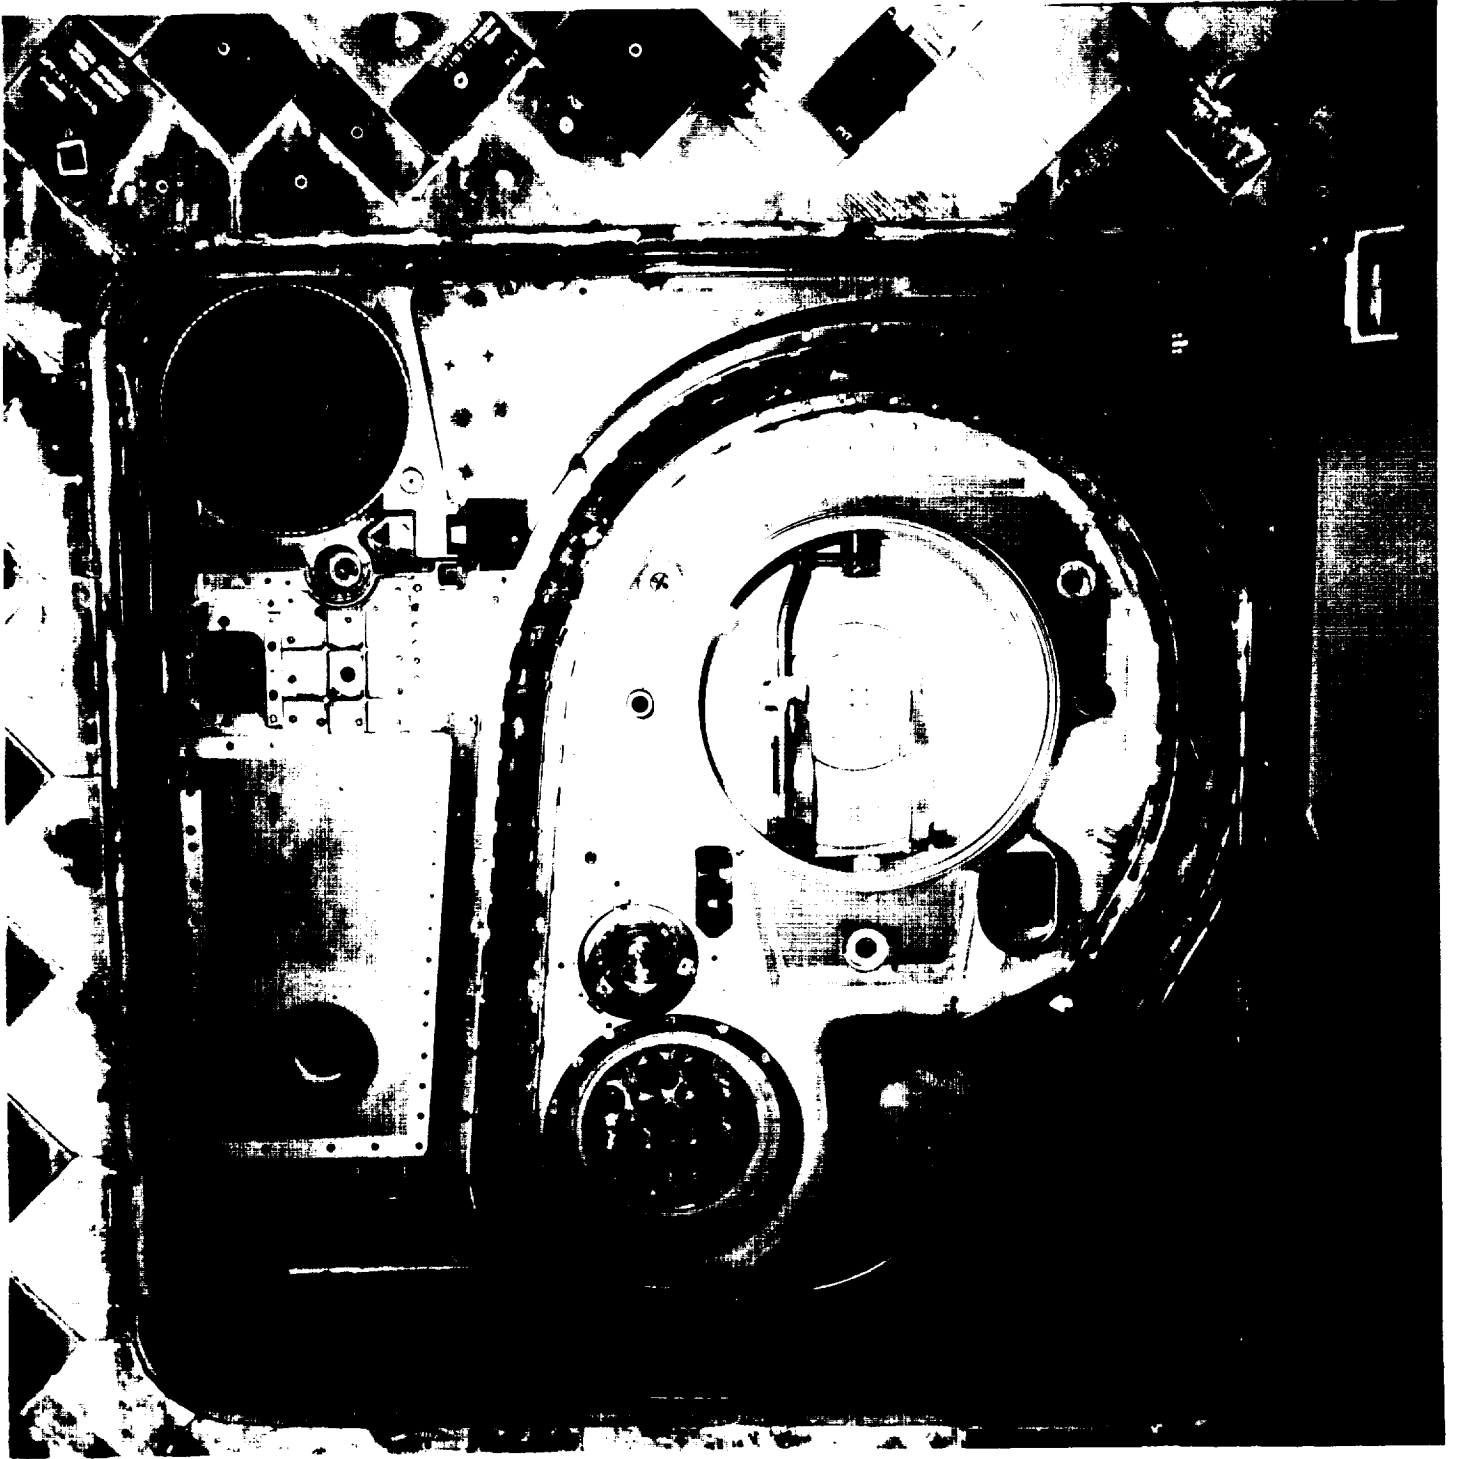
**Photo 27: LO2 ET/ORB Umbilical**

Orbiter umbilical camera films showed nominal separation of SRB's from the External Tank and normal separation of the ET from the Orbiter. The LO2 ET/ORB umbilical TPS was undamaged. All lightning contact strips were intact. Numerous divots and eroded areas were visible on the horizontal and vertical sections of the cable tray. The LH2 ET/ORB umbilical appeared to be in good condition with little or no TPS damage. Foam was missing or eroded from the horizontal (clamshell) section of the cable tray and the aft surface of the -Y vertical strut. A thin, metallic object with straight edges (lightning contact strip) originated from the LH2 ET/ORB umbilical area shortly after umbilical separation and drifted in a general -Y-Z direction. Two of the five lightning contact strips from the LH2 umbilical appeared to be missing. Loss of lightning contact strips was the subject of a previous IFA.

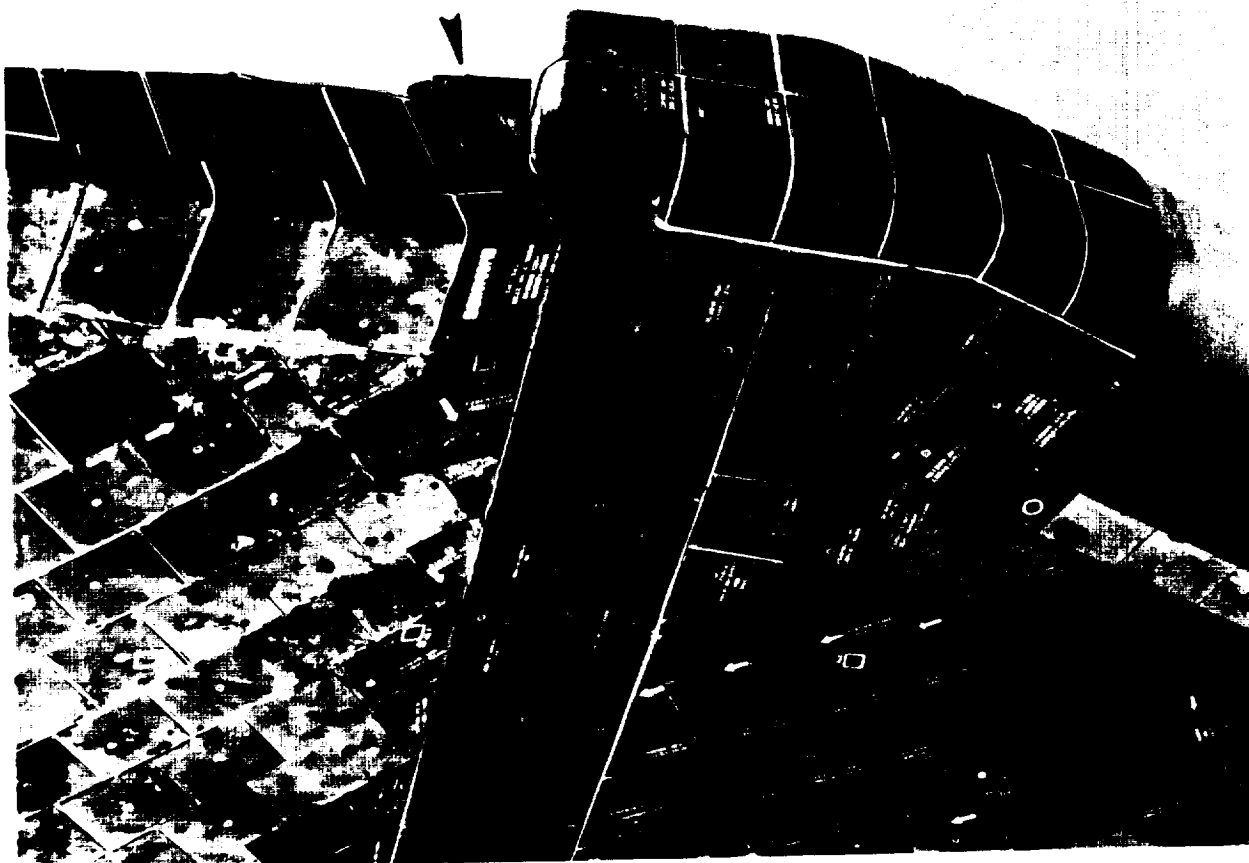
**Photo 28: Flipper Door #15**

Right outboard flipper door #15 was dislocated from the rail

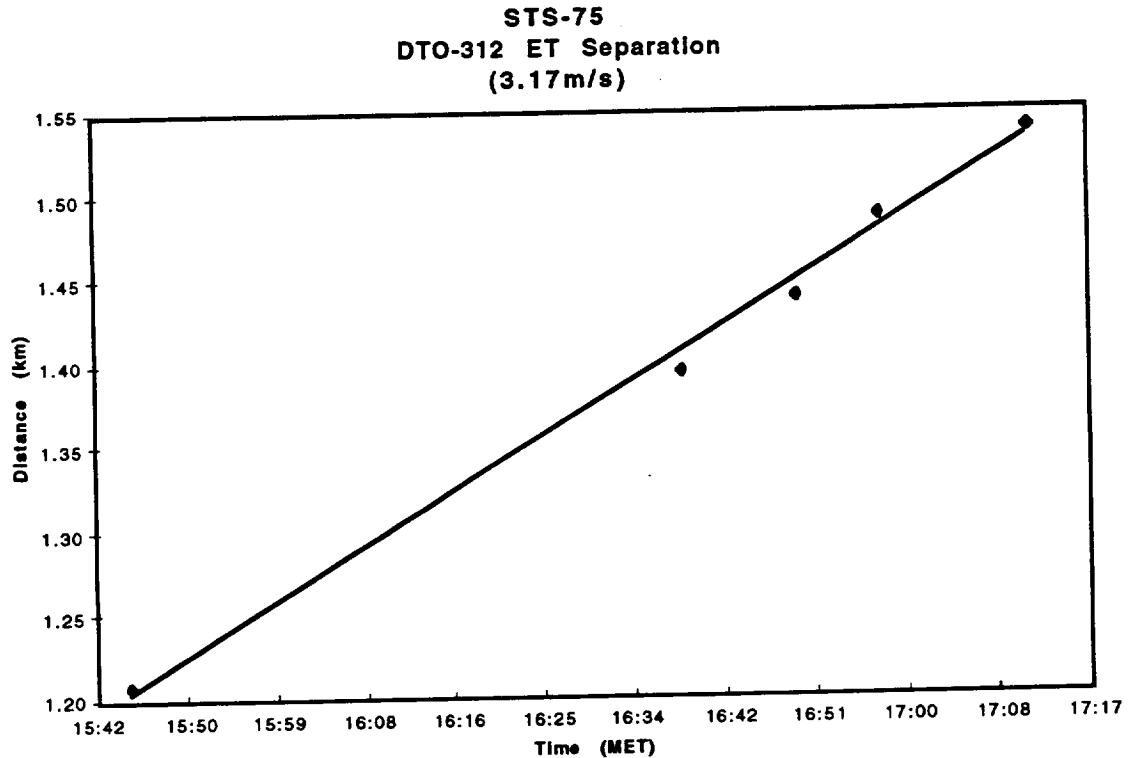
Figure 2.4.1 (A) ET Separation Velocity

Using the 35 mm handheld (Nikon F4) camera film, the external tank distance was calculated over a 5 frame sequence. The external tank was calculated to be a distance of 1.21km away from the Orbiter at 15:45 MET; 86 seconds later at 17:11 MET the tank was calculated to be at a distance of 1.54km. The tank separation velocity was determined to be 3.17 m/s. Roll rate was estimated at 0.1°/sec, and tumble rate was estimated at 0.03°/sec. The separation velocity and roll/tumble rates were similar to previous mission measurements.

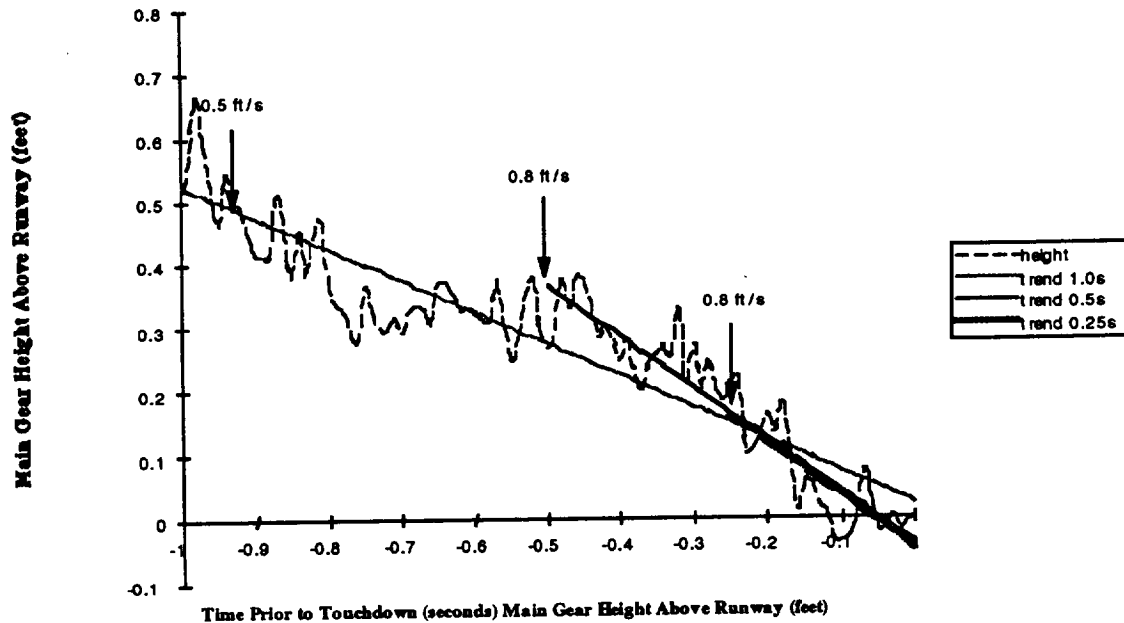
Figure 2.5.1 Main Gear Height Versus Time Prior to Touchdown (Film)

The measured main gear values were found to be below the maximum allowable values of 9.6 ft/sec for a 211,000 lb. vehicle and 6.0 ft/sec for a 240,000 lb. vehicle (the landing weight of the STS-75 Orbiter was reported to be 228,500 lb.). The sink rate measurements for STS-75 are given in Table 2.5.1. In Figure 2.5.1 the trend of the measured data points for film image data are illustrated.
