Mechanical Properties Degradation of Teflon® FEP Returned From the Hubble Space Telescope

Joyce A. Dever and Kim K. de Groh
Lewis Research Center, Cleveland, Ohio

Prepared for the
36th Aerospace Sciences Meeting & Exhibit
sponsored by the American Institute of Aeronautics and Astronautics
Reno, Nevada, January 12-15, 1998

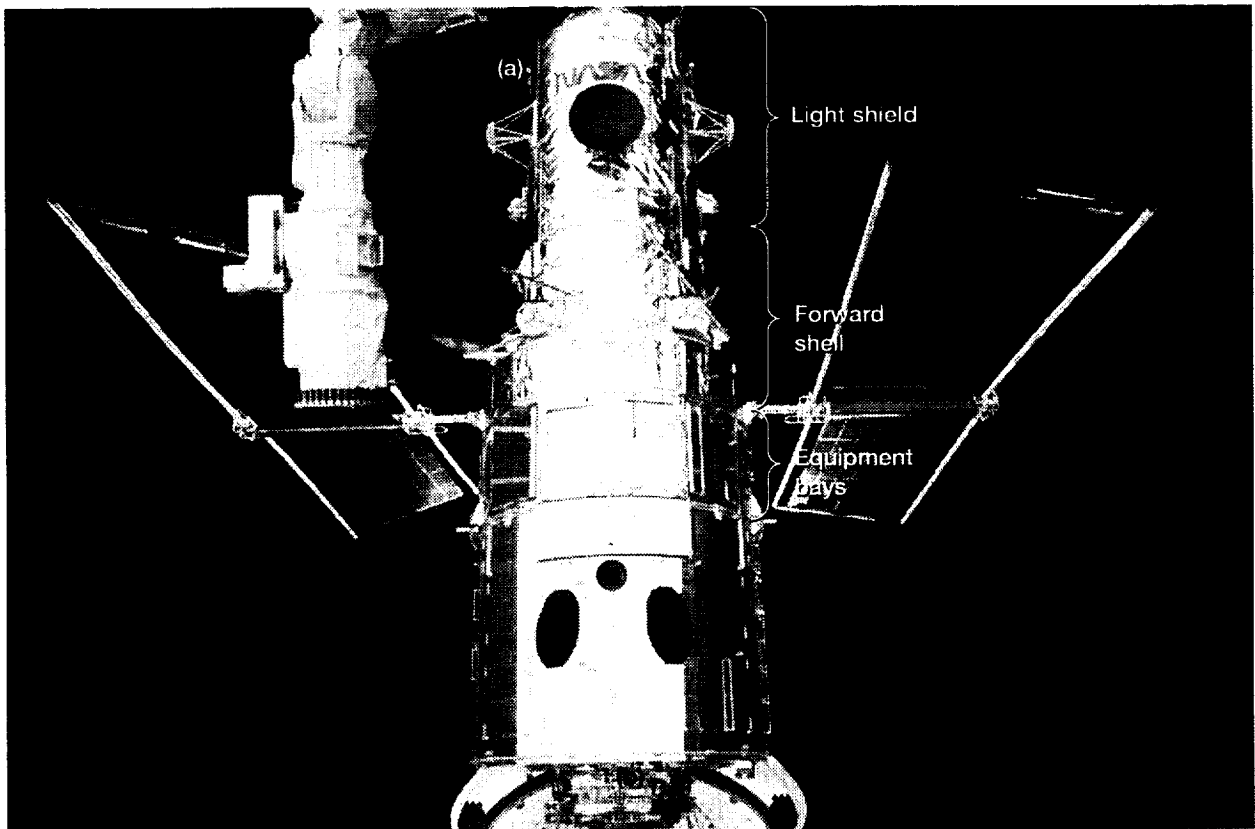
MLI blankets are used on HST to control the temperatures on the HST Light Shield (LS), Forward Shell (FS), and Equipment Bays shown in Fig. 1. MLI blankets were also used as covers for the magnetic sensing systems (MSS) retrieved during SM1. The approximate location of the MSS covers is also indicated in Fig. 1. The MLI blankets are comprised of the following layers: The

Also during SM2, the cryo-vent cover (CVC) on the aft shroud of HST (Fig. 1) was removed to allow installation of a new instrument on HST. This CVC contained a thermal control coating comprised of the following components: The top space-exposed surface was 127 μm (0.005 in.) FEP. The underside of the FEP was coated with silver followed by Inconel. The FEP/silver/Inconel assembly was bonded to the CVC with an acrylic adhesive. Small x-cuts were made throughout the surface of the silvered FEP assembly to allow venting from air bubbles that were produced during bonding to the CVC. Two separate pieces of CVC silvered Teflon were removed from the CVC piece. One was removed by mechanically pulling the coating off of the CVC surface and was used for chemical analysis. The other piece was removed using acetone to dissolve the adhesive to facilitate easy removal of the silvered Teflon from the CVC. The piece that was chemically debonded was used for mechanical properties

Figure 1.—Photograph of Hubble Space Telescope showing the Light Shield, Forward Shell, Equipment Bays and locations from which samples were retrieved. (a) Approximate location from which Magnetic Sensing System covers and Light Shield sample were retrieved from the opposite side of telescope. (b) Approximate location from which cryo-vent cover was retrieved.
