NASA/TM-1998-206932

Technical Assessment of the National Full Scale Aerodynamic Complex Fan Blades Repair

January 1998

National Aeronautics and
Space Administration

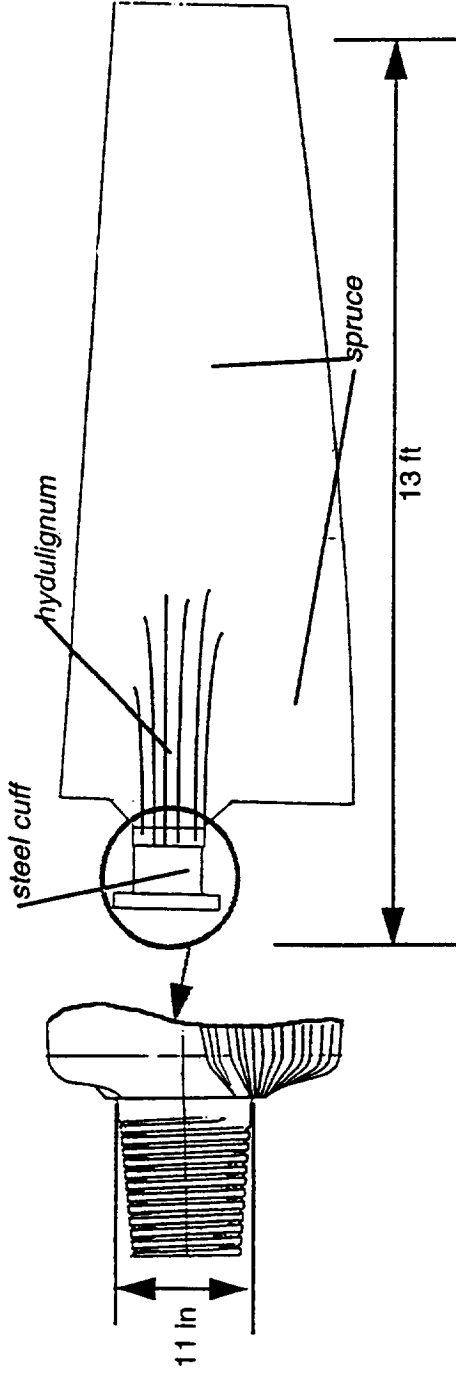
Figure 4. NFAC blade assembly materials.

Recent cracking of the National Full Scale Aerodynamic Complex (NFAC) wooden fan blades has been attributed to higher mean loads and higher cyclic loads due to complex fan inflow disturbances. The blade configuration and material composition is shown in fig. 4. Hydulignum is a compressed material that is manufactured from birch veneers approximately 1/16 in. thick (ref.1). Hydulignum is a very dense material with tensile strengths up to 30 ksi in the grain direction. Sitka Spruce is a lighter wood with lower strength, but has long been the standard material used for wooden fan blades construction for NASA Wind Tunnels, see ref. 2. For the NFAC blades, the hydulignum laminates (pressed boards) indicated in fig. 5, are approximately 3/4 inch. thick. Physical evidence of cracking is illustrated in fig. 5. Based on diagnostic test data obtained in 1996, and utilizing full scale fatigue test data (ref. 1), all evidence and analyses indicate that the blade(s) cracked in the manner expected, and at about the operational hours expected. Because of fan inflow disturbances, the high. 1/Rev. blade dynamic loading is the main contributor to fatigue damage (i.e. cracking). Also, a 4/Rev. blade dynamic loading was found to be significant, and higher than expected. There is ample evidence that the close proximity of the first fundamental mode frequency to a strong 4/Rev. disturbance (see fig. 6 taken from ref. 3) has contributed to the higher than expected 4/Rev. cyclic loading.

- Hydulignum: yellow birch compressed wood
1/16" veneers
impregnated with phenolic resin
tensile strength = 30 ksi (RT)
20% reduction (recoverable) in strength @ 140F
fatigue strength = 9 ksi (RT, 10⁸ cycles, R=-1, reversed bending)
- Sitka Spruce: tensile strength = 12 ksi (RT)
fatigue strength = 4 ksi (10⁸ cycles)
- Steel: normalized 4340
yield strength = 55 ksi

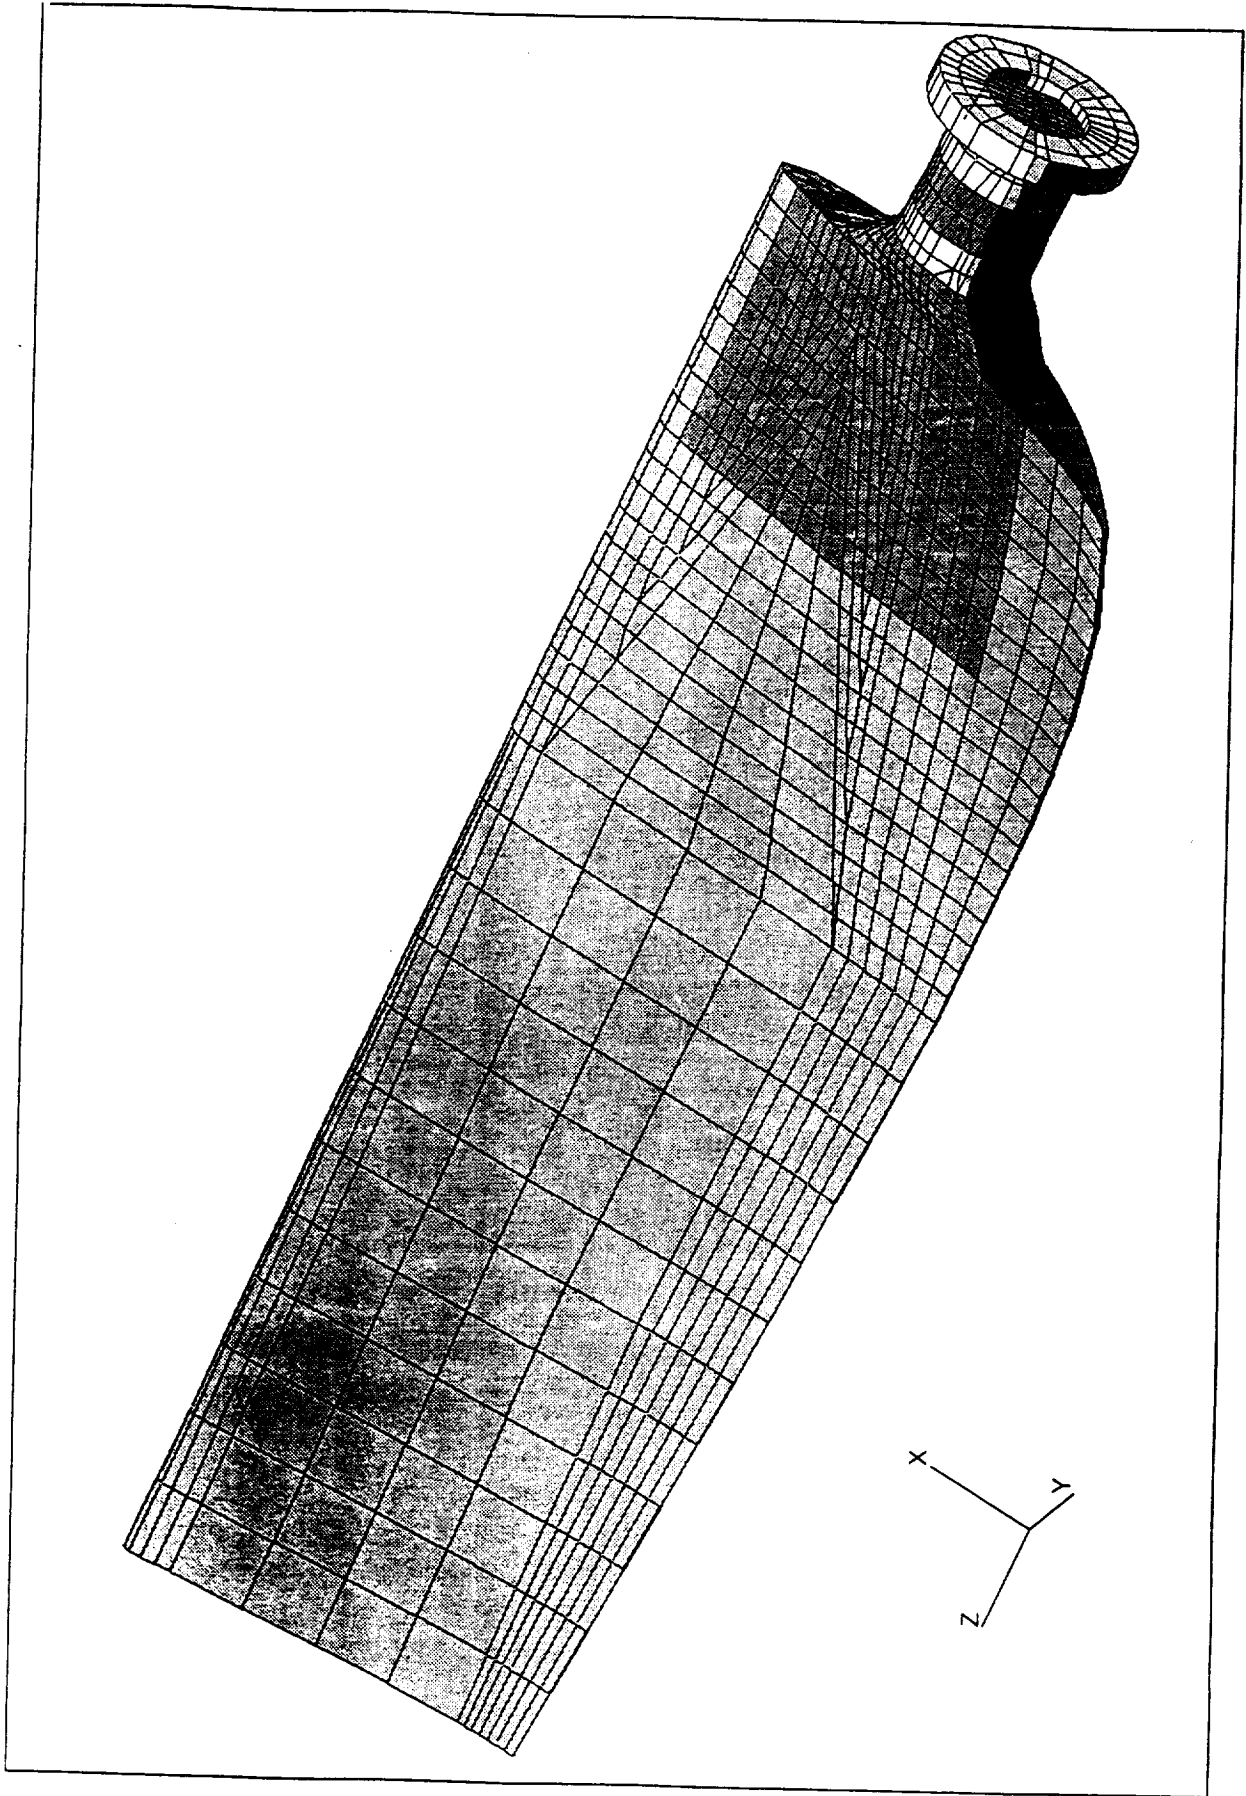
Figure 11. Finite element model of repaired blade assembly.

Extensive NASTRAN finite element analyses were performed for the fan blade assembly with the repair installed (see figures 11 and 12). Note that in figure 12, that the blade retention shaft is modeled along with the blade assembly. The most recent finite element analysis indicates that the overwrap is transferring about 40% of the load instead of 30%, which would give the repaired blades even longer operational life.

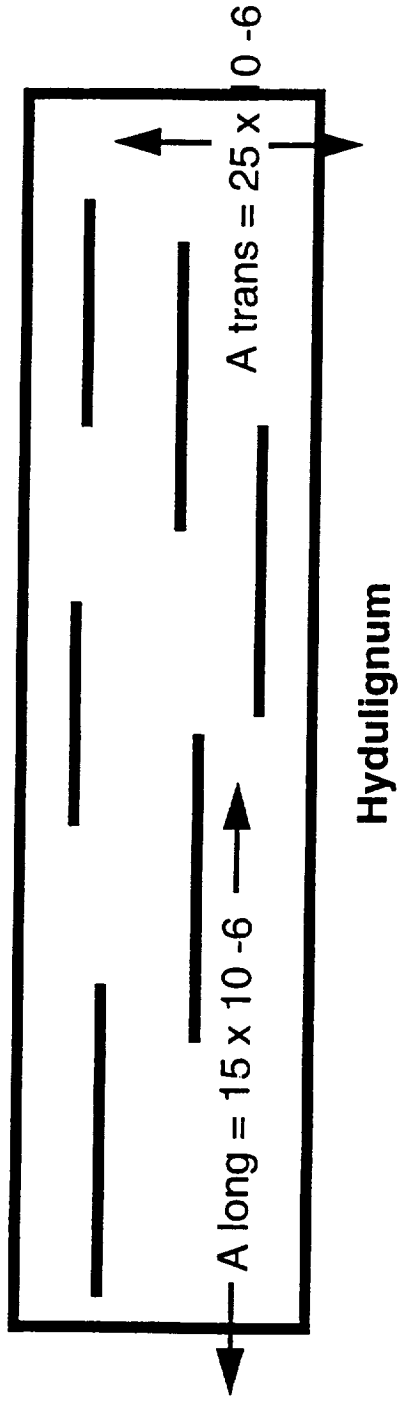
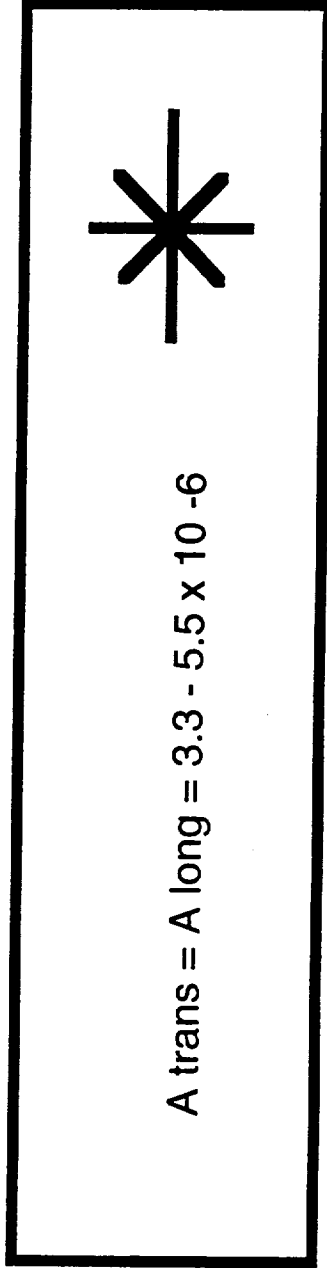
Figure 13. Thermal expansion properties of Hydulignum and carbon composite materials.

Evaluation of the problem suggested that the delamination occurred as a result of residual thermal strains induced as a result of large variations in coefficient-of-thermal-expansion (C.T.E) between the dissimilar materials. Typical C.T.E. values for the various materials are as follows: (1) Hydulignum, 25×10^{-6} in./in./°F in the transverse direction, and 15×10^{-6} in the longitudinal direction (fig. 13). (2) Carbon composite wrap is 3.3 to 5.5×10^{-6} in./in./ °F; (fig. 13) (3) Sitka Spruce, 10×10^{-6} in./in./ °F and (4) steel cuff, 6×10^{-6} in./in./ °F.

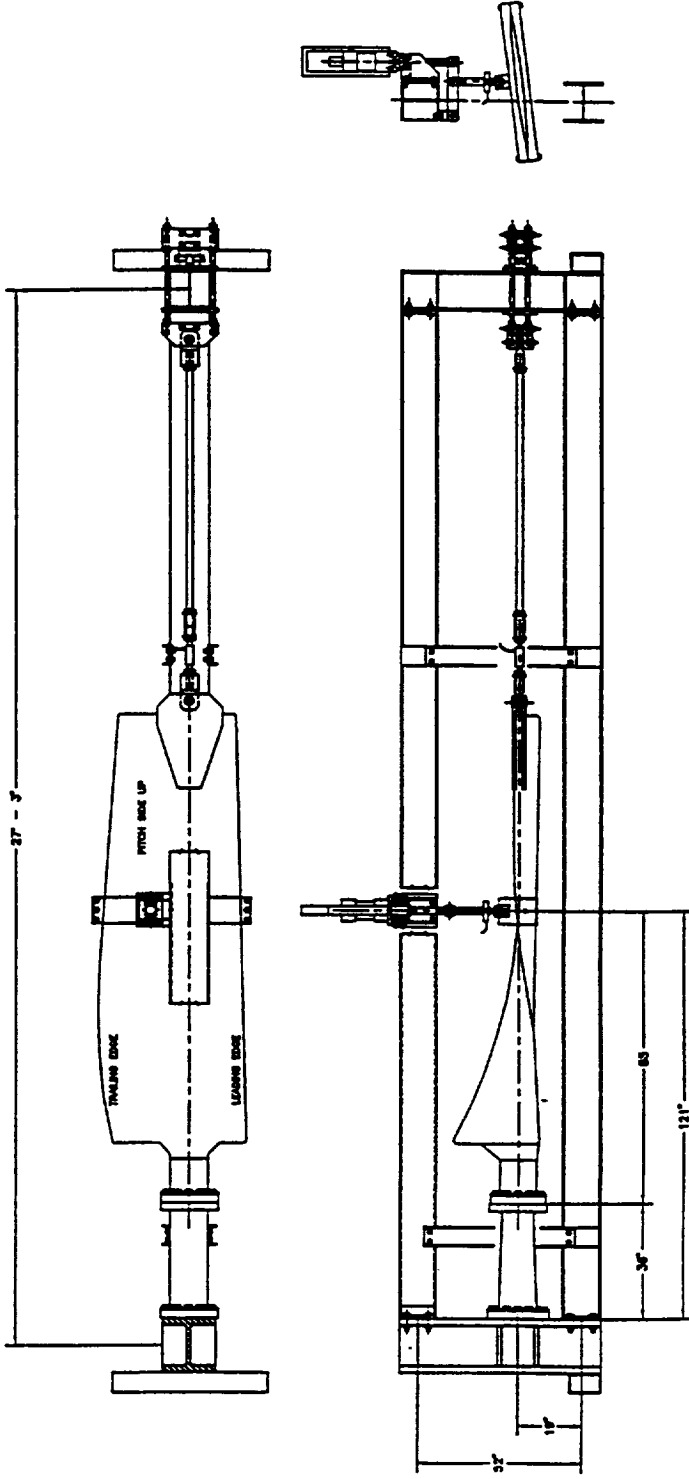
Figure 17 Fatigue test fixture.

Upon removal from the autoclave, the three prototype blades were exposed to temperatures of 30-35°F with no evidence of significant delaminations or disbonds. Two of the three blades were to be installed in the two available fatigue test fixtures at NASA Ames (see figure 17). In light of the excellent bond strengths obtained along with other process/design enhancements implemented for the blade repair, coupled with good fatigue strength of the low bond strength repair on blade 136, fabrication of all remaining blades is underway. Fatigue tests of 2 of the prototype blades (see Appendix B) will determine the expected fatigue life for the newly repaired blades with adhesive primers and process enhancements.

- steady, centrifugal loading applied axially at blade tip (induces no moment)
- moments, shear, and torque applied through a load transverse to the blade at a single point
- temperature environment simulated using heated air forced through an insulated chamber
