ENGINE OPERATING CONDITIONS THAT CAUSE THERMAL-
FATIGUE CRACKS IN TURBOJET-ENGINE BUCKETS

By James R. Johnston, John W. Weeton, and Robert A. Signorelli

Lewis Research Center
Cleveland, Ohio

MEMORANDUM 4-7-59E

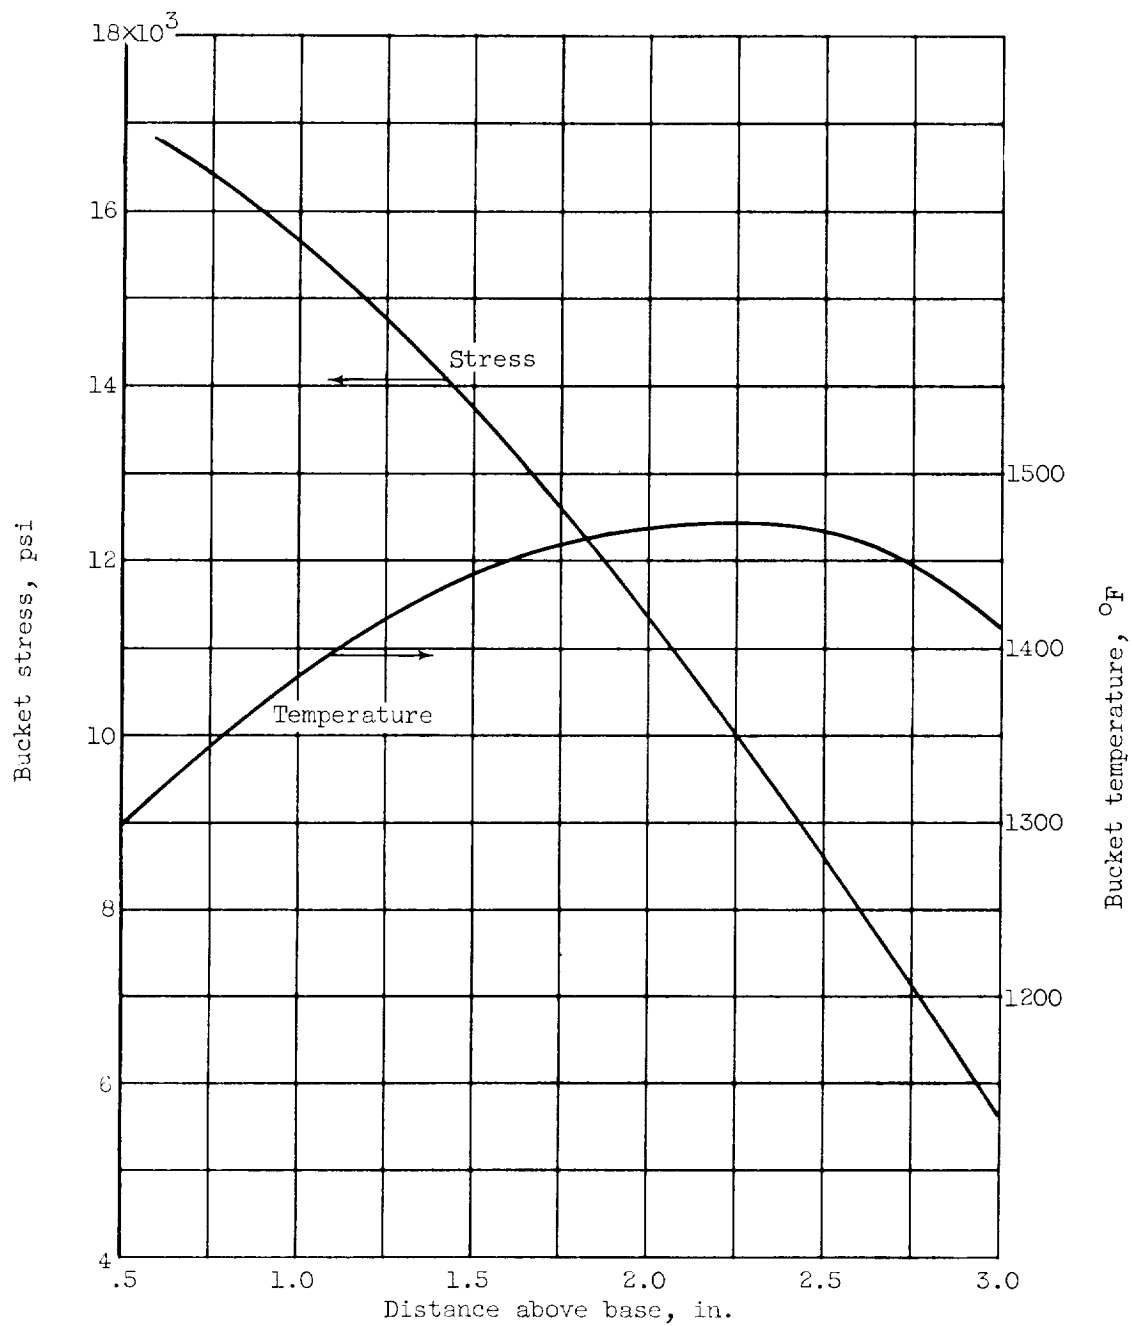
The centrifugal stress and temperature distributions in the bucket airfoil at rated engine conditions are shown in figure 1. The stress calculations were made using rotational speed, material density, and bucket geometry (ref. 3). The temperature distribution in the test engine was obtained with a spare turbine wheel prior to the installation of the test wheels. Six thermocouples were imbedded in the bucket airfoils to provide the spanwise temperature profile. By using the stress and temperature distribution in the bucket and stress-rupture data for the material, expected failure time can be computed for various sections along the airfoil span. The point with the lowest expected life is the critical zone; that is, the zone where fracture would occur if temperature and centrifugal stress were the only factors contributing to failure. The critical zone was given (for similar stress and temperature data) in reference 1 as centered at approximately 1.5 inches from the base of the airfoil. The expected life in the critical zone was greater than 10,000 hours.

Figure 1. - Distribution of centrifugal stress and temperature in J47 turbine bucket at rated-speed conditions.

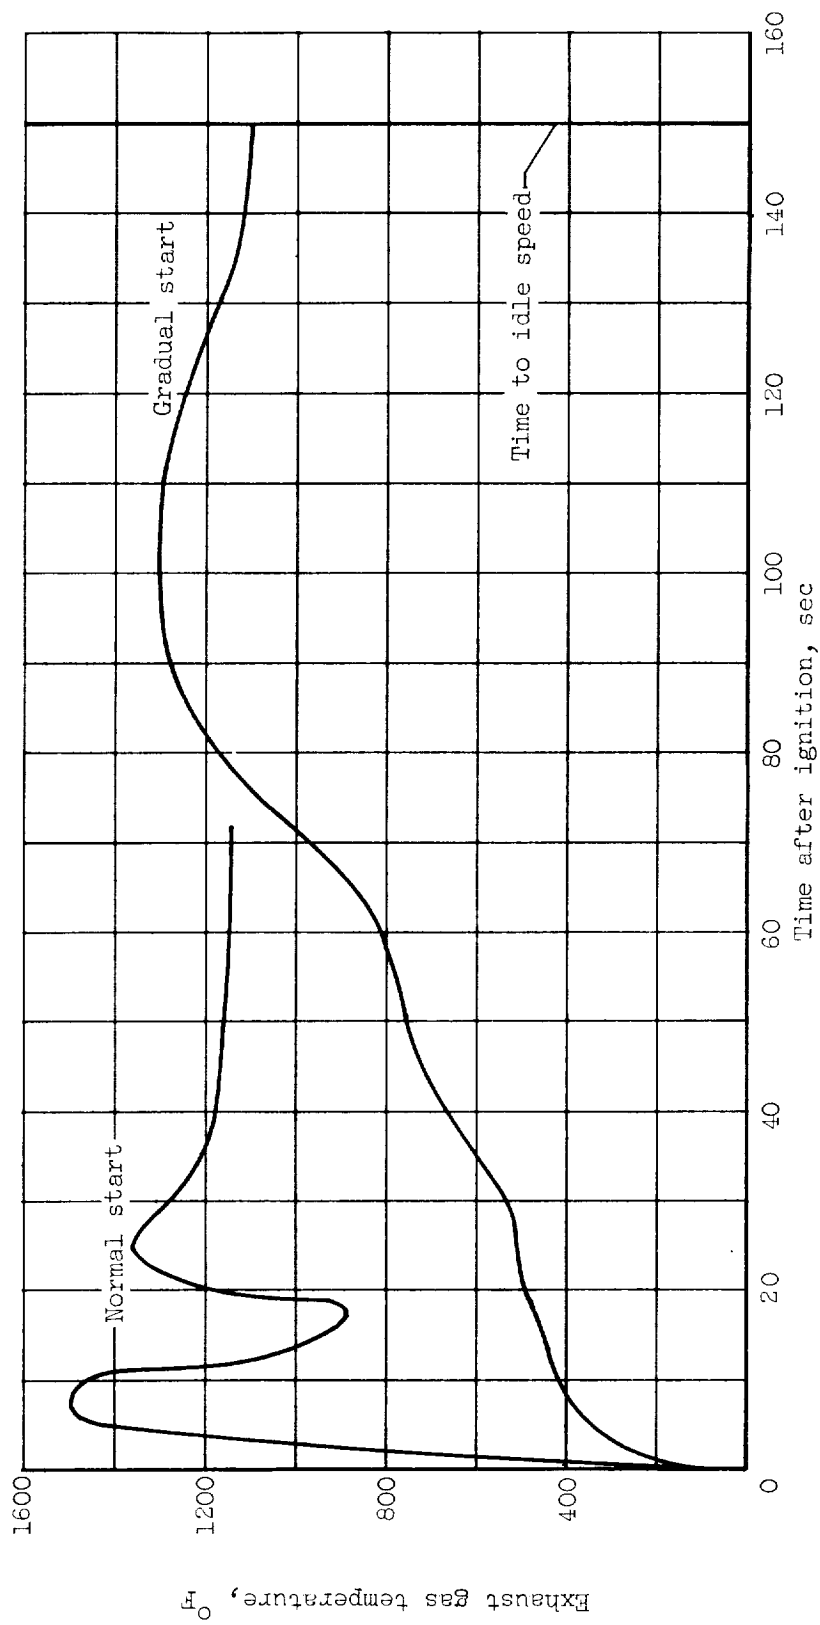
In the standard-engine fuel system, duplex fuel nozzles in all eight combustors are supplied by two common manifolds. In the standard engine, fuel is supplied only to the small slots while starting in order to limit the fuel flow in each combustor. However, the fuel flow necessary to sustain combustion causes the engine temperature to rise very rapidly. To prevent this rapid temperature rise, a distributing valve was designed to supply fuel to each combustor nozzle in sequence. This permitted the engine to ignite on one combustor and the engine temperature to increase gradually as each succeeding nozzle was supplied with fuel. A comparison of the exhaust gas temperatures for the gradual start and a normal start is shown in figure 2.

Figure 2. - Exhaust gas temperature during normal and gradual starts of J47 engine.

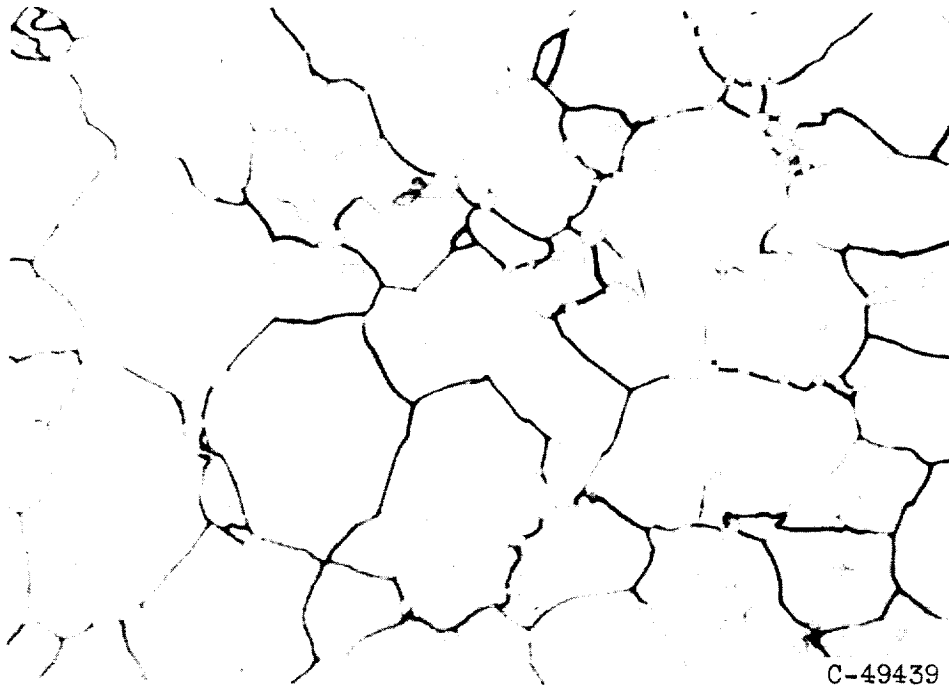
Typical microstructures of untested buckets of S-816 and M-252 are shown in figure 5. The structures appear to be normal for the as-heat-treated condition of each alloy. The microstructures of both alloys

(b) S-816. Etchant, aqua regia plus glycerol.

Figure 5. - Microstructures of as-received buckets. X750.
