NASA/TM—1999-208907

Plumbrook Hypersonic Tunnel Facility Graphite Furnace Degradation Mechanisms

Nathan S. Jacobson
Glenn Research Center, Cleveland, Ohio

March 1999

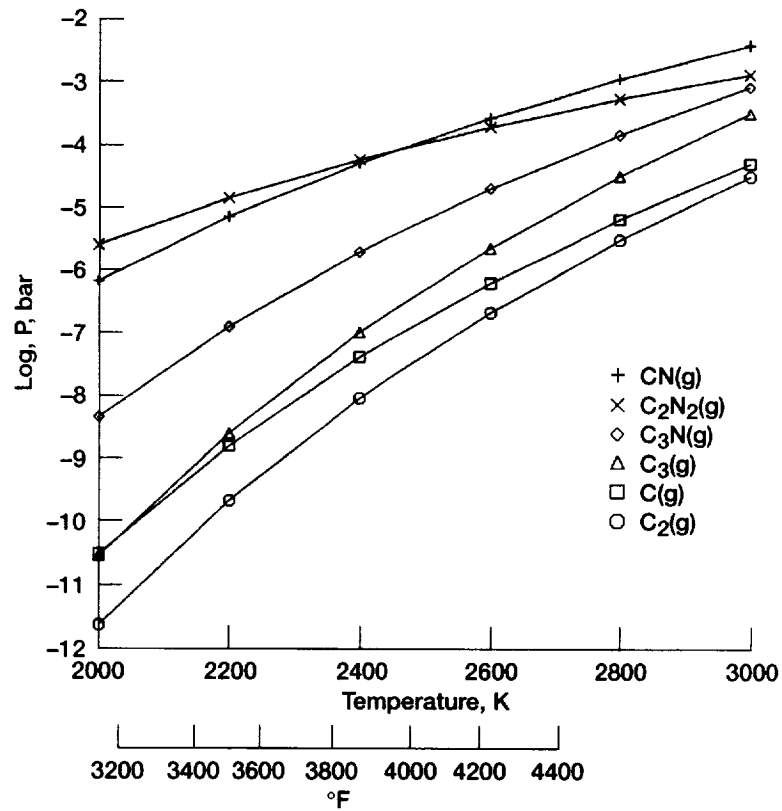
Figure 3.—Calculated reaction products for an infinite amount of carbon, 1.4 bar nitrogen.

To correctly apply this code to the problem at hand, the proper choice of reactant amounts is necessary. We fix the chemical activity of graphite equal to one (essentially an infinite piece of graphite) and put in fixed amounts of nitrogen. A total pressure of 1.4 bar (6 psig or 20.7 psia) was used and an input of 1.4 moles of nitrogen. This gives a constant pressure of 1.4 bar nitrogen above the graphite in the final products. However a portion of the nitrogen reacts to form such carbon-nitrogen species as $CN(g)$ and $(CN)_2(g)$ at reasonably large vapor pressures, as illustrated in figure 3. This suggests the key reactions are:

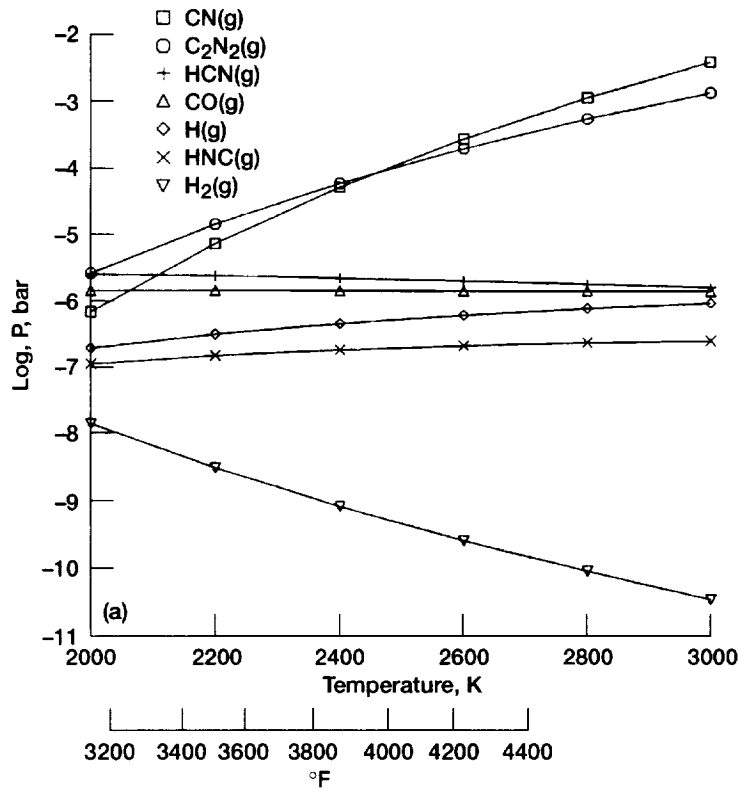
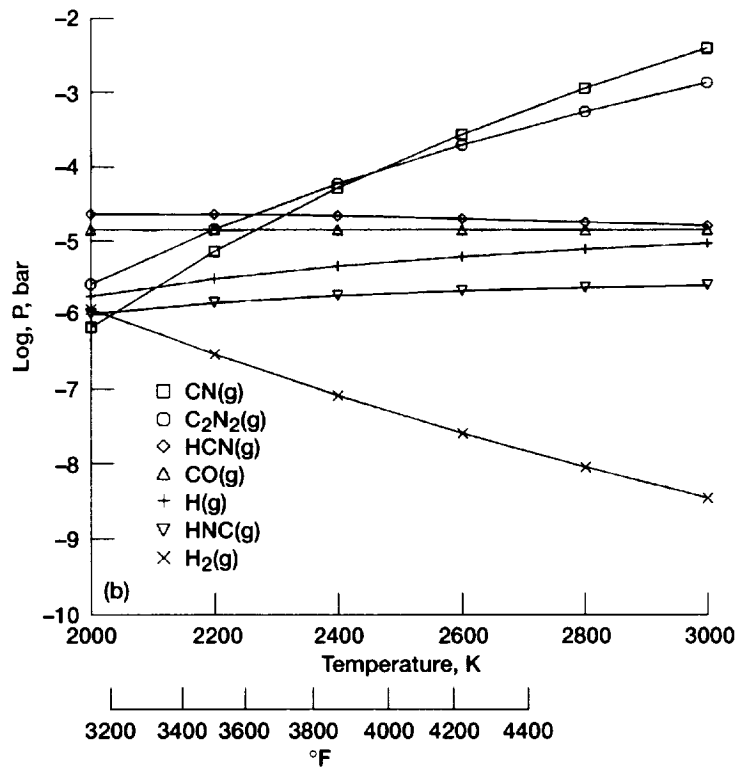
Figure 5.—Calculated reaction products for an infinite amount of carbon, 1.4 bar nitrogen, and varying initial amounts of water vapor. (a) 1 ppm water vapor. (b) 10 ppm water vapor. (c) 100 ppm water vapor. (d) 1000 ppm water vapor.

Examining the thermochemical equilibria between carbon and $\text{H}_2\text{O(g)}/\text{N}_2(\text{g})$ is more complex than that with $\text{N}_2(\text{g})$ alone. Carbon and water vapor cannot be in equilibrium at high temperatures, i.e., reaction (2) goes to completion. Any amount of water vapor in a system with carbon is completely consumed. Thus we model a total pressure of 1.4 bar with 1.4 bar nitrogen and initial water vapor levels of 1, 10, 100, and 1000 ppm. This is illustrated in figures 5(a) to (d), respectively. The key reaction is now:

Note that as water vapor content of the system increases, reaction (3) becomes more important. This can be seen in figures 5(a) to (d), where the amount of CO(g) and HCN(g) increase with water vapor content. Note also the presence of HCN(g) and HNC(g) . HCN is hydrogen cyanide and NHC is an isomer—nitrogen hydride carbide (ref. 7).

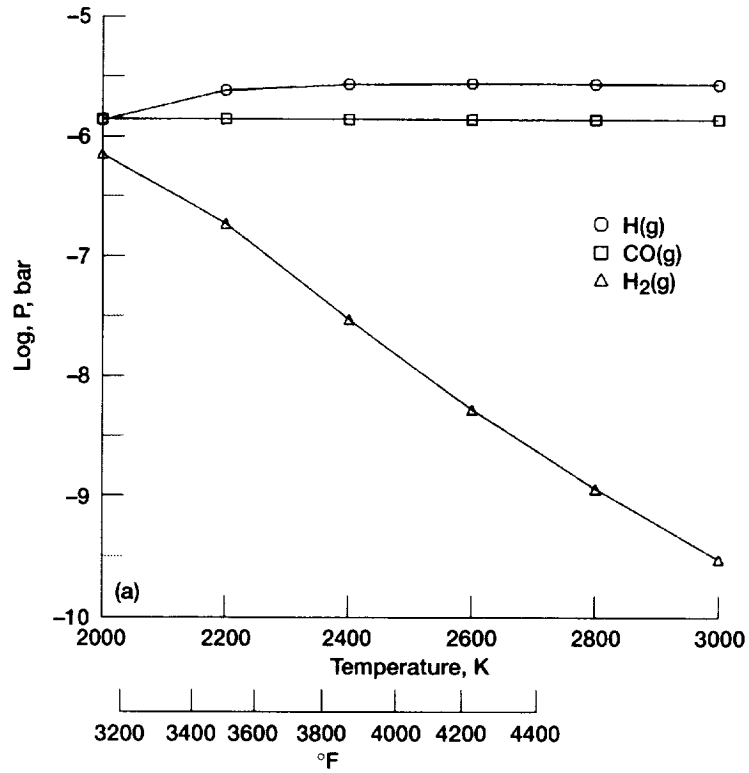
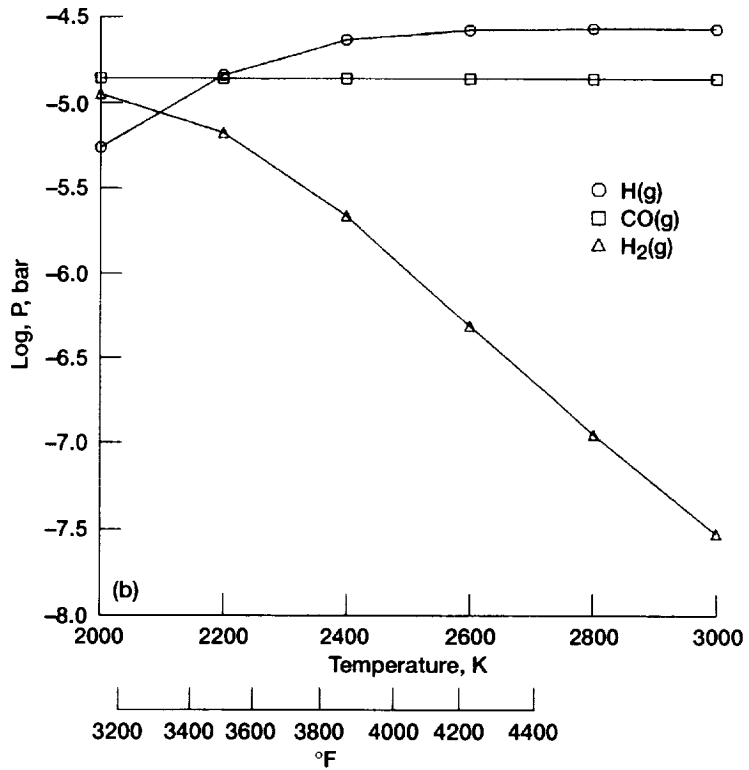
Figure 6.—Calculated reaction products for an infinite amount of carbon, 1.4 bar argon, and varying initial amounts of water vapor. (a) 1 ppm water vapor. (b) 10 ppm water vapor. (c) 100 ppm water vapor. (d) 1000 ppm water vapor.

If the nitrogen purge gas is replaced with Ar or some other inert gas, the reactions (refs. 1 and 3) which form C-N compounds would be eliminated. However in a furnace this size, there will always be some amount of water vapor. Thus the water-gas equilibrium will always occur (reaction 2). Figure 6(a) to (d) illustrates the effect of an Ar/H₂O purge gas. As expected all of the water vapor reacts completely to CO(g) and H₂(g). H₂(g) is dissociated at the higher temperatures.
