ON-ORBIT TEFLON® FEP DEGRADATION

Jacqueline A. Townsend, Patricia A. Hansen
NASA/GSFC
Greenbelt, Maryland 20771
301-286-6685
jacqueline.a.townsend.1@gsfc.nasa.gov
patricia.a.hansen.2@gsfc.nasa.gov

ABSTRACT

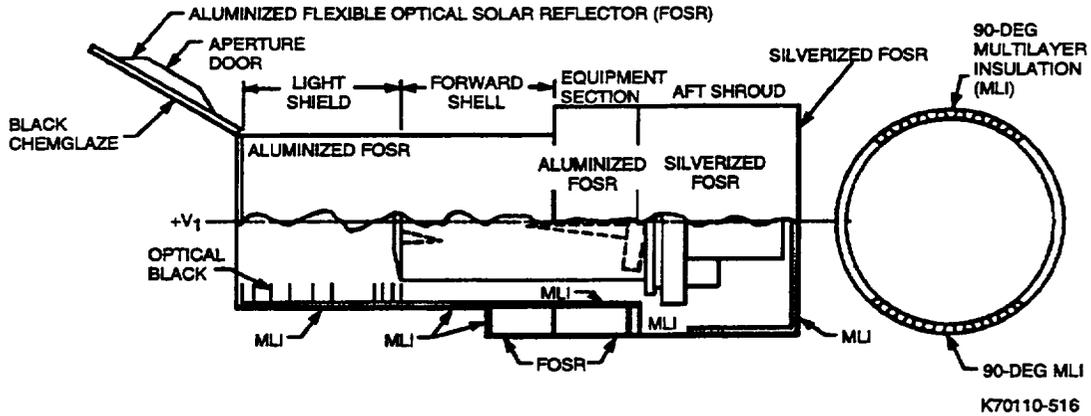
FIGURE 1: LOCATION OF HUBBLE SPACE TELESCOPE THERMAL CONTROL MATERIALS
 In this image, Flexible Optical Solar Reflector (FOSR) is defined as metallized Teflon films used either as the top layer of MLI blankets or as tapes on radiator surfaces. MLI blankets were used on the entire Light Shield and most of the Forward Shell and Equipment Bays (Equipment Section). Tapes were used on the Aperture Door, a few locations on Equipment Bays, the entire Aft Shroud, and Aft Bulkhead (bottom of the telescope).
