NASA/TM—1999-209399

Analyses of Contaminated Solar Array Handrail Samples Retrieved from Mir

Kim K. de Groh
Glenn Research Center, Cleveland, Ohio

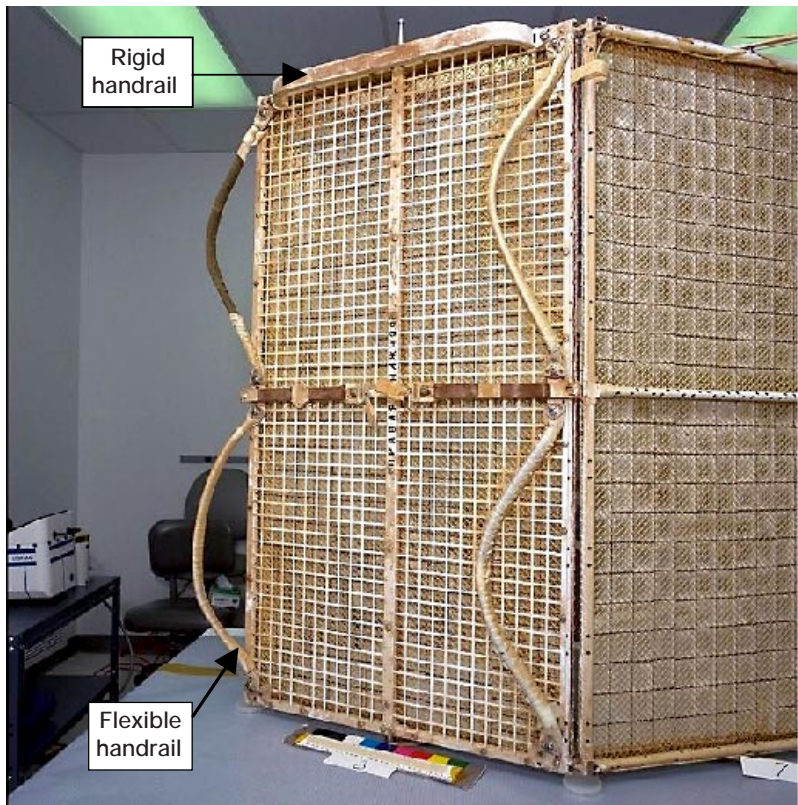
Figure 2. Backside of the retrieved Mir solar array, panel 8 (ref. 2).

Rigid Handrail Sample. The rigid handrail can be seen at the top of panel 8 in figure 2. The handrail is an aluminum rectangular hollow bar (~1.6×3.2 cm cross-section) coated with a white thermal control paint. The white paint is believed to be the Russian paint AK-573 whose components consist of silicone and acrylic binders with a ZnO white pigment (ref. 1). The nonuniform discoloration of the previously white handrail is visible in figure 2. Two sections were provided for analyses. One section was a curved end of the handrail and was labeled “zero-point.” This curved handrail section had streaky, nonuniform brown discoloration on the space-facing side of the handrail, and two distinct very uniform discolored sections, dark tan and dark brown, on the array facing side of the handrail. The space-facing and array facing sides of the curved handrail section are shown in figure 3(a) and 3(b), respectively. The second sample was cut from the flat section of the handrail (a 2.54 cm wide section). This sample was discolored on all sides of the exterior surfaces. The smaller surfaces, positioned perpendicular to the array, are dark tan, while the larger surfaces, array-facing or space-facing, are dark brown. One of the larger surfaces (side A) was more uniform in color than the other side and appeared to have faced the solar array based on similarity in appearance to the curved section. The space-facing side of the flat rigid handrail sample is shown in figure 4.

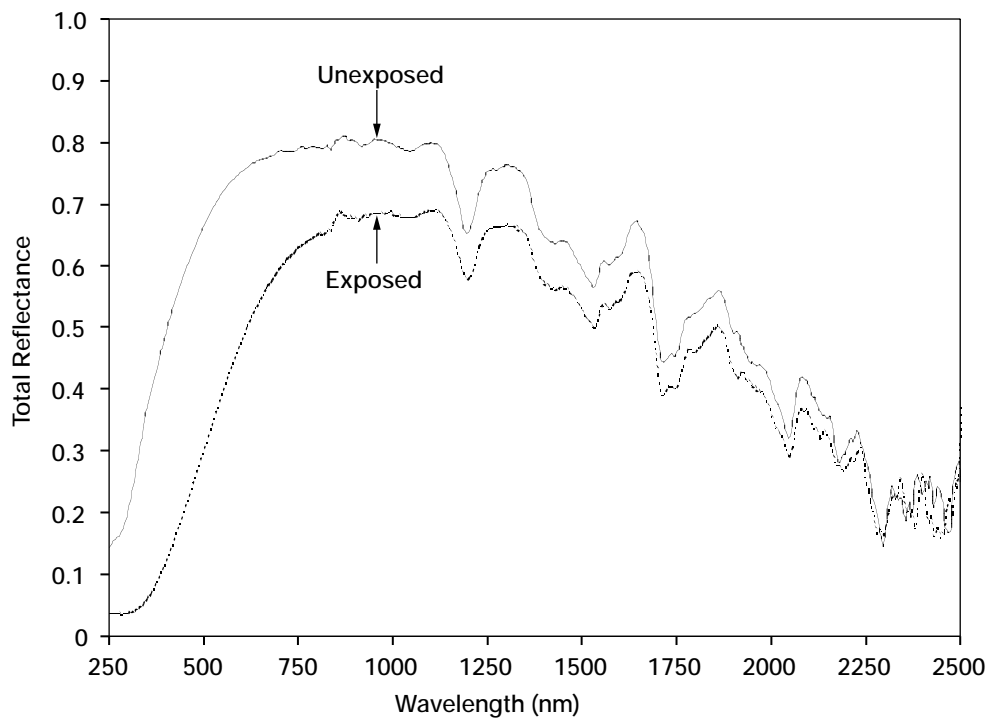
The results of optical property characterization are provided in table I. The surface browning has increased the solar absorptance of both types of handrail samples significantly. The solar absorptance of unexposed AK-573 is 0.294 (ref. 1). The solar absorptance of the darkened handrail paint was 0.537 to 0.555, an increase of 0.243 to 0.261. The spectral reflectance of the solar array facing side of the handrail sample is shown in figure 7. The flexible handrail over-wrap fabric had an increase in absorptance of 0.14 in the exposed area compared to the unexposed area. The total reflectance spectral data for the exposed and unexposed areas are shown together in figure 8.

Figure 8. Total reflectance for unexposed ($\alpha_s=0.330$) and exposed ($\alpha_s=0.465$) areas of the flexible handhold tape over-wrap fabric.

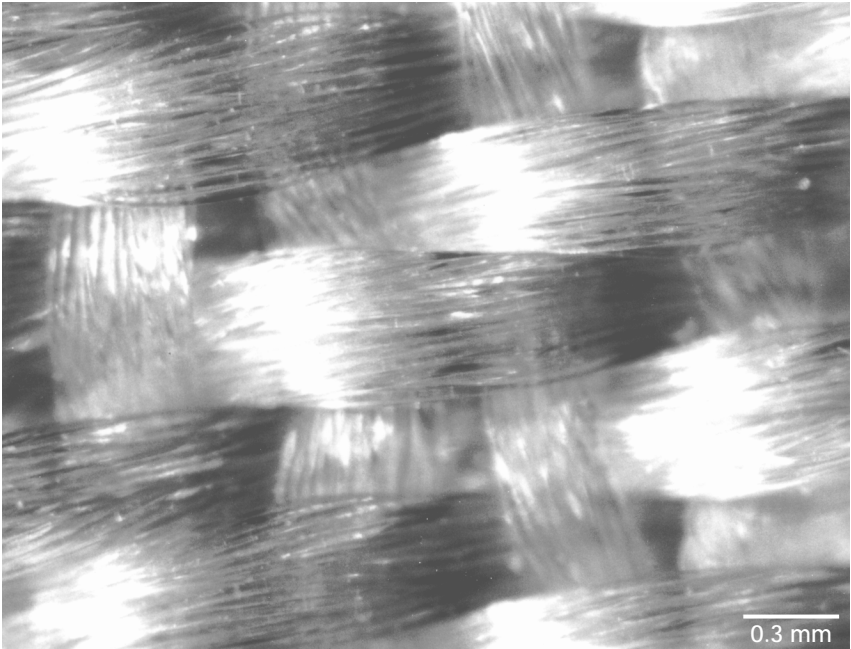
Flexible Handhold Over-Wrap Tape. Optical microscopy examination of the exposed, brown region of the handhold tape fabric revealed micro-crazing of a contamination layer, as shown in figure 11. This crazed layer is not present on the protected, unexposed region that has an off-white color (see fig. 12).

Figure 12. Protected, white side of the flexible handhold over-wrap tape fabric.

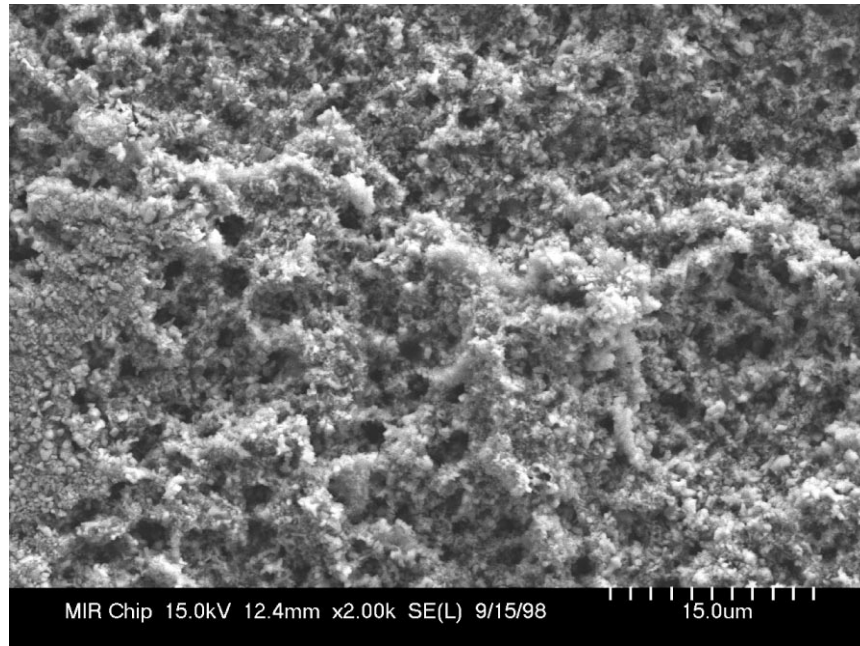
Rigid Handrail Sample (Paint Chip Sample). A flake of paint containing the brown contaminant stain was easily removed from the flat handrail sample for FESEM imaging. The sample was broke into two pieces, which exposed a clean white cross-section surface for analysis. The image and the corresponding EDS spectra for the cross-sectioned clean paint surface are shown in figures 13 and 14, respectively. The image shows a very rough porous surface. The spectra indicates that the paint consists primarily of Zn, O and C, with small amounts of Si, Ti and Al. These results appear to be consistent with the Russian white paint TP-CO-02, which contains Al and Ti in addition to Zn, O and Si which are found in AK-573 (ref. 3). In backscattered imaging, dark areas were observed and were found to be composed primarily of Ti and Zn, with a little O.

Figure 13. Cross-sectioned surface of the rigid handrail white paint.

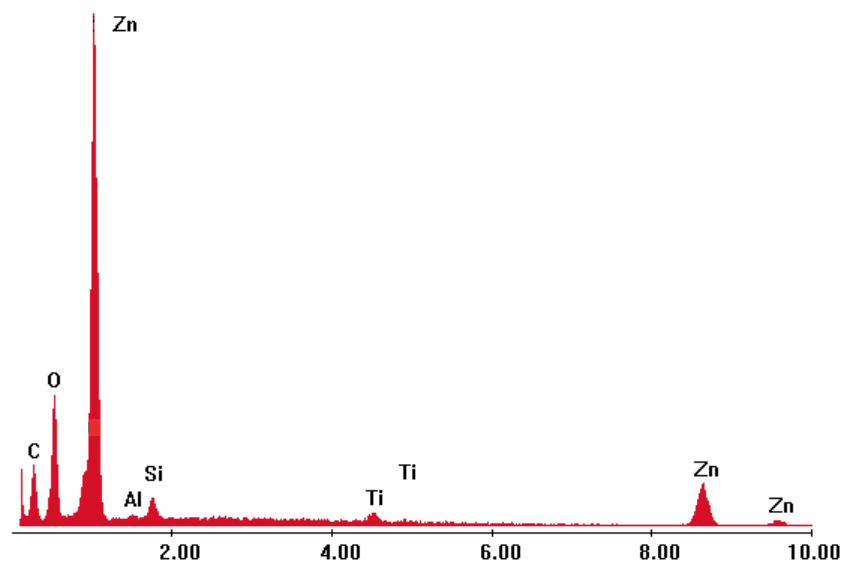
Figure 14. EDS spectra of the cross-sectioned paint sample shown in Figure 13.

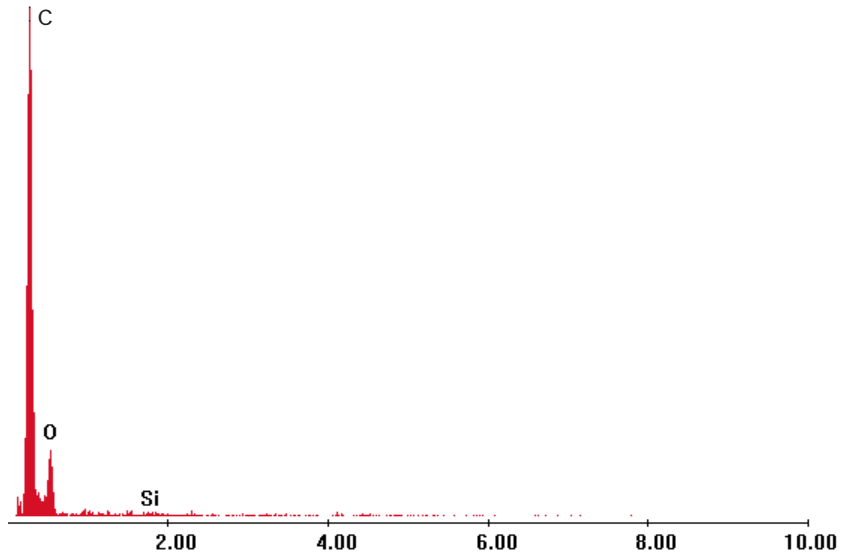
Figure 19. EDS spectra of the unexposed topside of the flexible handhold fabric, shown in Figure 18.
