Hubble Space Telescope Thermal Blanket Repair Design And Implementation

ABSTRACT

Substantial damage to the outer layer of Hubble Space Telescope (HST) thermal blankets was observed during the February 1997 servicing mission. After six years in LEO, many areas of the aluminized Teflon® outer blanket layer had significant cracks, and some material was peeled away to expose inner layers to solar flux.

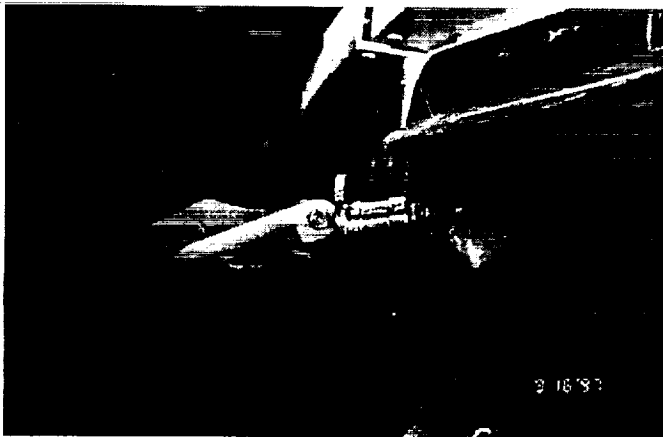
Figure 5 - NOBL curved door, doorstop attachment, doorknob attachment

The doors on Bays 6 and 9 have a curved cross-section to accommodate the reaction wheels. The NOBL foil was bonded to a 1mm steel support frame that was curved to conform to the door surface (figure 5). The vent holes on these doors were not easily accessed (as on the flat doors) because the holes in the door blankets were smaller than the vent holes. The NOBL's for these doors would be clipped to the doorstop and doorknob stem of each respective door, as shown in figure 5. This turned out to be a quicker and simpler installation than that of the flat doors using the vent plugs, but the flat doors did not have a similar doorstop/doorknob configuration.

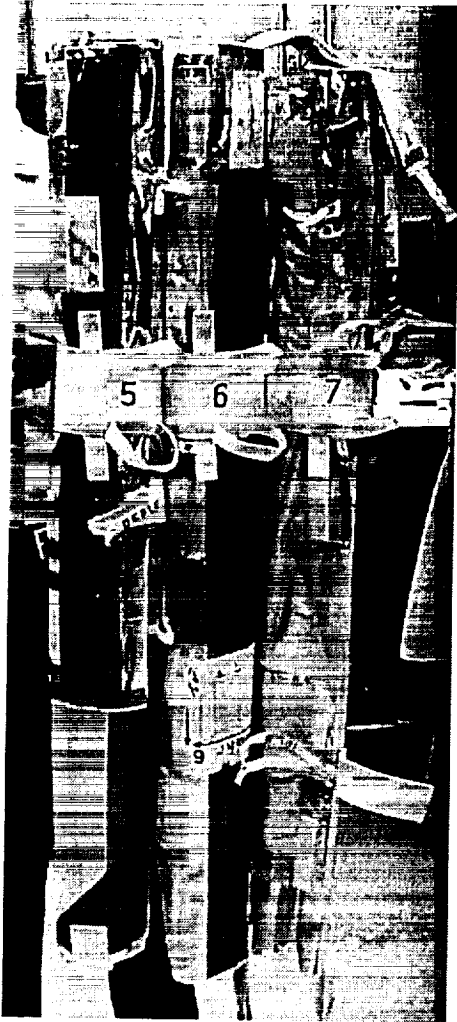
Figure 15 – SSRFs rolled up for stowage

The sunward side of the FS/LS comprises a 40m² area on the 3m-diameter telescope tube. Seven rolls of scrimmed Teflon® material were designed to cover most of this area without affecting deployables or blocking access to handrails, foot sockets, and other components. Figure 14 shows the layout of the installed material. The SSRF pieces were fabricated on a detailed HST surface simulator to allow precise cutouts and aid in location of attachments. Clip/cable attachment assemblies were attached to each SSRF, and adjusted to their predicted length. After fabrication, each SSRF piece was rolled up for compact stowage on the Shuttle (Figure 15).
