STRUCTURAL RESPONSE AND FAILURE OF A FULL-SCALE STITCHED GRAPHITE-EPOXY WING

Dawn C. Jegley and Harold G. Bush
NASA Langley Research Center
Hampton, VA

Presented at the AIAA/ASME/ASCE/AHS 42nd Structures,
Structural Dynamics and Materials Conference

AIAA Paper No. 2001-1334-CP
Seattle, WA

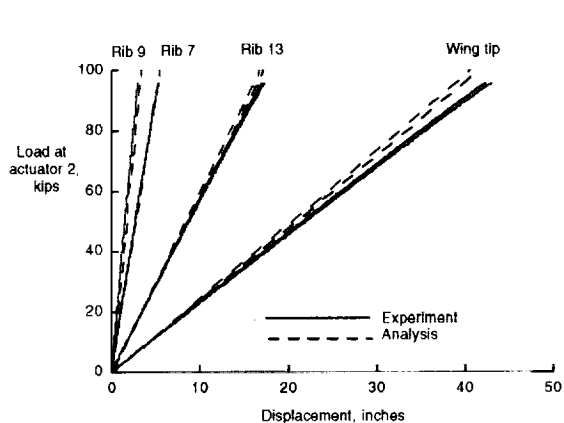
Fig. 7. Displacements at six outboard load introduction points.

Analytical and experimental displacements at the six most outboard actuator locations are shown in figure 7. Solid lines represent the measured displacements and dashed lines represent predicted displacements. Measured displacements are the elongation of the actuator rather than a measurement perpendicular to the floor. Since the initial position of all actuators active in the 2.5G condition is vertical, the difference between the displacement perpendicular to the floor and the stroke of the actuator is dependent upon the rotation of the actuator during loading. The largest displacement (and largest rotation) is for actuator 2 at the wing tip. The measured deflection is 40 inches and the initial position of the intersection of the actuator assembly and the test article is 168 inches above the floor. The angle between the initial vertical position of the actuator and the final tilted position can be calculated to be less than 2 degrees, resulting in a negligible difference between vertical displacement and stroke⁷.

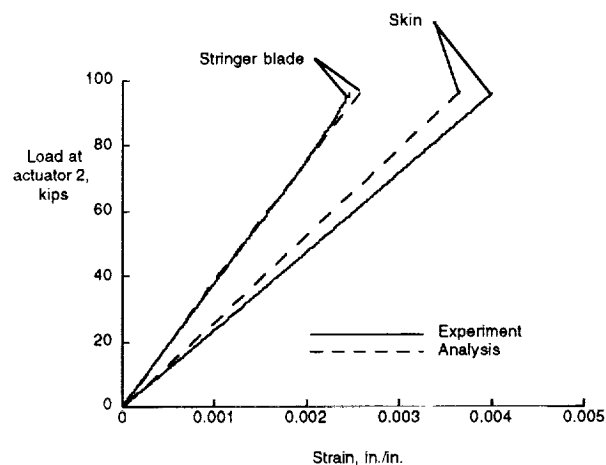
Fig. 9. Strain in stringer blade and skin at stringer 4 in the lower cover panel between ribs 12 and 13.

Strains in the lower cover panel at stringer 4 between ribs 12 and 13 and at stringer 7 between ribs 7 and 8 are shown in figures 9 and 10, respectively. Excellent correlation between experiment and analysis is seen in the skin between ribs 7 and 8 and in the stringer between ribs 12 and 13 until immediately prior to failure. The repair, which was not modeled in the analysis, is located between ribs 8 and 9 and may have some influence on these blade strains. Strains remain linear until immediately prior to failure. Strains in the lower cover runout of stringer 2 at rib 10 are shown in figure 11. Analytical strains at this runout agree well with experimental data.

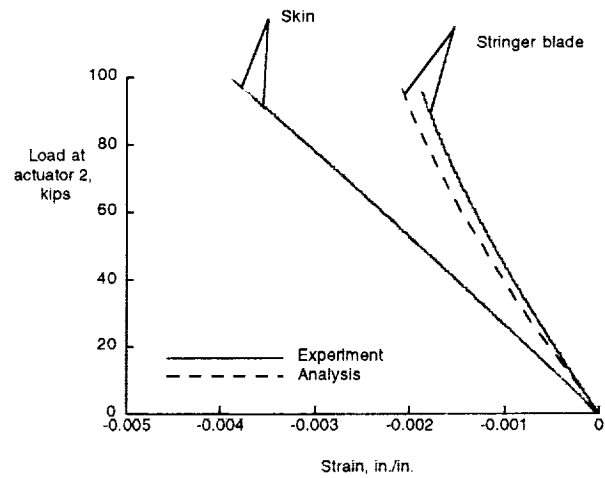
Fig. 14. Strain in stringer blade and skin at stringer 2 in the upper cover panel between ribs 8 and 9.

Strains in the upper cover panel at stringer 6 between ribs 12 and 13, at stringer 6 between ribs 9 and 10, at stringer 2 between ribs 8 and 9, and at stringer 8 between ribs 8 and 9 are shown in figures 12, 13, 14, and 15, respectively. For most of these cases, the agreement between analytical and experimental results is good. Excellent correlation between experiment and analysis is seen in the skin inboard from rib 12 and in the stringer outboard from rib 12 until immediately prior to failure. The repair, which was not modeled, is located between ribs 10 and 11 and may have some influence on experimental strain data. Strains do not remain linear in the upper cover panel. The maximum strains in any upper cover runout location are in the runout region at the rear spar at rib 9. Strains at this stringer runout 10.5 inches inboard from rib 9 are shown in figure 14. The blade is tapered in height as well as thickness at this location.
