THERMOGRAPHIC ANALYSIS OF COMPOSITE COBONDS ON THE X-33

ABSTRACT

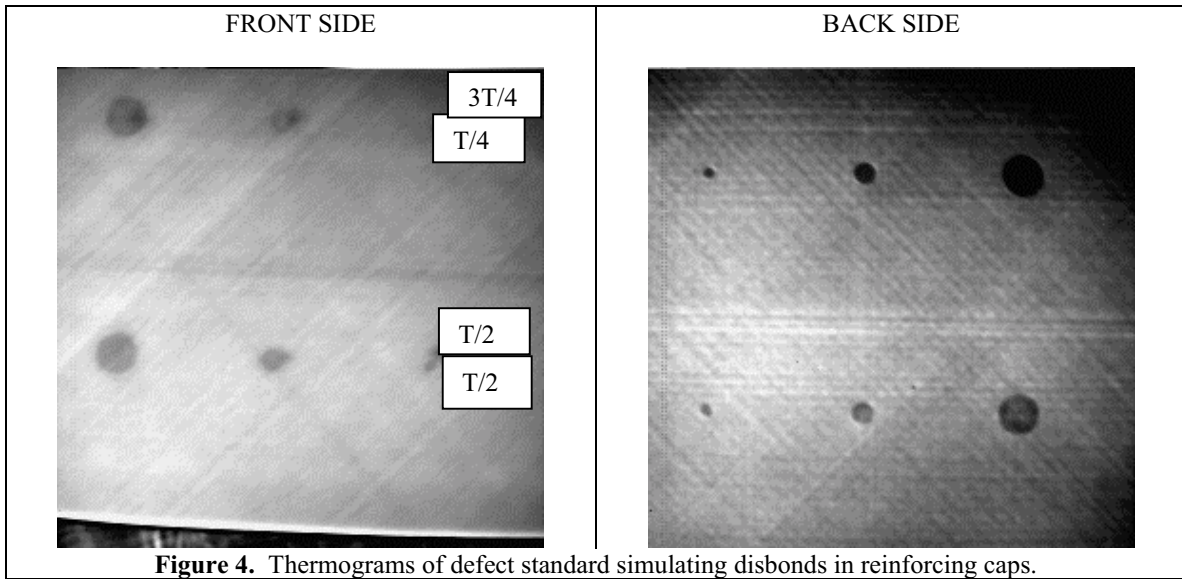
Figure 4. Thermograms of defect standard simulating disbonds in reinforcing caps.

Inspection of the wet bond line may have also detected defects in the reinforcing caps above the bond line. Defect standards were fabricated to simulate defects in the reinforcing caps themselves. Inserts were fabricated into sample panels between plies at various depths to simulate internal unbonds. The images shown in Figure 4 were acquired

with the digital system previously described, with the exception that a 25 mm lens (6"x6") field of view was employed. In the images the depth of the insert is given as a fraction of the panel thickness (T). Three insert diameters were used including 0.50, 0.25 and 0.125 inch.

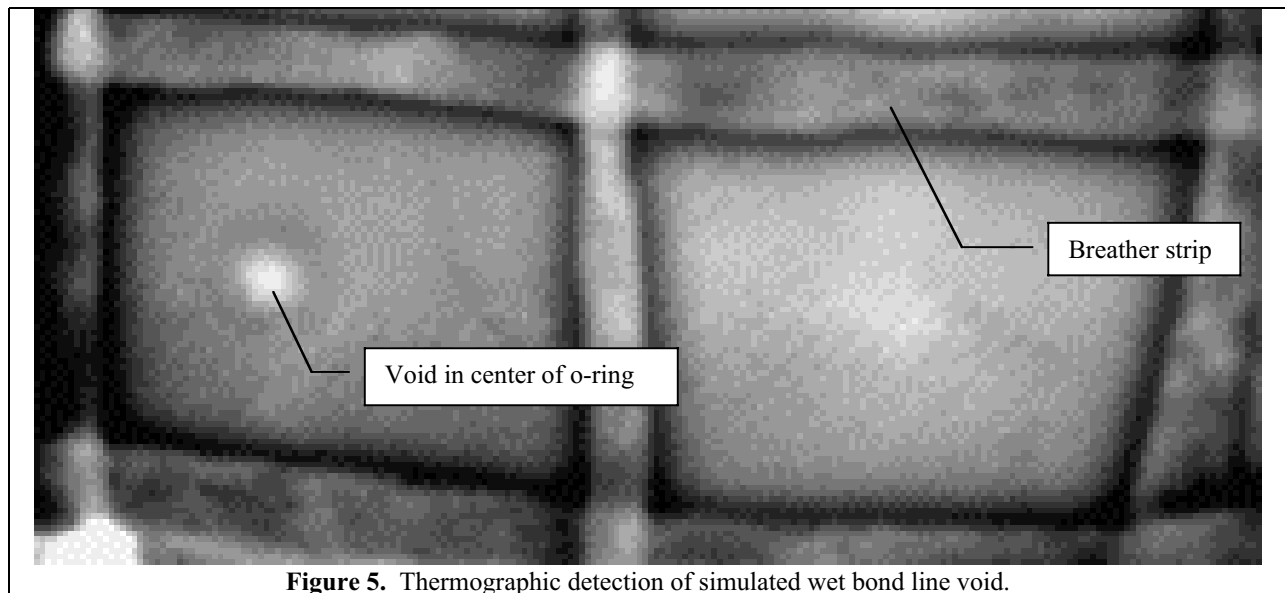
Figure 5. Thermographic detection of simulated wet bond line void.

As a method to simulate unbonds during cure a defect panel was fabricated with inserts in the wet bond line. The simulated void shown thermographically in Figure 5 was produced by inserting a 0.5 inch diameter rubber o-ring between the simulated cap and underlying material. The cap was covered with a layer of release ply and vacuum bagged. Narrow strips of breather cloth were used in this instance rather than the split plastic breather tubes. The part was then inspected by heating the surface with a pair of shop lamps for about 10 seconds. Note how the void trapped within the o-ring remains hotter than the surrounding bond line demonstrating the presence of a void.

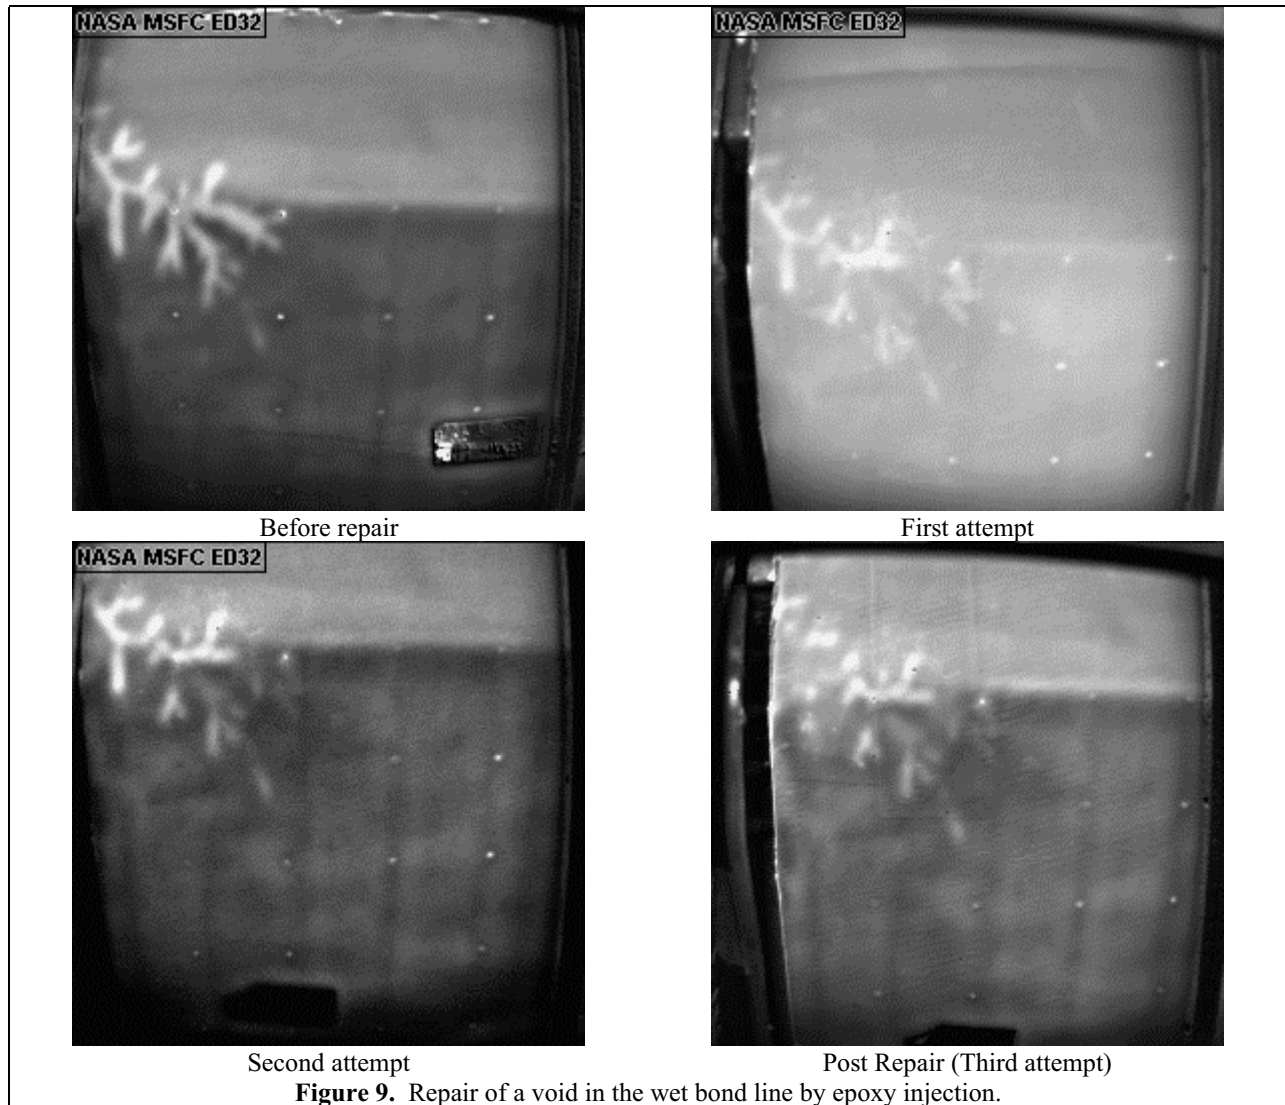
Since this defect was unacceptably large an action was taken to try to fill the void with epoxy. To aid in the repair process lead foil tape markers were placed on the cap identifying the exact location of each leg of the void and verified by re-inspecting the region. Holes were then drilled in the reinforcing cap over the void and injected with epoxy to fill it. Thermograms were taken at various stages in this process are shown in Figure 9. After the third injection of epoxy, the size of the void had been diminished sufficiently that it was deemed acceptable.
