NASA/TM—2002-211509

RQL Sector Rig Testing of SiC/SiC Combustor Liners

Michael J. Verrilli and Lisa C. Martin
Glenn Research Center, Cleveland, Ohio

Combustor liners, manufactured from silicon carbide fiber-reinforced silicon carbide, (SiC/SiC), were tested for 260 hrs using a simulated gas turbine engine cycle. This report documents the results of the last 56 hours of testing. Damage occurred in one of the six different components that make up the combustor liner set, the rich zone liner. Cracks in the rich zone liner initiated at the leading edge due to stresses resulting from the component attachment configuration. Thin film thermocouples and fiber optic pyrometers were used to measure the rich zone liner's temperature and these results are reported.

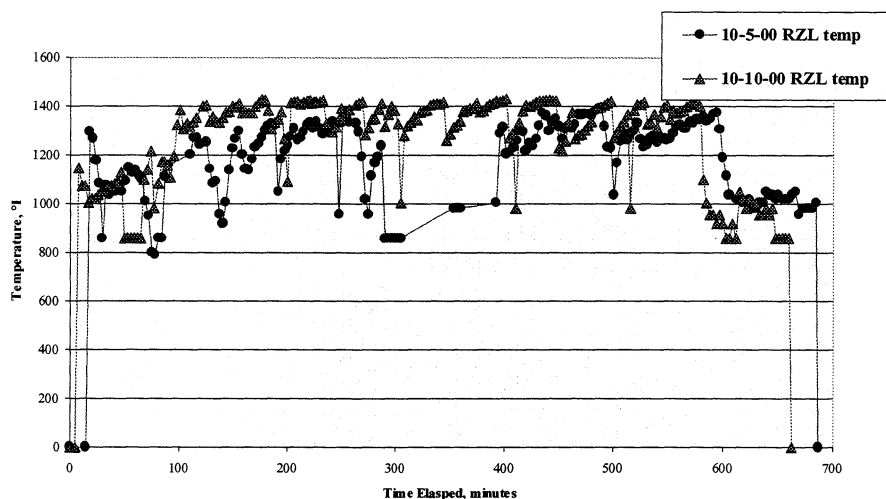
Figure 13 – Rich zone liner temperature measured during sector rig testing.

7.3.1 Fiber Optic Pyrometry Data – Figure 13 shows the temperature of a RZL versus time measured during two of the test runs. The temperature was measured 3.5 in. aft of the fuel/air nozzle and was obtained during the fourth and fifth test runs, when the second set of RZLs was installed. Note that the pyrometry system is not accurate below about 850 °F.

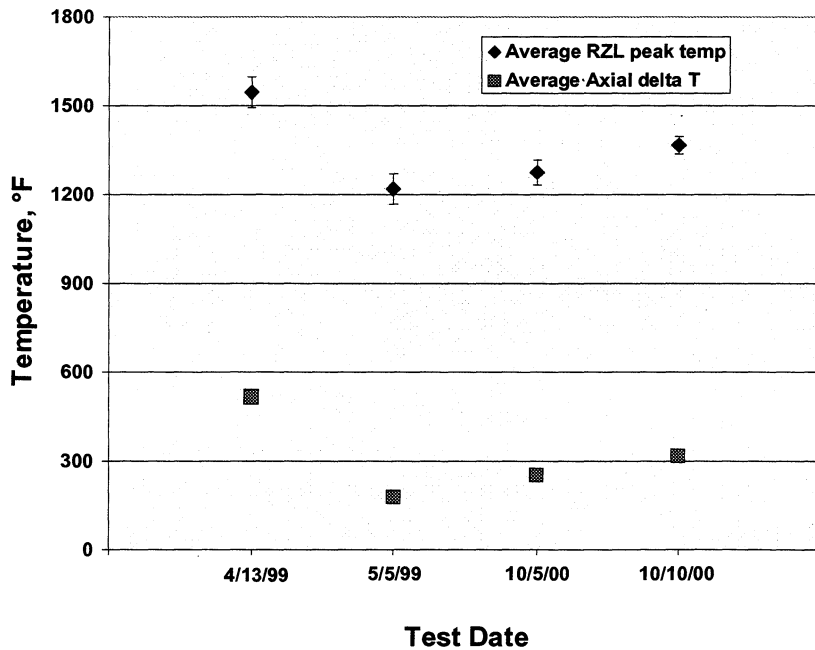
Figure 14 – Average peak temperature of rich zone liners measured during the supersonic cruise portion of the test cycle and calculated axial delta T as a function of test date.

The average peak temperature measured during the supersonic cruise portion of the cycle is shown in Figure 14. Data obtained during the current study is shown along with some temperature data obtained during the previous 205 hours of testing. The maximum rich zone liner temperatures measured during the current study are within the range obtained during previous sector testing. Figure 14 also shows the axial temperature gradient, which is the difference between the average peak liner temperature and the combustor inlet air temperature, T3. The leading edge of the RZLs is cooled by the inlet air and therefore is at the same temperature. The axial gradients vary from 175 to 515 °F.

The most critical aspect of material performance under the combustion environment is managing the thermal stresses (refs. 8–9). Liner temperature measurements indicated that a thermal gradient exists along the flow direction during operation (Figure 14). The gradient is based on temperatures measured along one linear section of the RZLs. It is likely that temperatures varied around the circumference of the liners, as a variation in oxide color (and therefore oxide thickness) was generally observed in tested RZLs (Figure 11). The presence of carbon deposits on the ID (Figure 12) likely affected the liner temperatures. Also, the thermal stresses, that are most important to design of the liners, are due to through-thickness temperature gradients. Thus, it is possible that the data in Figure 14 represents a lower bound for temperature gradients that would be critical to liner durability.

As part of this study, modifications of the fuel/air nozzles were made in an attempt to reduce the flow of by-pass air into the combustion stream and thus reduce the axial thermal gradient in the RZLs. The fuel/air nozzles contain seals that were designed to minimize the by-pass air flowing into the combustor. The presence of by-pass air in the combustion flow cools the upstream portion of the RZLs, but does not affect the temperature in the hottest portion of the liner, the aft end. This was verified with pyrometry data from tests conducted in 1999. The axial temperature gradients measured during tests conducted in 1999 bounds the gradients measured during the present study (Figure 14). Thus, the modifications of the fuel/air nozzles did not reduce the thermal gradients along the flow direction.

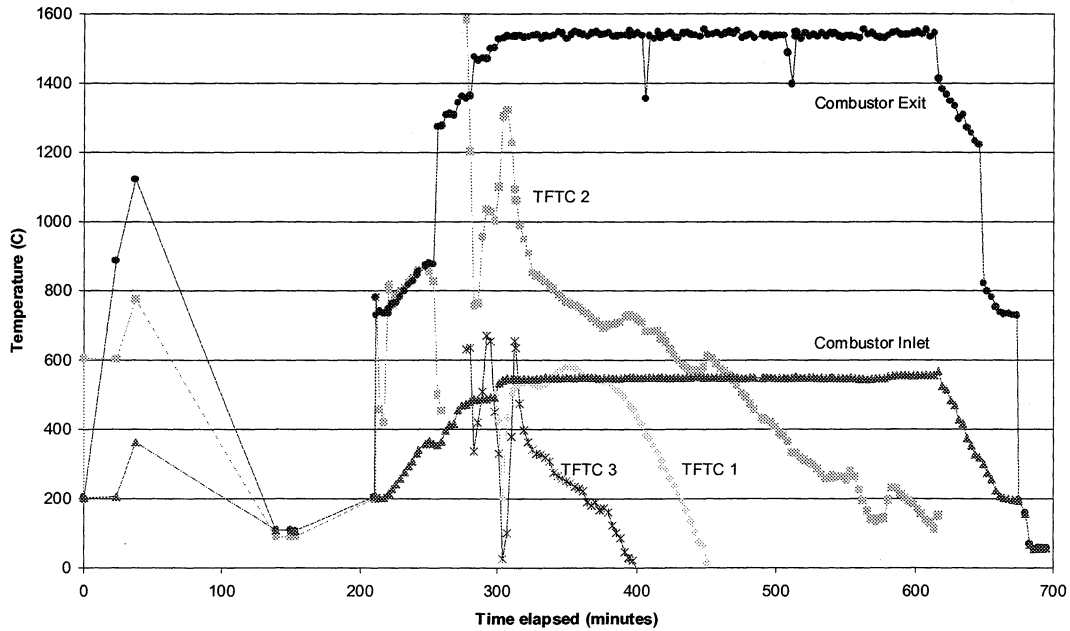
Figure 15 – Thin film thermocouple data obtained during sector rig testing.

7.3.2 Thin Film Thermocouples – The RZLs instrumented with thin film thermocouples were exposed to room temperature air for approximately 220 minutes and heated air for approximately 210 minutes flowing about 2 lbs/s prior to the combustor being lit. This exposure was due to facility problems that prevented the initiation of testing. Only a few temperature data points were recorded during this period, however, the thin film thermocouple data obtained during this time indicated that the material surface temperature was between the combustor inlet and combustor exit temperatures. Once the combustor was lit, the thin film thermocouple output was erratic as the temperatures were increasing. The output of two thin film thermocouples and the combustor inlet and exit temperature data are shown in Figure 15. The thermocouple data eroded with time after exposure to the elevated temperatures.

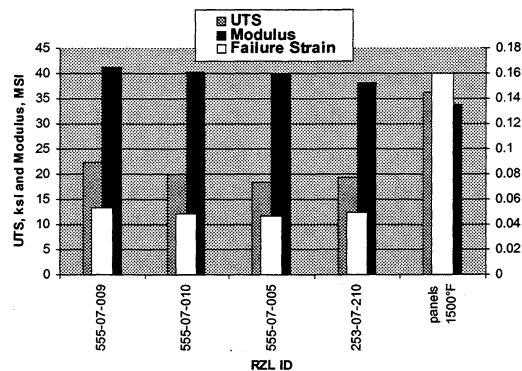
Figure 17 – As- manufactured strength, modulus, and failure strain obtained through ring burst tests for the rich zone liners exposed in the sector rig.

As part of the characterization of the as-manufactured RZLs, the hoop tensile properties were measured. A hydrostatic ring test facility was used to test two witness coupons from each component at room temperature (ref. 11). The strength, modulus, and strain to failure for the four rich zone liners are compared to data obtained from plate specimens machined from the same vintage material in Figure 17. On average, the rich zone liner witness coupons had 45% lower strength, 70% lower failure strain, and 20% higher modulus than the plate specimens. Thus, the properties indicate that the rich zone liner composite was more brittle and weaker than material in plate form. Note that panel data was the basis for the component design.

Quality of material may have contributed to the severity of damage observed. The as-manufactured components were ranked based on NDE results, mechanical and thermal properties from witness coupons, and microstructural quality. The highest rated rich zone liners were selected for initial rig testing. Three sets of RZLs (six total) were tested during the first 205 hours of sector rig operation in 1999. The first set failed catastrophically due to design issues with the attachment system. The other two sets of RZLs tested in 1999 did develop cracks, but had less damage (in terms of total crack length) and were tested longer (65 and 80 hrs) than those tested in this study. The four RZLs discussed in this paper were

ranked lower than the six tested in 1999. In particular, the last PL-side RZL (253-07-210) that failed (Figure 10) had the lowest rank of the ten.
